**Project Name:** HOLLINGWORTH RD, LITTLEBOROUGH  
**Project Date:** 27/04/2021  
**Inspection Standard:** MSCC3 Sewers & Drainage GB (SRM4 Scoring)

**Company:** VISTRY PARTNERSHIPS YORKSHIRE LTD  
**Contact:** IAN HEBBLETHWAITE  
**Street:** THUNDERHEAD RIDGE  
**Town or City:** GLASSHOUGHTON  
**County:** WEST YORKSHIRE  
**Post Code:** WF10 4UA

**Company:** SUB GROUP LTD  
**Description:** SURVEYING  
**Contact:** JOE WALSHAW  
**Department:** CCTV  
**Town or City:** DONCASTER  
**County:** SOUTH YORKSHIRE  
**Post Code:** DN3 1PQ  
**Phone:** 01302 880537  
**Email:** joe.walshaw@sub-group.co.uk

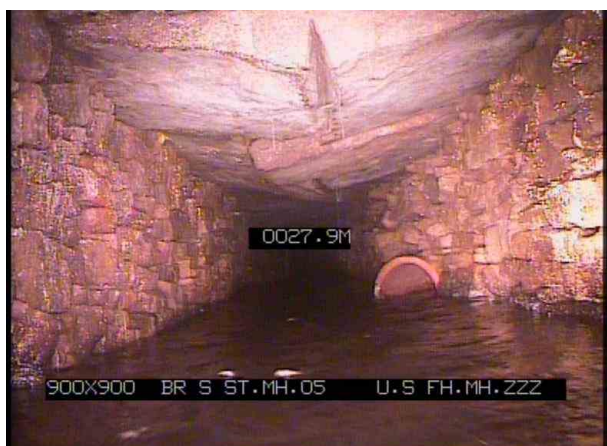
| Section | PLR | Grade | Description |
|---|---|---|---|
| 5 | ZZZX | 4 | Broken sewer from 11 o'clock to 1 o'clock |

| Scale: | 1:262 | Position [m] | Code | Observation | MPEG | Photo | Grade |
|---|---|---|---|---|---|---|---|
| | | 27.90 | B | Broken sewer from 11 o'clock to 1 o'clock: SLAB BROKEN | 00:02:36 | ZZZX_e4a6e72c-c616-483d-9fd | 4 |

ZZZX\_e4a6e72c-c616-483d-9fda-125620884cf1\_20210427\_1  
12813\_967.jpg, 00:02:36, 27.90 m  
Broken sewer from 11 o'clock to 1 o'clock, SLAB BROKEN

- Grade 3: Best practice suggests consideration should be given to repairs in the medium term.
- Grade 4: Best practice suggests consideration should be given to repairs to avoid a potential collapse.
- Grade 5: Best practice suggests that this pipe is at risk of collapse at any time. Urgent consideration should be given to repairs to avoid total failure.

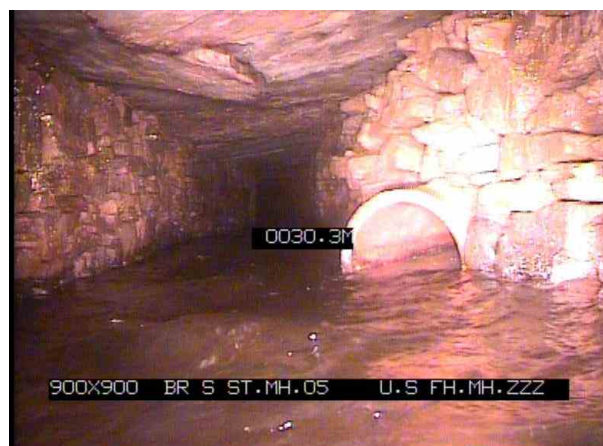
| Section | PLR | Grade | Description |
|---|---|---|---|
| 5 | ZZZX | 5 | Connection, intruding at 3 o'clock, 225mm diameter, 200mm intruding |

ZZZX\_c4718e43-bf3e-4306-81df-7f17a0411a36\_20210427\_1  
13023\_517.jpg, 00:04:24, 30.30 m  
Connection, intruding at 3 o'clock, 225mm diameter, 200mm intruding

- Grade 3: Best practice suggests consideration should be given to maintenance activities in the medium term.
- Grade 4: Best practice suggests consideration should be given to maintenance activity to avoid potential blockages.
- Grade 5: Best practice suggests that this pipe is at a high risk of backing up or causing flooding.
