**ENGINEERING REPORT 9142**

**CROSSFIELD BARN RETAINING WALL  
GANDY LANE  
WHITWORTH**

**CLIENT: BESPOKE GARDENS  
(GORDON HAMILTON)**

**25.09.2023 MP/CH**

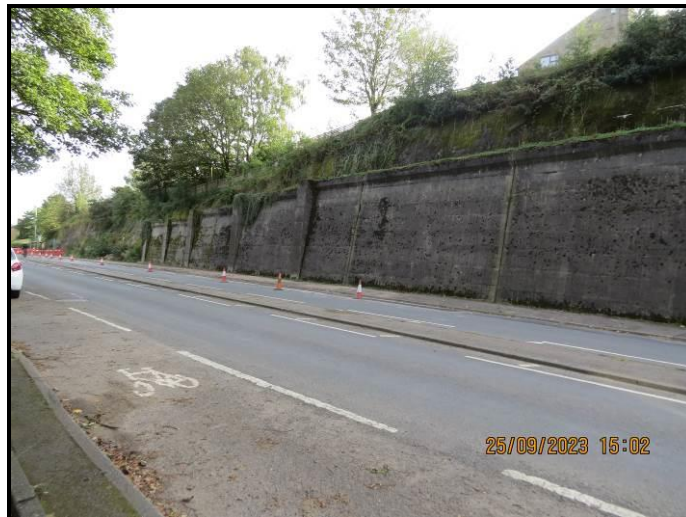
- 2.1 The retaining wall is located on the top of an existing North Eastern facing embankment above a 4 – 5 metre high reinforced concrete retaining wall located on the South West side of Whitworth Road, Rochdale. (Photographs 011, 015).

Photograph 011 Whitworth Road, retaining wall and upper slope

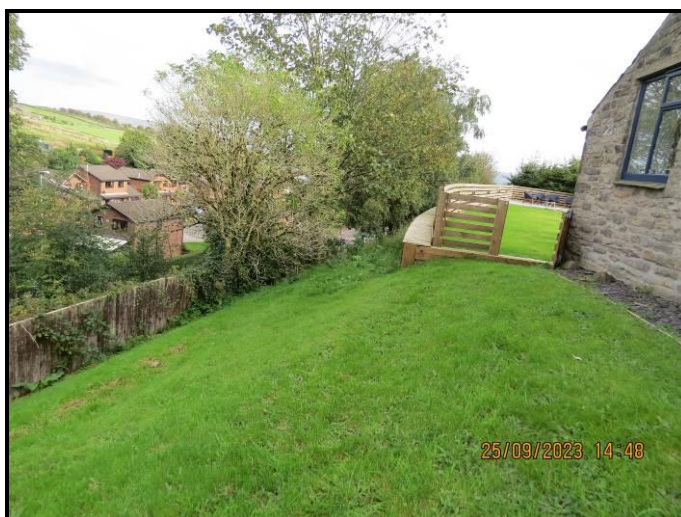
- 2.2 From the top of the wall the embankment slopes to the lower wall area of Crossfield Barn at an angle of approximately 29° - 30° incorporating an existing timber boundary fence with mature trees and foliage offset from the corner of Crossfield Barn by a distance in the order of 5 metres. (Photograph 008).

Photograph 008 Close up of new wall and existing foliage

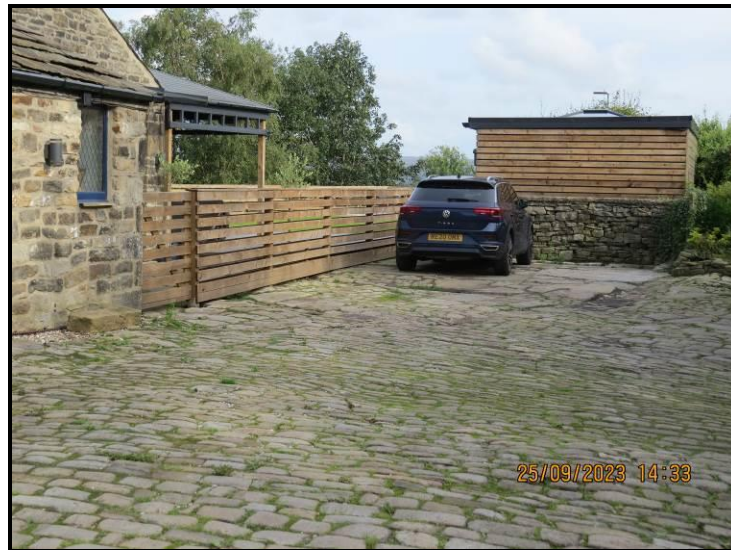
**Photograph 002 Courtyard to South East elevation of Crossfield Barn**

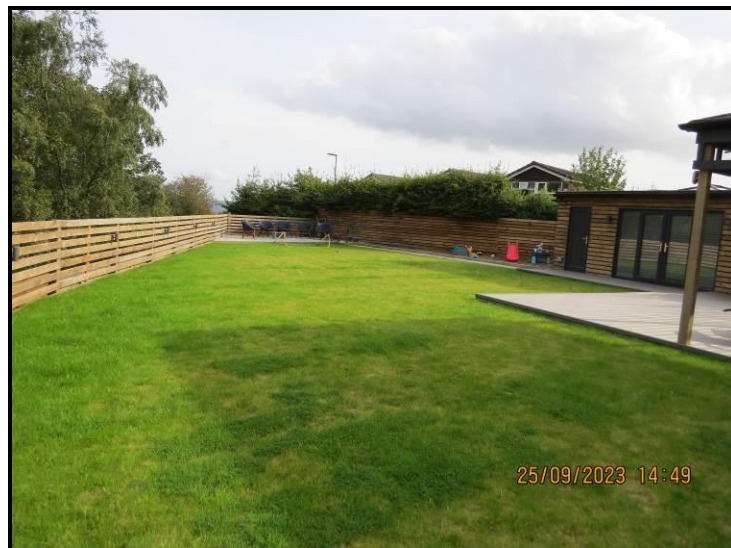
- 2.2 The main wall is aligned on a North West/South East orientation supporting the edge of the lawn to the property, comprising of a 200mm thick concrete base 1200mm wide, founded on firm to stiff sub-strata supporting a composite inner block (on face) 200mm, 50mm – 100mm cavity in nominal reinforcement and an outwards concrete block face 110mm thick, forming an overall wall thickness in the order of 450mm, extending for a height above existing ground level of mainly 1 metre increasing slightly to 1.2 metres towards the South Eastern end. (Photographs 001, 009).

**Photograph 009 Top lawn area**

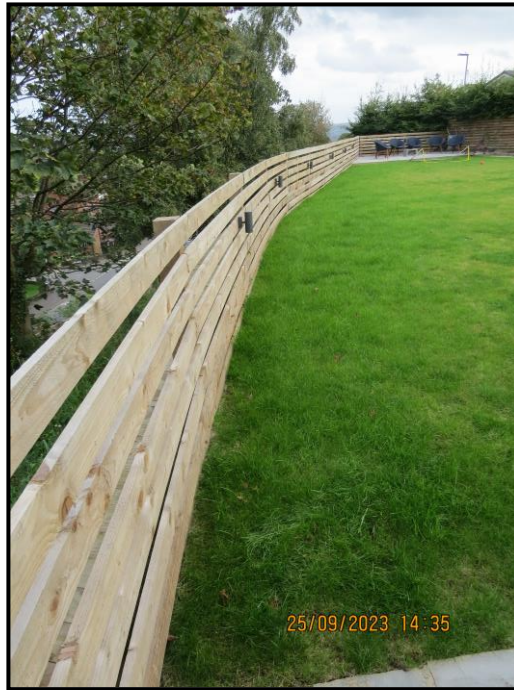
- 2.3 The foundations are between 400mm – 450mm below existing sloping ground level and the lower slope from the base of wall maintains the profile of the original 29° - 30° angle without any visual evidence of surface movement, tension cracking or separation.
- 2.4 The vertical alignment of the outer horizontal boarded batten fence is good and the general curvature of the fence and wall parapet top is undisturbed. (Photographs 002, 003, 005, 006).

**Photograph 002 Wall profile looking North West – South East**

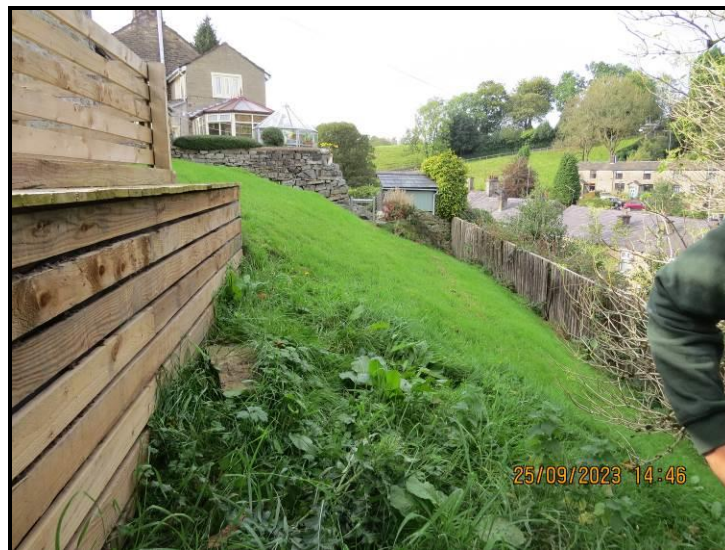
**Photograph 006 Existing garden slope 29° looking South East – North West**

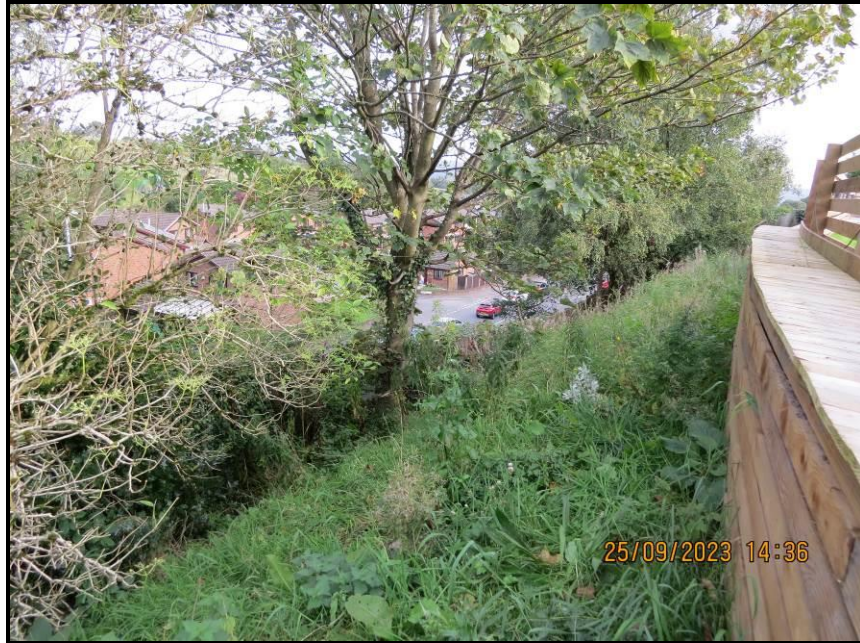
- 2.5 Following the wall construction there is no visual evidence of ground movement or tension cracks to the lower slope, nor any change in profile to the re-laid lawn area of the upper garden. (Photographs 003, 007, 008, 009).

**Photograph 003 Existing embankment above Whitworth Road looking North West – South East**

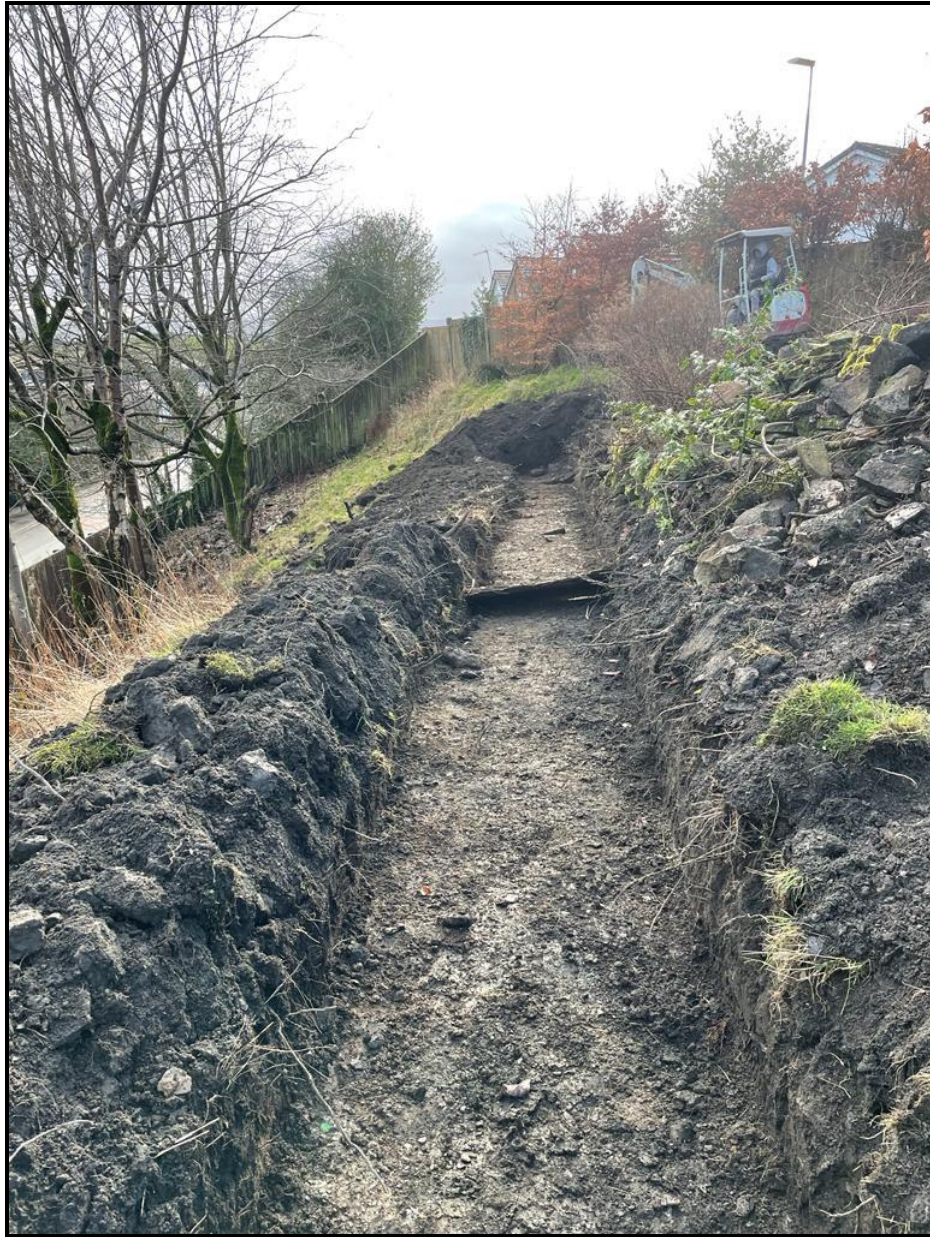
001E Firm to stiff sub-strata

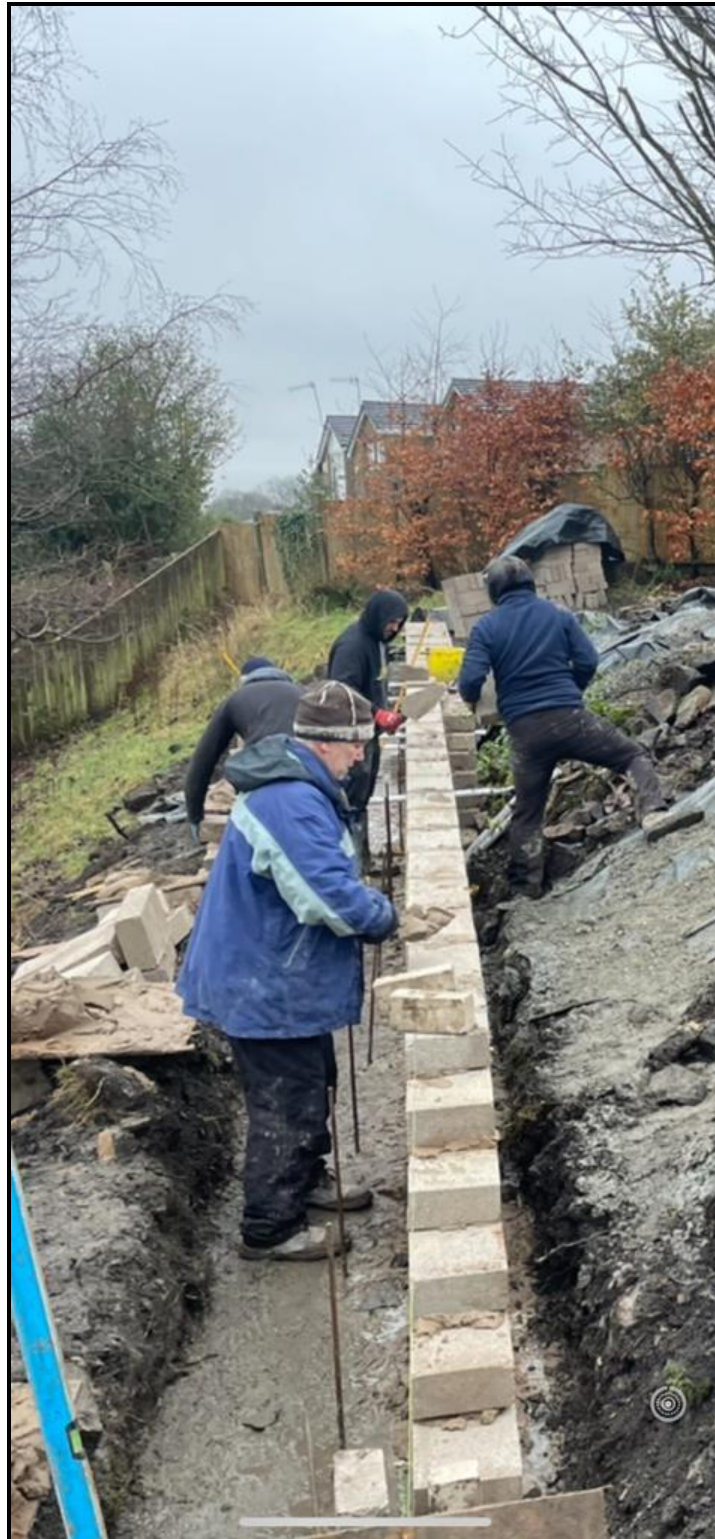
002E Inner leaf construction looking North West – South East

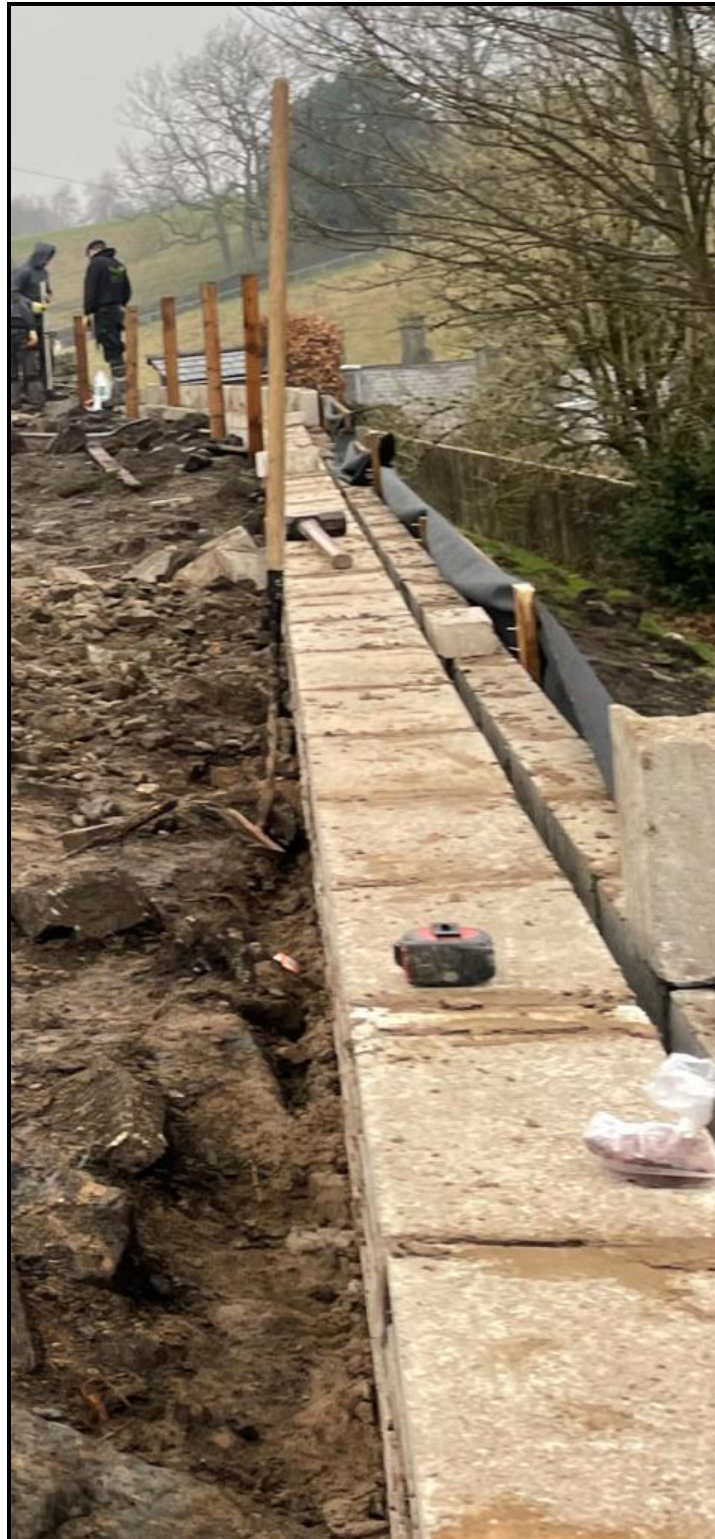
003E Overall block layout looking South East – North West

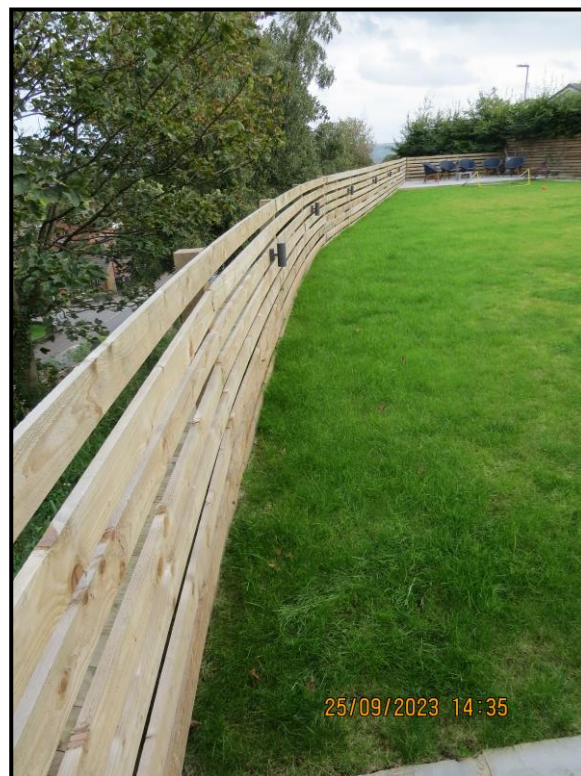
002 Wall profile looking North West – South East

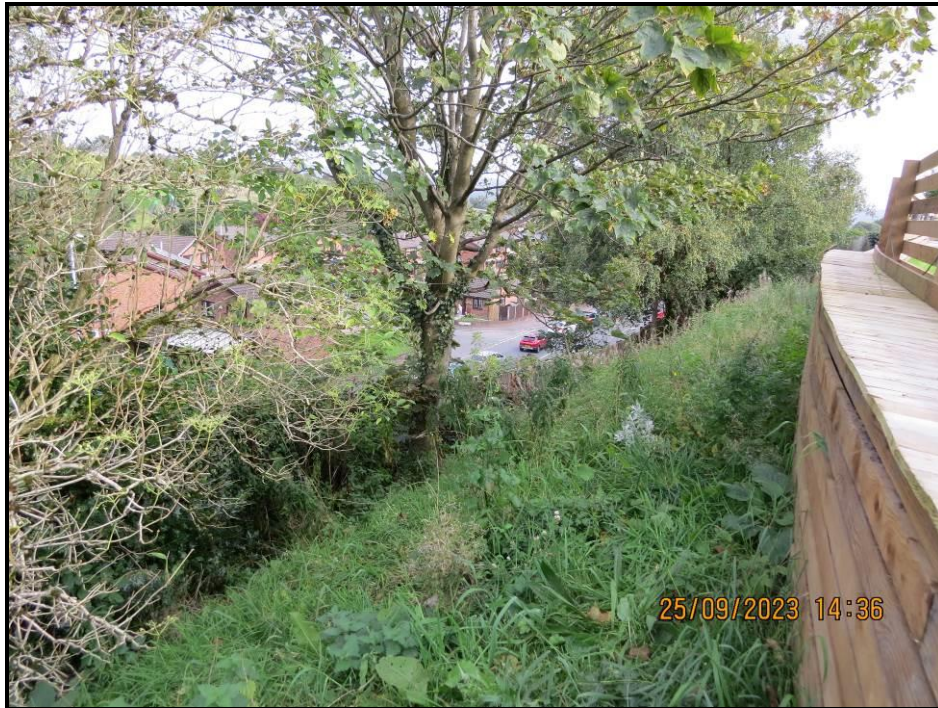
003 Existing embankment above Whitworth Road looking North West – South East

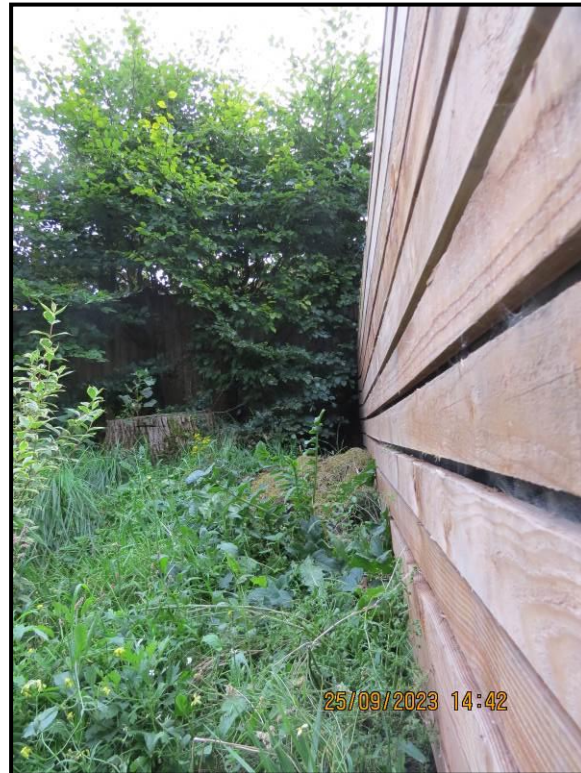
005 Return wall South East frontage

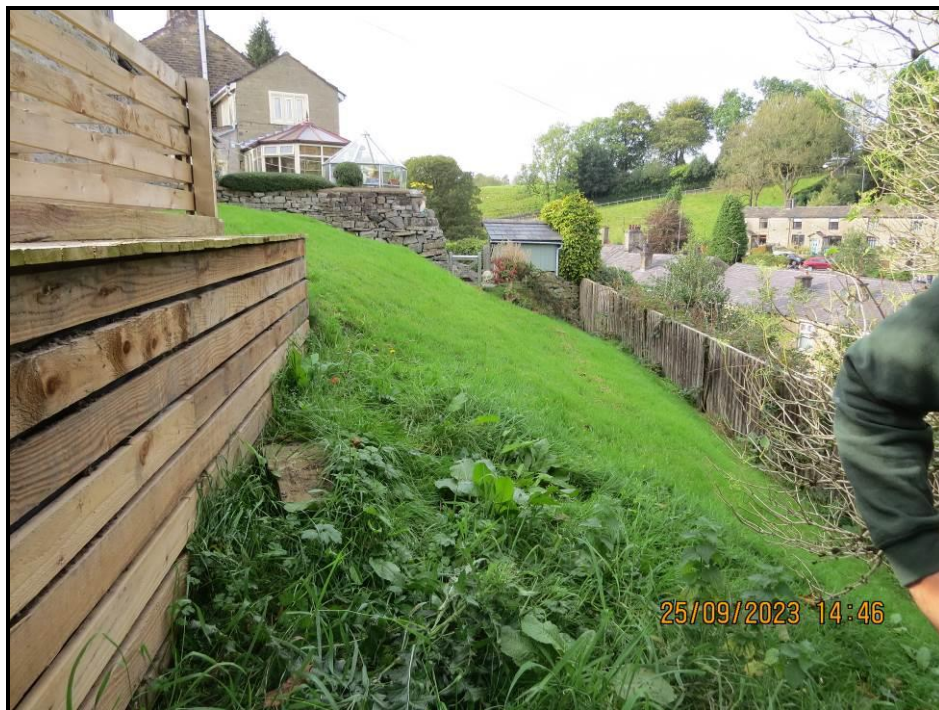
006 Existing garden slope 29° looking South East – North West

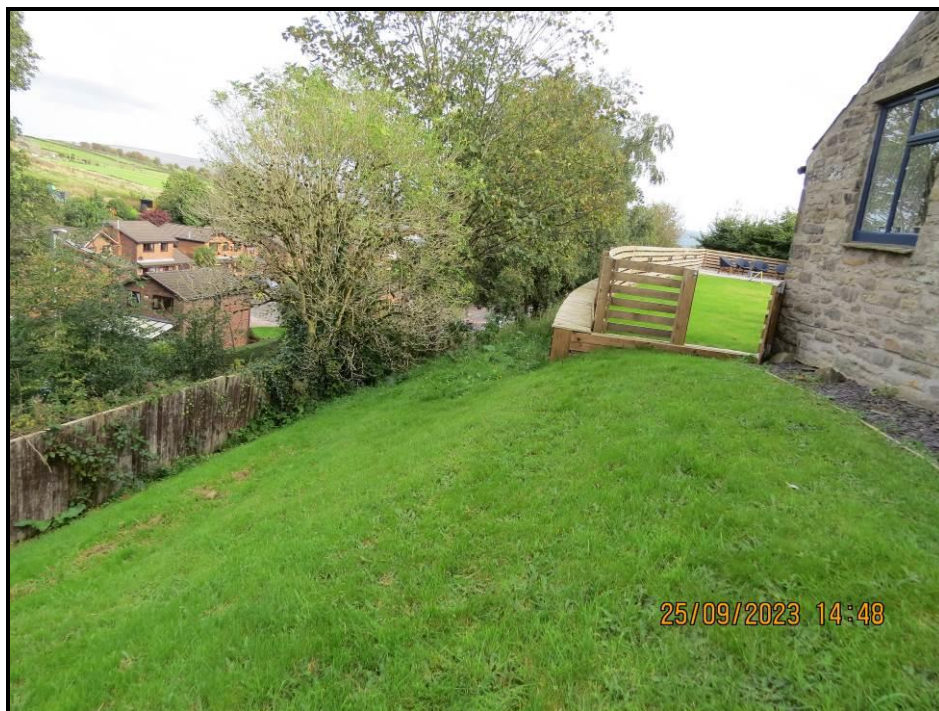
008 Close up of new wall and existing foliage

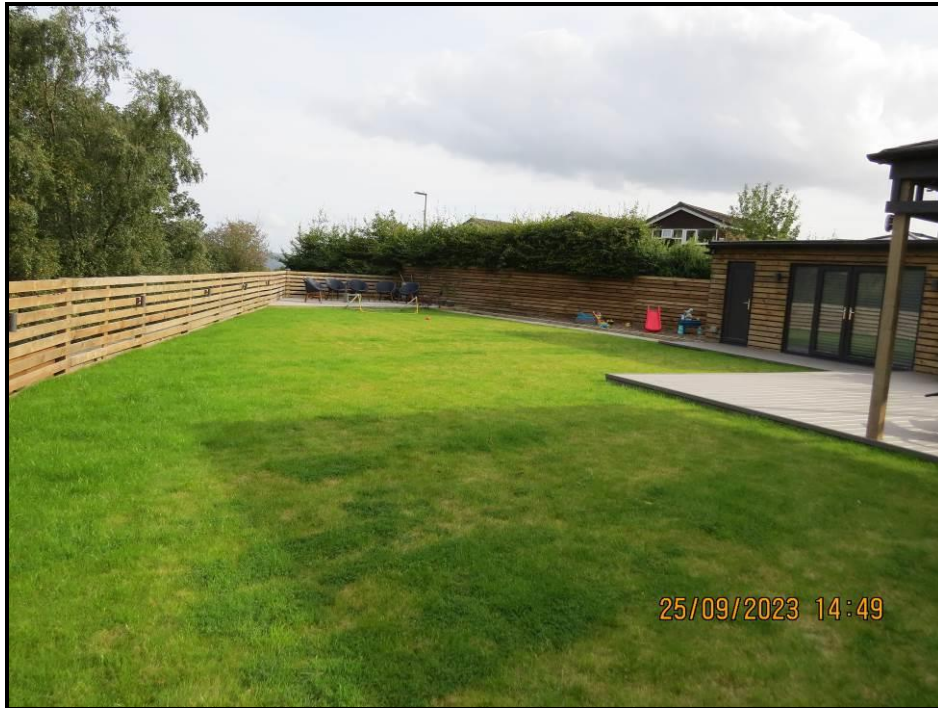
009 Top lawn area

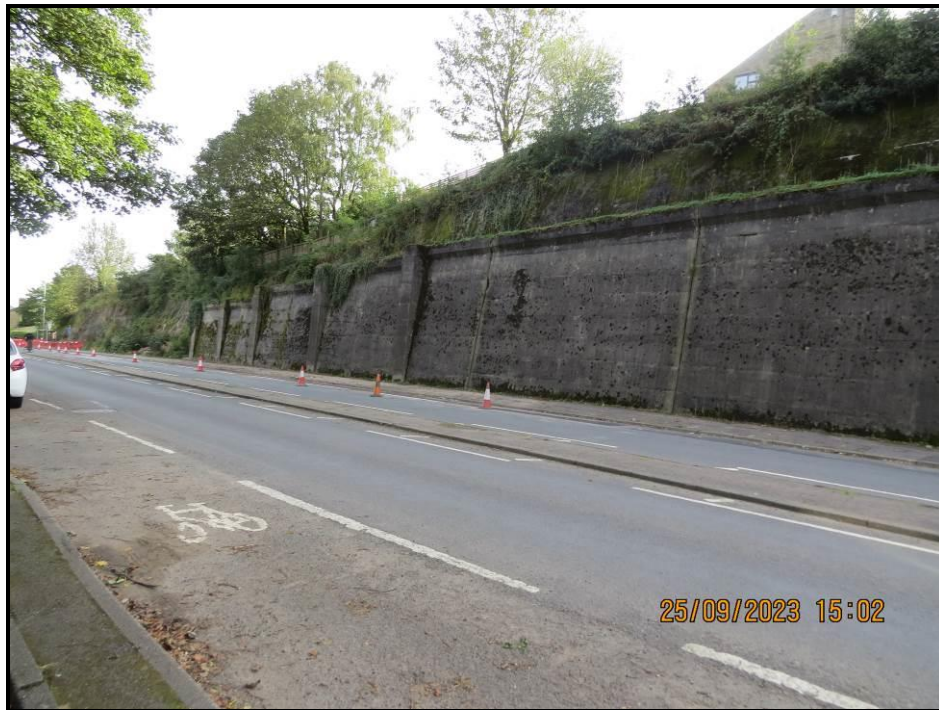
011 Whitworth Road, retaining wall and upper slope
