## GAS MEMBRANE VALIDATION

| <b>Site: Boothroyden Road, Middleton</b> | |
| Date Validated: 20-12-2021 | Project Number: 13-500 |
| Ground Gas Risk Assessment: <b>Amber 2</b> | |

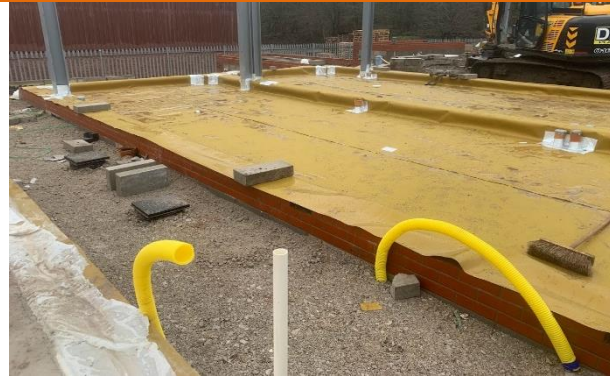
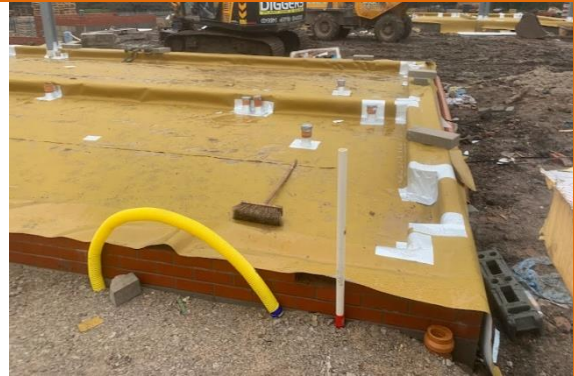
**Plot – 30**

**General Condition of Membrane-Good Condition**

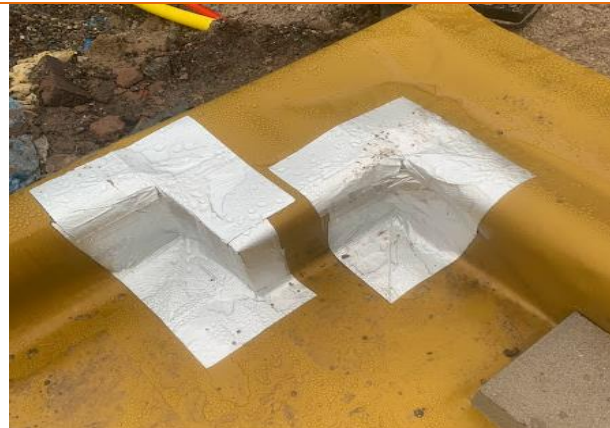
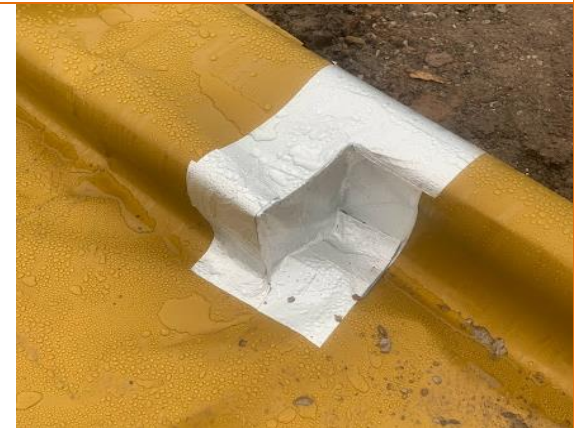
**Verification of Joints and Seals-Good Condition**

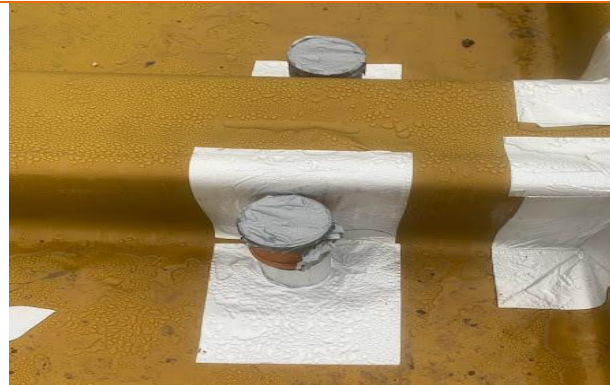
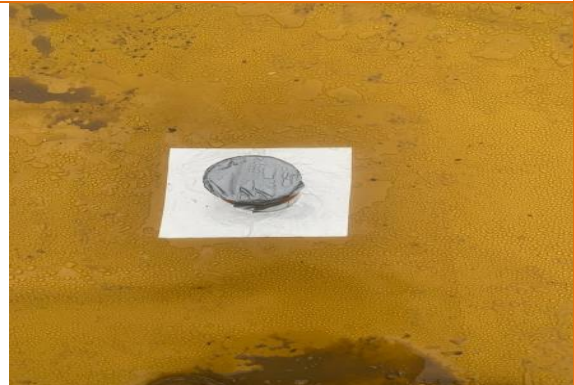
**Verification of Service Penetrations-Good Condition**

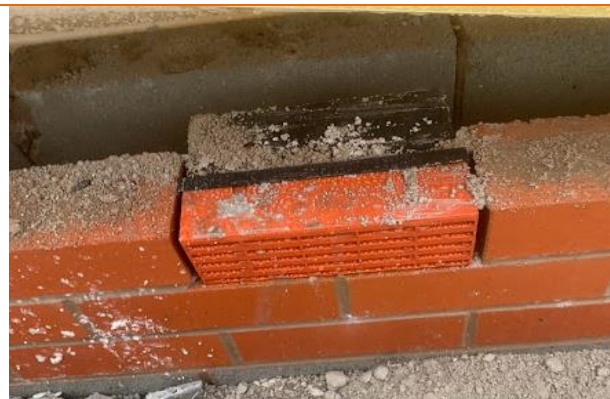
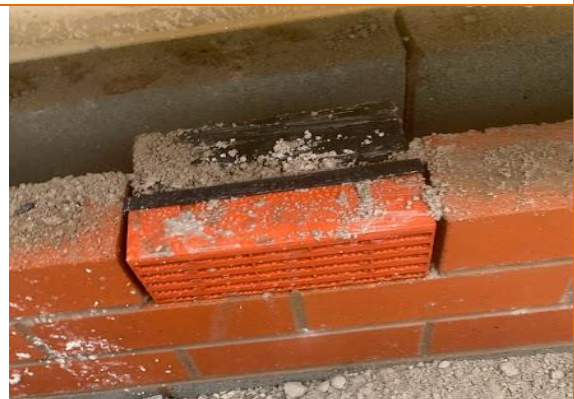
**Verification of Ventilation-Good Condition**

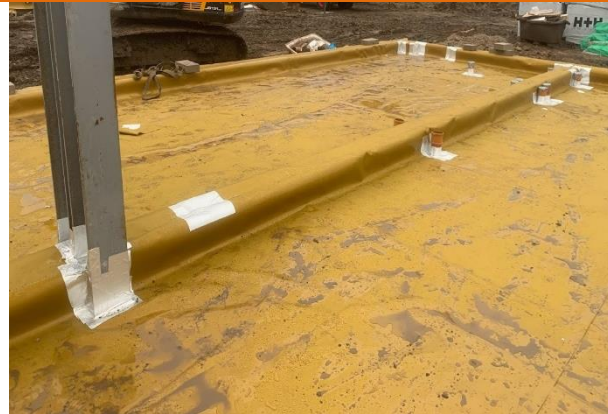
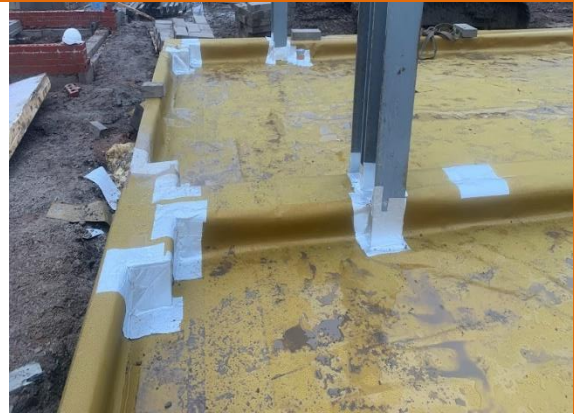
**Plot - 31**

**General Condition of Membrane-Good Condition**

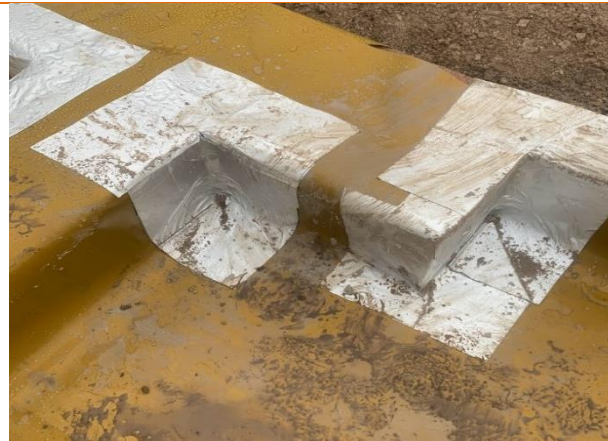
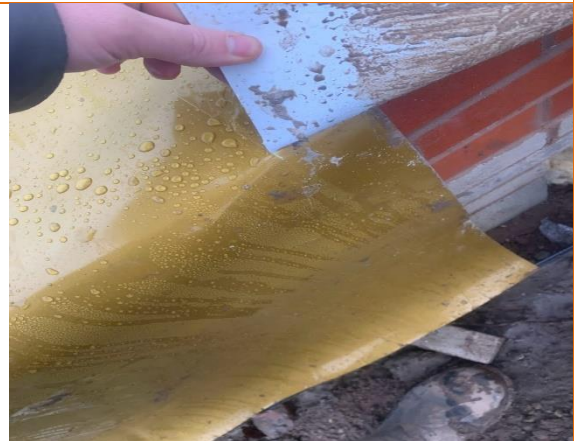
**Verification of Joints and Seals-Good Condition**

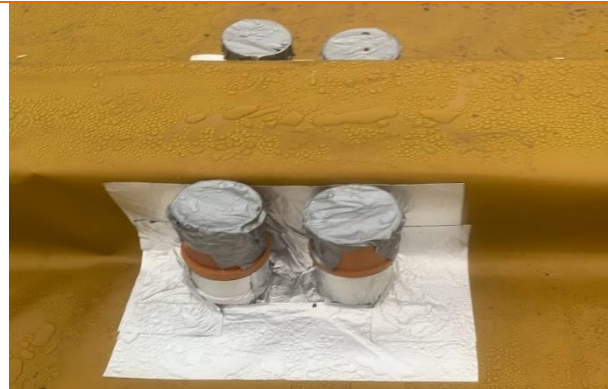
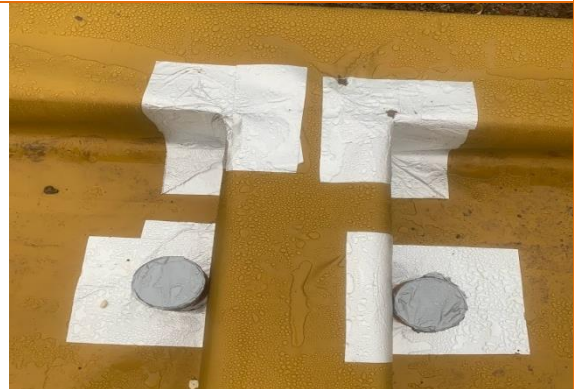
**Verification of Service Penetrations-Good Condition**

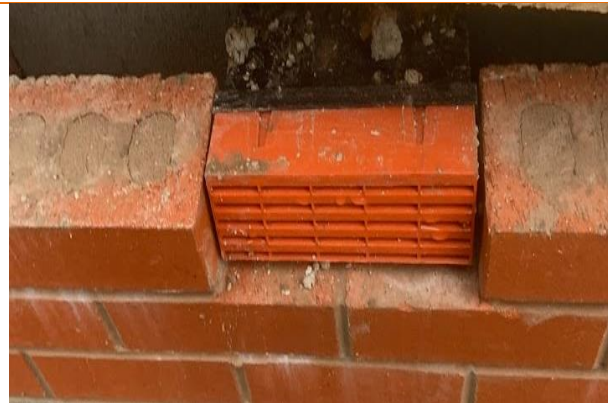
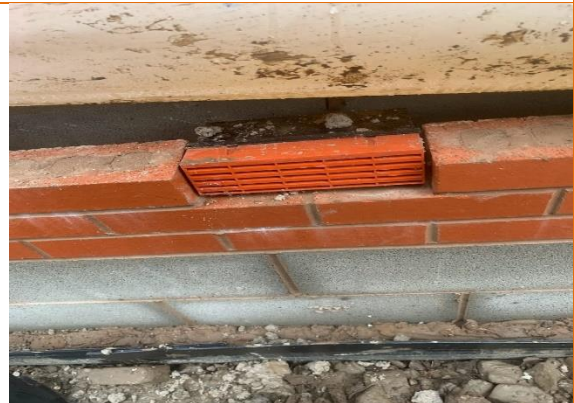
**Verification of Ventilation-Good Condition**

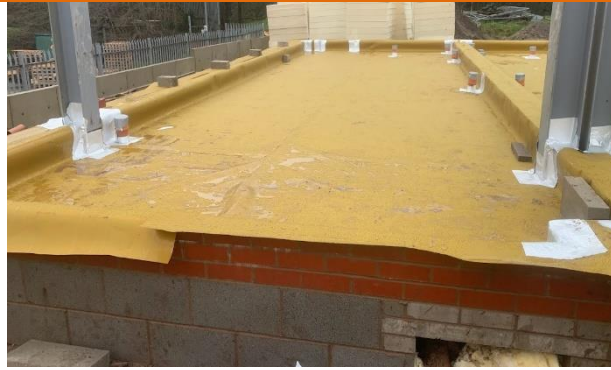
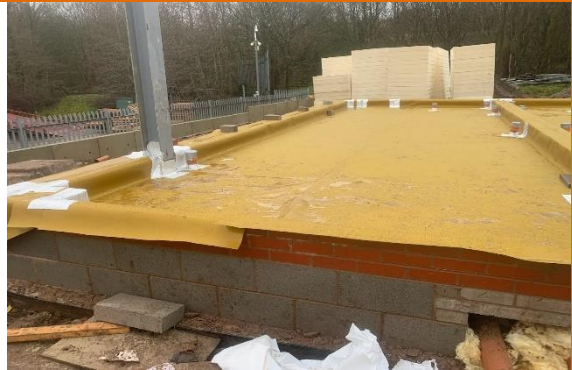
**Plot - 32**

**General Condition of Membrane-Good Condition**

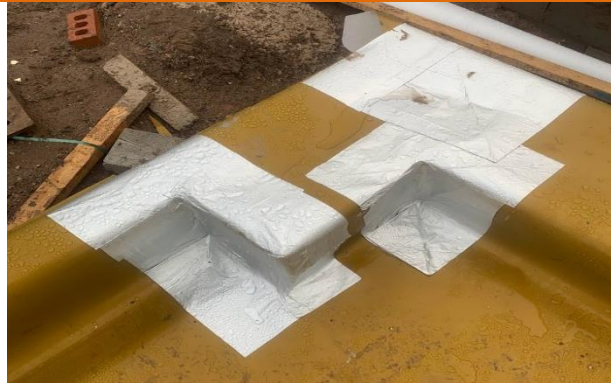
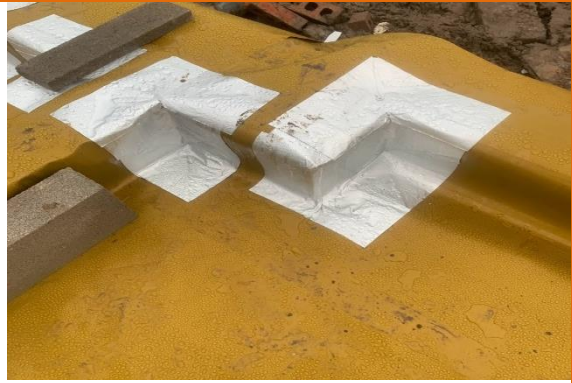
**Verification of Joints and Seals-Good Condition**

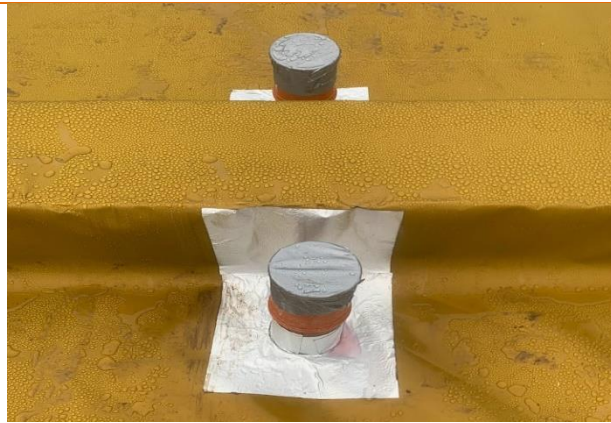
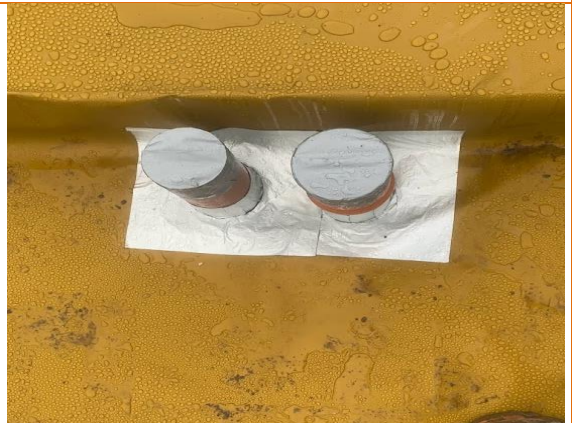
**Verification of Service Penetrations-Good Condition**

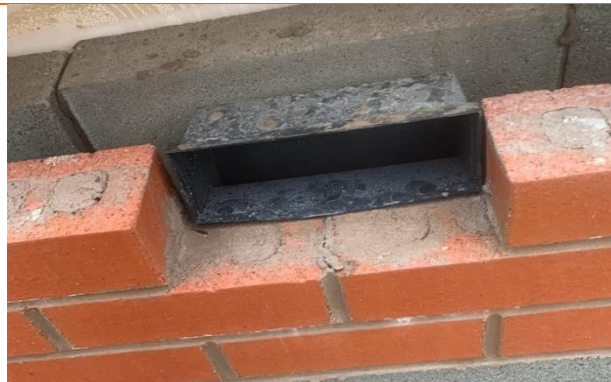
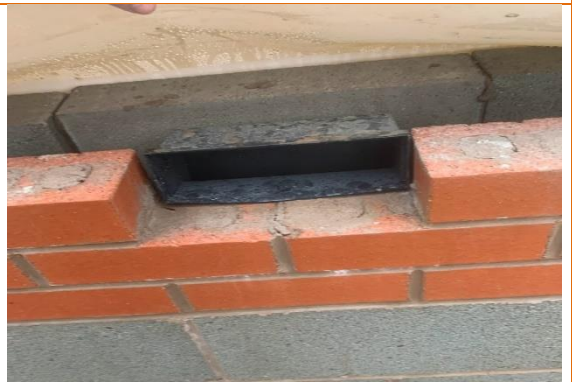
**Verification of Ventilation-Good Condition**

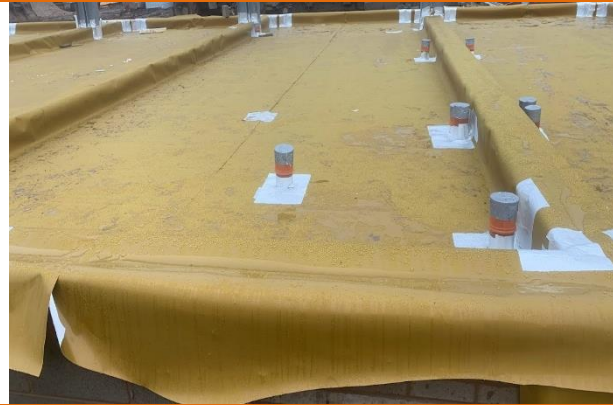
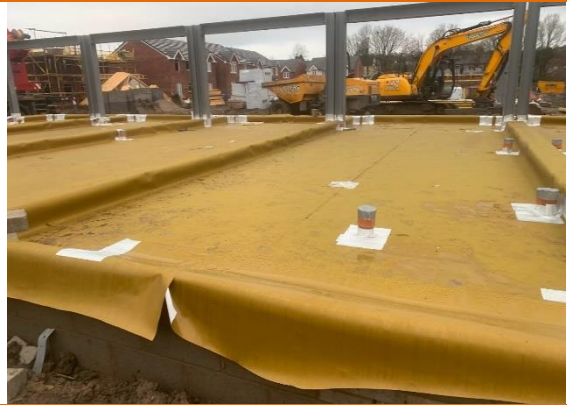
**Plot - 33**

**General Condition of Membrane-Good Condition**

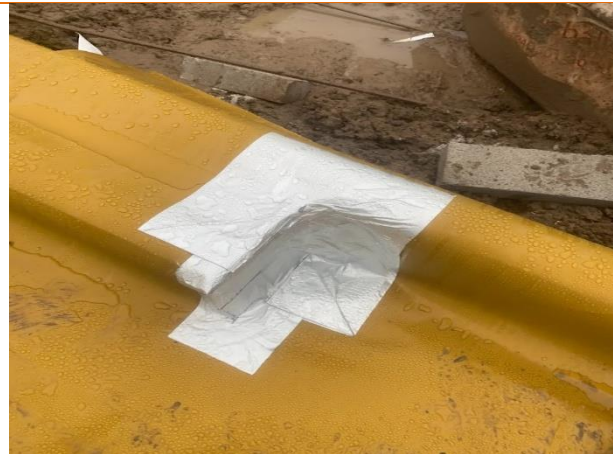
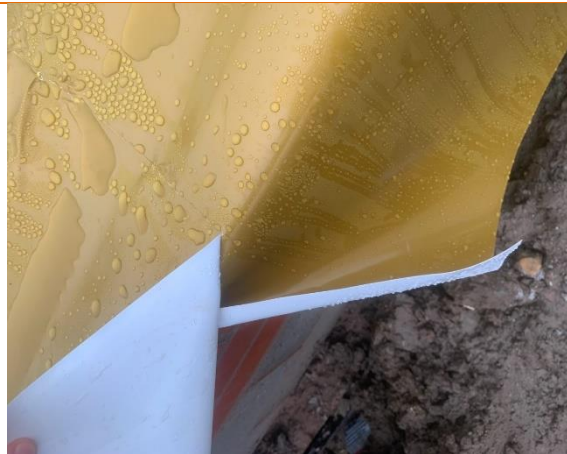
**Verification of Joints and Seals-Good Condition**

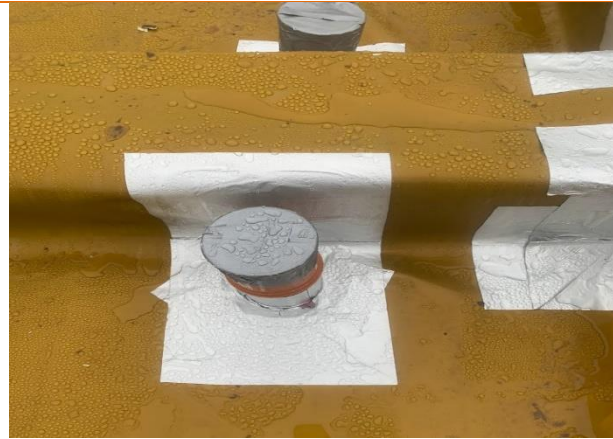
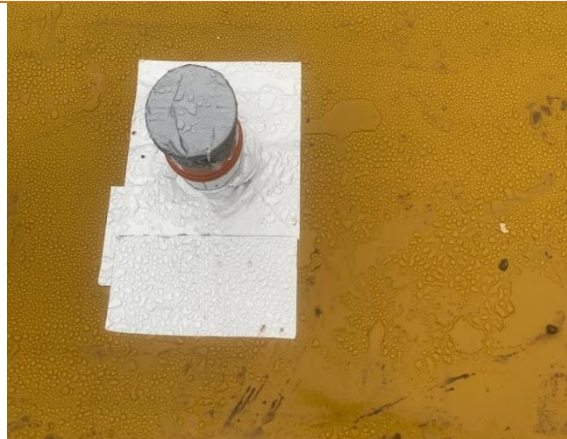
**Verification of Service Penetrations-Good Condition**

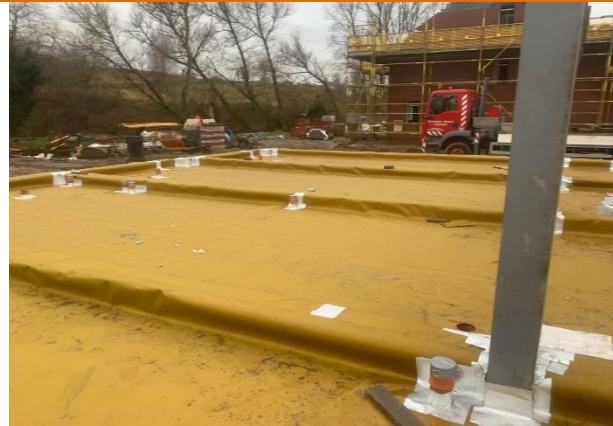
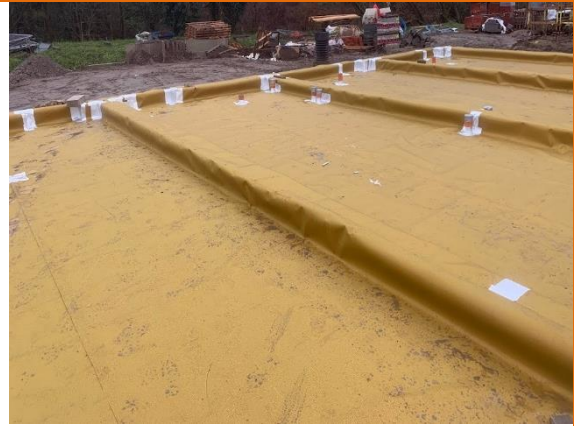
**Plot - 34**

**General Condition of Membrane-Good Condition**

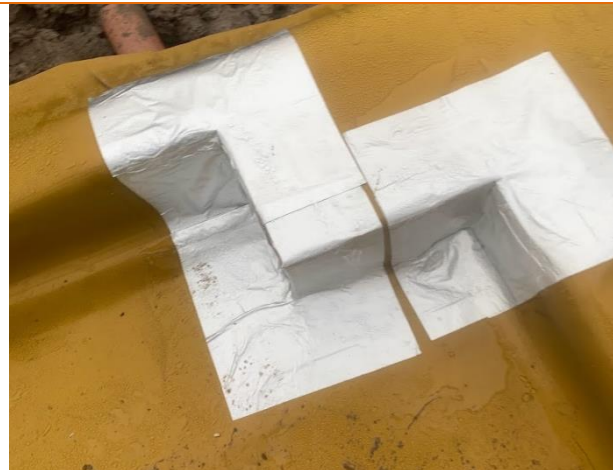
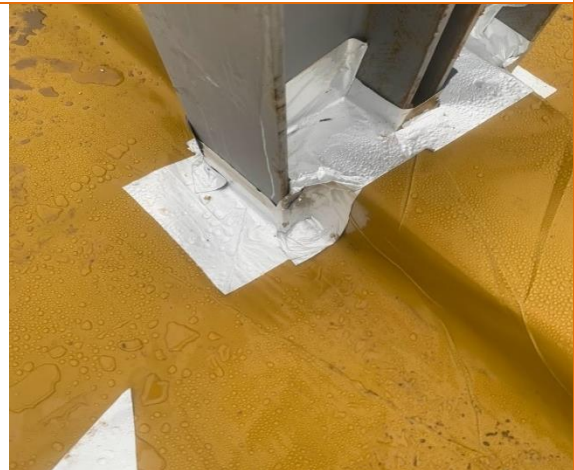
**Verification of Joints and Seals-Good Condition**

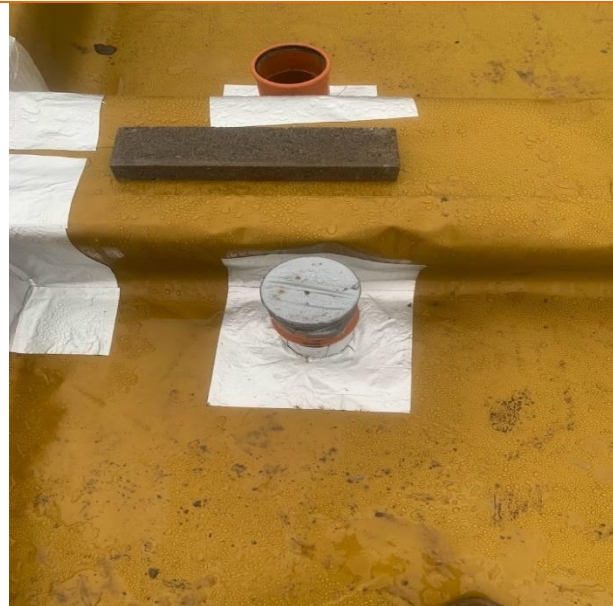
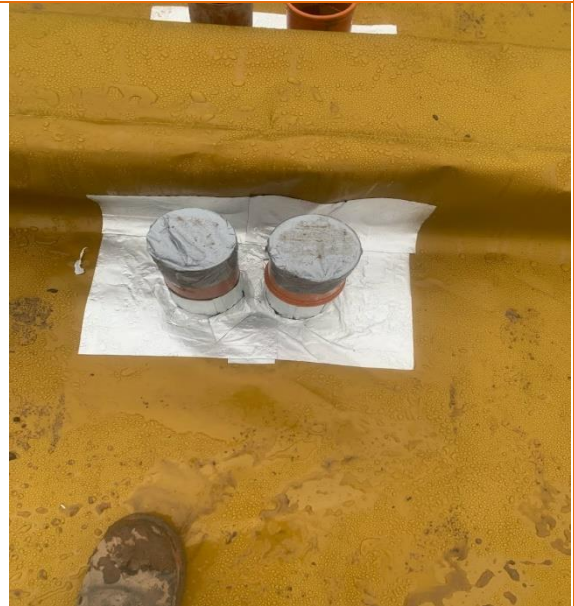
**Verification of Service Penetrations-Good Condition**

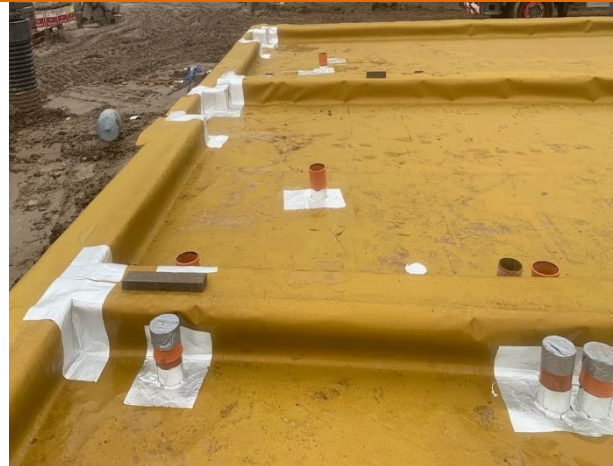
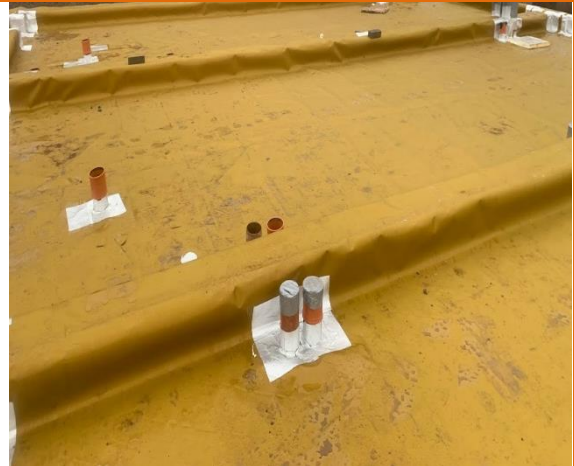
**Plot - 35**

**General Condition of Membrane-Good Condition**

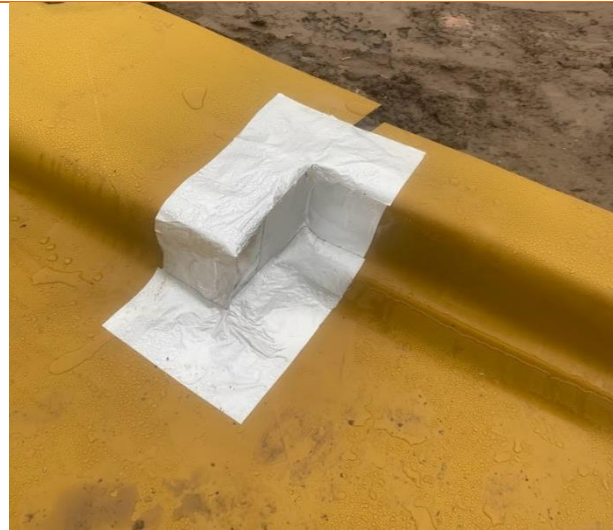
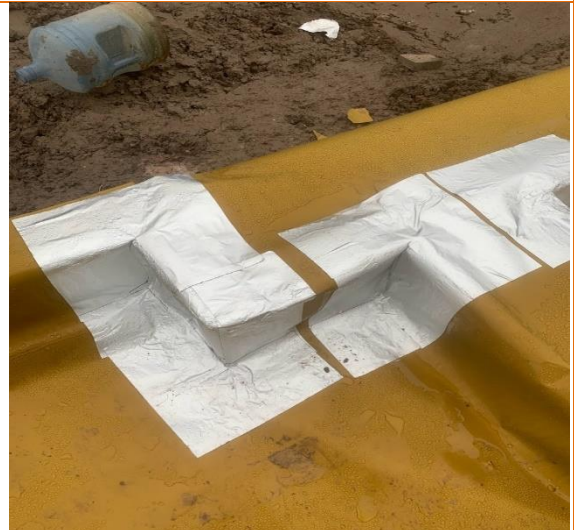
**Verification of Joints and Seals-Good Condition**

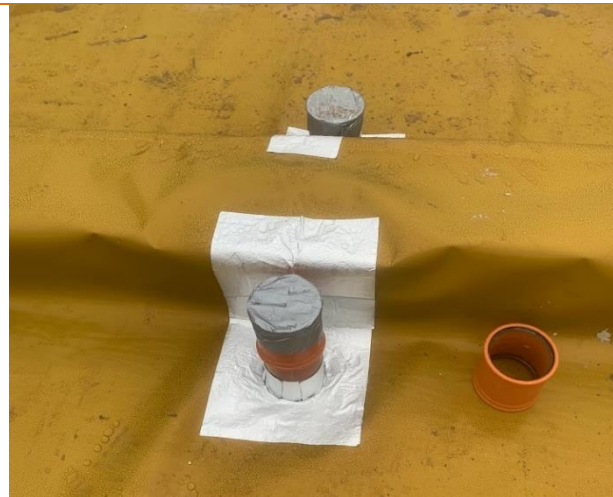
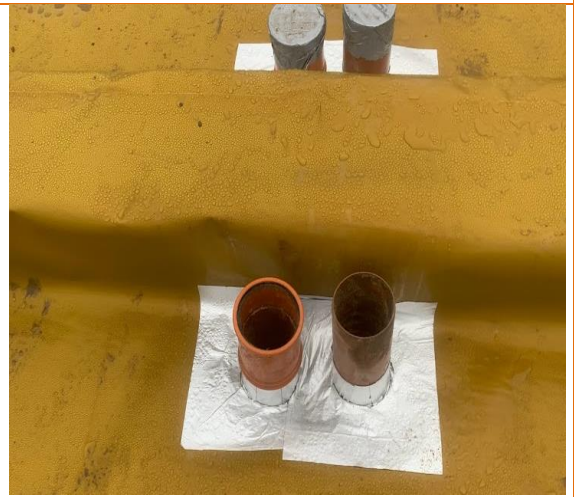
**Verification of Service Penetrations-Good Condition**

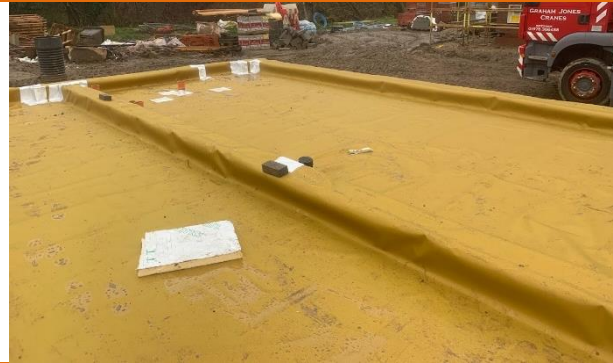
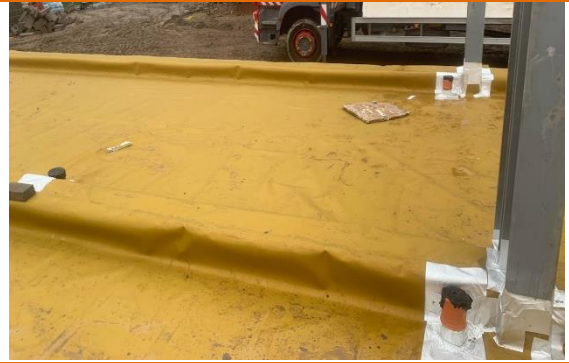
**Plot - 36**

**General Condition of Membrane-Good Condition**

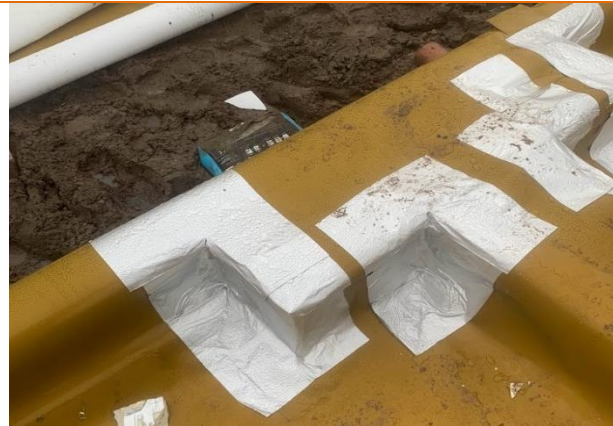
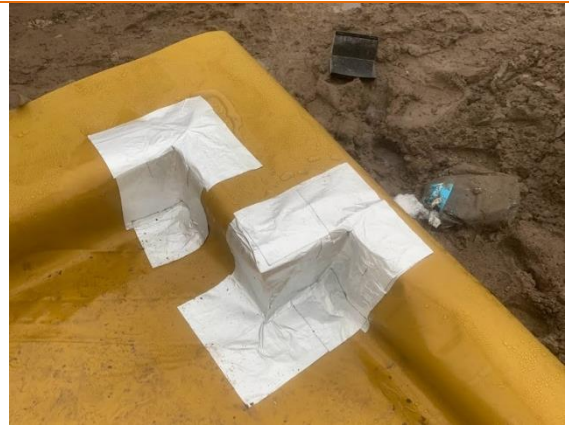
**Verification of Joints and Seals-Good Condition**

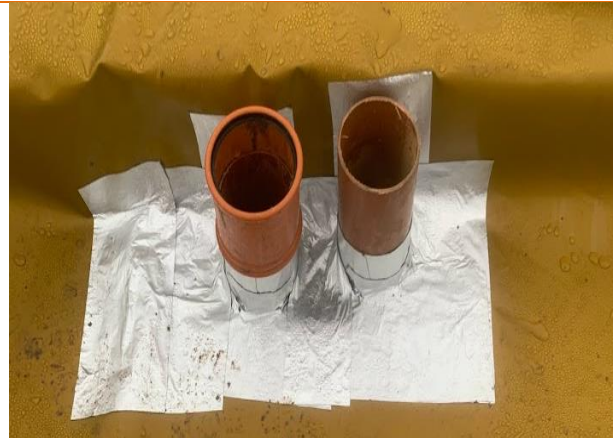
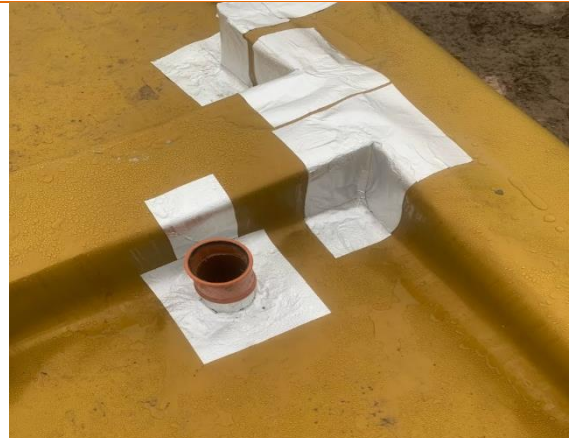
**Verification of Service Penetrations-Good Condition**

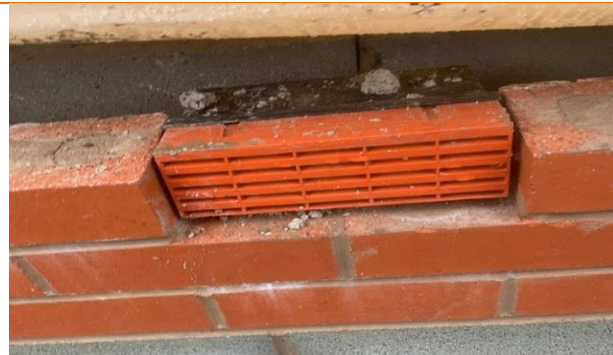
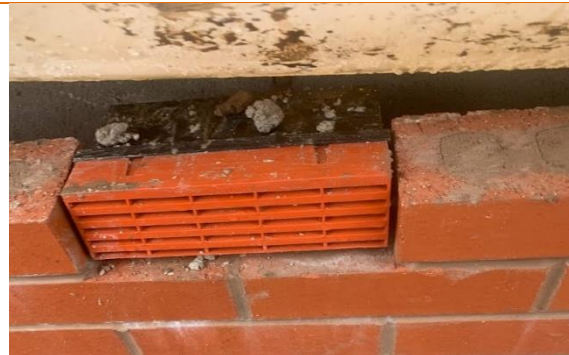
**Verification of Ventilation-Good Condition**
