Week 5 – W/E 13.09.2024 – Stonework dismantling and window repairs

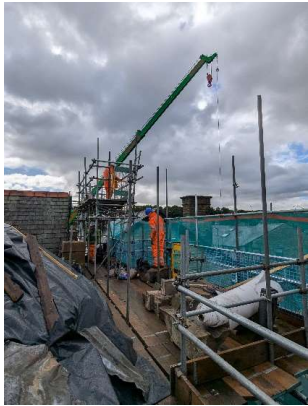
Crane used to dismantle upper stonework of entrance from the entrance gable and oriel window

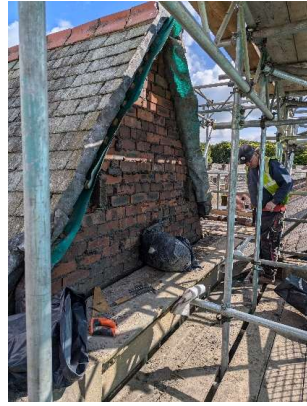
Stonework dismantled from the entrance gable

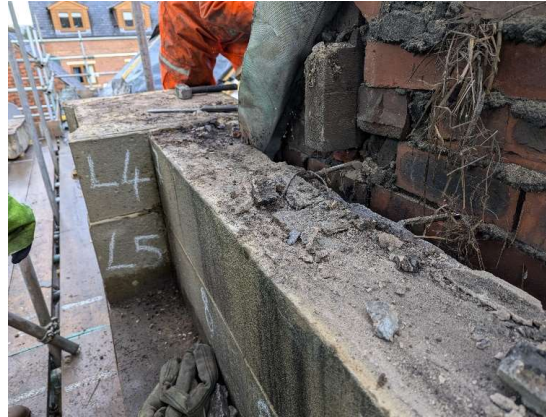
All stonework referenced and identified on a reference drawing before dismantling

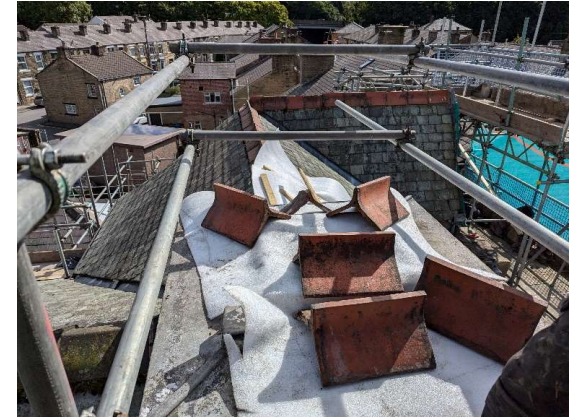
Roof cowel removed for repair

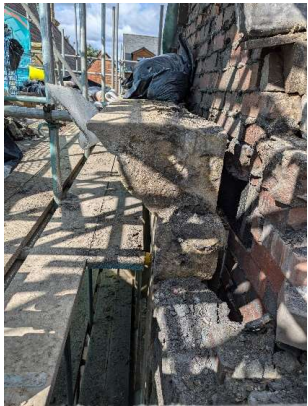
Gable dismantled down to the window head detail and temporary support provided

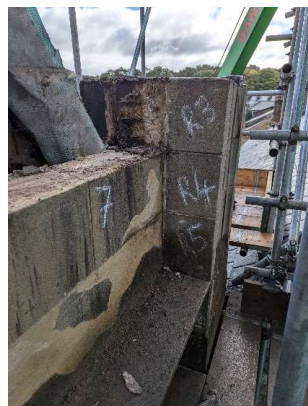
Displaced pilaster stone during dismantling.

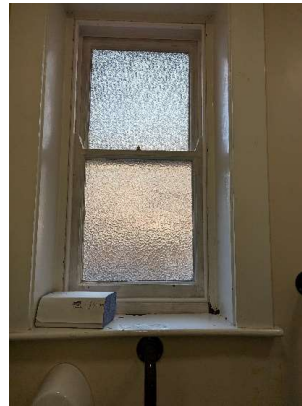
First repaired windows re-installed

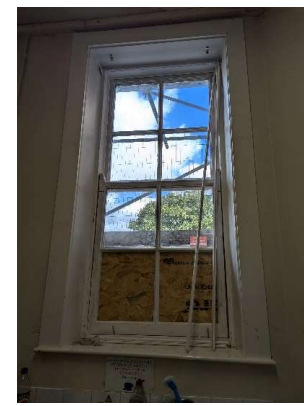
Repaired kitchen window re-installed

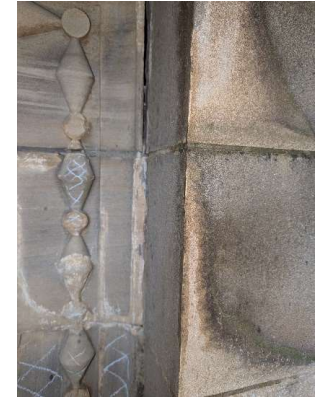
Indent repairs agreed on site. Some further dressing back agreed.
