**MILNROW LIBRARY- REPAIR WORKS  
DESIGN, ACCESS AND IMPACT STATEMENT  
NOVEMBER 2023**

**ROCHDALE BOROUGH COUNCIL  
MILNROW LIBRARY  
DESIGN, ACCESS AND IMPACT STATEMENT  
NOVEMBER 2023**

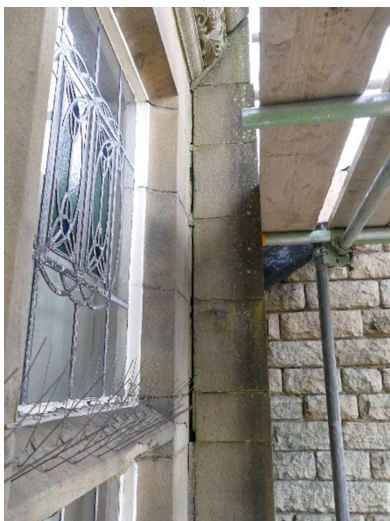
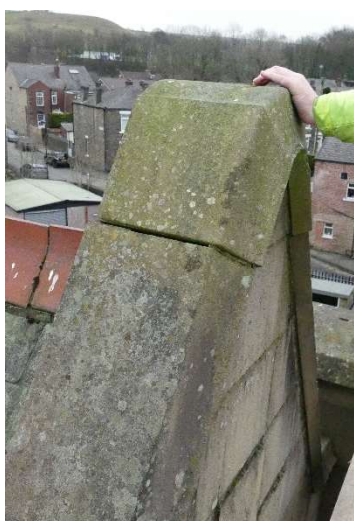
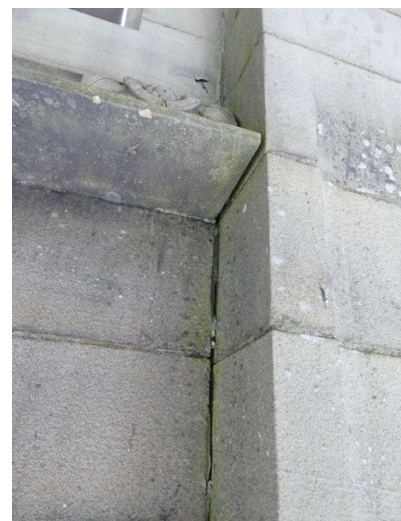
**From the first floor stair window upwards the entrance gable was found to be fully unrestrained. This could be moved independently of the side walls.**

**Issue:** This is likely to be a result of corroding metal cramps and ties within the wall construction, between the brick construction and the stone facings to the entrance gable and piers. A temporary steel frame support has been added to the roof void at the back of the gable, but the deterioration of the ironwork will continue and this needs to be addressed. It also presents a potential risk to the safety of those accessing the building below.

The movement of this wall has allowed water to penetrate between the side piers and the spandrel and through lifted flashings at the back. This is clearly evidenced internally where there is extensive water damage.

The side piers are currently at risk of collapse. The same approach as is proposed for the spandrel is proposed for the side piers. The works will include the careful cutting out and replacement of any corroded ferrous fixings discovered during the works. This will remove the future risk to the integrity of the stonework.

**Proposal:** It is proposed that the ceiling and roof structure are carefully propped and that this section of the gable wall is dismantled down to the base of the panel, so that corroding ties can be identified and replaced with appropriate stainless steel ties, before the panel is carefully re-built. All stonework is to be carefully labelled and identified on the plan and stored safely during the works. The re-construction is to re use all original stone, only using indents where there is no other option. (Refer also to section on spalling stone facings and split stonework).

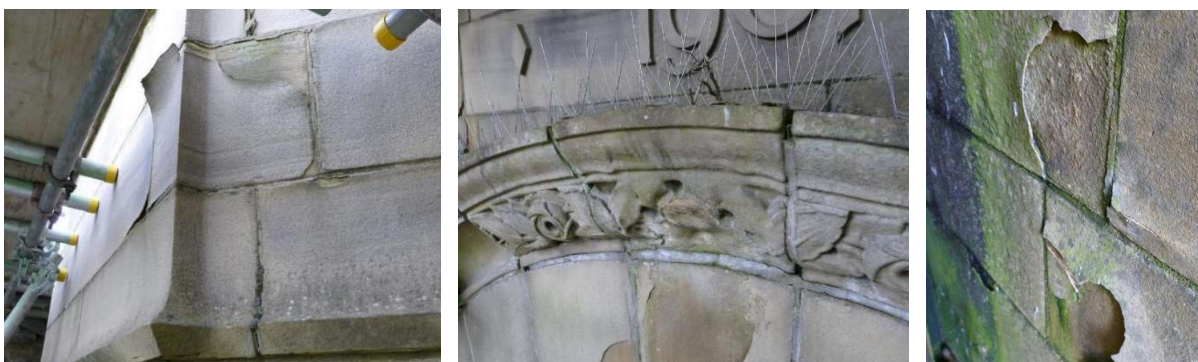
**There is extensive spalling and splitting of the facing stonework.**

**Issue:** A combination of the use of a relatively friable face bedded stone and a later re-pointing in a cementitious mortar, have led to the widespread spalling of the stone facings. This is unsightly and presents a risk of falling material onto those below, but it also exposes the head of the stonework below rendering it prone to increased spalling. This is a situation that will not resolve itself and will develop exponentially as areas of the stonework continue to fall and expose lower areas.

**Proposal:** It is proposed that the existing cementitious mortar is carefully cut out, using hand tools, and that the entire wall is re-pointed in a suitable lime mortar. Sections of stone that have spalled, a little, will be cut back to sound stone and be re-dressed. Where the depth of decay is greater and would leave too much of a ledge below for it to be effectively filleted, the stone is to be carefully cut out to a minimum depth of 100mm and a new stone indent installed to fully match the existing. Wherever possible, stone removed from the elevation is to be re-used for further repairs if of sound quality.

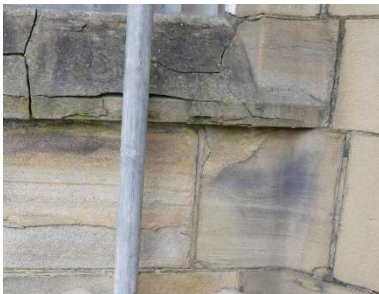
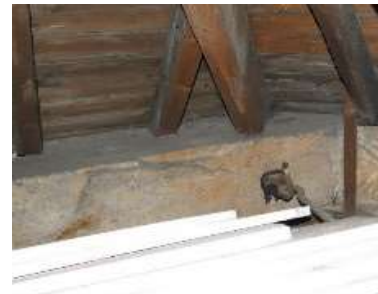
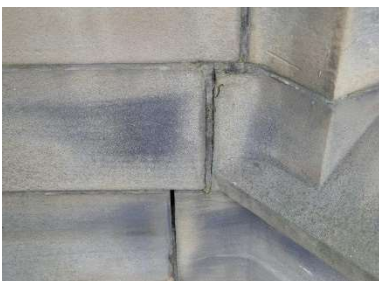
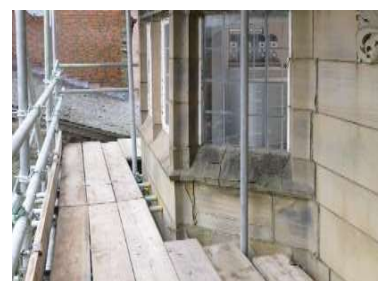
**There is historic displacement evident but there is also evidence that the oriel window structure is now compromised and will continue to move.**

**Issue:** Past movement in the alignment of the oriel window, in particular from the corbel/cantilevered base upwards, has led to the cracking of the side cill and a displacement in the key of the stonework into that of the main wall face. A past reinforcement scheme, using ferrous steel angles and resin bolt ties, has corroded and this is now splitting the stonework in a number of places on the mullions and has compromised the central upper lintol, which holds a principal iron tie back to the structure behind. This situation will not improve and the displacement will continue. The exposed, splits in the stonework will allow water to penetrate and the overall stability of the oriel window will eventually fail.

**Proposal:** An assessment of the structure and of the current, compromised reinforcement strategy, has determined that the bay will need to be carefully dismantled in order to remove the ferrous framing and bolts and to restore the verticality and integrity of the bay. It is proposed that the base is supported back to the structure behind and that the damaged sections of stone are stitch repaired, where they are not critical to the stability, and are replaced with new matching stone, dressed to fully match the original where they have a structural duty. The stone that is removed is to be assessed and re-purposed for smaller indent repairs elsewhere wherever possible. This work will require a robust propping strategy and recording of the stone elements removed for re-installation as the oriel structure is re-assembled. The leaded lights will need to be temporarily removed, stored and then re-installed, having been repaired as necessary by a leaded light specialist.

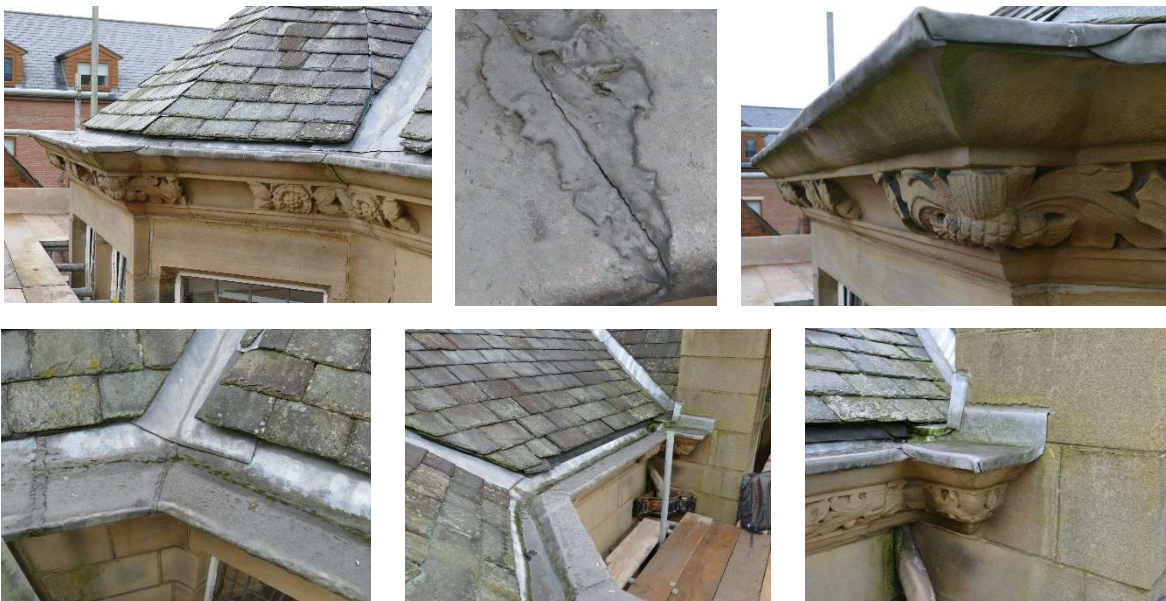
**The entrance elevation is capped with a decoratively corbelled stone gutter. The gutter has a lead lining but this has failed and the depth is insufficient to contain heavy rainfall.**

**Issue:** The south west facing roof planes drain into a corbelled stone gutter that follows the outline of the oriel window and drains via an embellished iron hopper head and rainwater pipe to the side of the entrance gable. The lead lining of the gutter is welded such that it is effectively one sheet and the excessive length and restrained corners have led to its fatiguing and splitting in a number of locations. This is evidence by cracks and ruffles and by the numerous repairs that have been carried out in the past. There is also evidence , in staining from wall washing below, that the gutter is inundated during heavy rainfall. The drip detail to this lining is also stopped short of the rim of external stone lipping and water is not fully thrown clear.

**Proposal:** This section of roof will need to be carefully cleared of the slates to allow the repair works to the oriel window. It is proposed that the detail is re-worked with the installation of a stone indent raising strip to the upper face of the corbelled gutter. This will have little visual impact from ground level and will be largely concealed by the new lead drip, but will increase the capacity of the gutter to reduce the risk of future inundation. The lay board and roof edge detail will be adapted to incorporate a discreet Nicholson ventilation strip and to raise the flashing level to accord with the raised gutter rim. The lead sheet will be replaced with new sand cast lead sheet and will be detailed in shorter bays with T-pren movement joints and lead cover strips. These will dress up to the tilting fillet and be protected with a sacrificial flashing so that their future replacement can be carried out without stripping the roof finish. The T-pren is expected to have a functional life well in excess of 20 years.

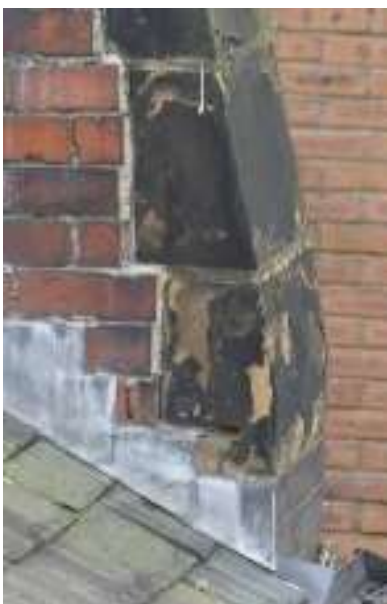
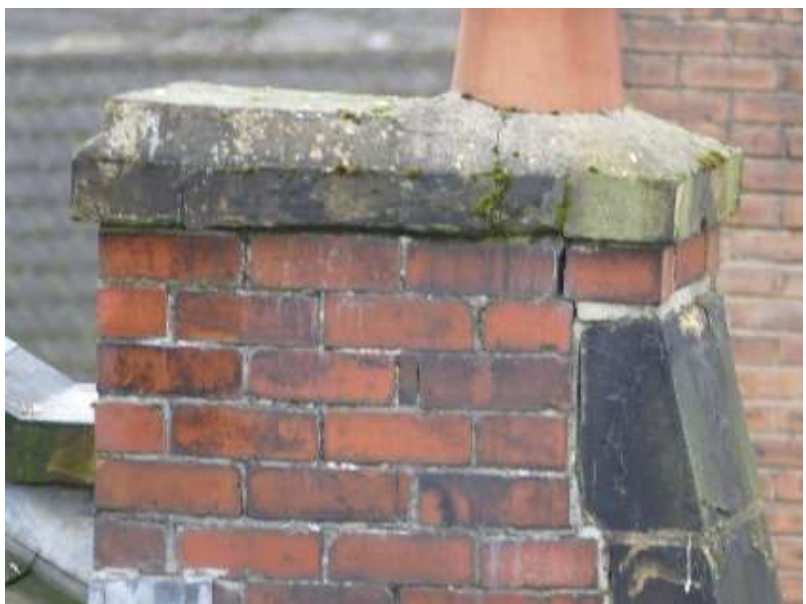
**The rear chimney has two stone offsets to the south east side and the upper of these is displaced,**

**Issue:** The south east face of the chimney shows signs of spalling. One of the two stone offsets is displaced and cracked and the brickwork behind has open joints. There has been longstanding water ingress through the stack, evident in the meeting room and at the lower level within the office. The jointing to the whole of the top section of the stack is displaced and open and the flaunching to the head of the chimney is split.

**Proposal:** It is proposed that the top of the chimney is dismantled as shown on the drawings. This will allow it to be re-built with the incorporation of reinforcing mesh, to support the stone offsets and to resist future movement. The existing split and weathered capping stone will be replaced to fully match the original detail.

The brickwork will be carefully recorded, cleaned and sorted before being fully reinstated as the existing and with the incorporation of a chimney flashing and improved abutment flashings, to better shed the water. This will also make it less vulnerable to moisture ingress in the future.

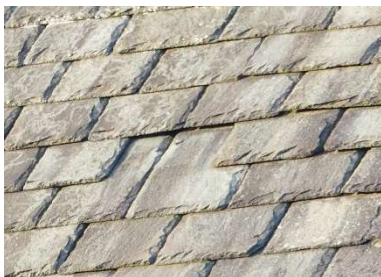
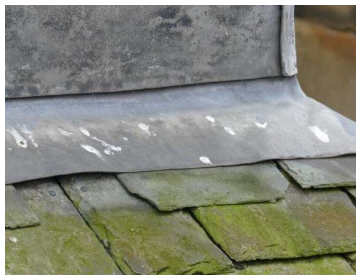
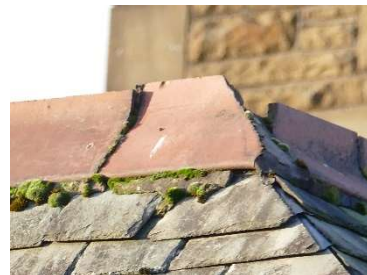
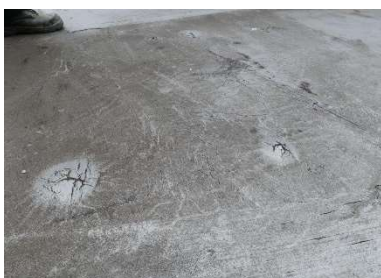
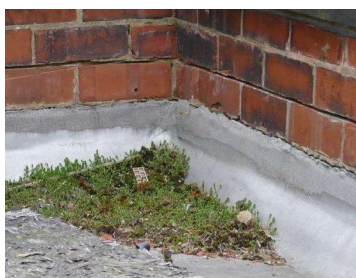
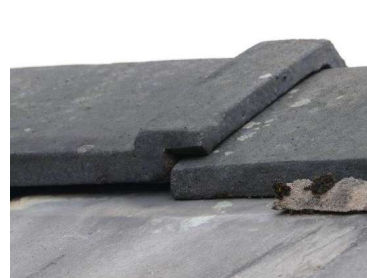
**The roof was last re-furbished in 2000 and is in need of some localised repair.**

There are several slates that have slipped or that are missing. There are slates that have started to spall and some that have split.

There are open joints between many of the ridge tiles and some that have spalled.

The existing asphalt finish to the flat roof, is split and blistered and has seen many repairs over the past 20 years. A number of the flashings have been removed and some have been replaced with ubiflex but other sections of the roof are open to water ingress.

**Proposal:** It is proposed that the roof is re-furbished where necessary only. Damaged, slipped and missing slates are to be replaced with slates that fully match those around them. These are to be sourced ethically and as locally as is feasible.

Lead hips are to be re-dressed and all flashings are to be checked and repaired, re-fixed or replaced, as noted on the drawings. New lead is to be sand cast and is to be marked with Smart water.

The blistered and split asphalt is to be carefully repaired and the surface re-paired to provide a good level of integrity. A new top course and protective paint is to be installed to ensure the on-going integrity of the roof.

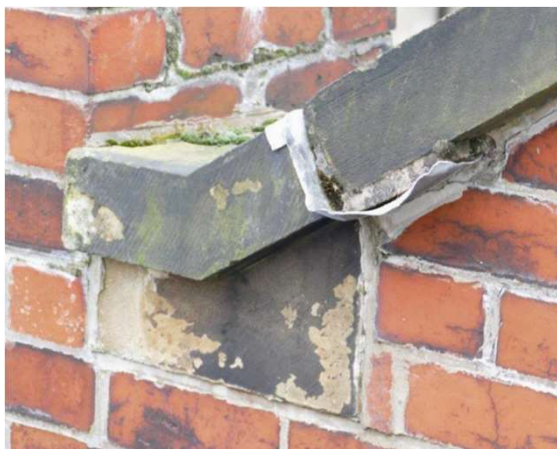
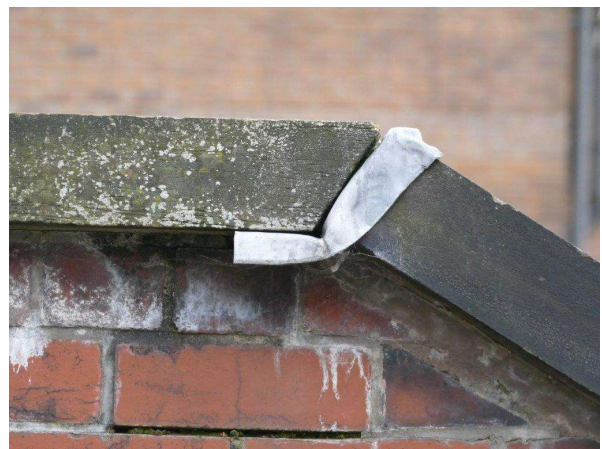
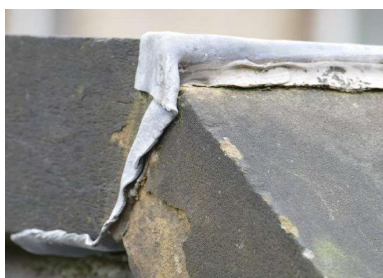
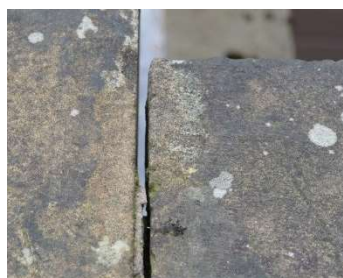
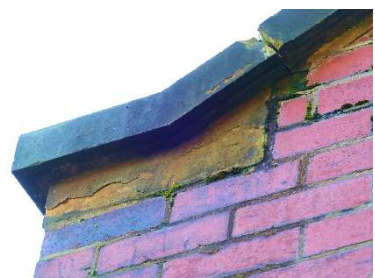
**Some of the stone copings around the building have open joints.**

**Issue:** There is salt and dirt staining where open jointed copings have allowed water to penetrate to the wall below. Copings have, in the 2000 refurbishment, had lead flashings installed at the joints to prevent water from tracking into the fabric. The mortar from many of the joints has now weathered back and water is able to enter both faces of the lead sheet flashings. Evidence of the water ingress is seen in the spalling of the sandstone copings, the staining of the walls below and the growth of mass in the joints of the brickwork below.

**Proposal:** The proposal is that all copings are lifted, as part of the works, and that a new bitumen and sand faced lead flashing is installed below all copings to provide a robust and long term line of water resistance. This will be partnered with stainless steel angle supports and dowels to each coping and the full re-bedding and pointing of the copings in an appropriate lime mortar.

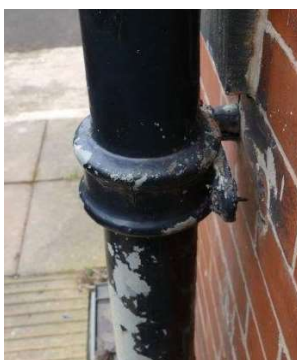
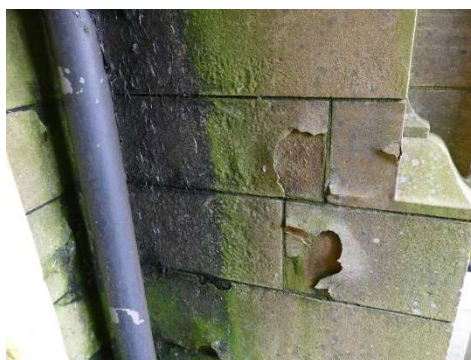
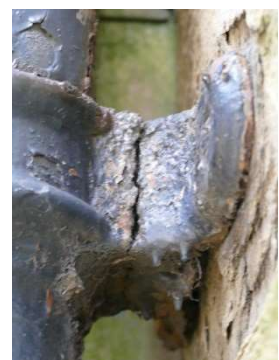
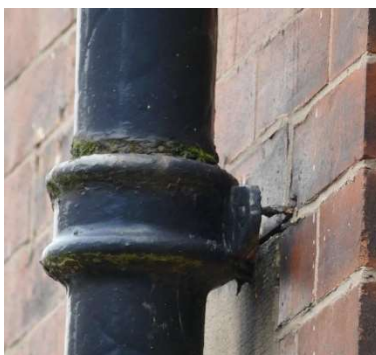
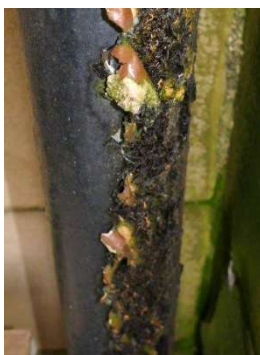
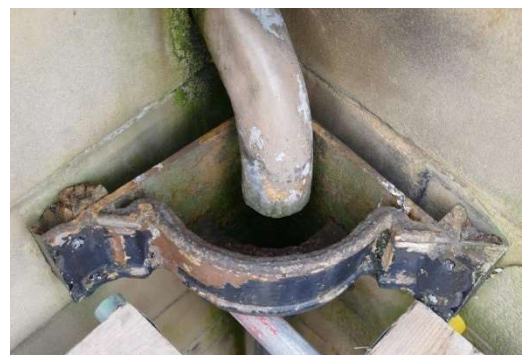
##### **Rainwater goods are corroding, some fixings have failed and some are leaking..**

The decorative hopper to the front elevation has a split fixing and is also corroded and in need of re-decoration/protection.

Existing staining and moss/algae growth will be conservatively cleaned to remove the most unsightly build up but to leave the overall time worn patina.

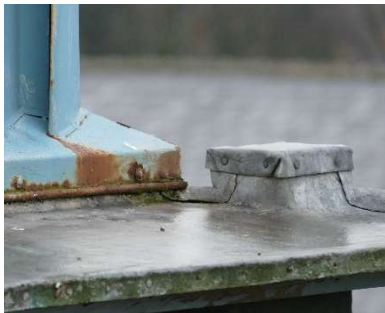
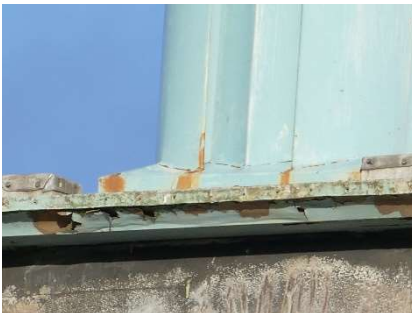
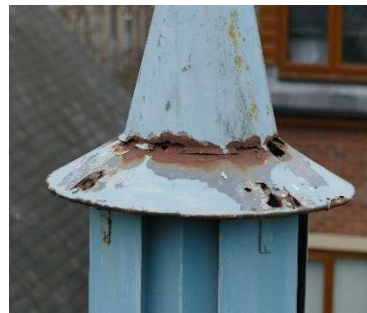
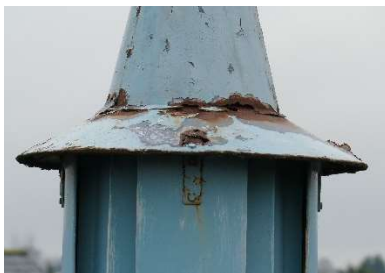
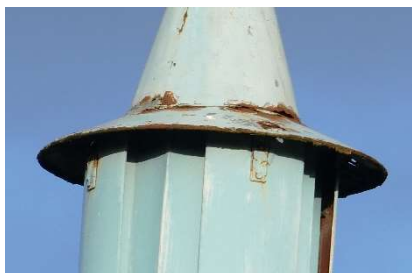
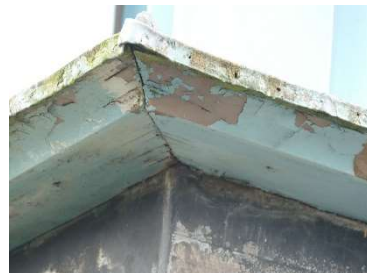
**The turret is heavily corroded and its structural integrity is impacted..**

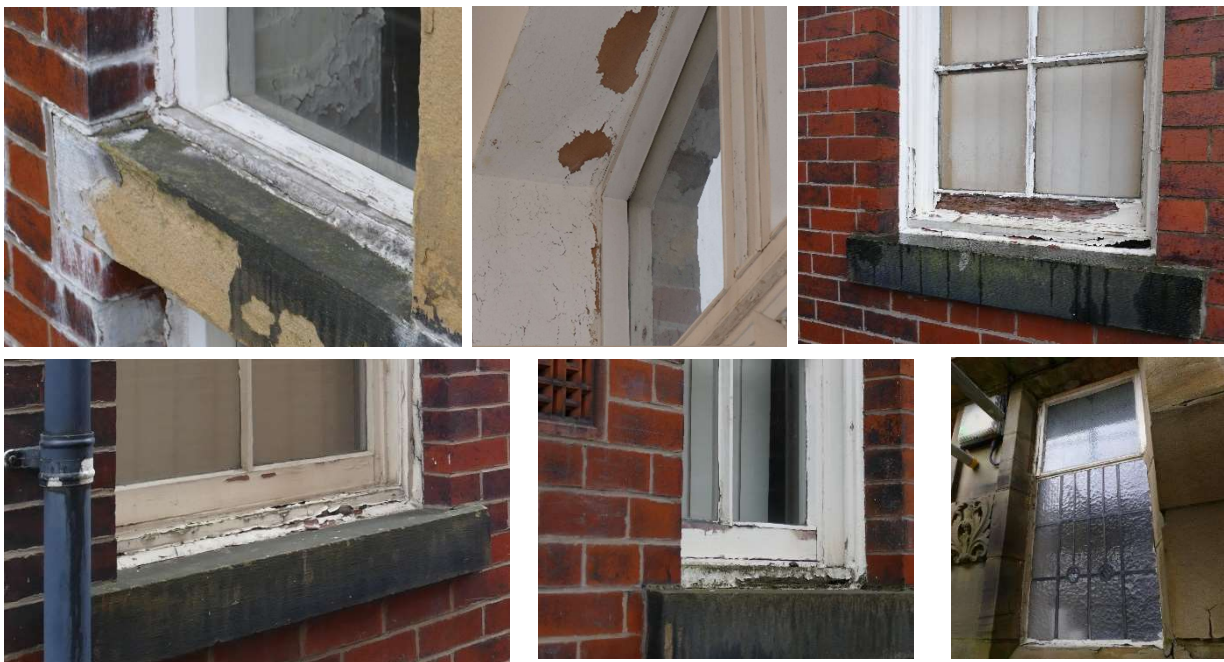
**All windows are painted shut and many of the windows have rotten cills, sashes and cases.**

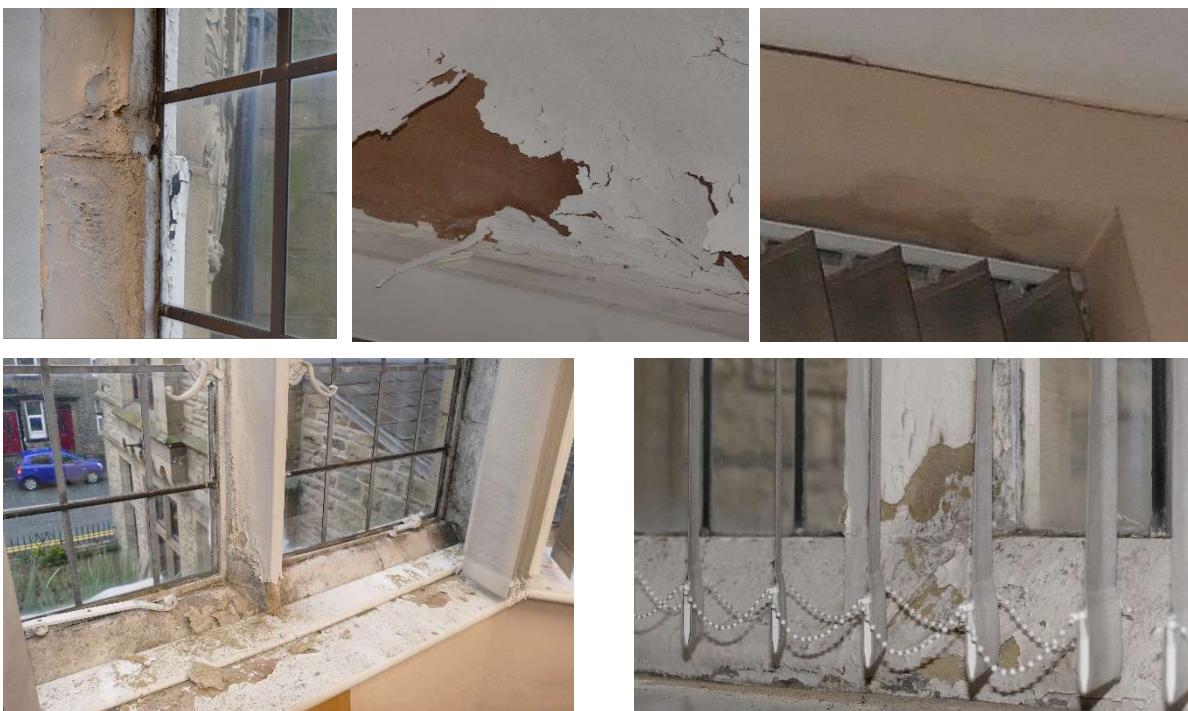
**Water damage around windows, in particular, has compromised the aesthetic appearance of the interior of the building and has impacted upon the fabric. Inappropriate coatings have also lead to increased deterioration of the fabric.**

Mullions and transoms damaged by trapped moisture will be uncovered and the damage assessed with the Conservation officer and appropriate measures taken to restore and repair the stonework. Any indent repairs will be made using stone to fully match the existing and wherever possible, stone salvaged from the original will be re-used for the repairs.
