**Issue Date**  
17<sup>th</sup> April 2022

**Reference Number**  
HCA02246

## Asbestos Demolition Survey

Units F13, F14 and F15  
Fieldhouse Industrial Estate  
Rochdale  
Lancashire  
OL12 0AA

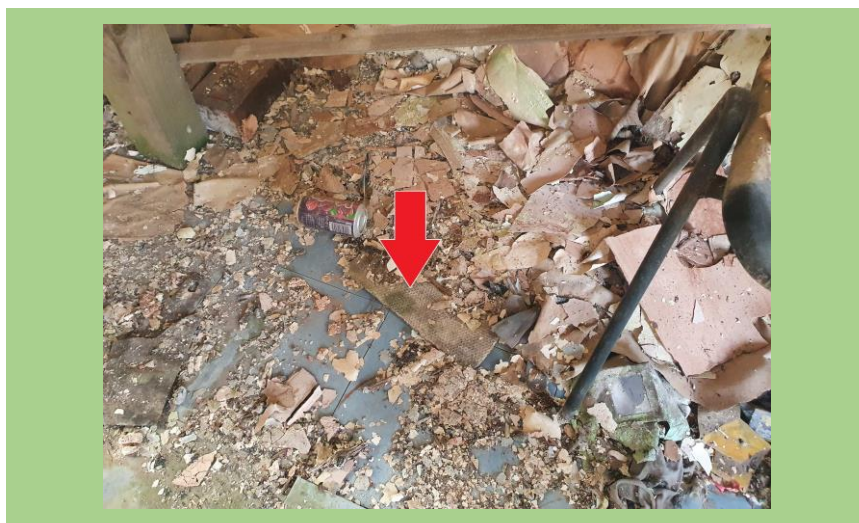
| Sample Number | 3 VI 2 | Floor Plan Colour | Red |

| Floor, Room | Ground floor, G.01 | Location | Loose on the floor |
| Material | Cement sheeting debris | Quantity | <1 sq. m. |

| Material Assessment | | Priority Assessment | |
|---|---|---|---|
| Extent of Damage (0-3) | 3 | Likelihood of Disturbance (0-3) | 3 |

| Additional Comments |
|---|
| Further asbestos containing cement debris may be present within the refuse and rubble throughout this area. |

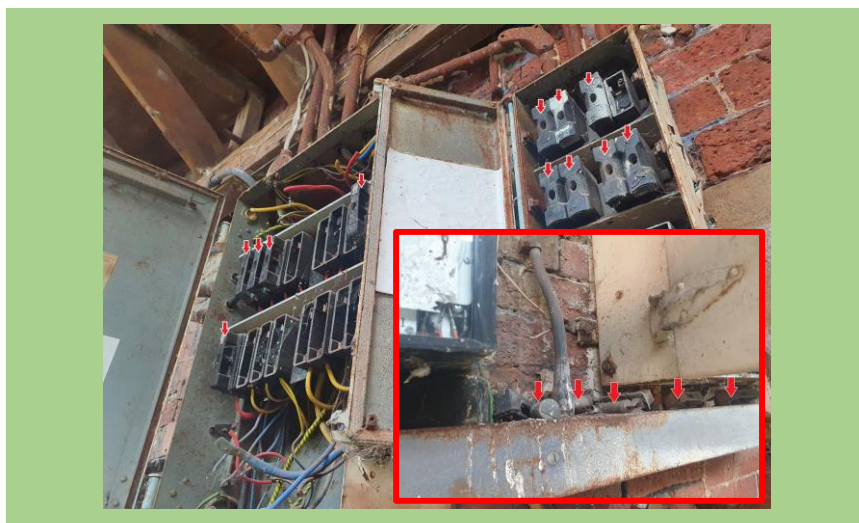
| Sample Number | 8 | Floor Plan Colour | Green |

| Floor, Room | Ground floor, G.03 | Location | Within the fuse boxes and laying loose on the surrounding surfaces |
| Material | Millboard plugs within the barrel fuses | Quantity | 25 units (visible) |

| Material Assessment | | Priority Assessment | |
|---|---|---|---|
| Extent of Damage (0-3) | 0 | Likelihood of Disturbance (0-3) | 3 |

| Further suspect barrel fuses may be present within the refuse and rubble throughout this area. |

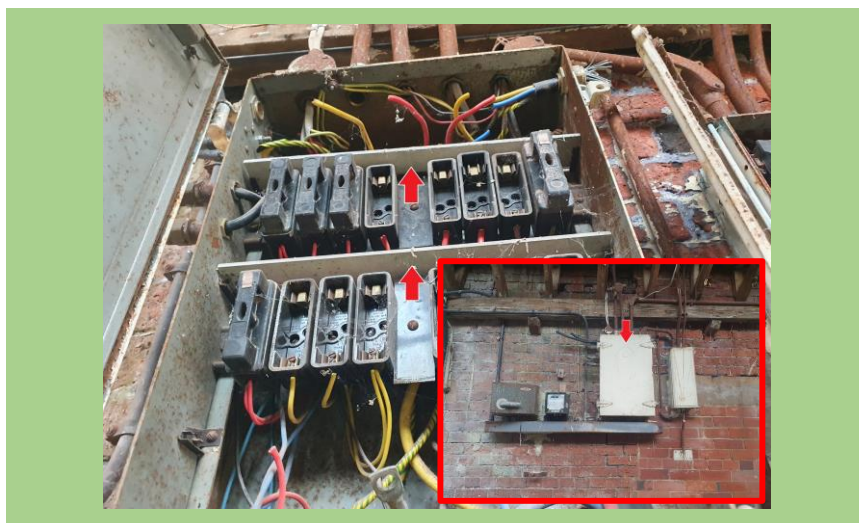
| Sample Number | 10 | Floor Plan Colour | Brown |

| Floor, Room | Ground floor, G.03 | Location | Within the wall mounted fuse box |
| Material | Cement arc shields | Quantity | 2 units |

| Material Assessment | | Priority Assessment | |
|---|---|---|---|
| Extent of Damage (0-3) | 1 | Likelihood of Disturbance (0-3) | 1 |

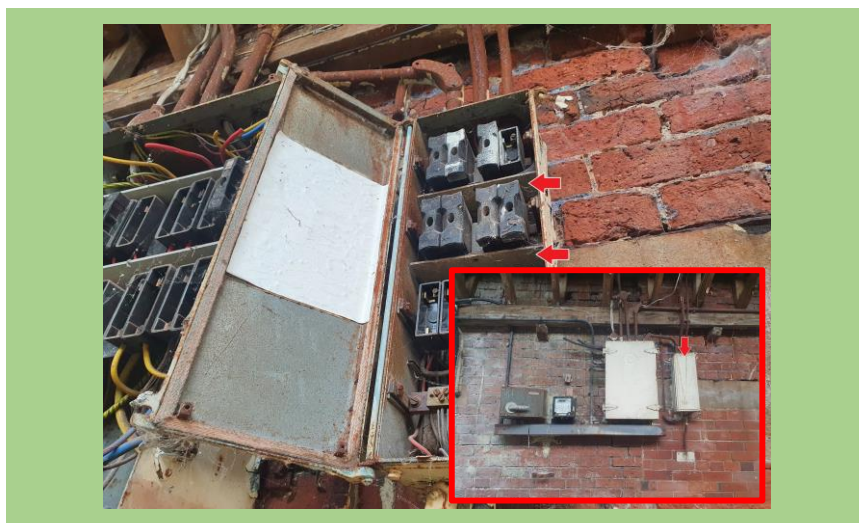
| Sample Number | 12 | Floor Plan Colour | Brown |

| Floor, Room | Ground floor, G.03 | Location | Within the wall mounted fuse box |
| Material | Cement arc shields | Quantity | 2 units |

| Material Assessment | | Priority Assessment | |
|---|---|---|---|
| Extent of Damage (0-3) | 1 | Likelihood of Disturbance (0-3) | 1 |

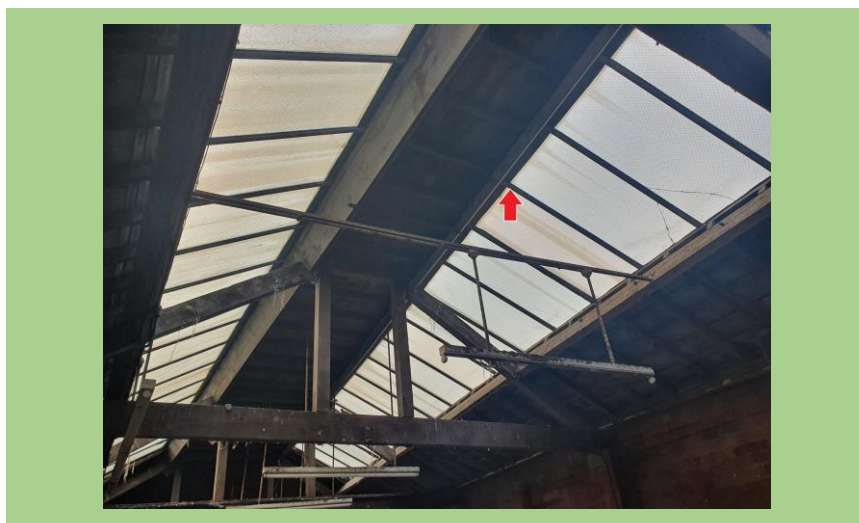
| Sample Number | 15 NS | Floor Plan Colour | Pink |

| Floor, Room | Ground floor, G.03 | Location | Rooflight frames |
| Material | Presumed textile rope seals | Quantity | 46 units |

| Material Assessment | | Priority Assessment | |
|---|---|---|---|
| Extent of Damage (0-3) | 0 | Likelihood of Disturbance (0-3) | 1 |

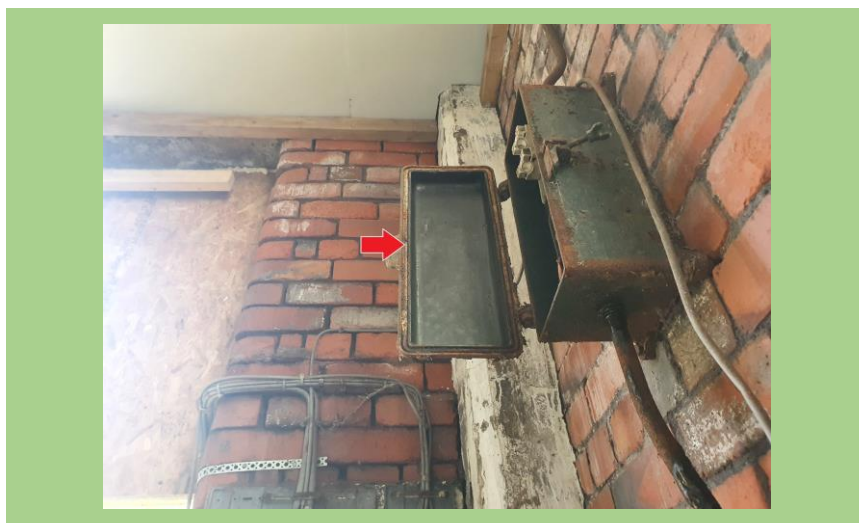
| Sample Number | 18 | Floor Plan Colour | Pink |

| Floor, Room | First floor, 1.01 | Location | Within the wall mounted fuse box |
| Material | Textile rope seal to the door | Quantity | 1 unit |

| Material Assessment | | Priority Assessment | |
|---|---|---|---|
| Extent of Damage (0-3) | 1 | Likelihood of Disturbance (0-3) | 1 |

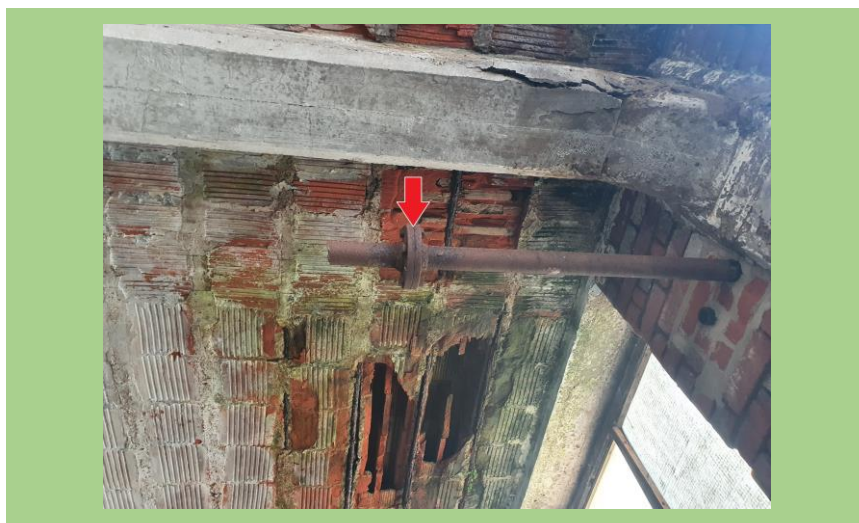
| Sample Number | 19 NS | Floor Plan Colour | Orange |

| Floor, Room | First floor, 1.01 | Location | Sealed pipework flange |
| Material | Presumed gasket | Quantity | 1 unit |

| Material Assessment | | Priority Assessment | |
|---|---|---|---|
| Extent of Damage (0-3) | 0 | Likelihood of Disturbance (0-3) | 1 |

| Additional Comments |
|---|
| The presumed asbestos containing gasket within this pipework flange is recessed within the flush joint. As such no sample could be obtained. |

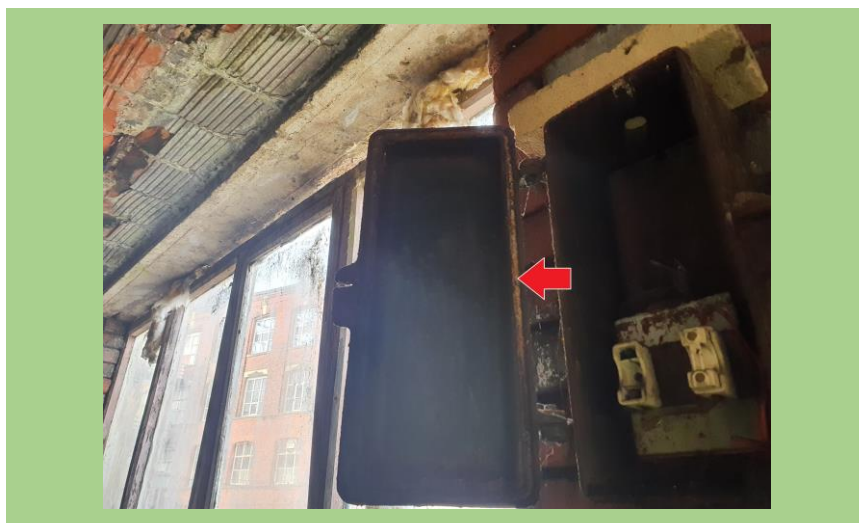
| Sample Number | 21 VI 18 | Floor Plan Colour | Pink |

| Floor, Room | First floor, 1.01 | Location | Within the wall mounted fuse box |
| Material | Textile rope seal to the door | Quantity | 1 unit |

| Material Assessment | | Priority Assessment | |
|---|---|---|---|
| Extent of Damage (0-3) | 1 | Likelihood of Disturbance (0-3) | 1 |

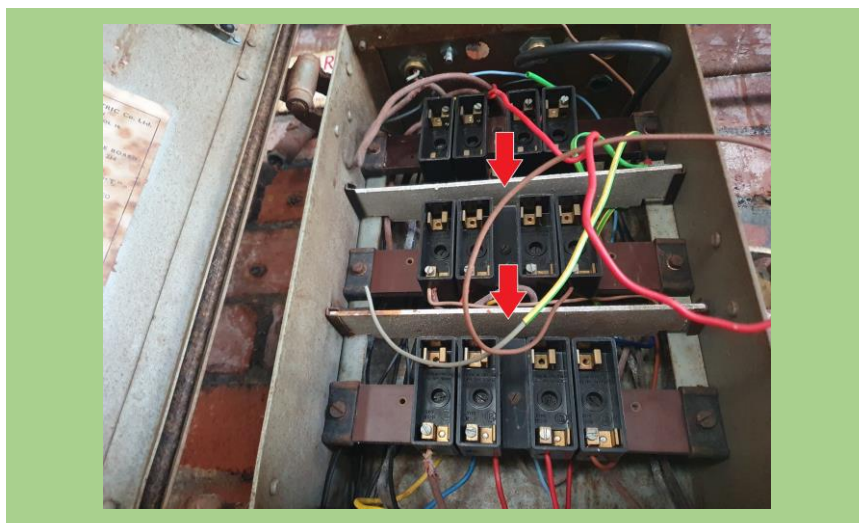
| Sample Number | 25 | Floor Plan Colour | Brown |

| Floor, Room | First floor, 1.01 | Location | Within the wall mounted fuse box |
| Material | Cement arc shields | Quantity | 2 units |

| Material Assessment | | Priority Assessment | |
|---|---|---|---|
| Extent of Damage (0-3) | 1 | Likelihood of Disturbance (0-3) | 1 |

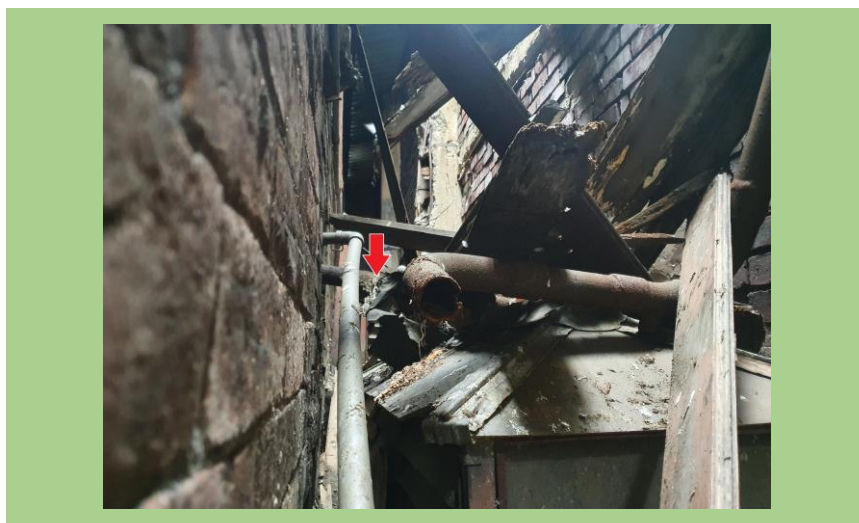
| Sample Number | 27 NS | Floor Plan Colour | Blue |

| Floor, Room | External, between the buildings | Location | Pipework |
| Material | Thermal insulation | Quantity | 1 lin. m. |

| Material Assessment | | Priority Assessment | |
|---|---|---|---|
| Extent of Damage (0-3) | 3 | Likelihood of Disturbance (0-3) | 1 |

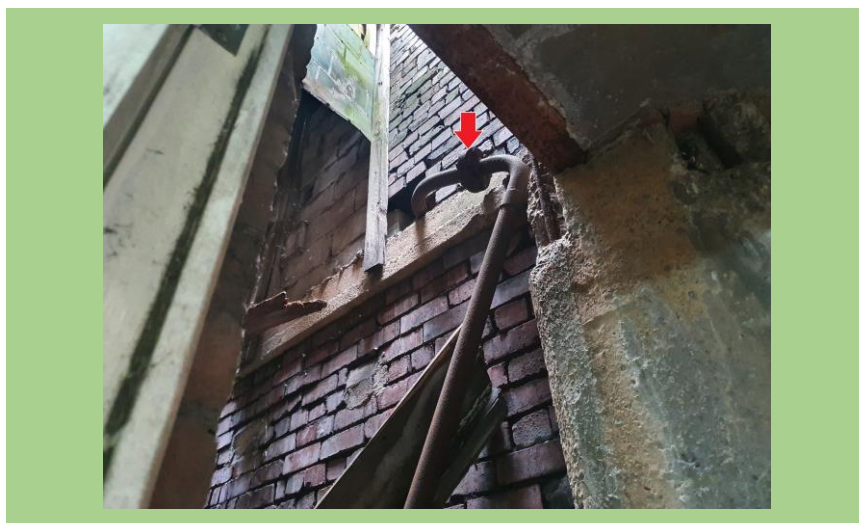
| Sample Number | 28 NS | Floor Plan Colour | Orange |

| Floor, Room | External, between the buildings | Location | Sealed pipework flange |
| Material | Presumed gasket | Quantity | 1 unit |

| Material Assessment | | Priority Assessment | |
|---|---|---|---|
| Extent of Damage (0-3) | 0 | Likelihood of Disturbance (0-3) | 1 |

| Additional Comments |
|---|
| The presumed asbestos containing gasket within this pipework flange is recessed within the flush joint. As such no sample could be obtained. |

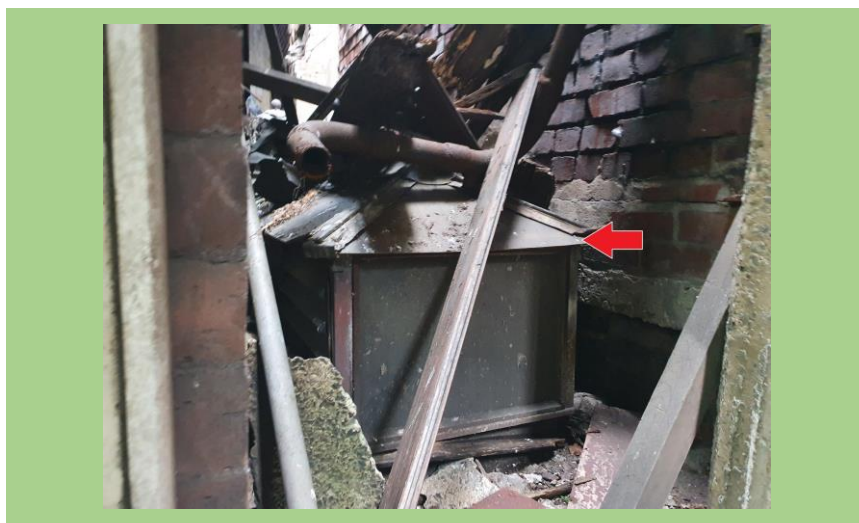
| Sample Number | 30 NS | Floor Plan Colour | Pink |

| Floor, Room | External, between the buildings | Location | Rooflight frames |
| Material | Presumed textile rope seals | Quantity | 4 lin. m. |

| Material Assessment | | Priority Assessment | |
|---|---|---|---|
| Extent of Damage (0-3) | 0 | Likelihood of Disturbance (0-3) | 1 |

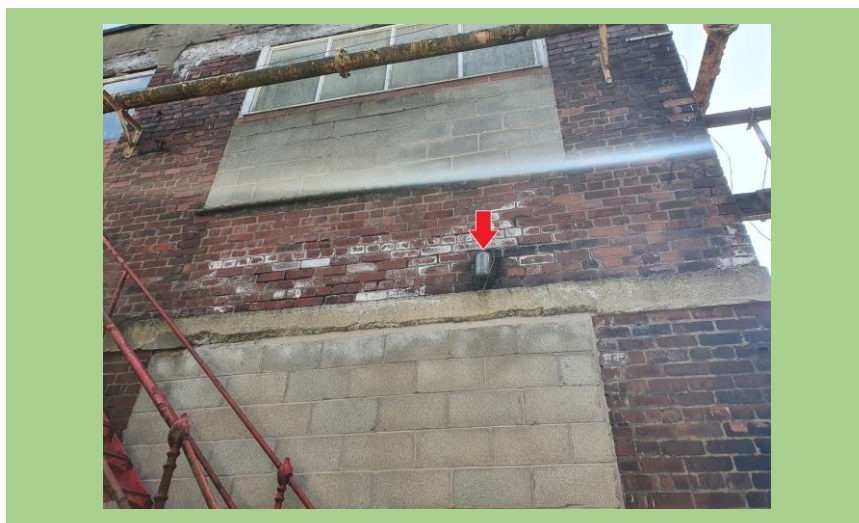
| Sample Number | 34 NS | Floor Plan Colour | Light blue |

| Floor, Room | External | Location | Wall mounted emergency light casing |
| Material | Presumed mastic seal | Quantity | 1 unit |

| Material Assessment | | Priority Assessment | |
|---|---|---|---|
| Extent of Damage (0-3) | 0 | Likelihood of Disturbance (0-3) | 1 |

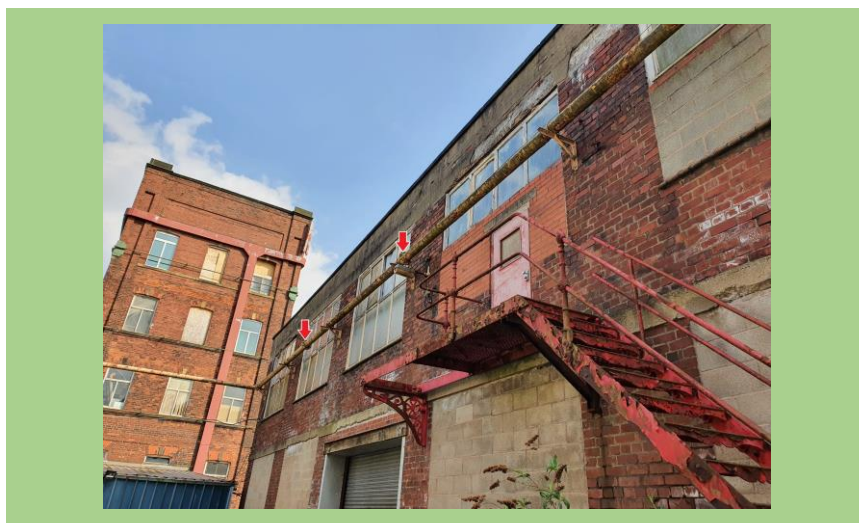
| Sample Number | 35 NS | Floor Plan Colour | Orange |

| Floor, Room | External | Location | High level gas pipework |
| Material | Presumed gaskets | Quantity | 5 units |

| Material Assessment | | Priority Assessment | |
|---|---|---|---|
| Extent of Damage (0-3) | 0 | Likelihood of Disturbance (0-3) | 1 |
