Phase I Geoenvironmental Site Assessment  
Plot 3, Pilsworth Road, South Heywood

Reference: 11-697-R11-2  
Date: November 2022

# PHASE I GEOENVIRONMENTAL SITE ASSESSMENT

Plot 3  
Pilsworth Road  
South Heywood  
OL10 2TT

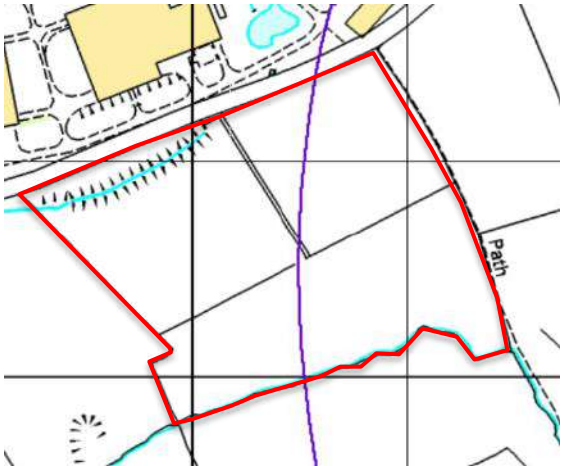
| MAP EDITION | HISTORICAL LAND USE | HISTORICAL MAP EXCERPT |
|---|---|---|
| <p><b>1999</b><br/><b>1:10,000</b></p> | <p>There are no significant changes. A ditch is shown in the location of the culvert in the north.</p> | <p>A historical map excerpt from 1999 at a scale of 1:10,000. It shows a red boundary enclosing a plot of land. A blue line representing a ditch or culvert runs along the northern edge of the plot. A purple line runs vertically through the plot. A dashed line labeled 'Path' is visible on the right side. A north arrow is located in the bottom left corner.</p> |

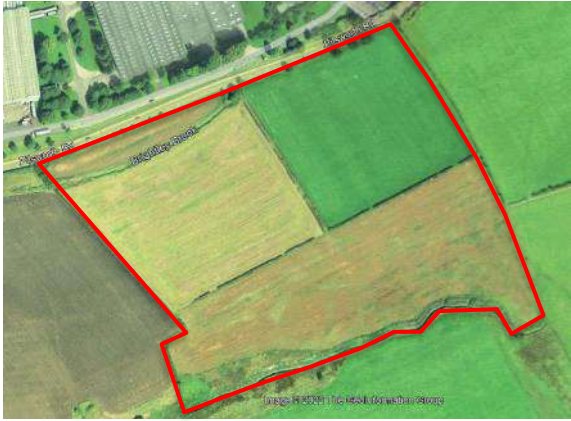
| MAP EDITION | HISTORICAL LAND USE | HISTORICAL MAP EXCERPT |
|---|---|---|
| <p><b>2000</b><br/><b>Google Earth Aerial Imagery</b></p> | <p>There are no significant changes. The culvert in the north is recorded as Brightley Brook.</p> | <p>Aerial imagery from 2000 showing the site. A red boundary outlines the plot. A green area labeled 'Brightley Brook' is visible along the northern edge. The surrounding area includes fields and some buildings.</p> |

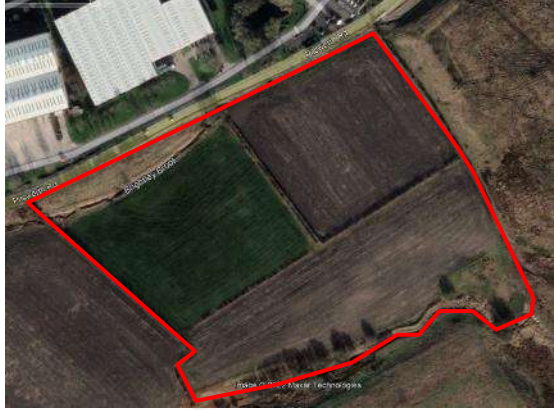
| MAP EDITION | HISTORICAL LAND USE | HISTORICAL MAP EXCERPT |
|---|---|---|
| <p><b>2022</b><br/><b>Google Earth Aerial Imagery</b></p> | <p>There are no significant changes.</p> | <p>Aerial imagery from 2022 showing the site. A red boundary outlines the plot. The area is mostly brown, indicating bare soil or winter vegetation. A green area labeled 'Brightley Brook' is visible along the northern edge. The surrounding area includes fields and some buildings.</p> |

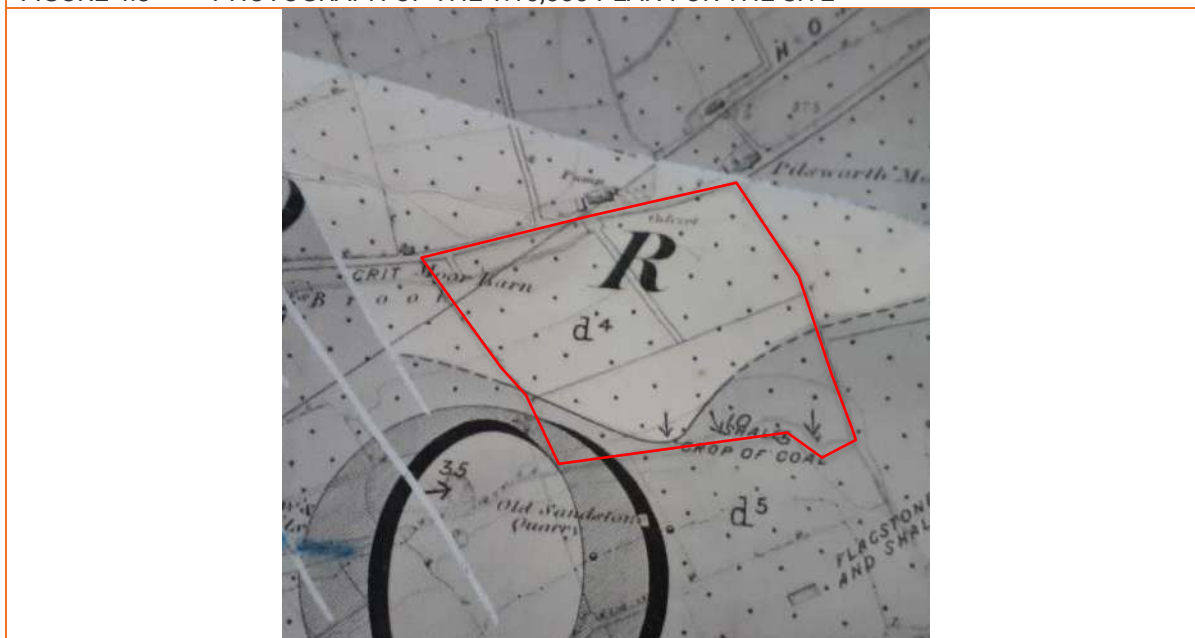
**FIGURE 4.3 PHOTOGRAPH OF THE 1:10,000 PLAN FOR THE SITE**

Figure 4.3 is a photograph of the 6 inch geological map for the site which shows a crop of coal in the south of the site dipping at between 5–10 degrees to the south. The seam name is not given.
