**PROPOSED DEVELOPMENT OF WARWICK MILL AND LONDON HOUSE  
MANCHESTER M24 1AZ**

**WARWICK MILL – WINDOW CONDITION SURVEY**

**November 2023**

**Prepared by  
GMA Architecture  
UK House  
82 Heath Road  
Twickenham TW1 4BW**

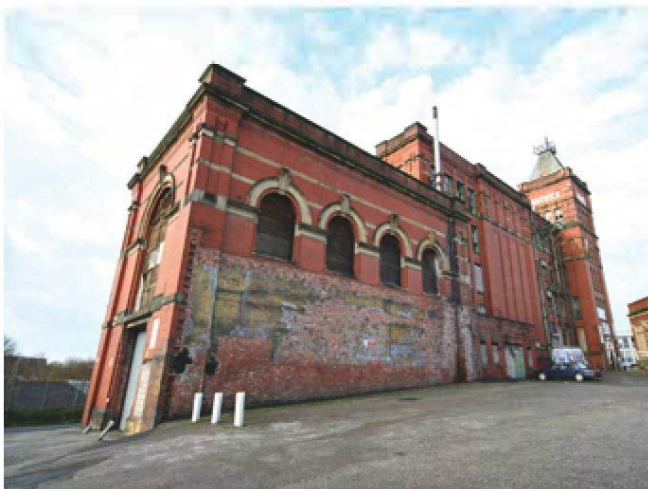
*Engine house showing damaged facade*

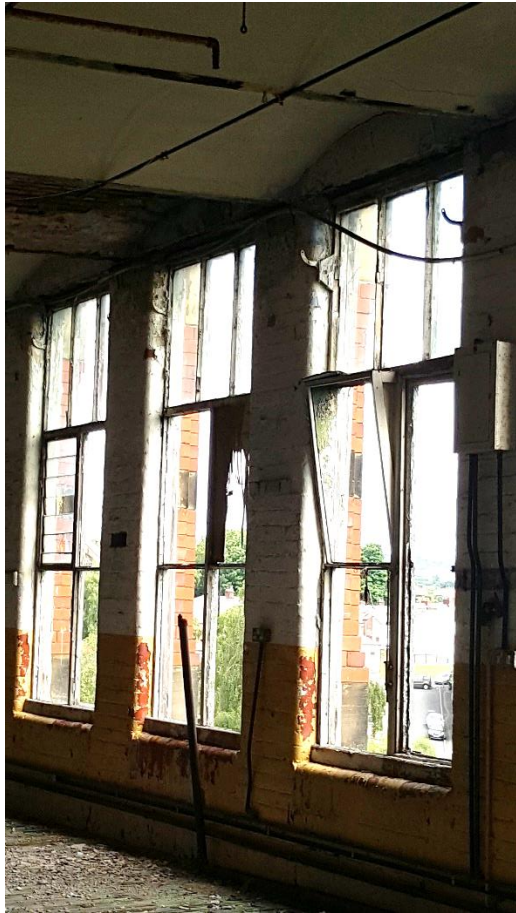
LOW CILL HEIGHTS/POOR VENTILATION  
HIGH LEVEL CONTROLS FOR RESIDENTIAL  
USE

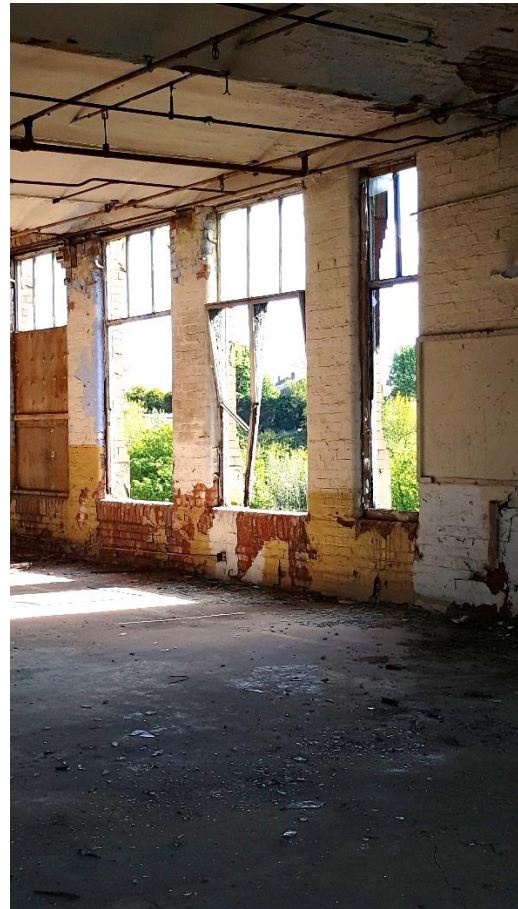
WINDOW FRAMES MISSING/  
VANDALISED

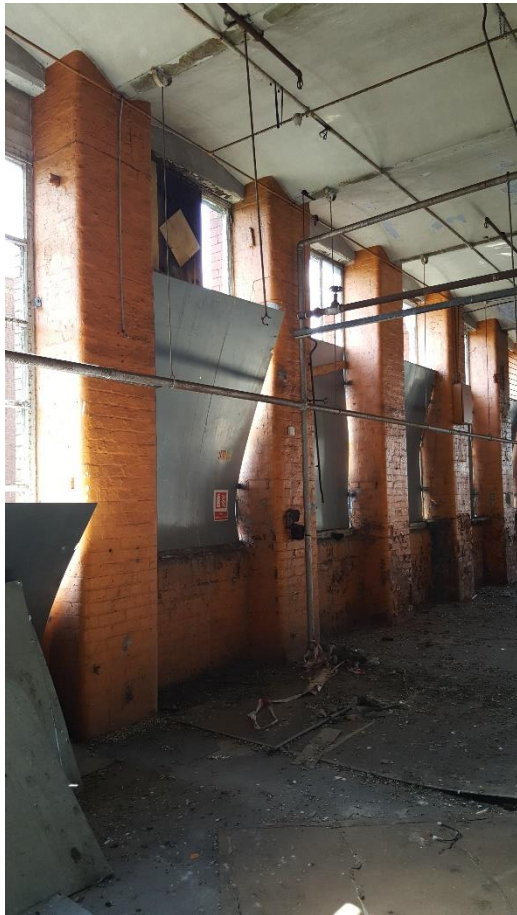
EXISTING WINDOW MISSING  
BEHIND PROTECTION

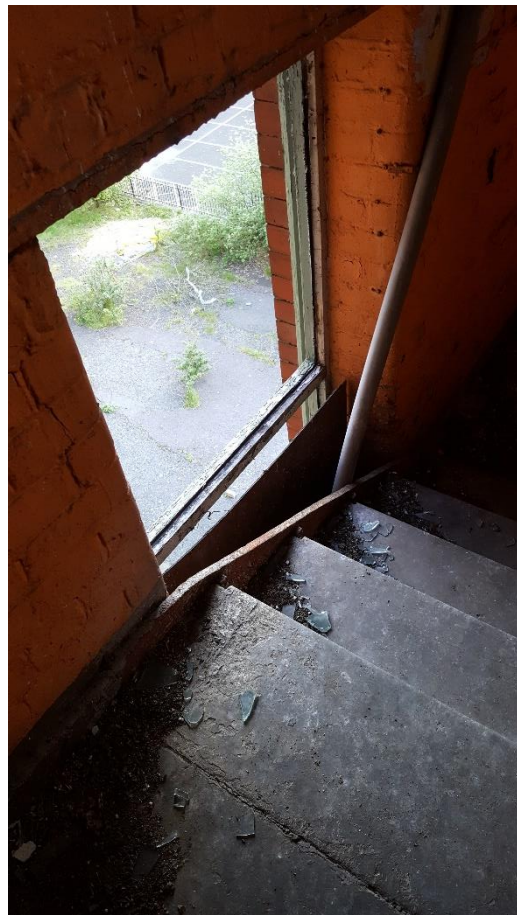
UNSAFE WINDOW ON MEANS OF  
ESCAPE ROUTE

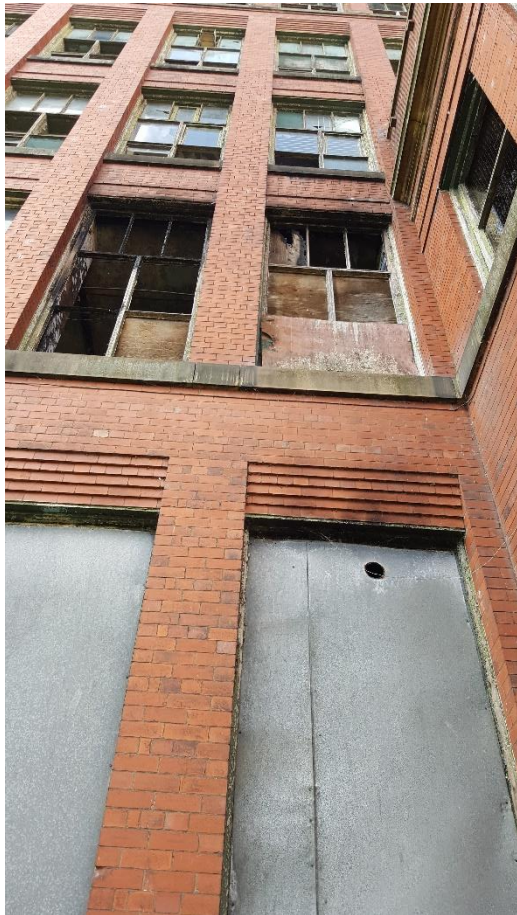
WINDOW COMPONENTS LOST/  
GLAZING MISSING GIVING RISE TO  
TIMBER DECAY

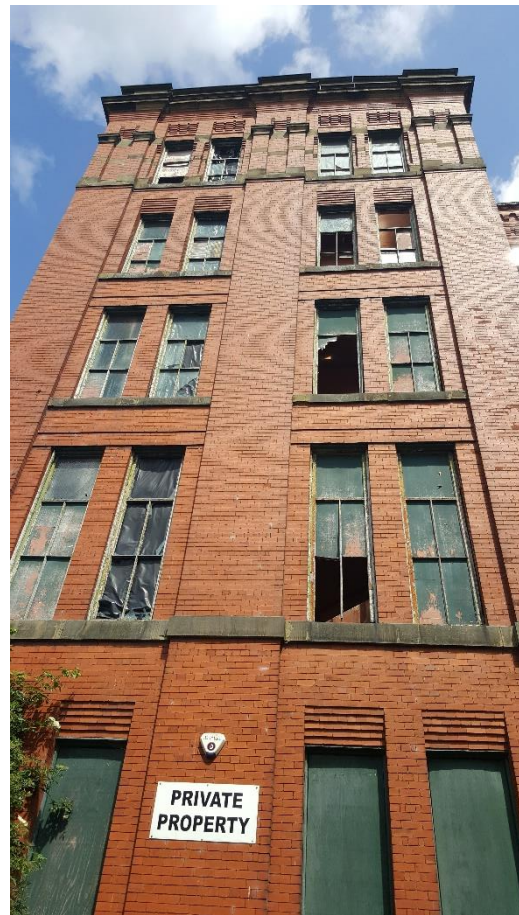
WINDOW COMPONENTS LOST/  
GLAZING MISSING GIVING RISE TO  
TIMBER DECAY

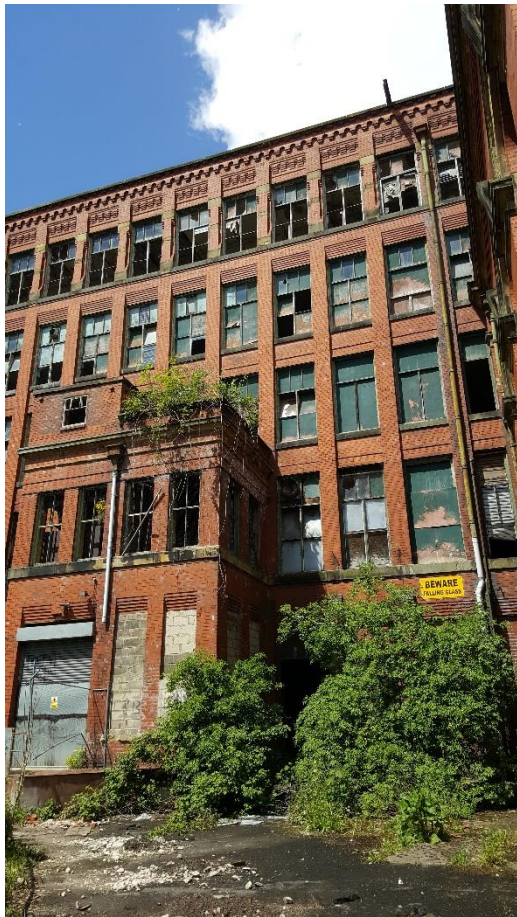
INFILLED WINDOW POSITIONS /  
WINDOW COMPONENTS LOST

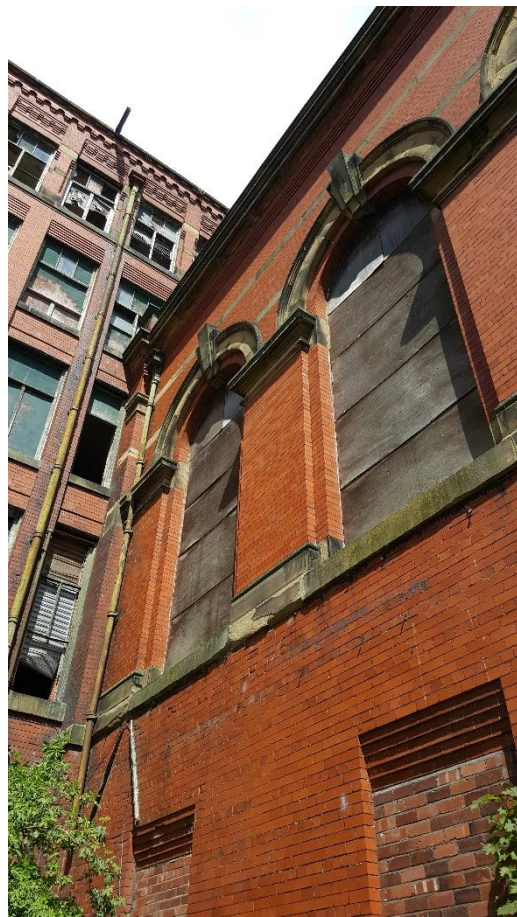
WINDOW DETERIORATION /  
MISSING INFILLED
