# Preliminary Roost Assessment & Nesting Bird Check

Longley Hey Farm  
Halifax Road  
Littleborough  
OL15 0LB

For  
Kelly Slicker

# Gritstone Ecology

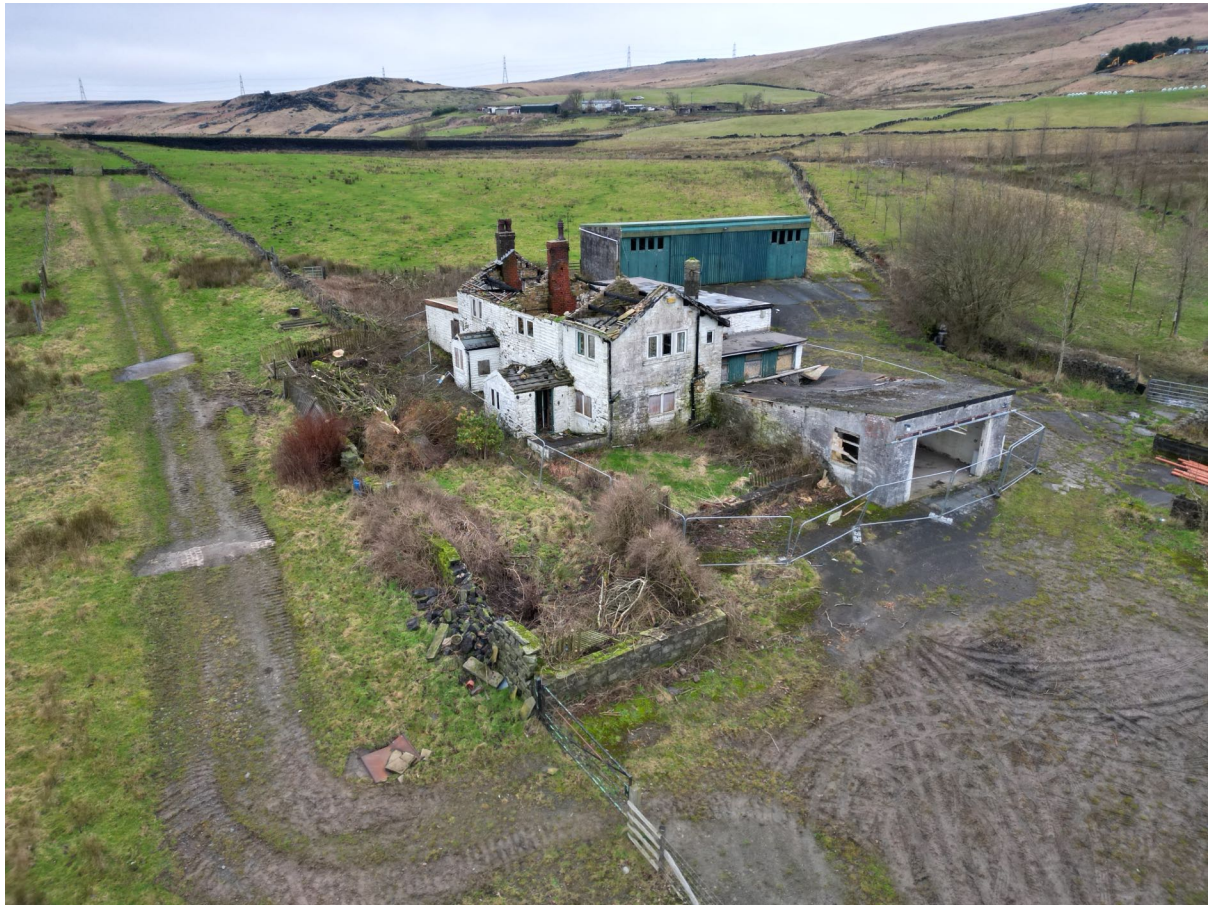
3.1a – Looking north toward the farmhouse.

Longley Hey Farm is an unoccupied derelict stone farmhouse which has been damaged by fire. The building consists of the original stone section of the farmhouse, and lean-to sheds which abut the northern, southern, and eastern walls.

The main section of the farmhouse has no roof, floors, ceilings, or enclosed spaces, and is fully open to the elements.

Some pieces of lead flashing are still present around the chimneys; although they are either fully open and exposed to the elements, or tight against brickwork. External timbers such as purlins, fascia boards, soffits, and gutters, were largely destroyed by the fire. Timbers that remain are fully open to the elements, and provide no suitable crevices for roosting bats.

Walls are white painted solid local stone, lintels are stone, sills are stone; window and door frames are UPVC, all glass has been destroyed.

External features which are typically used by roosting bats, such as gaps between roof tiles, under ridge tiles, under lead flashing, and behind roof timbers have been destroyed by the fire. Walls are white painted local stone, with no gaps in mortar, or cracks which could be used by roosting bats. There are no gaps between window and door frames (where present) and stonework.

There are no features remaining externally which are suitable or likely be used by roosting bats, and no indications of use by bats were present during the inspection.

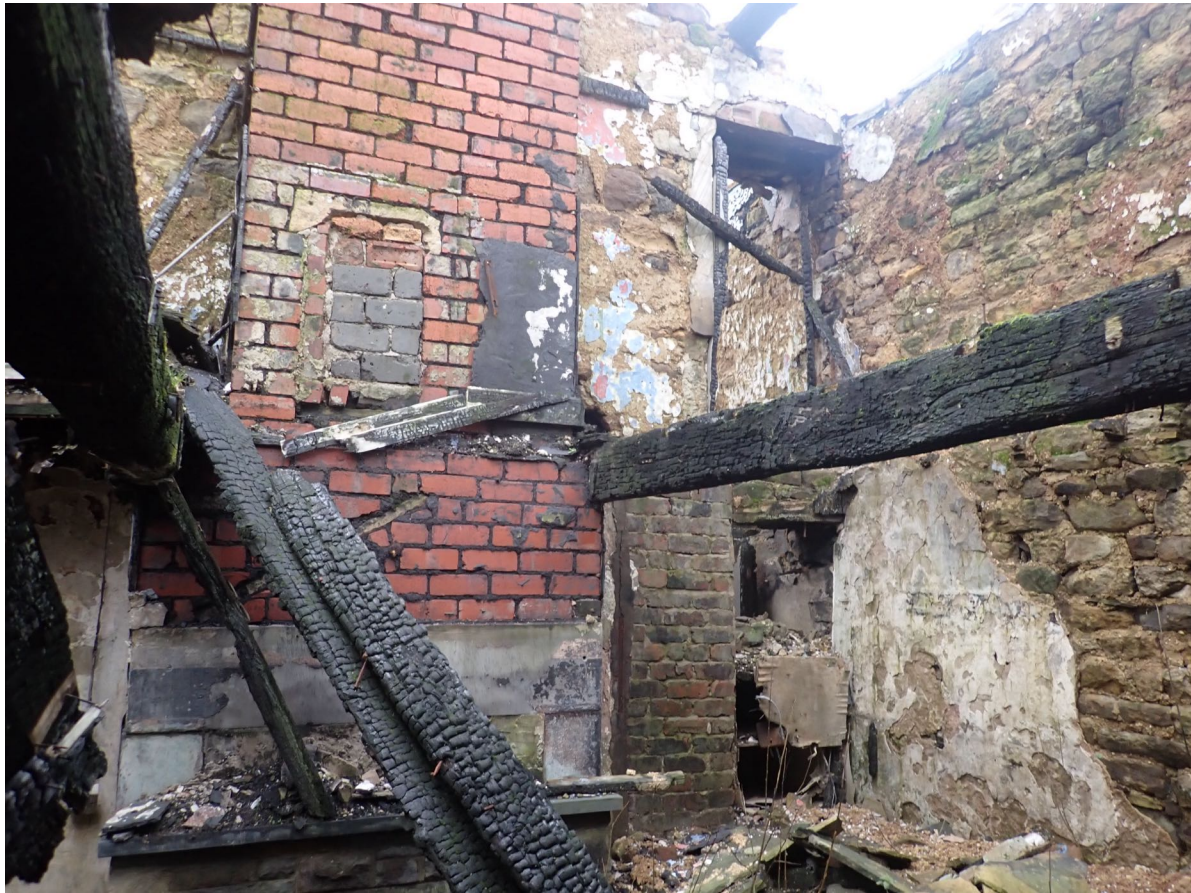
3.2a – The inside of the farmhouse.

Internally the main section of the farmhouse house was completely destroyed by the fire. There are no roof voids, floors, or ceilings, and the remains of the roof have collapsed into what was the cellar, leaving no enclosed spaces.

Internal walls are bare stone, or bare brickwork. There are minor gaps between blocks of stone, and bricks, where mortar has washed away, however these are superficial and do not lead into suitable crevices or cavities.

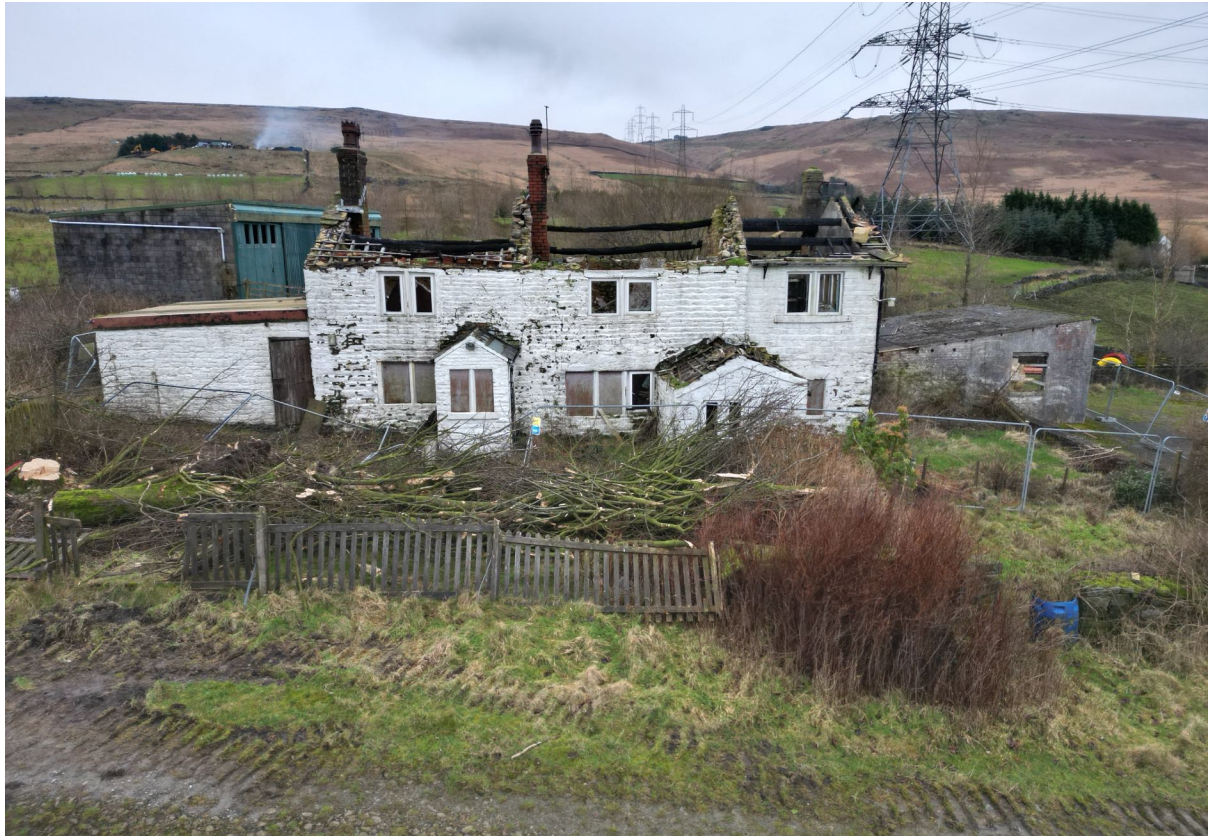
1 – The west side of the building.

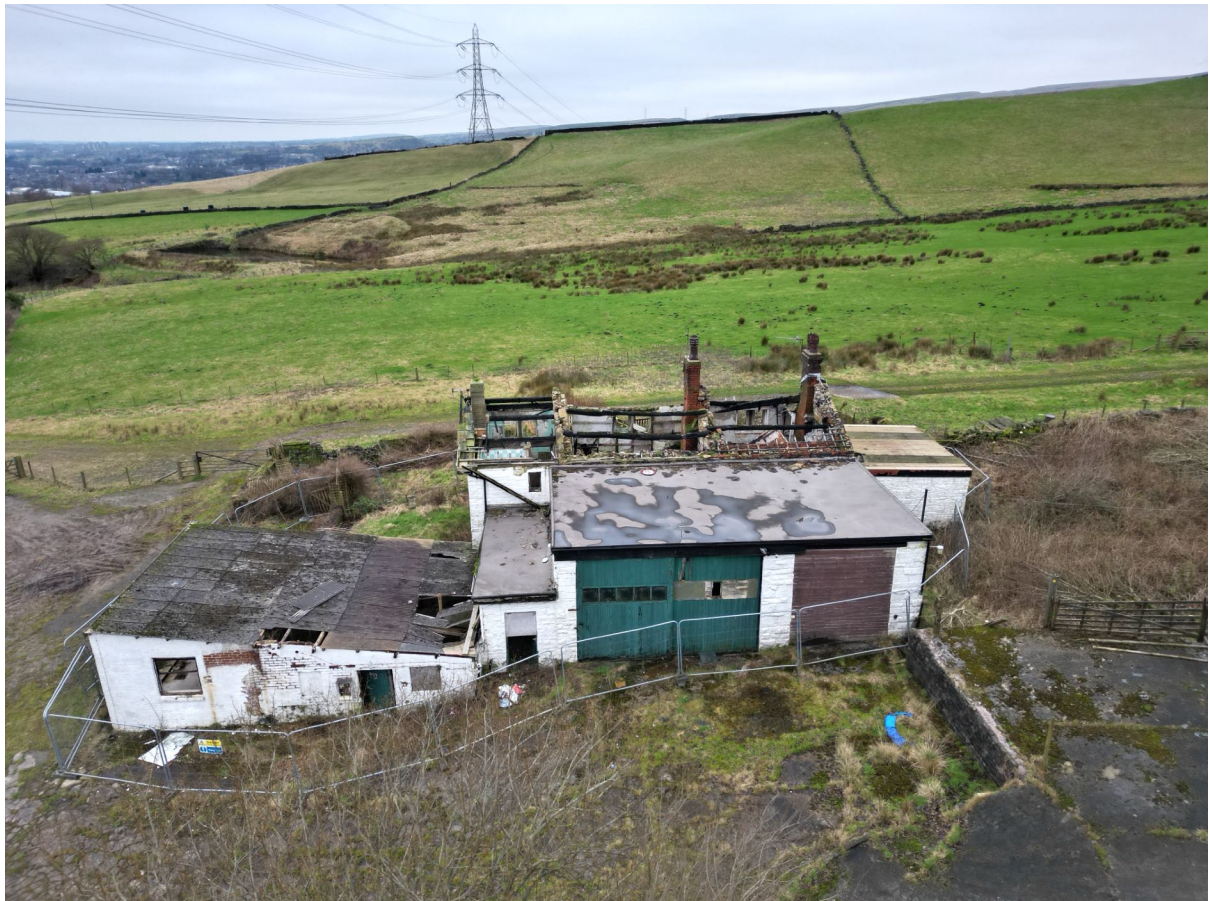
2 – The east side of the building.

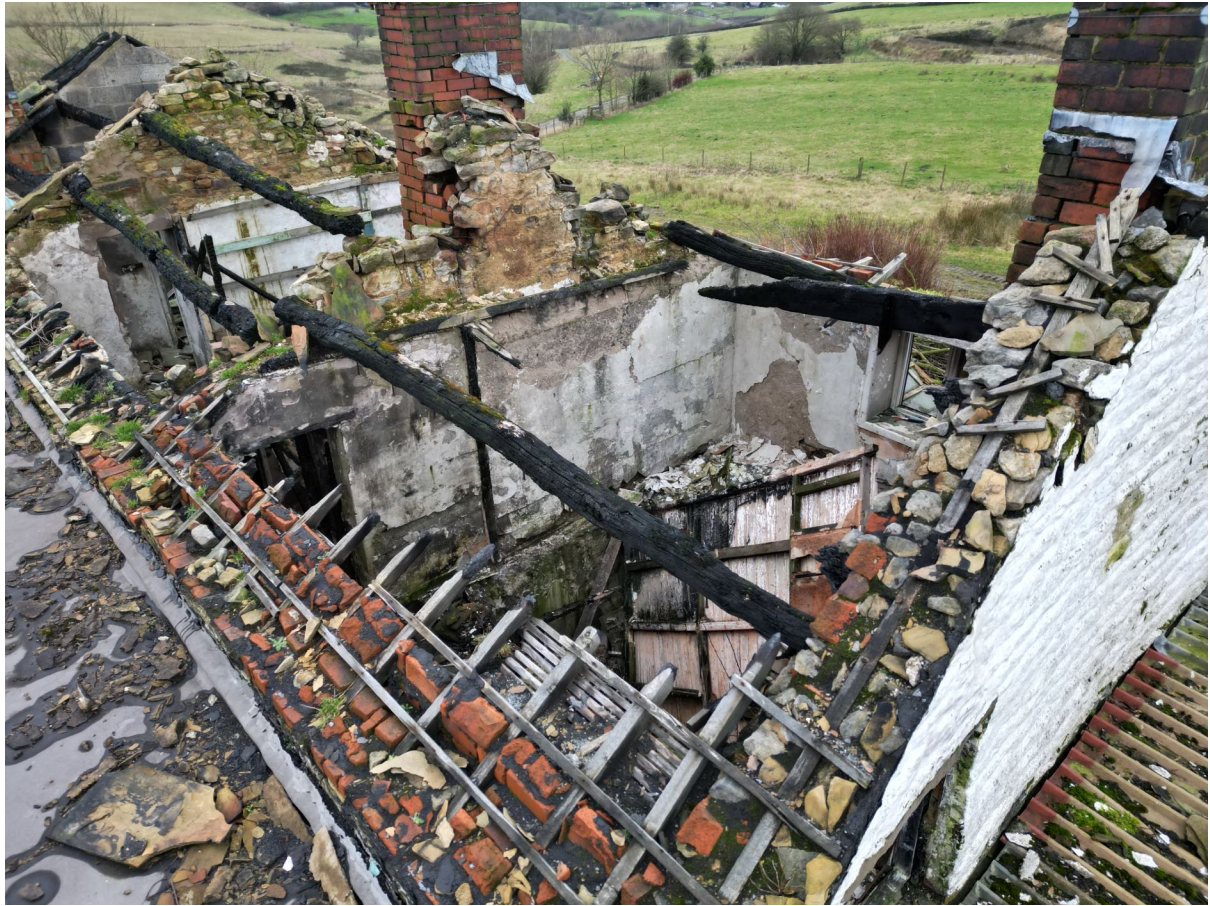
Prior to the fire, and subsequent damage by the weather and lack of maintenance, the building had a tiled roof covered with rough cut local stone, and would likely have been suitable for use by roosting bats. However in its current condition the building has no suitable features.

3 – The roof and inside of the building were destroyed by fire.

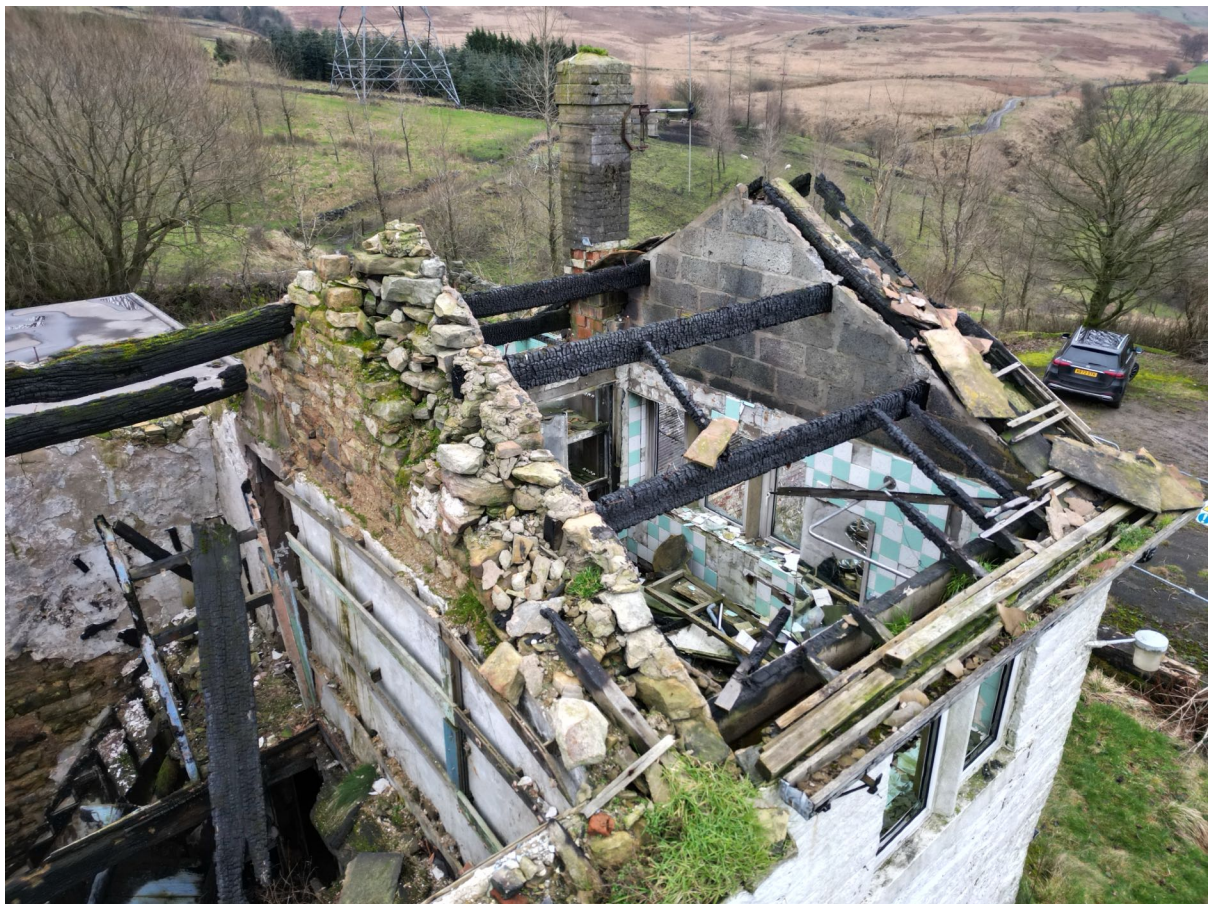
The top of walls at the eaves and gables are exposed to the elements, and any gaps between individual blocks of stone, or bricks, are either filled with the remains of mortar, or do not provide sufficient shelter to be used by roosting bats.

4 – Gaps in stonework and timbers at the top of the walls are open to the elements.

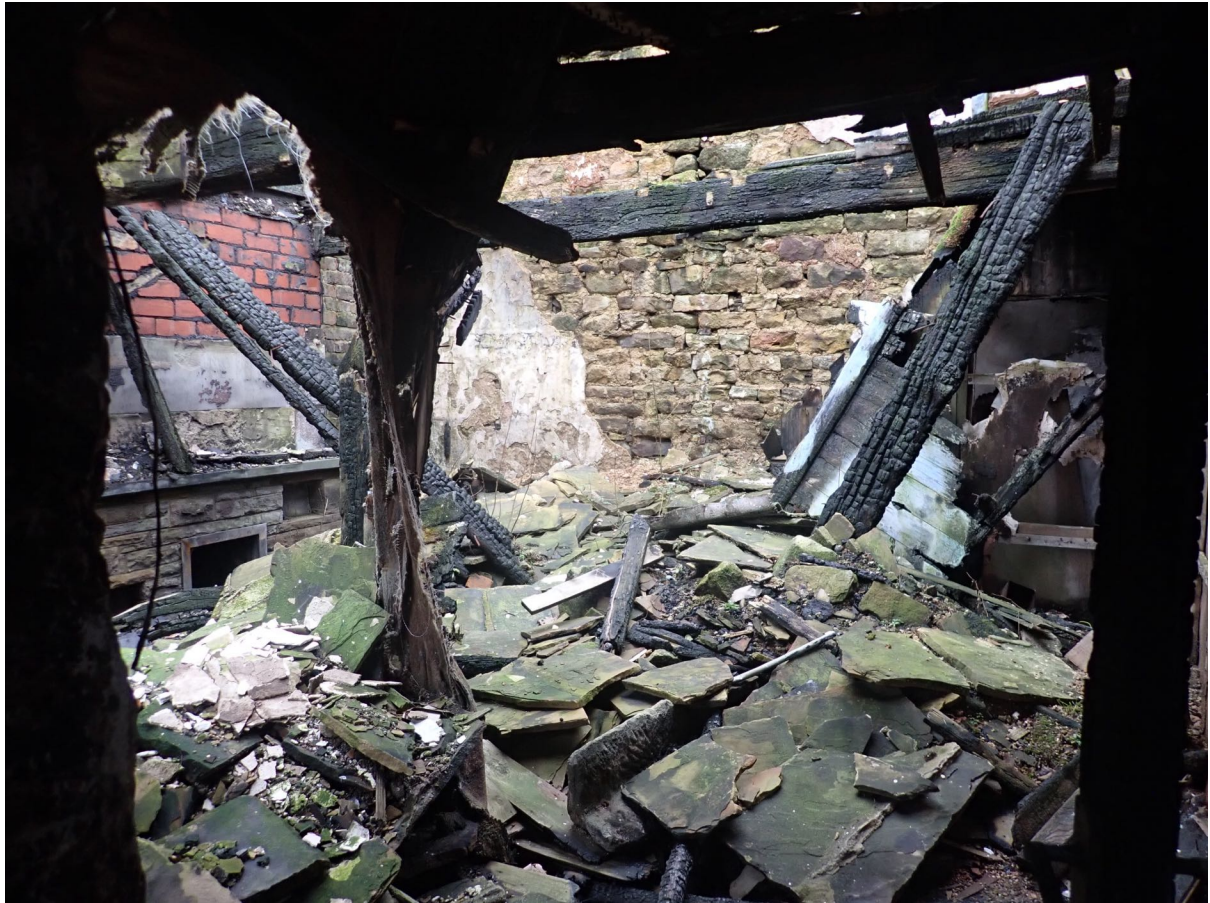
5 – Inside the farmhouse.

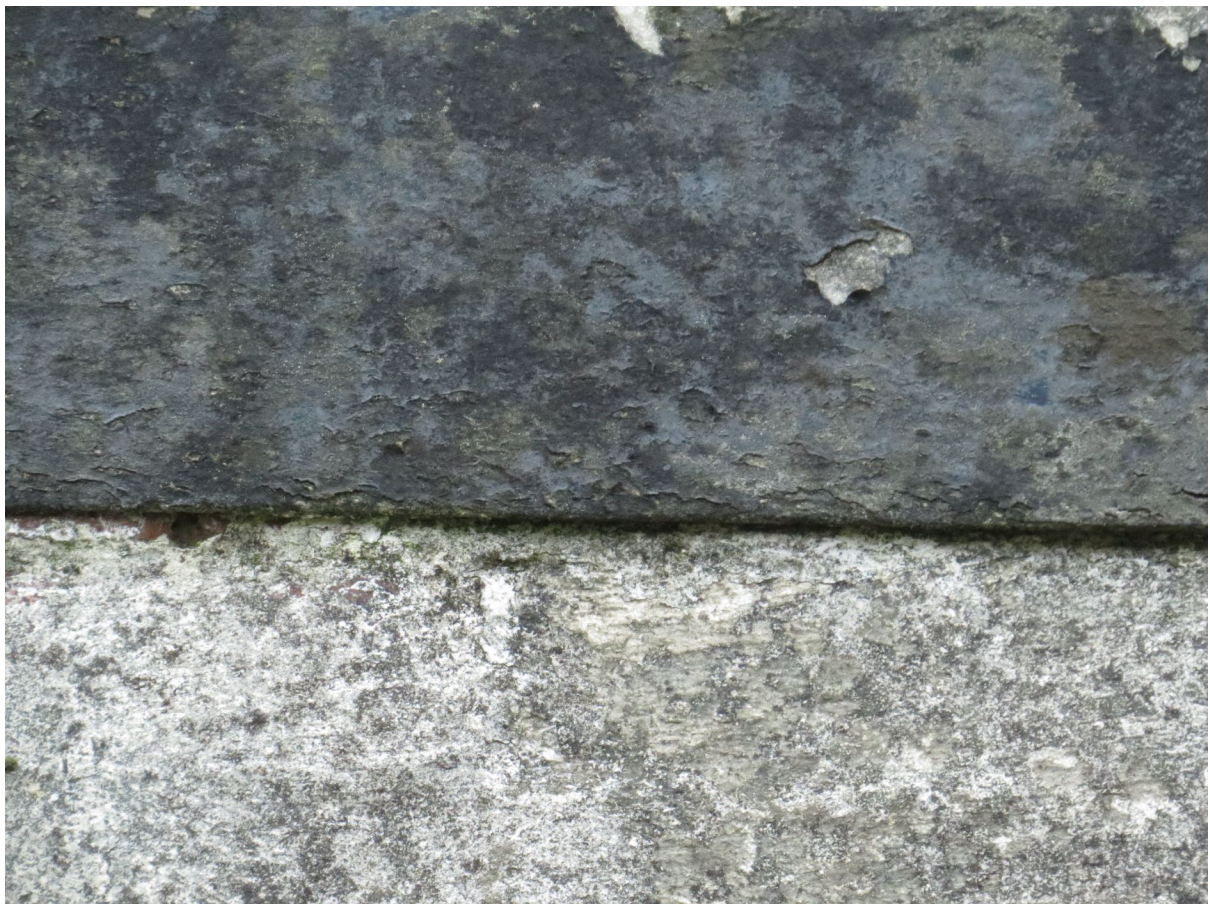
The southern lean-to was formerly a livestock shed. The building has a single-pitched roof covered with corrugated asbestos cement panels, and a simple timber supporting structure. Walls are white-painted solid brick. Asbestos cement fascia panels at the front of the building are fixed tightly against the wall with no gaps. Gaps between roofing materials and walls are filled with cement. There are no gaps between materials internally or externally which are suitable for use by roosting bats.

6 – Asbestos cement fascia are fitted tightly with no gaps.

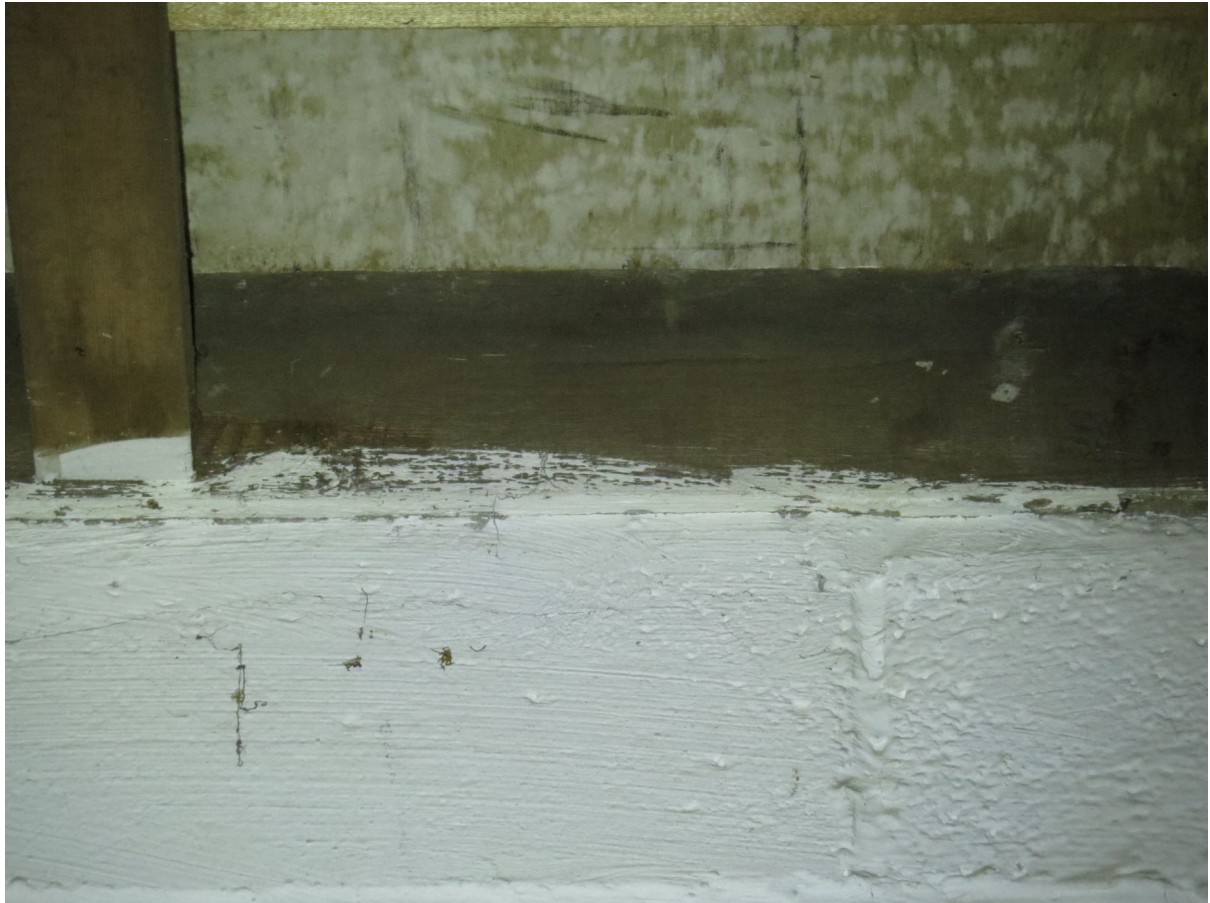
7 – There are no suitable gaps between roofing materials and blockwork.

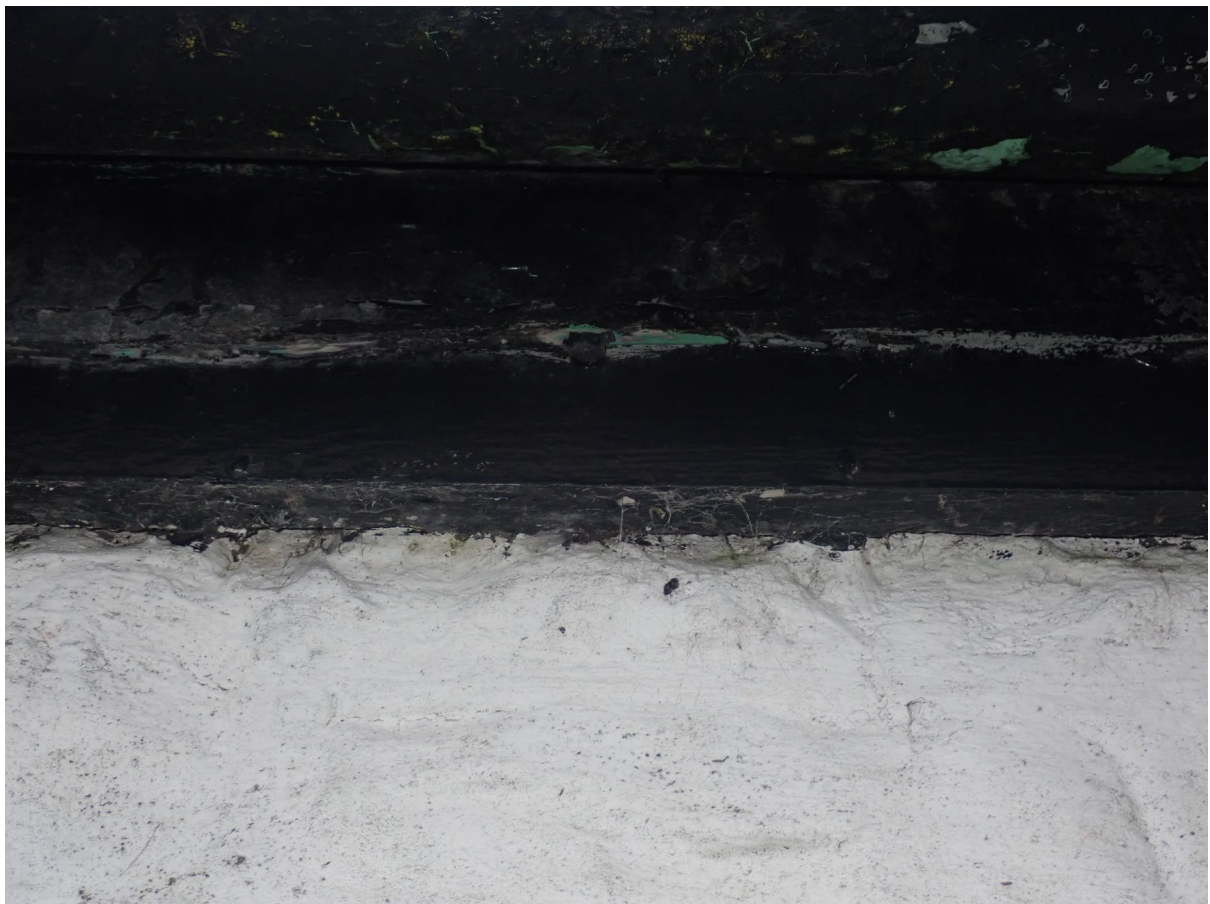
There are no features externally, which are suitable, or likely to be used by roosting bats; roof tiles and external timbers which are often used by roosting bats, were destroyed by the fire. Remaining timbers on the lean-to sheds are either missing, or fixed tightly against the walls.

8 – Fascia boards where present are fitted tightly with no suitable gaps.

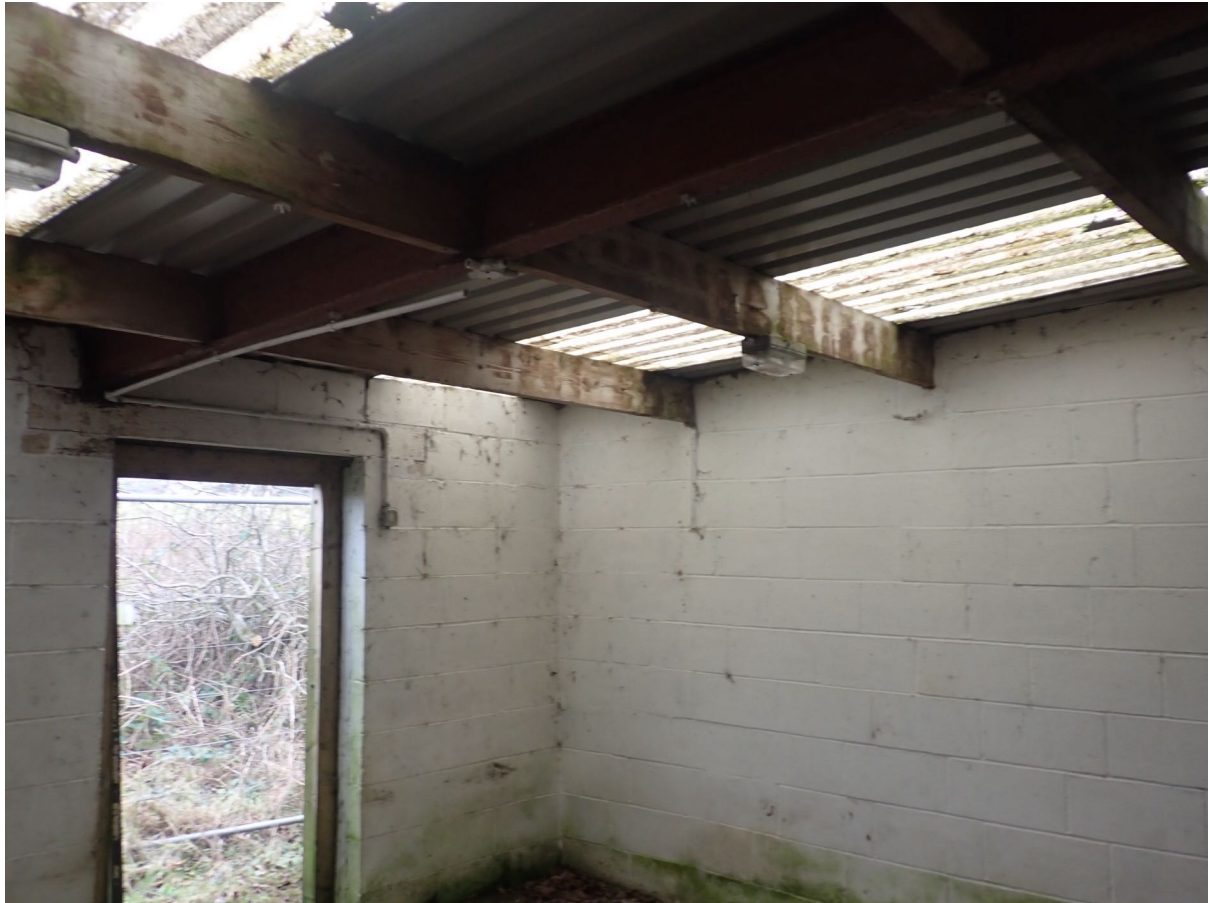
The northern lean-to has a single-pitched roof covered with corrugated steel panels, and a simple timber supporting structure. Internally the building has no internal roof voids, and walls are white painted blockwork. Timber fascia boards are fixed tightly against walls with no gaps. There are no gaps between materials internally or externally which are suitable for use by roosting bats.

9 – Inside the northern lean-to.

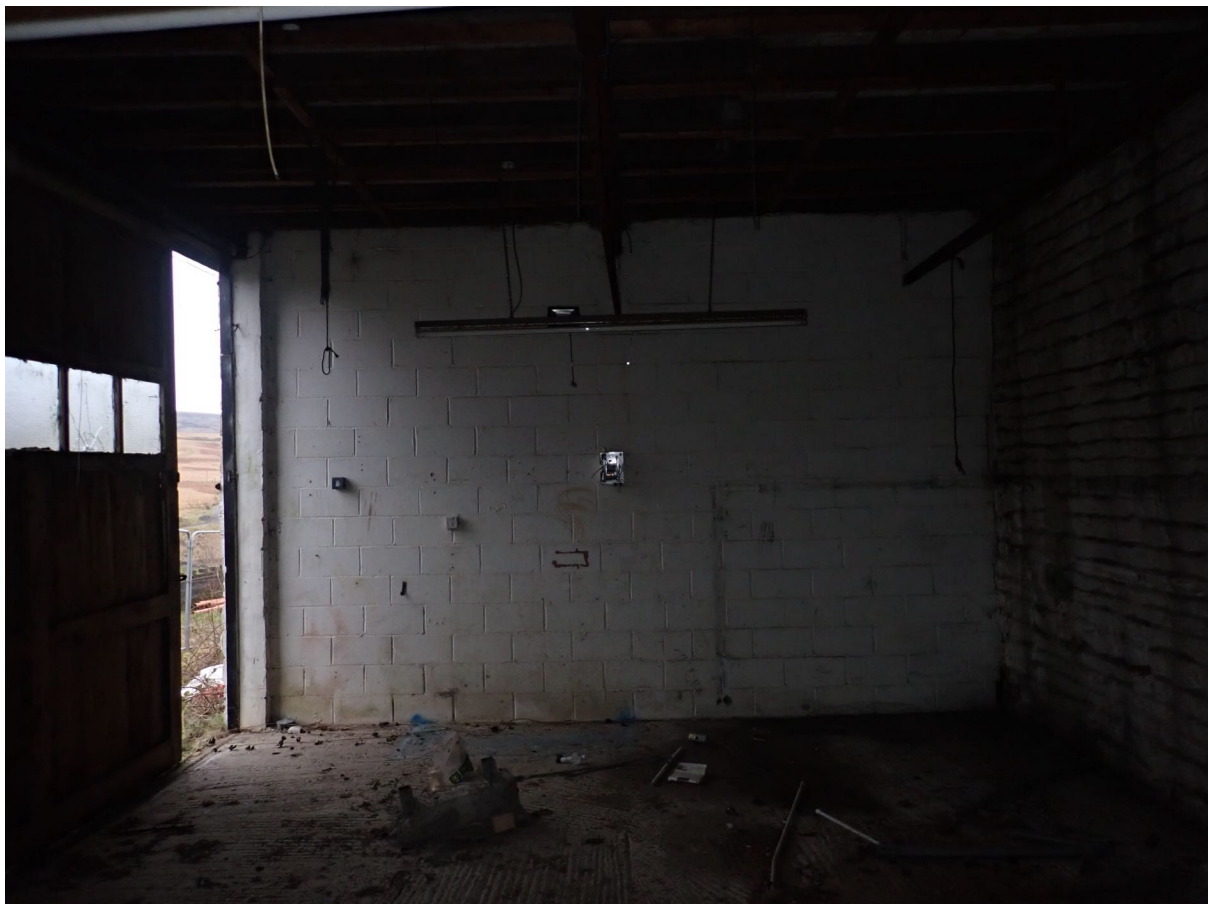
The eastern lean-to was formerly a vehicle storage shed. The building has a flat felt-covered roof, and white-painted concrete block walls. There is a large timber sliding door on the east

wall, and another doorway has been blocked with a single layer shiplap timber wall. Internally the building has a simple steel and timber roof structure, with no roof void, and the underside of plywood roofing boards are exposed. Internal walls are painted concrete blockwork, with no internal lining. There are no gaps between blockwork and roofing materials, and there are no crevices internally which are suitable for use by roosting bats.

10 – Inside the eastern lean-to.

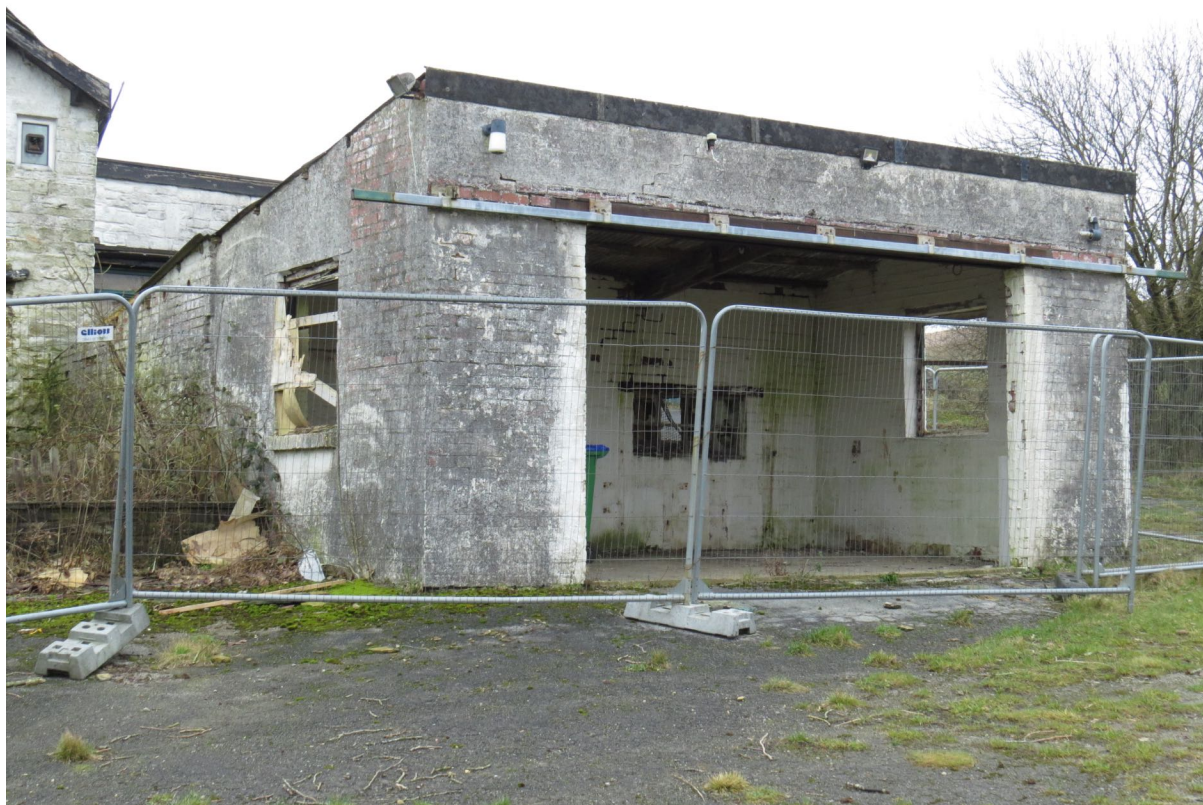
11 – Inside the southern lean-to.
