**22581**

**FORMER SARTEX QUILTS & TEXTILES**

**RE-DEVELOPMENT OF THE FORMER WEAVING SHED  
MEASURES TO DISCHARGE PLANNING CONDITION 3 (XI)**

# STRUCTURAL ENGINEERS REPORT

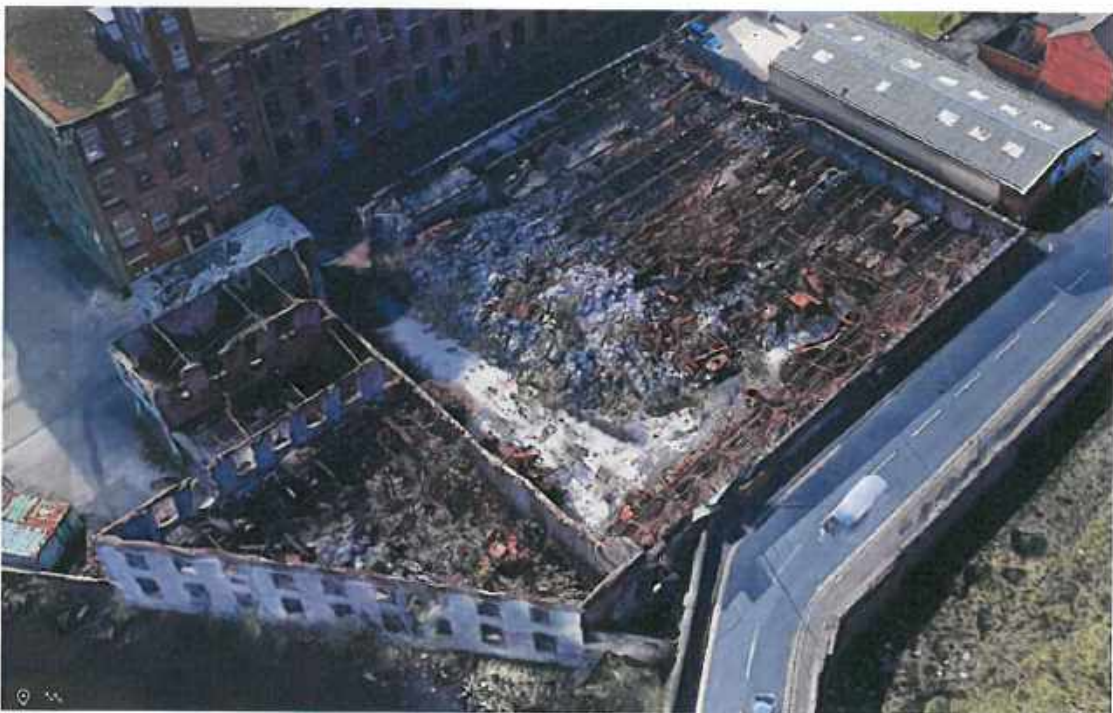
In the foreground is the Rochdale Canal. The main elevation (painted white) is directly built off the canal wall.

The engine house is the only area where any of the roof still exists.

The main area shows the remnants of the mill area. This had a “North light” roof.

In the upper right of the photograph is a more recent industrial unit. This is currently empty and although this is within the development boundary it is not part of the Listed Building Consent.

This stands at a higher level than the fire damaged mill. The rear boundary of the mill acts as a retaining wall to the higher level. The unit will be demolished as part of the new scheme.

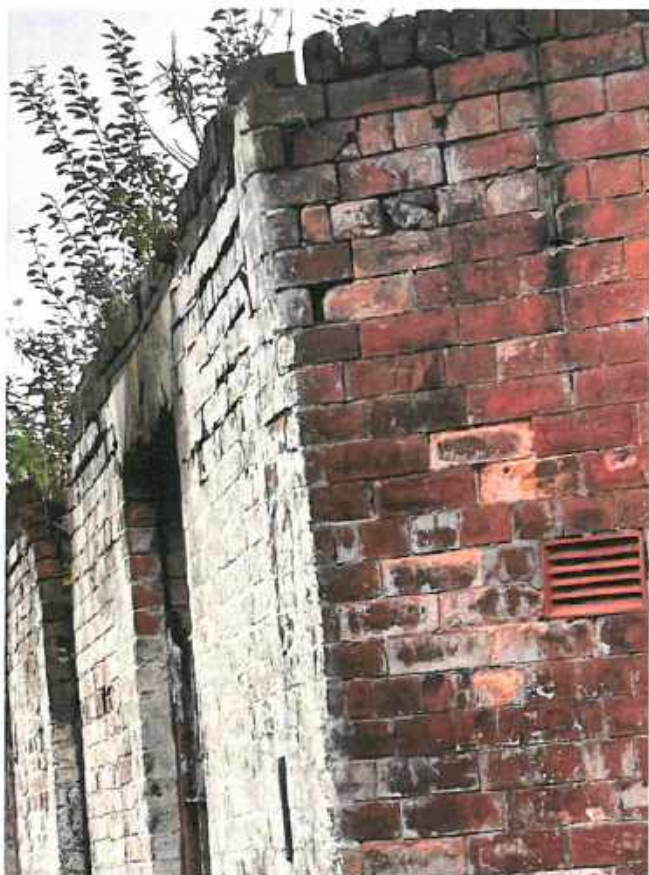
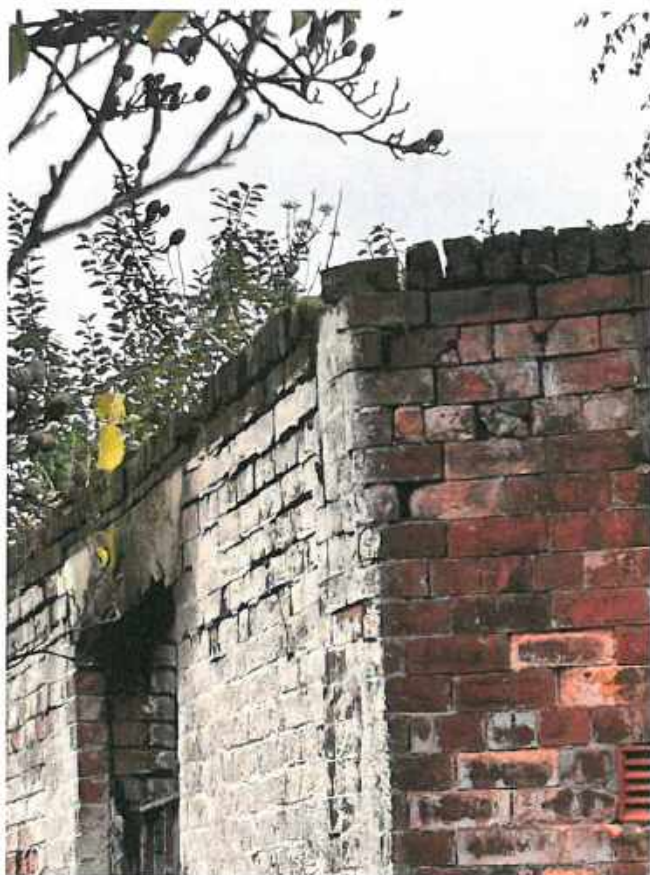
There is a nominal area of damaged masonry on the upper right-hand corner when viewed from the canal. See drawing HC-22581-(60)-02 and photographs 1 & 2.

It is proposed to take this down by hand. This will comprise of approximately 9 courses of brick as identified on the attached drawing, HC-22581-(60)-02.

The elevation is self-standing and is not connected to any internal structure. During the demolition / clearance, the elevation will remain untouched and will not have any affect on the canal. Following the site clearance, it would be prudent to introduce a nominal internal restraint scaffold.

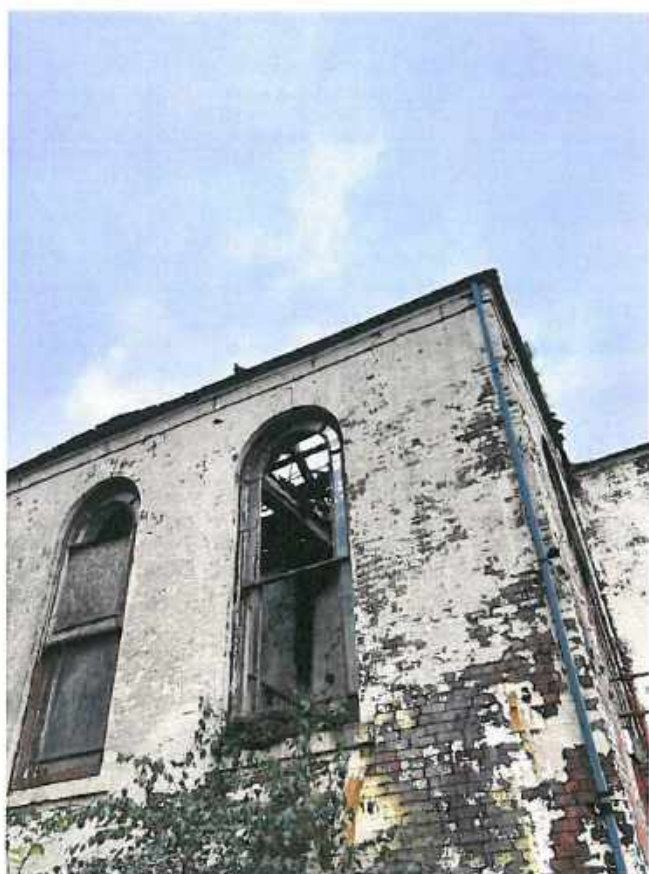
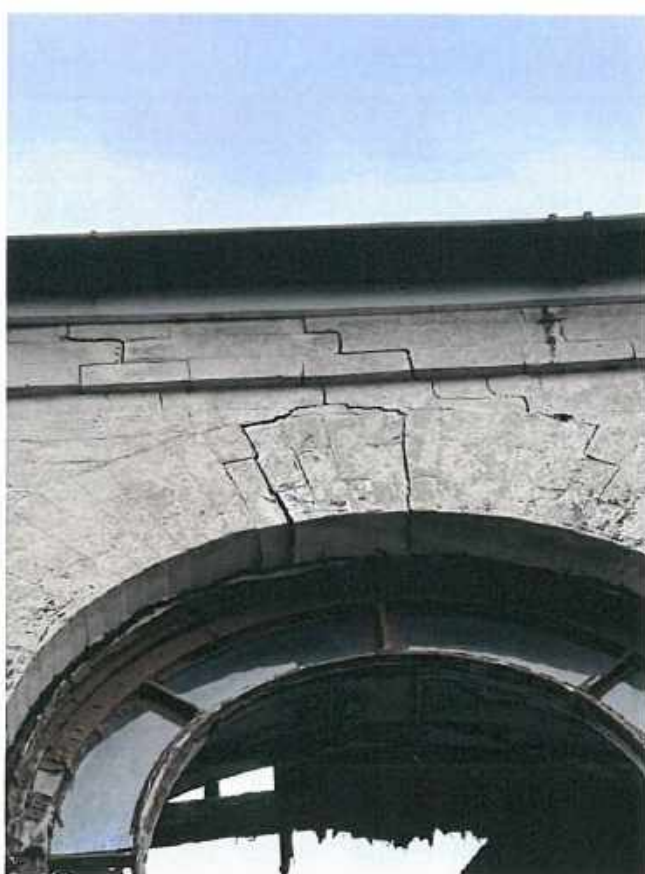
**2.07** On the side elevation (South), of the engine house, there is a failure of the brick arched window head, see photographs 3 & 4.

This will need to be supported before any demolition takes place. This can be in the form of a blockwork infill built off the existing window cill.

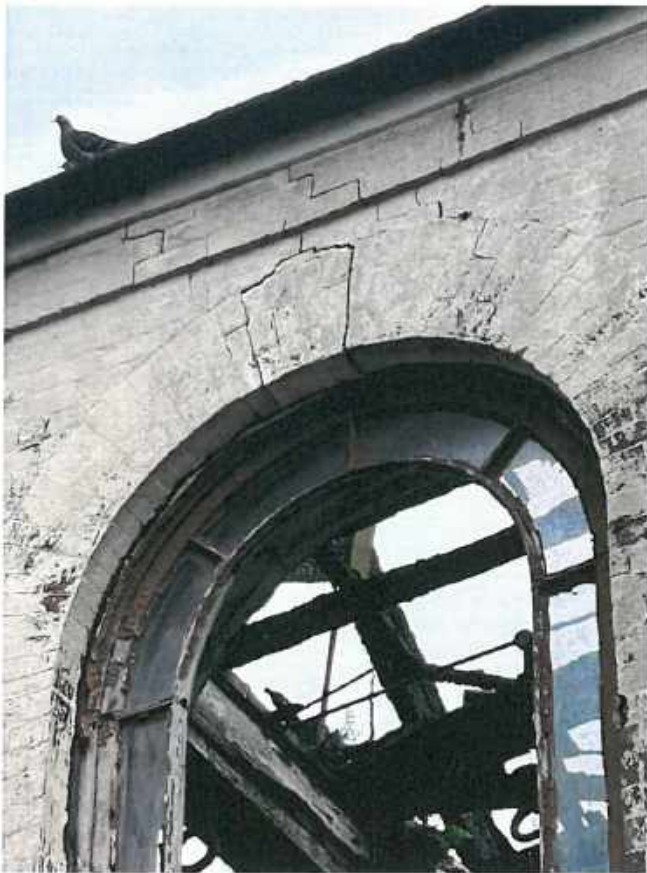
Photograph 5

**2.08** The roof structure to the Engine house is in a poor condition and will need to be removed.

It is considered that slates and timber above the bottom boom of the King Post trusses that form the roof structure will need to be carefully removed.

The large bottom of each truss should remain insitu to offer lateral restraint to the walls. Photograph 5.

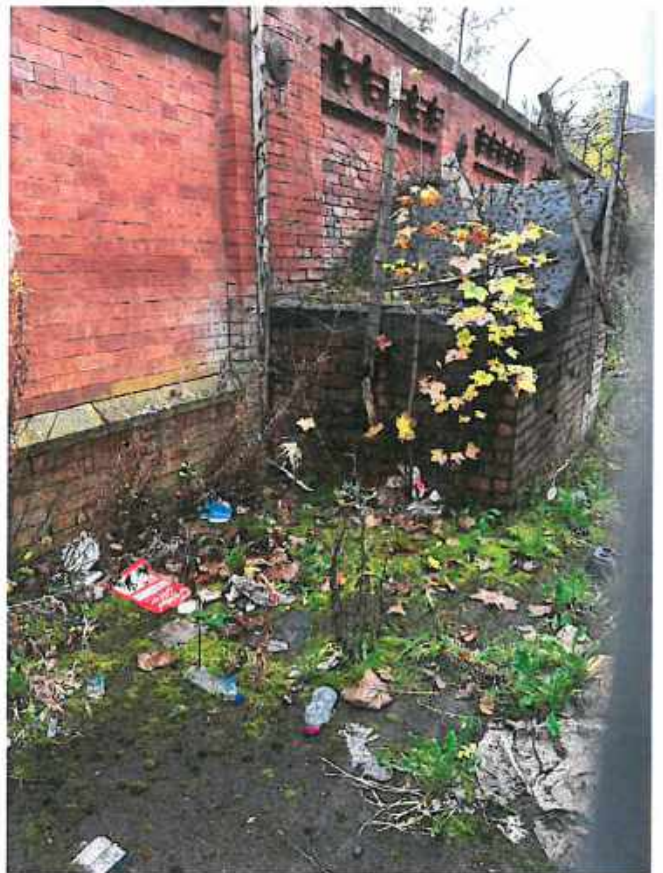
Photograph 6

The wall leans out towards the access way. It was formerly tied with pattresses. Following the removal of the internal lateral support after the fire the wall has continued to lean out.

**2.09** The wall to the access way requires taking down to at least window cill height.

The shelter above the external steps will also need to be removed. Photograph 6.

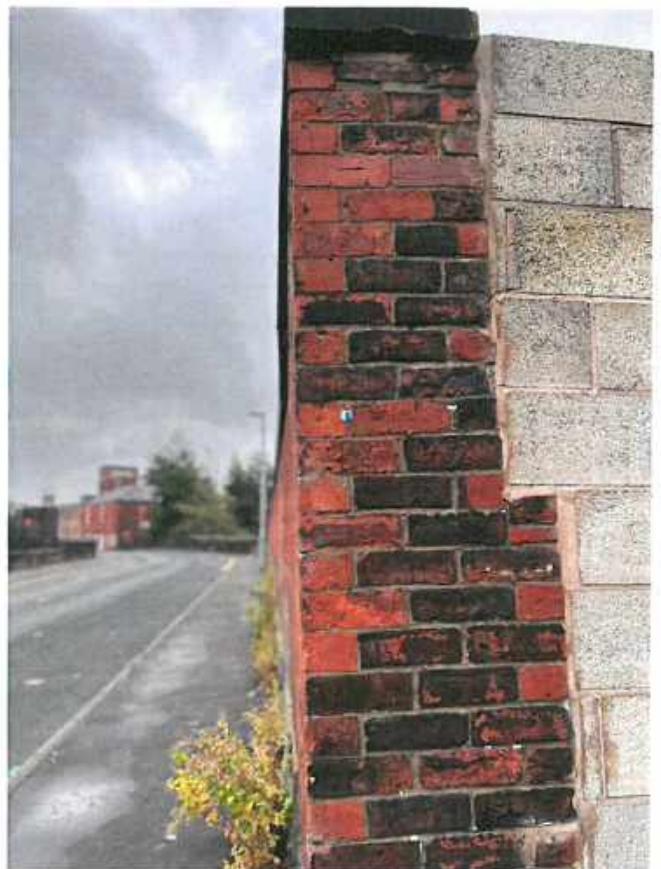
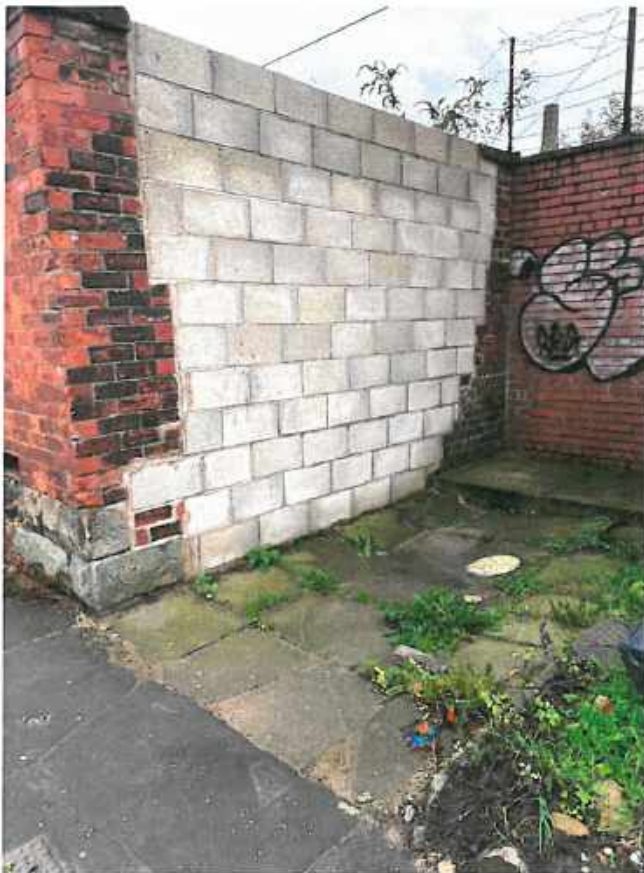
**2.11** The retaining wall to the Durham Street elevation is deemed to be satisfactory. The wall extends above Durham Street forming a boundary wall to the site. It is thought that the height of the wall as existing coincided with the valley and boundary gutter level of the North light roof.

This wall can remain. There should be no reason to interfere with this wall. The slight outward lean of the wall can be restrained as part of the development. Photographs 8 & 9. This does not require any attention at this time.

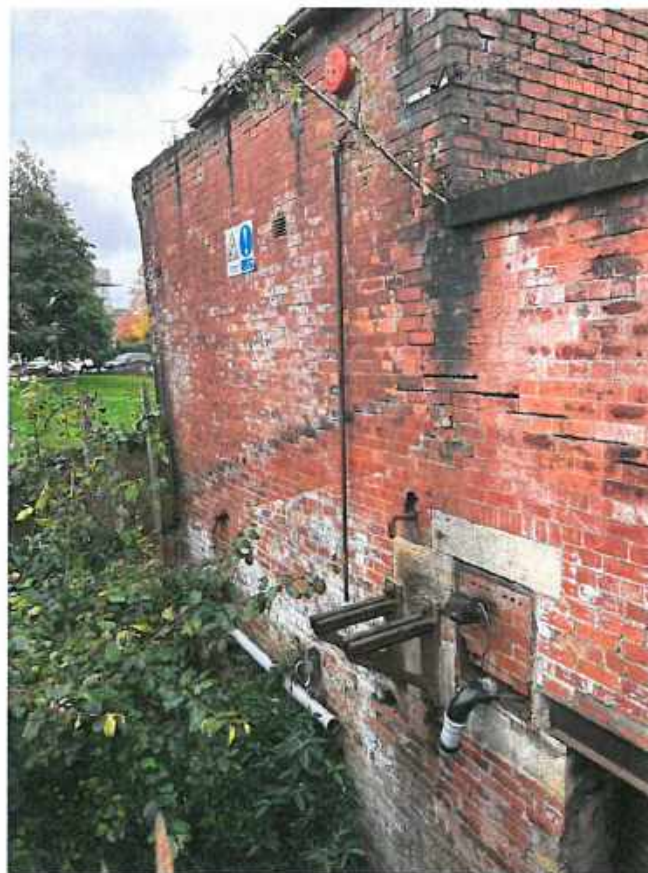
Photograph 10

Beyond the Durham Street bridge, the elevation becomes exposed as a two storey elevation, photographs 10 & 11. The upper section of this wall will require careful demolition, see photograph 10 and drawing HC-22581-(60)-02.

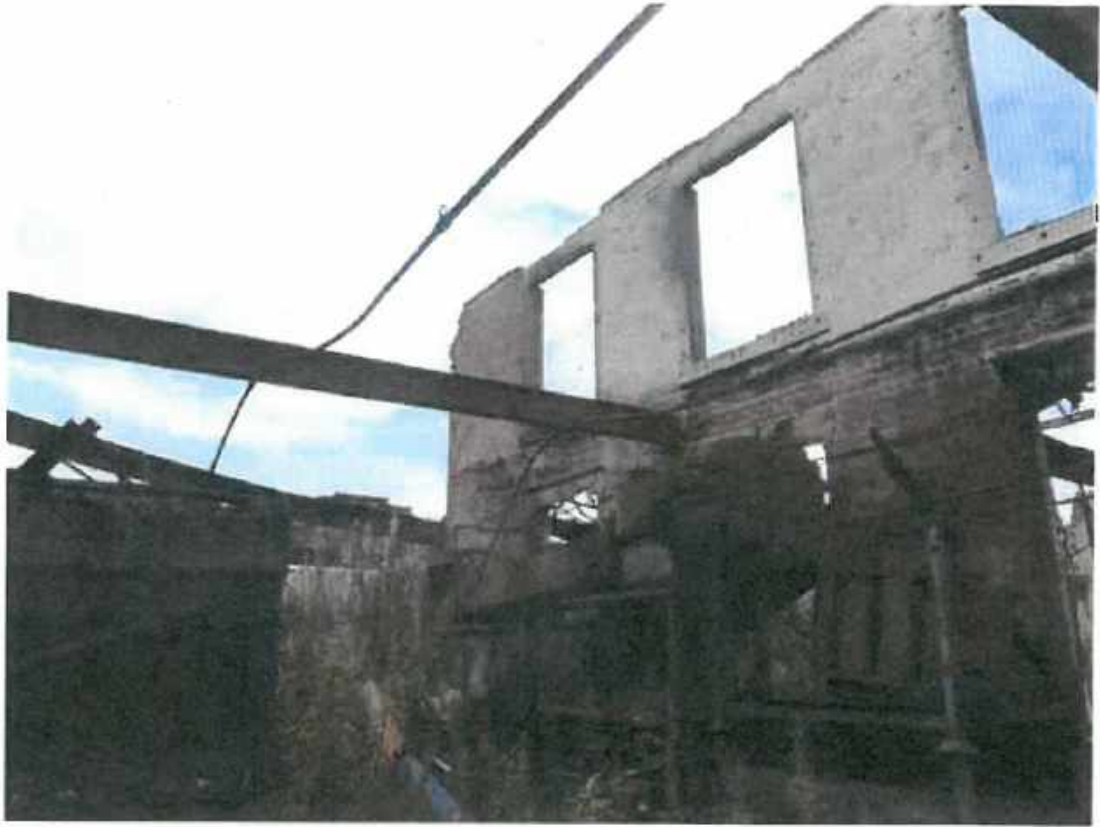
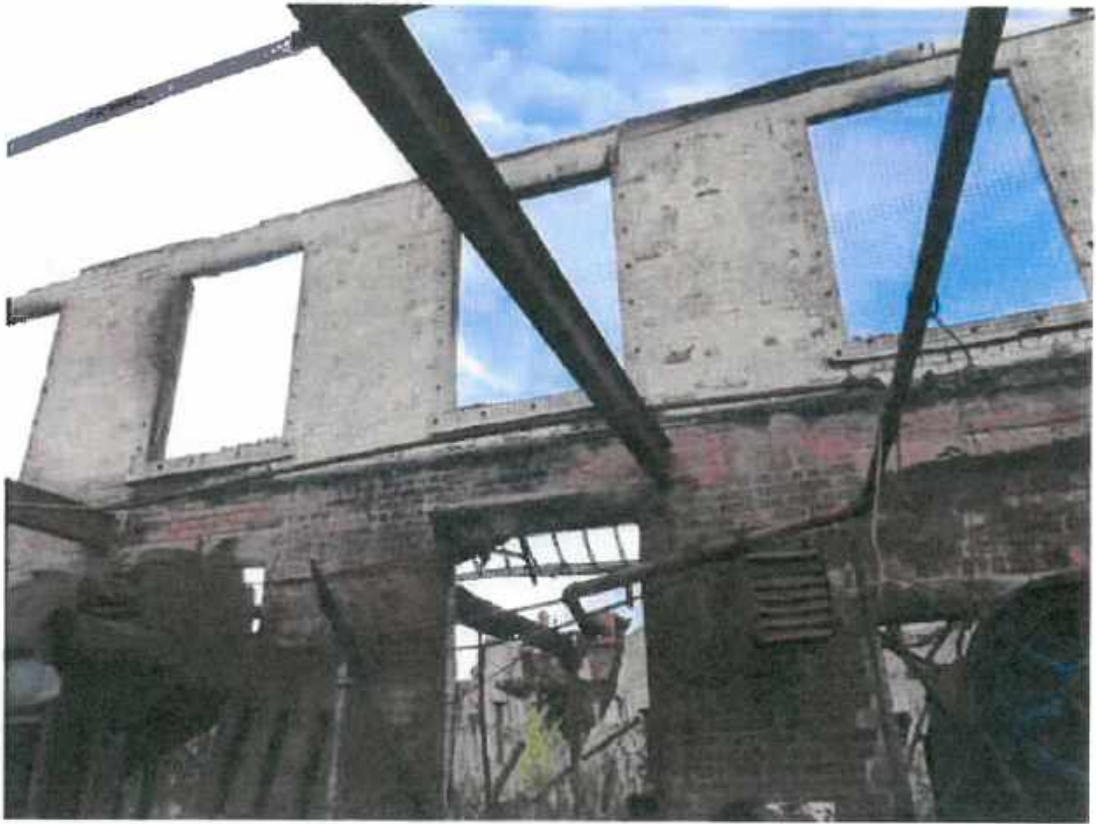
On the internal elevations the roof to the adjacent link has been completely destroyed leaving simple steel beams spanning between the engine house and the return elevation of the office wall. Photographs 13 & 14 are typical.

These beams have buckled and would need replacing if this was to be re-instated.

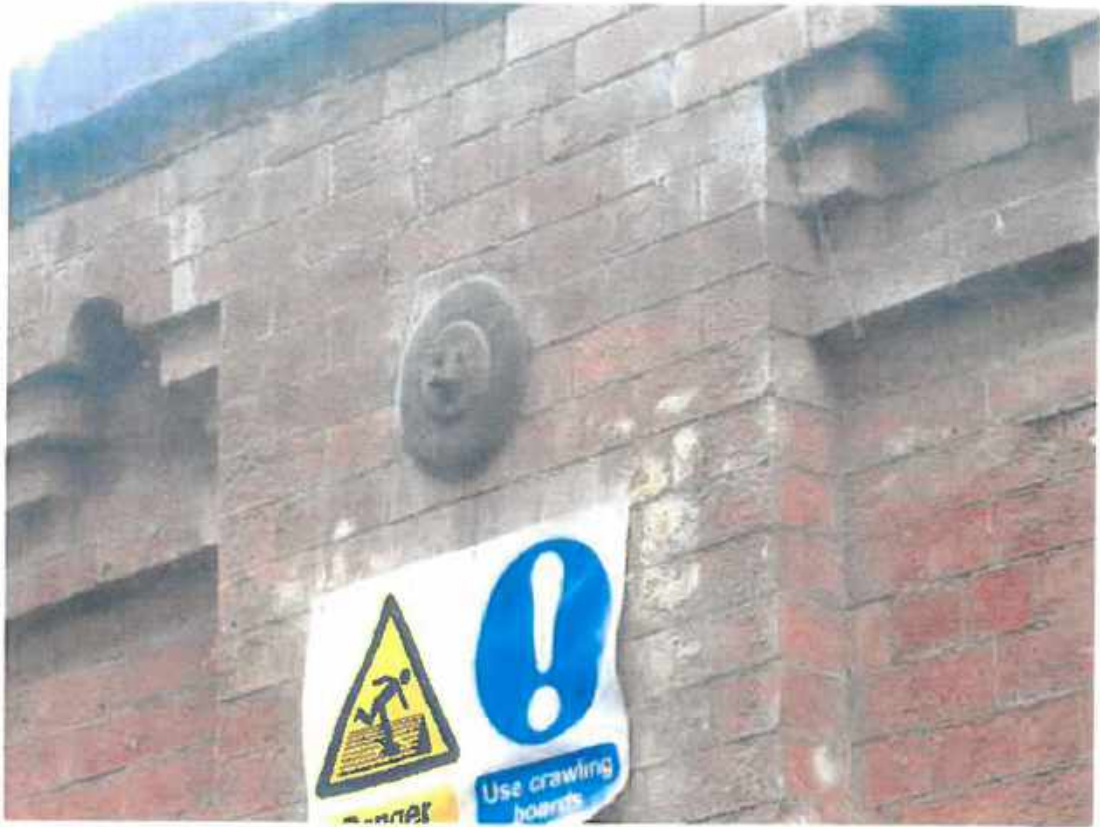
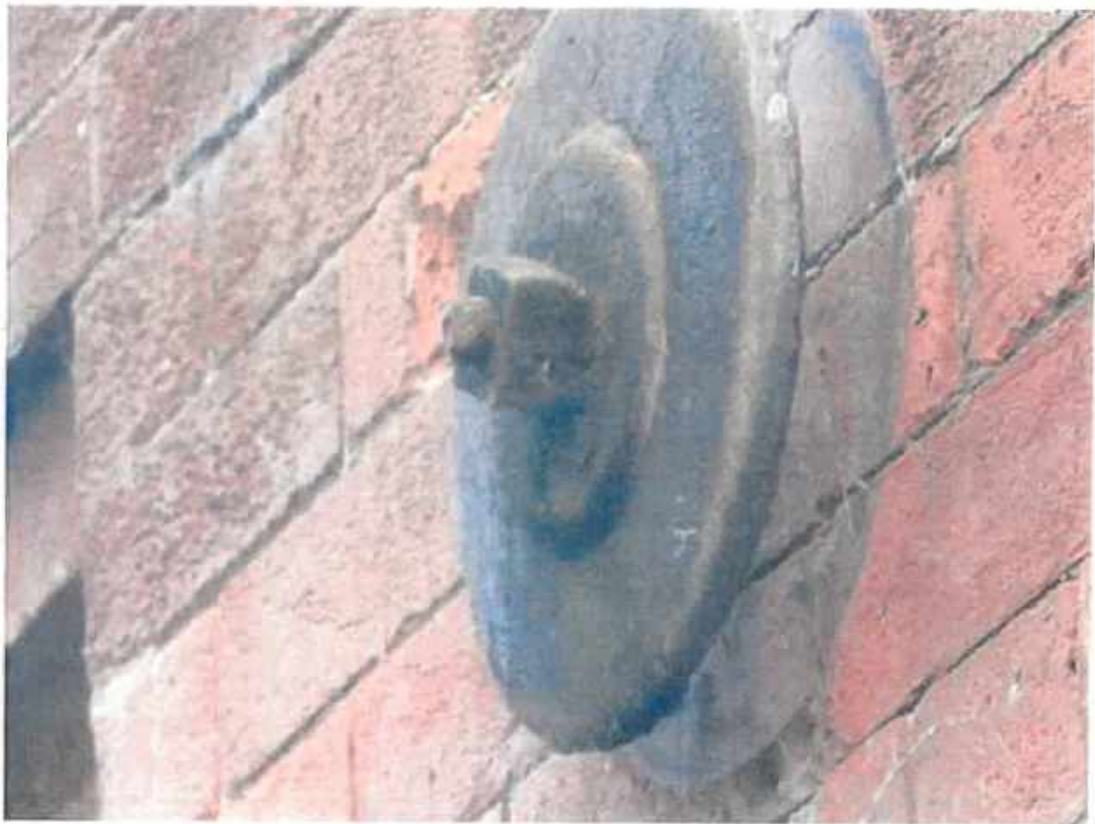
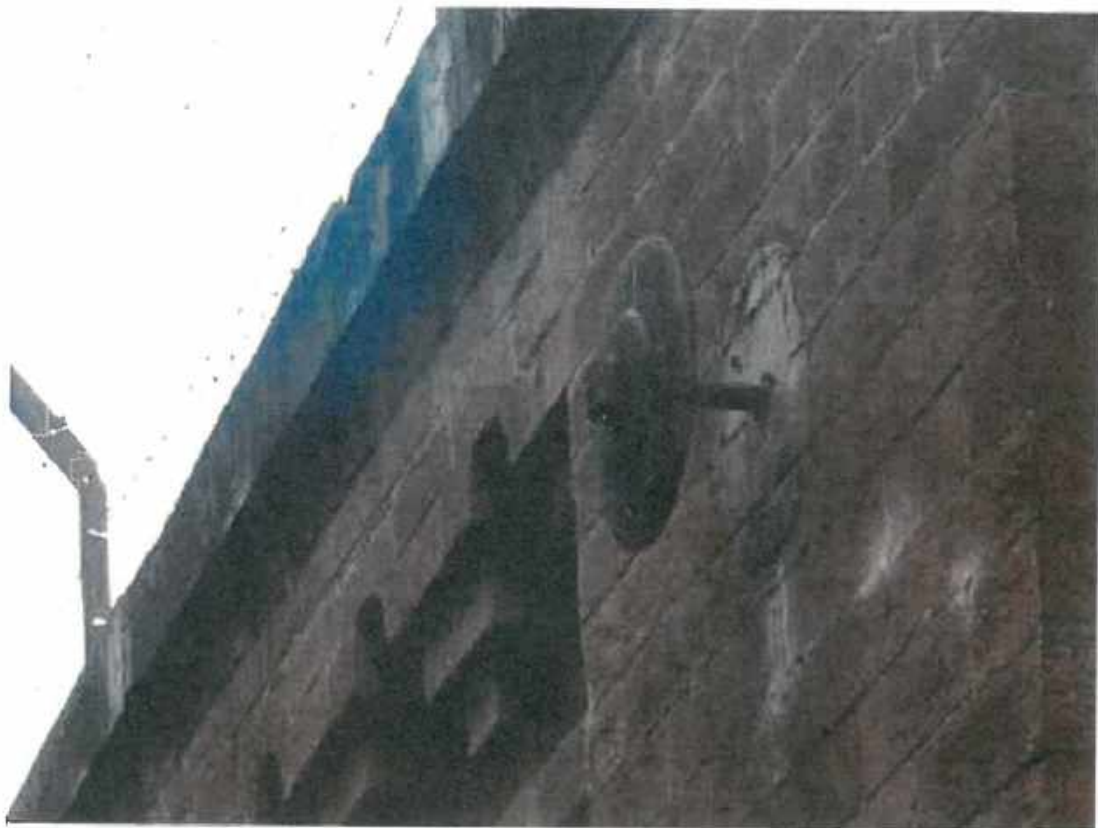
**3.03**      The left hand boundary wall suffers from significant bulging and was previously tied by tie bars and patresses – photographs 15, 16 & 17.

The fire has destroyed the tie bars and released the tension allowing the patress to move outwards – photographs 16 & 17. Subsequent bulging of the wall has made the wall unstable. The wall should be taken down and rebuilt or extensive local building and tying to any new structure will be required.

- 4.03** The extensive left hand side elevation would require rebuilding, ideally in its entirety.

However a local rebuilding approach could be undertaken. The latter would require extensive tying to the new structure to maintain stability. The section that retains the access should remain.

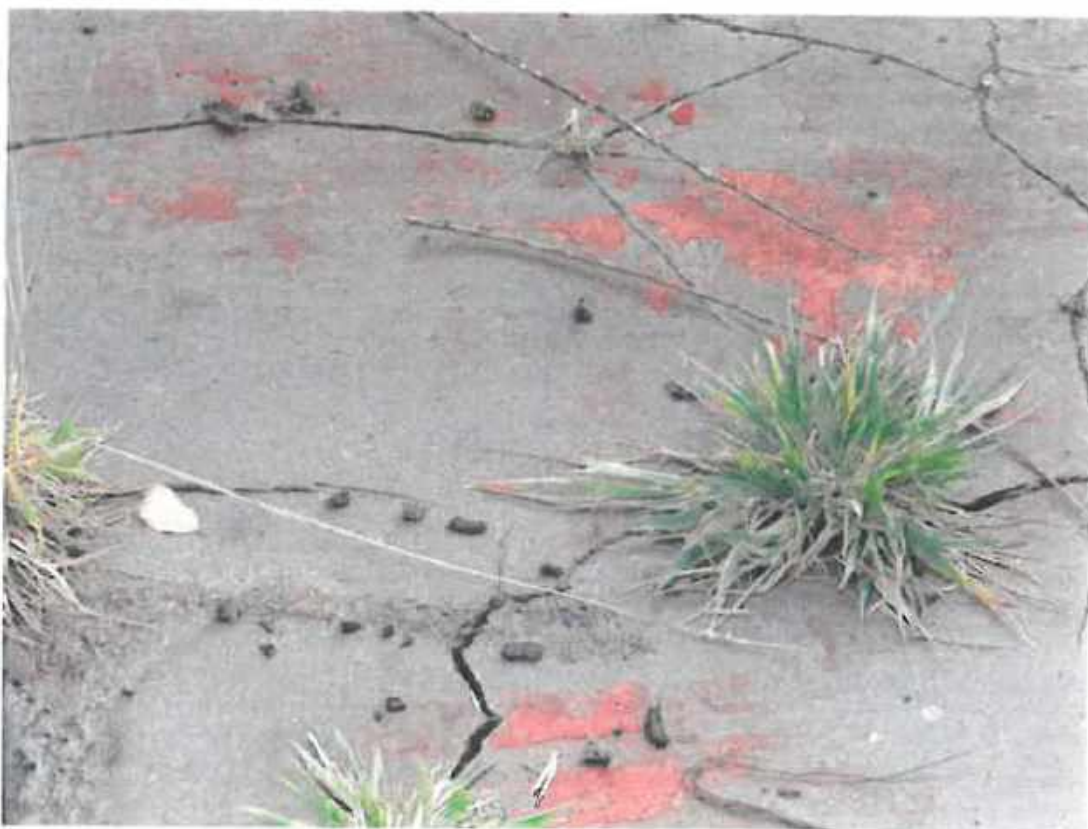
*Photograph 18*

**3.06**      The ground floor slab was surfaced with an asphalt which is badly crazed – photograph 18. The floor finish is beyond salvage and it is highly likely that the ground floor slab would require at least overlaying.

- 4.05** The ground floor slab should be considered for replacement or overlaying.

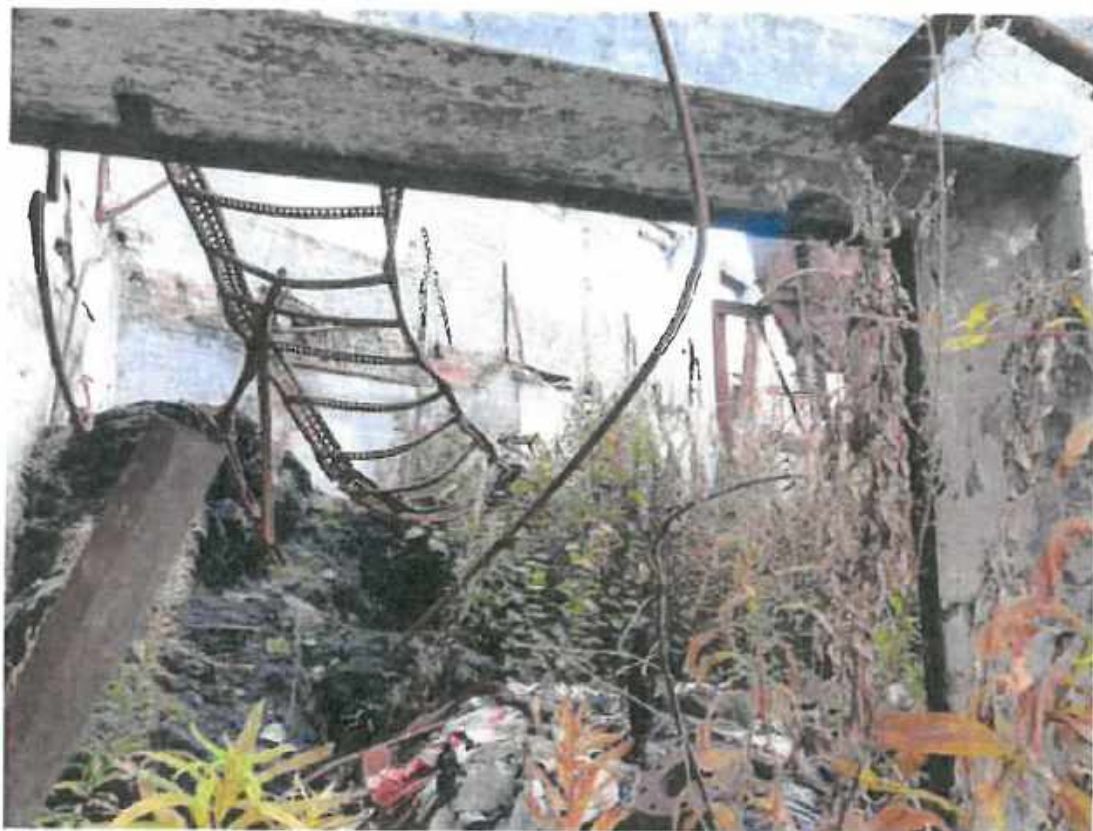
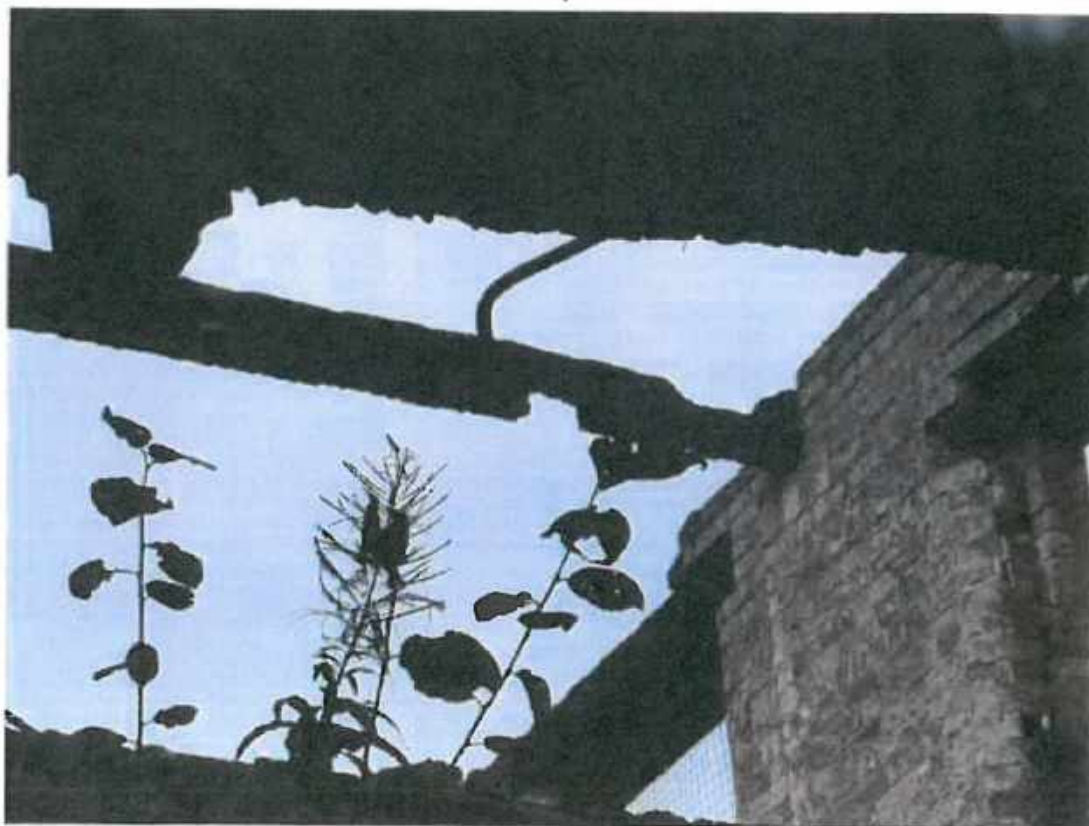
- 4.04** All timbers buried within the masonry or used as lintels, purlins etc, will require total replacement. Photographs 19 & 20 are typical.

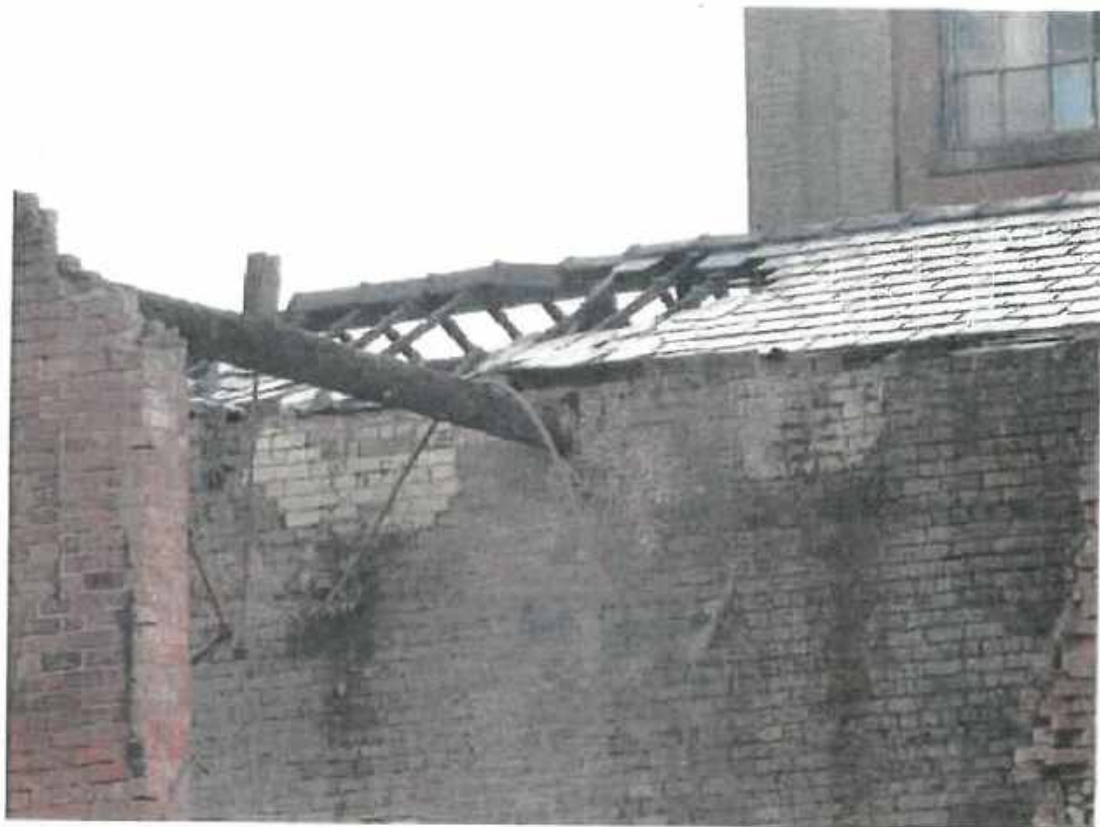
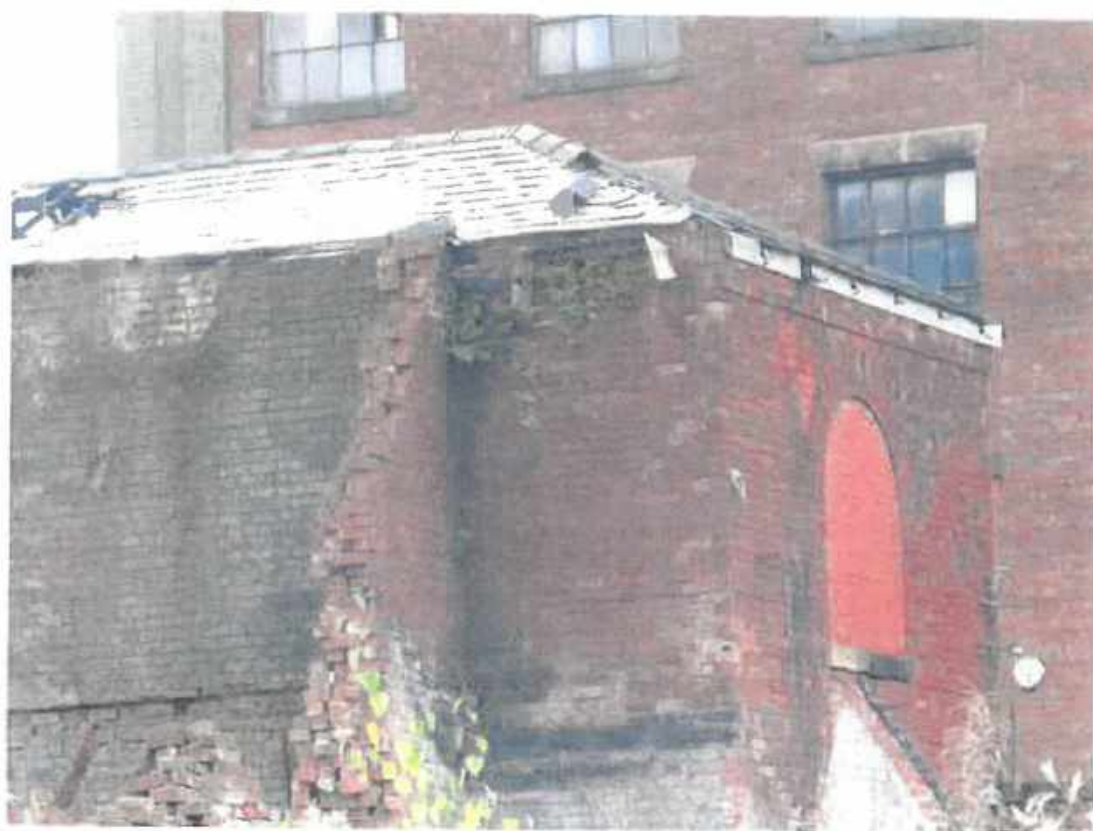
- 4.06** The roof to the engine house requires total replacement – photographs 21 & 22.

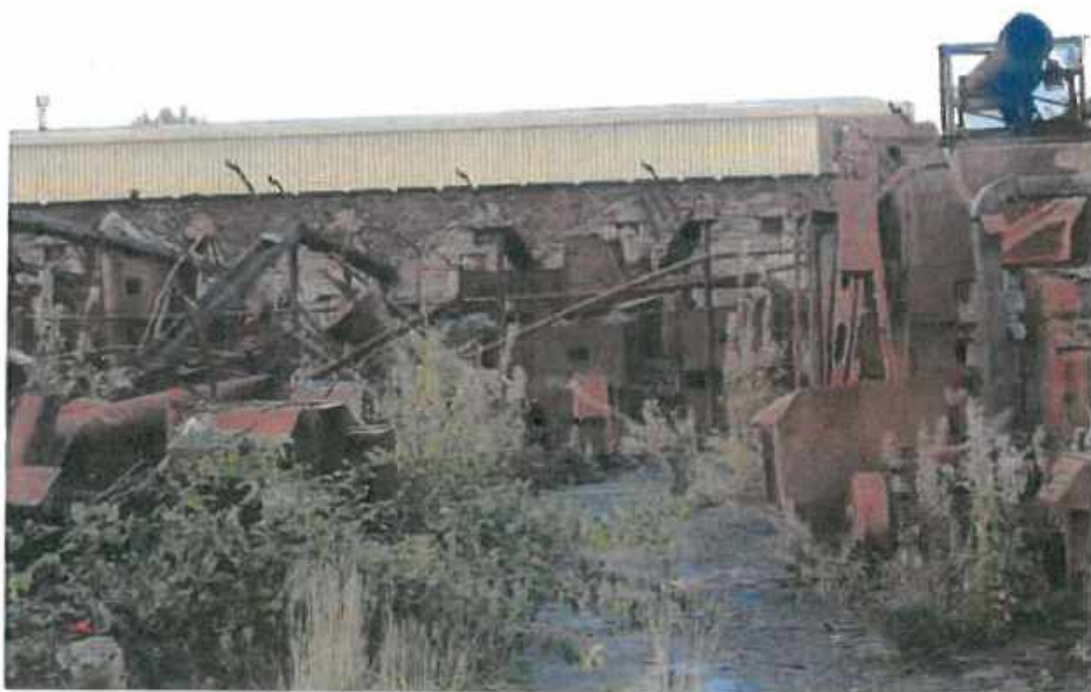
*Photograph 23*

- 4.07** The rear elevation – photograph 23, can generally remain as existing. Local careful removal of embedded steels will be required. This applies to all remaining elevations.

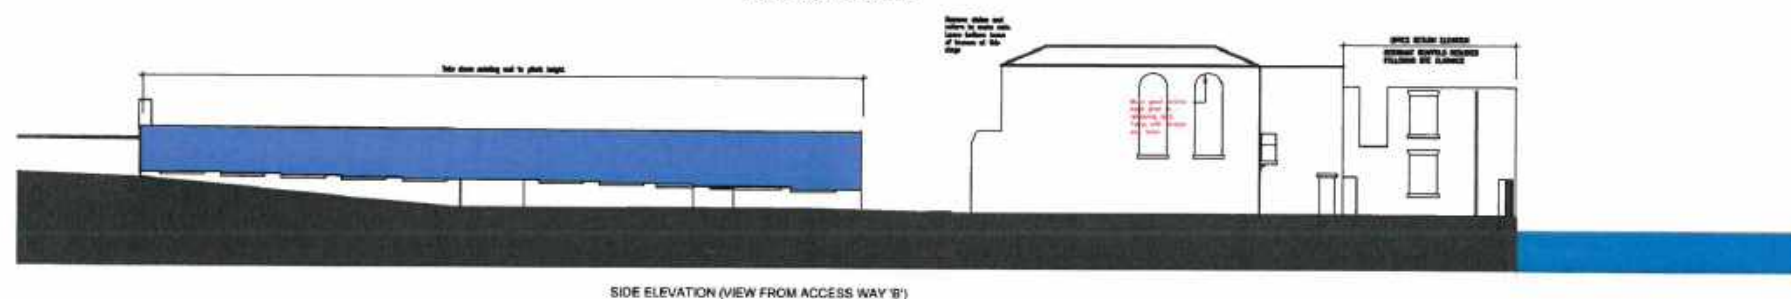
- 2.13** The wall at the rear of the engine house and the former offices will need to be removed. This will be raked back where it abuts the adjacent office walls. See drawing HC-22581-(60)-02.
