SITE: STAKEHILL LANE, MIDDLETON

## Terrain Surveys Site Attendance Report

**Client:** BWB Consulting (Birmingham)  
**Contact:** Lucy Reeves  
**Date:** 8<sup>th</sup> July 2024  
**Site:** Stakehill Industrial Estate  
**Job Ref:** TS24-386

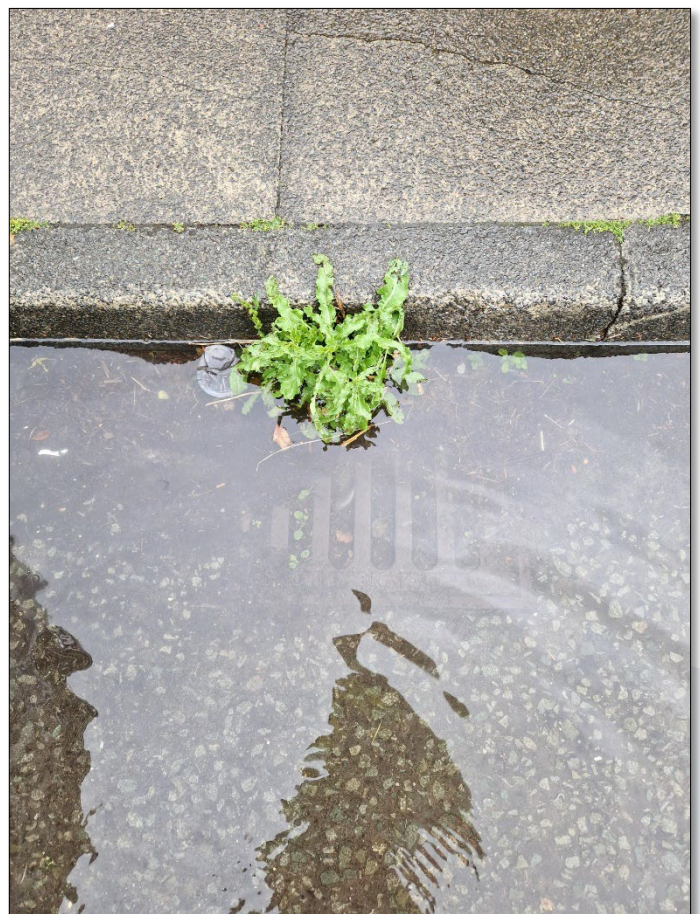
Road Gully Condition Example

The main line was noted to be free flowing although during the survey several of the road gullies were observed to be blocked and causing localised flooding.

- Combination Lorry Jetting Unit to attend site to empty and HPWJ all road gullys serving Bentley Ave
- Break out and replace seized manhole MH2 to complete survey of chamber and verify possible connectivity with MH3 (see Area 2)
