## **STRUCTURAL APPRAISAL REPORT**

**Updated 1<sup>st</sup> March 2024**

### **Proposed Development of New Platt Farm House, Carriage Drive, Littleborough**

**DATE OF INSPECTION:** 1<sup>st</sup> March 2024

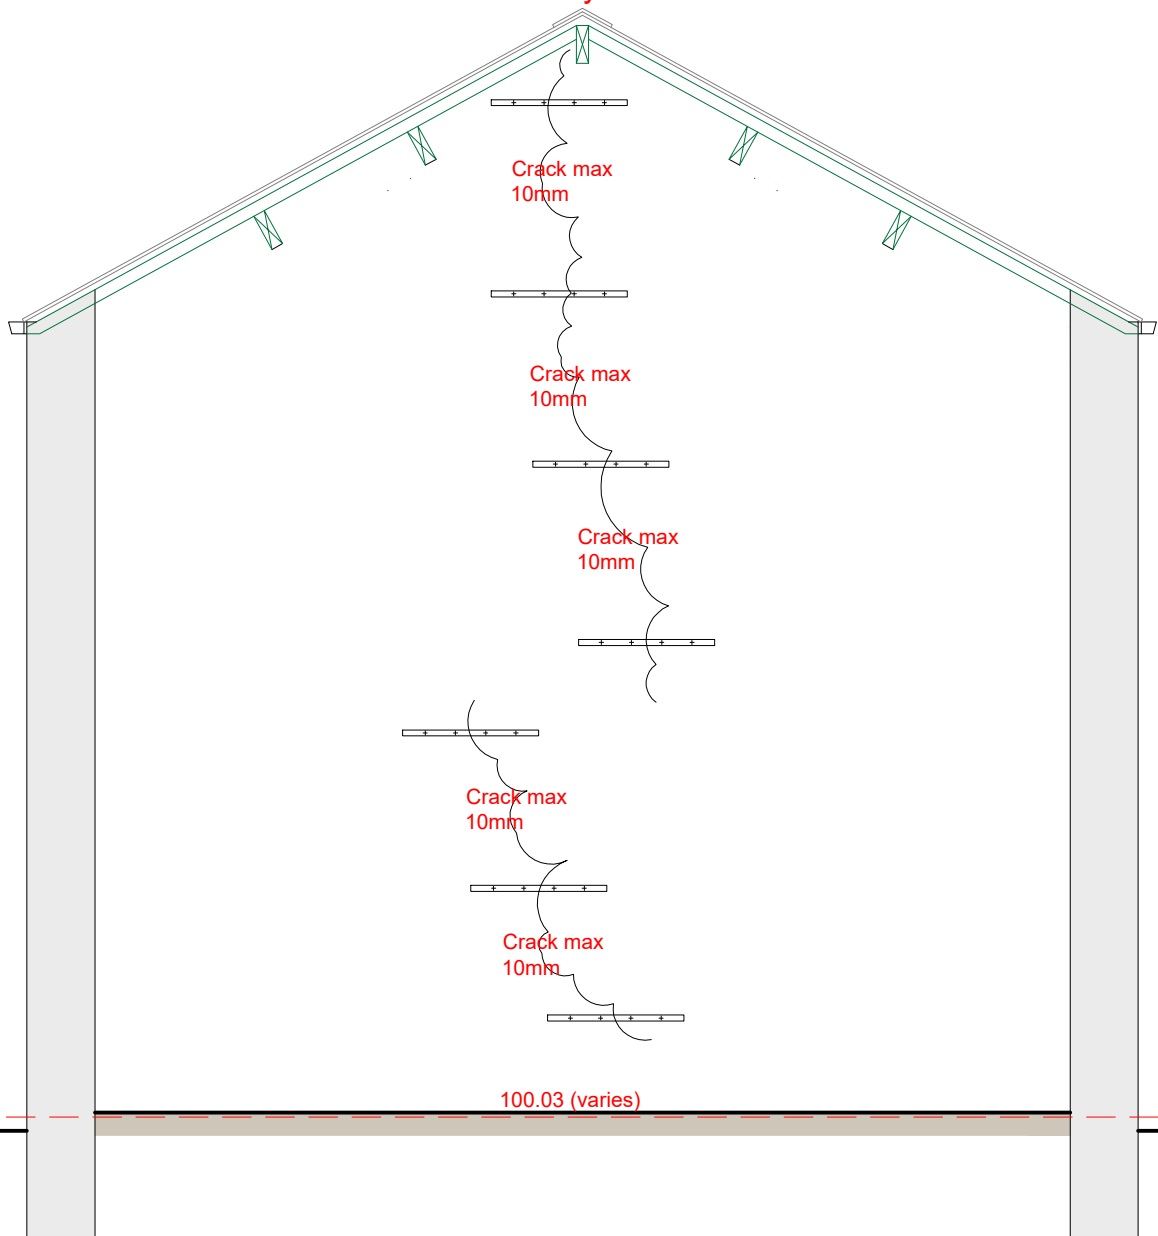
# INTERNAL PARTY WALL ELEVATION

6. 2 internal cracks noted on the original inspection have not altered and will require 6mm x 30mm galvanised straight bar heavy screwed into the stone either side to protect the cracks from moving further. Cracks likely to have occurred through age, minor movement and the effects of freeze thaw cycles and changes in ambient temperature and moisture variations given the barn is exposed to external weather changes.

450 x 6 x 50mm flat galvanised  
steel bar bolted / shot fixed to  
stone over existing crack  
flat bar every 1200mm max
