Arboricultural Survey & Impact Assessment  
Eazy Cars Ltd  
Proposed Car Workshop  
Manchester Road  
Rochdale

Report Reference: AIA-1933-1  
11 April 2024

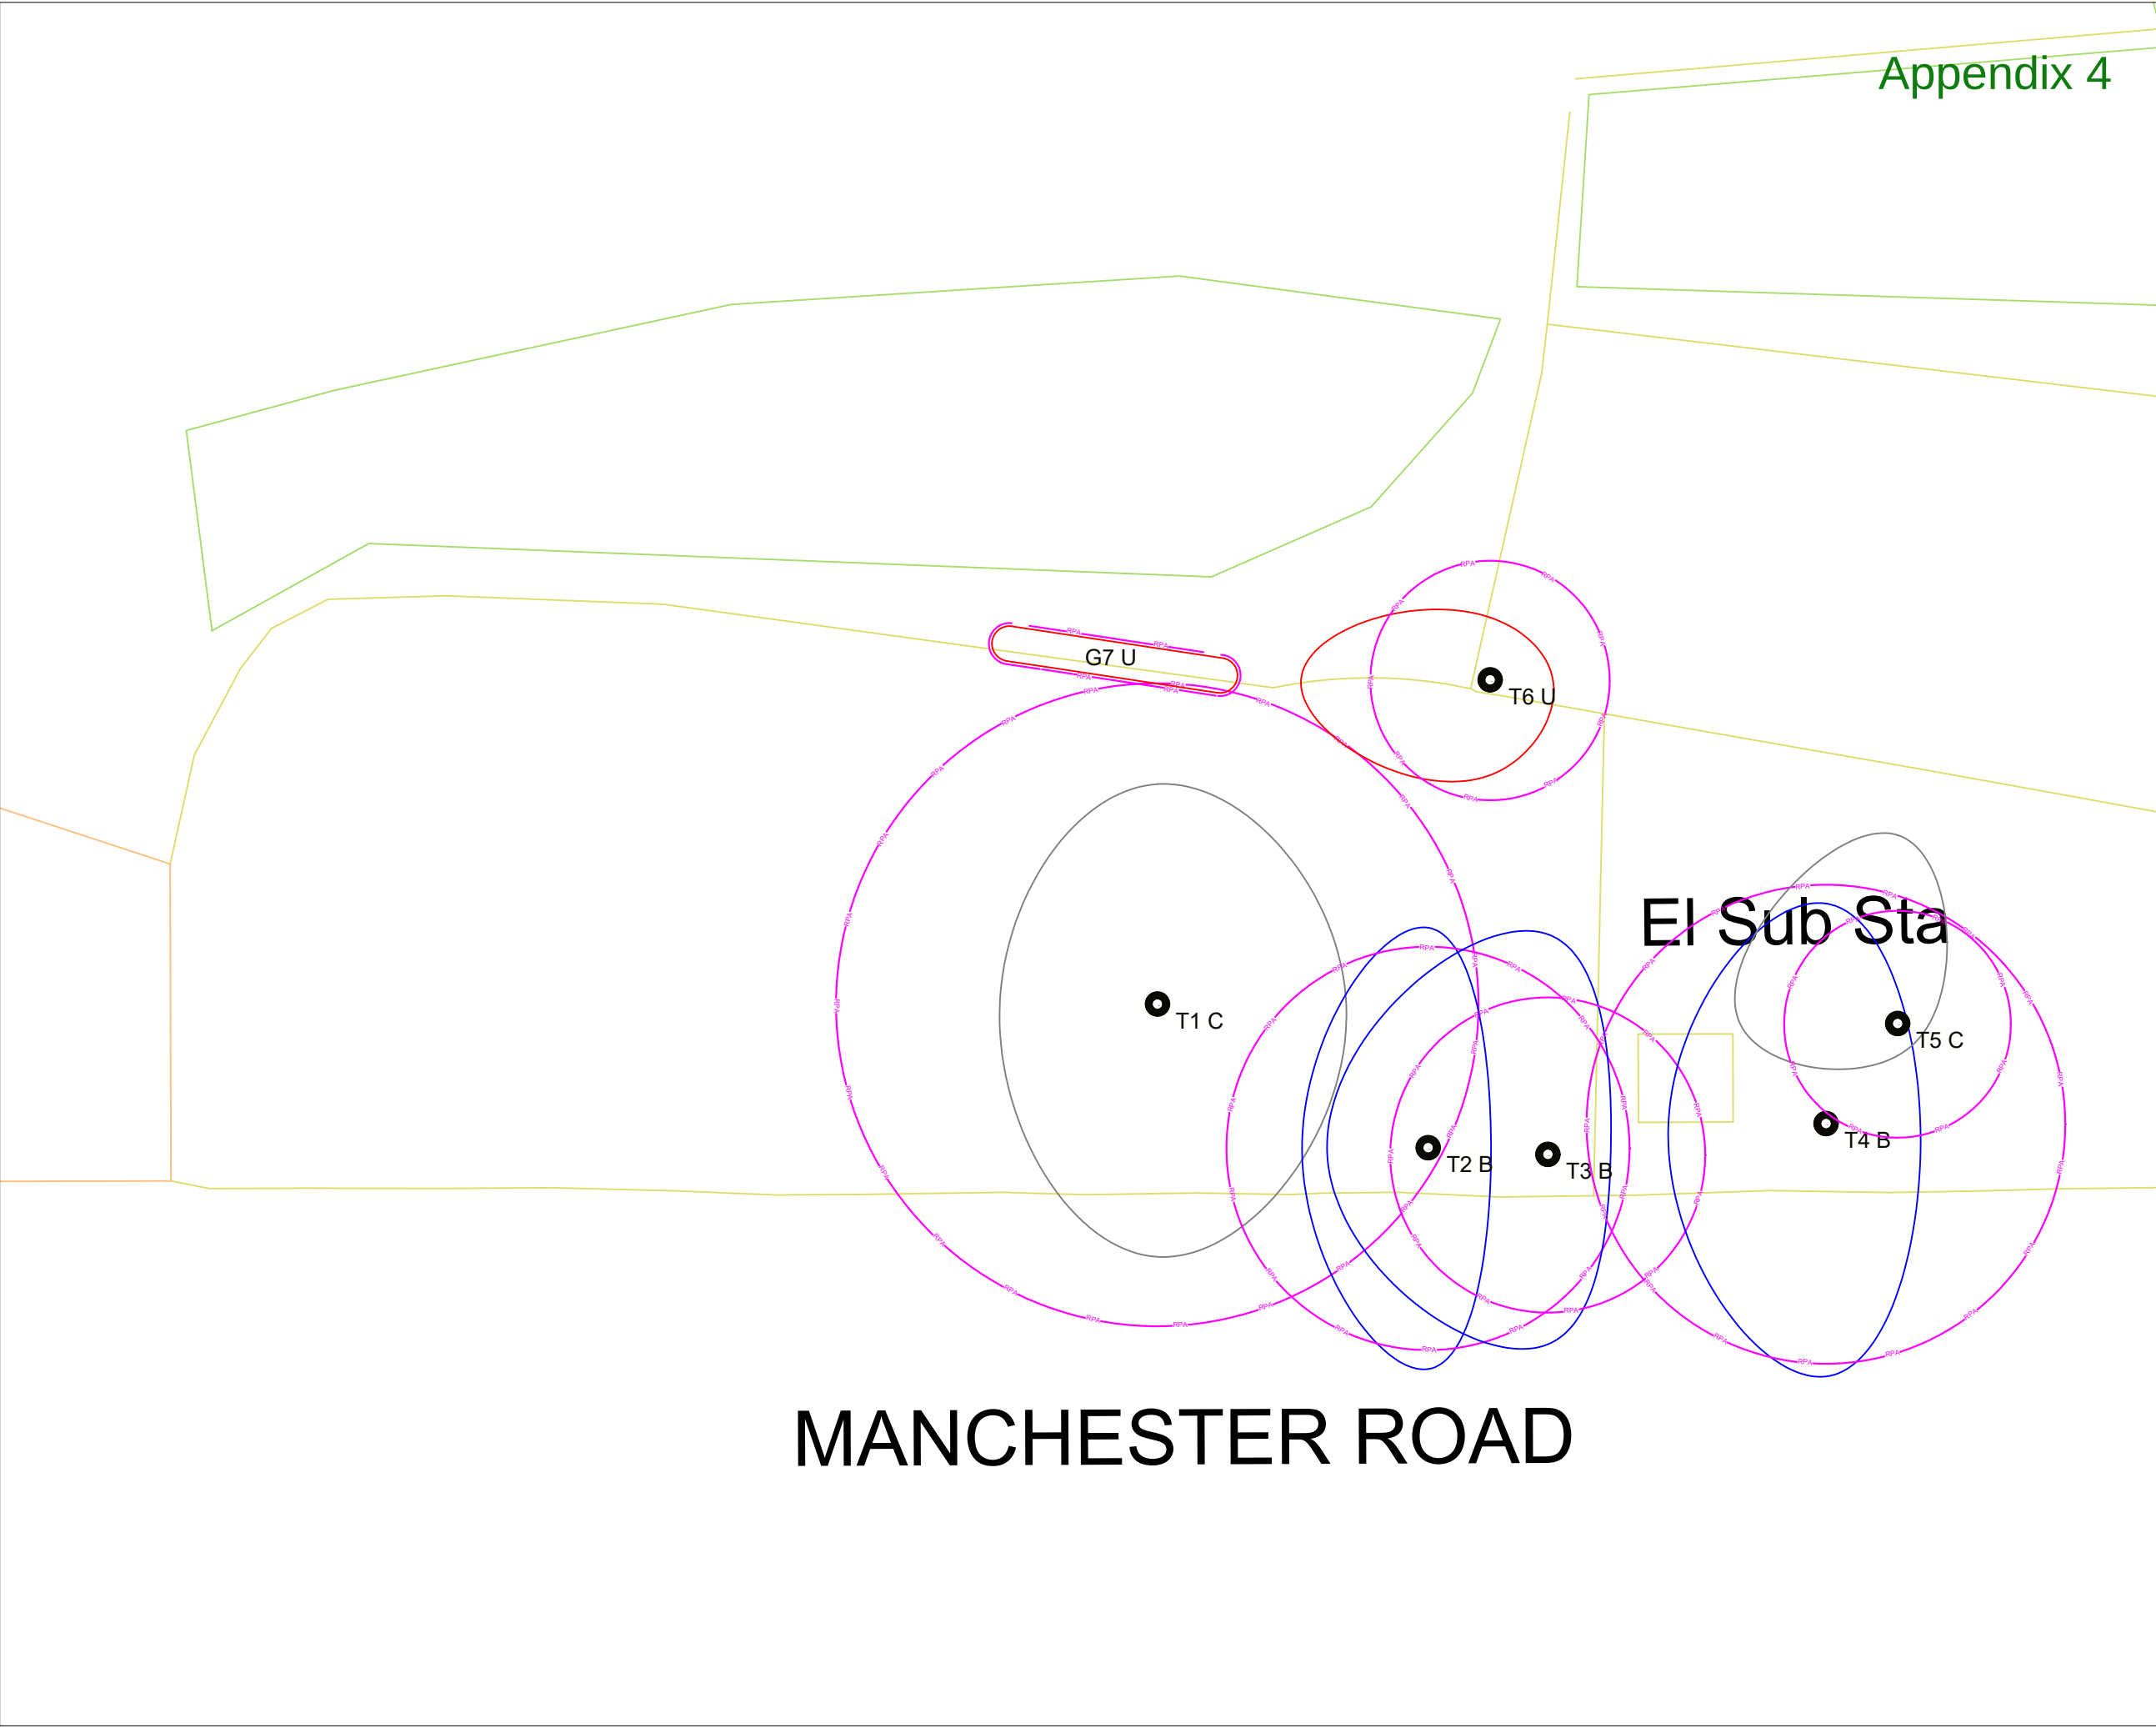
Drawing Title:  
**Tree Constraints Plan**

- 3.3.2 As recommended in BS5837 we have plotted the RPAs (in magenta) onto the attached Tree Constraints Plan (TCP) taking full account of the surrounding topographical factors, tree condition and likely root disposition.
- 3.3.3 Save for Sycamore T1 there are no foreseeable conflicts between the proposed development and retained trees that cannot be addressed by customary tree protection measures.
- 3.3.4 In terms of the possible retention of Sycamore T1 which is unlikely to be achievable beyond the relative short term special measures would have to be incorporated in the form of "no dig construction" where customer parking would overlap the RPA of T1. Refer to paragraph 3.4.1 below.

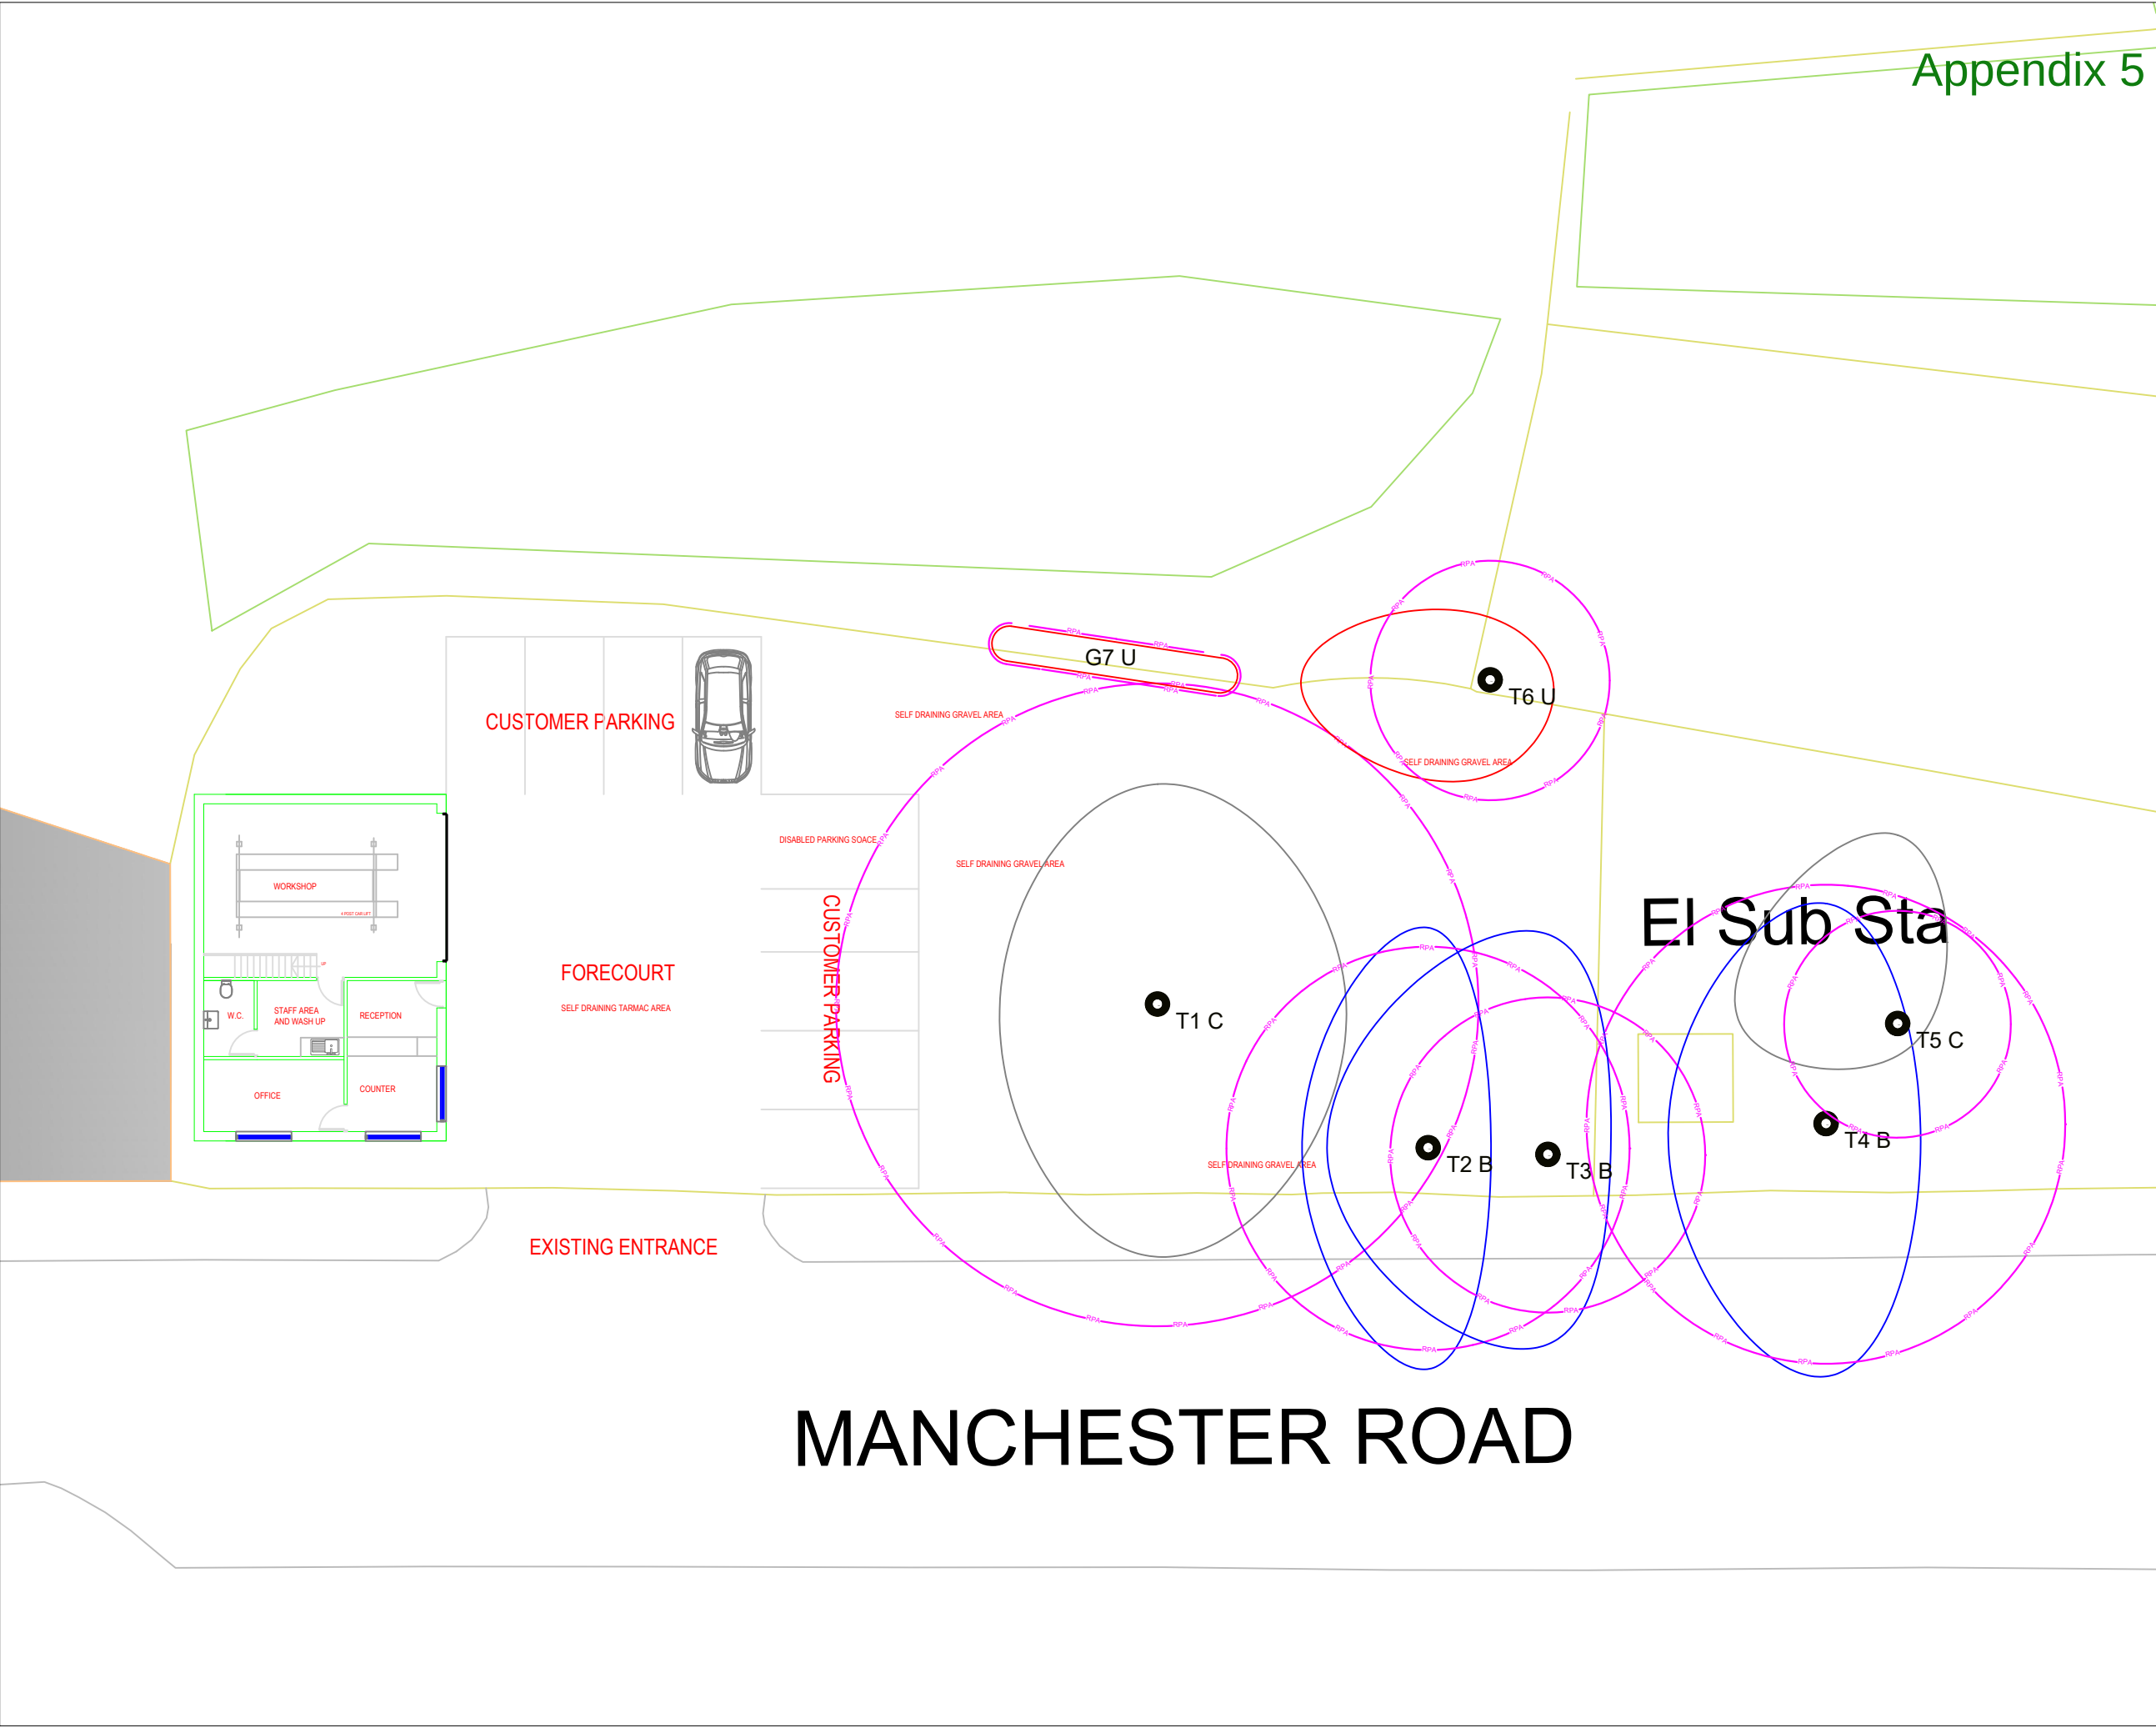
Drawing Title:  
**Tree Impact Plan**

- 3.4.1 If the LPA are minded to insist on retention of T1 the proposed customer parking will require new surfacing within the RPA of T1 amounting to approximately 6% of the RPA. This area will need to withstand the weight of vehicles without causing compaction to the underlying soils. As per BS5837 and Arboricultural Practice Note (APN12) the proposed surface will be constructed on a no dig basis. This matter can be addressed in the form of an Arboricultural Method Statement (AMS). It will be noted BS5837 paragraph 7.4.2.3 recommends new permanent hard surfacing should not exceed 20% of any existing unsurfaced ground. As such the necessary 6% incursion falls well within the recommended guidance. It is requested the LPA agree to condition an AMS and wider Tree Protection as part of a detailed planning permission.
