22261

The Barn, Clough House Farm, Lower House Lane,  
Wardle, Rochdale, OL12 9PL

May 2022

# REPORT ON STRUCTURE

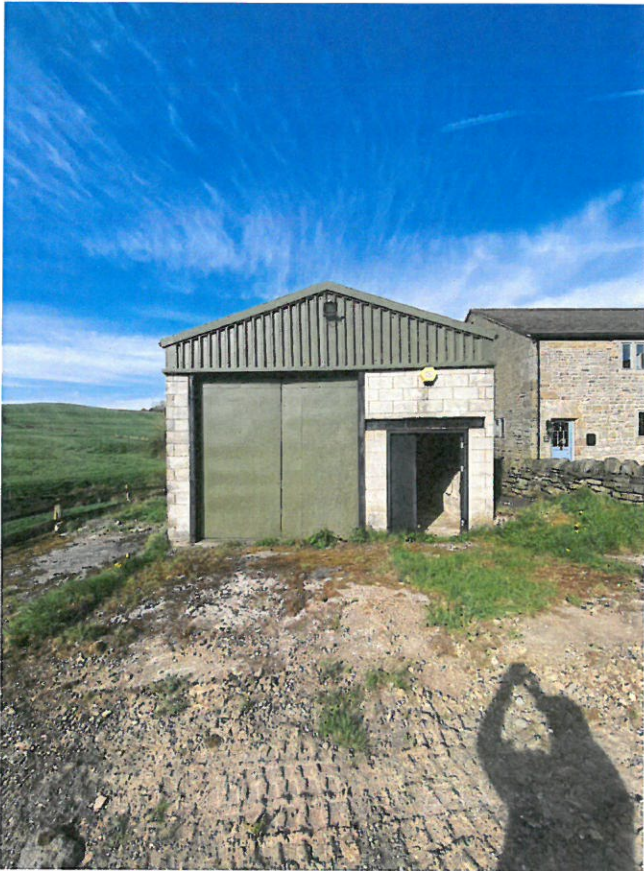
Photograph 1

- 2.03** The front elevation comprises of two large double doors, photograph 1. The existing left, right and rear elevations are shown in photographs 6, 7 & 8.

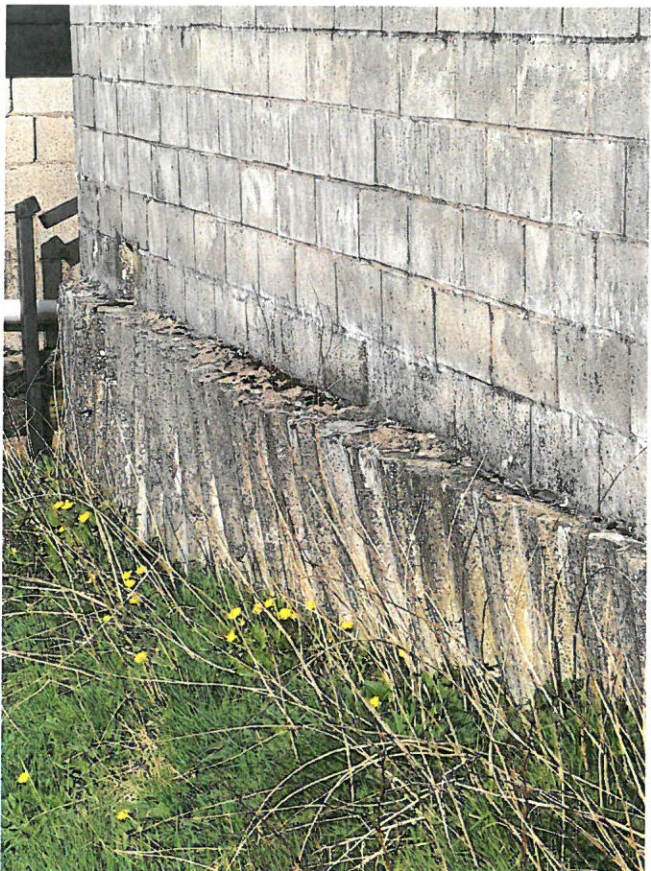
Photograph 2

- 2.01** Clough House Farm Barn is a single storey structure. The structure is of loadbearing blockwork sat on a concrete raft slab. The raft slab extends to deep levels on the rear left-hand corner due to a fall in the external ground levels. Photograph 2.

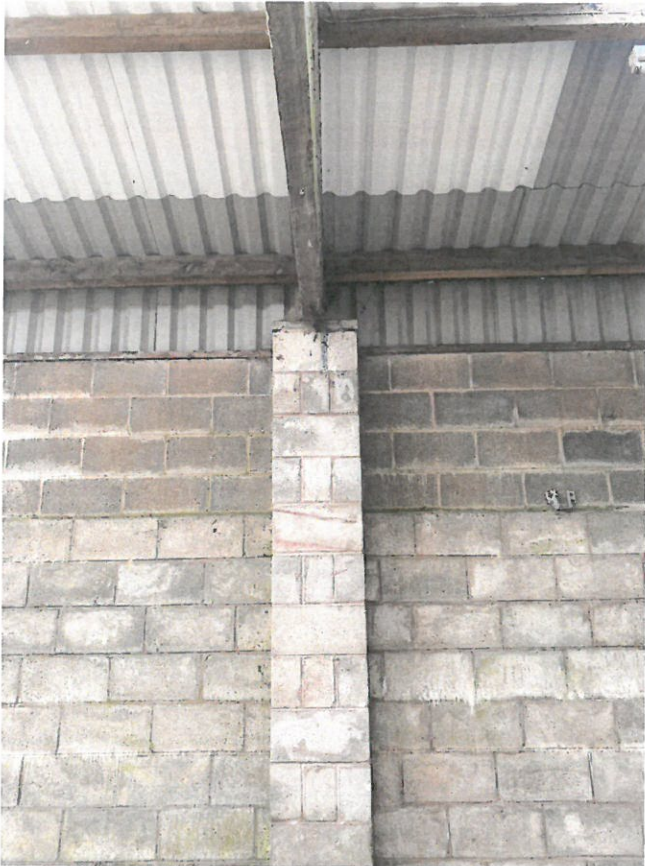
Photograph 3

- 2.02** The external walls are currently of a single skin blockwork. This is 140mm thick for the first 10 courses (approx. 2250mm). This is then topped by 4 courses (approx. 900mm) of 100mm blockwork. Above this is a 350mm depth of an uninsulated profiled metal sheet. Photographs 3, 4 & 5.

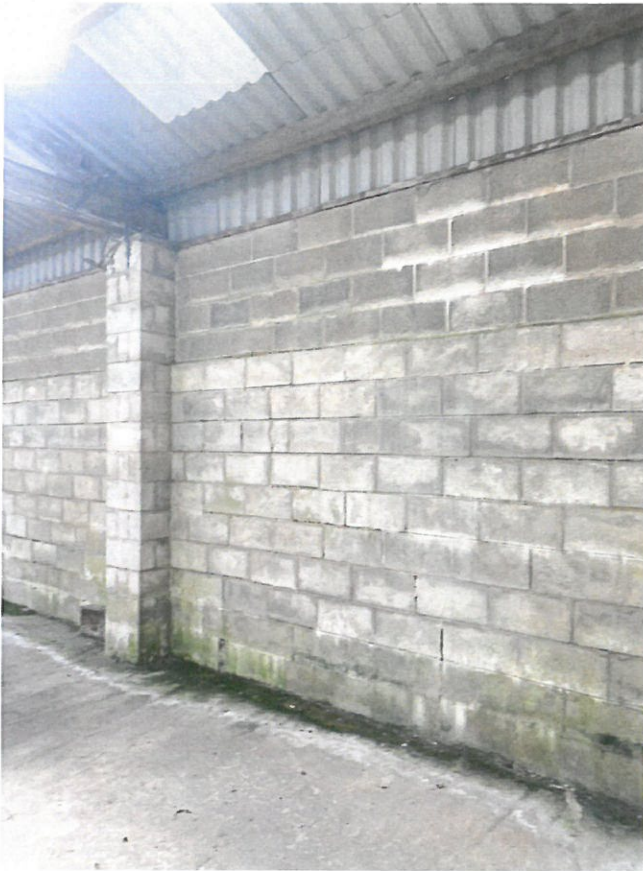
Photograph 9

- 2.04** internally the external walls on the long side elevations have buttressing piers coinciding with the bearing of the timber king post trusses that form the roof structure. Photograph 9. The block piers are 280mm x 440mm wide.

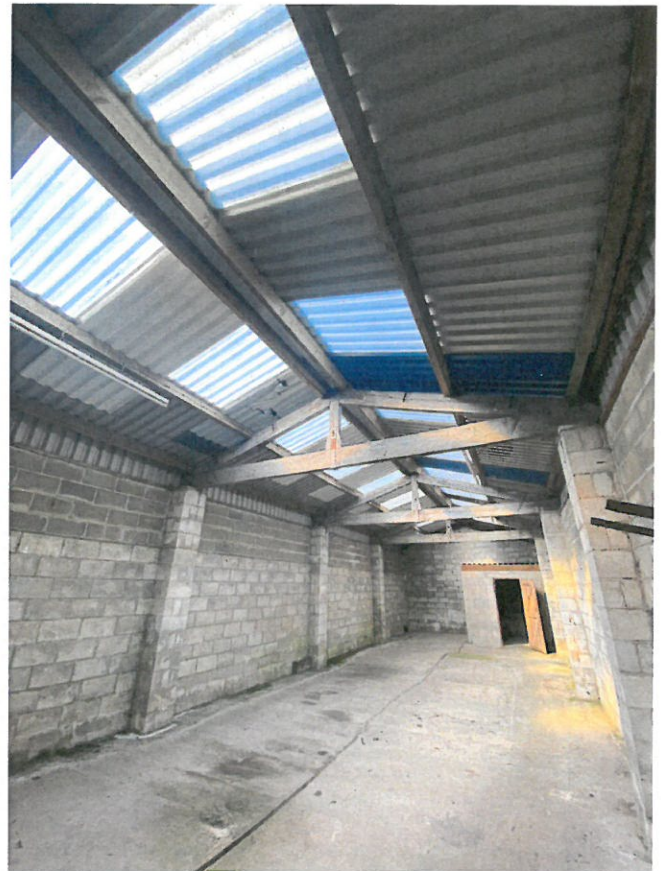
Photograph 10

- 2.05** There are four king post trusses forming the roof, including one that is positioned on the front elevation, photograph 10 & 11.
- 2.06** The roof covering is of an insulated profiled metal deck with translucent sheets acting as roof lights, photograph 12 & 13. There are 3 purlins per slope.

The truss over the front elevation may need to be replaced if it cannot be incorporated into the design of this elevation.
