**Re: Report on a tree for No 33 Fisherfield (located in the neighbouring garden of 35 Fisherfield, Rochdale OL12 7QW)**

## PRELIMINARY ARBORICULTURAL REPORT

Survey address: 33 Fisherfield, Rochdale OL12 7QW

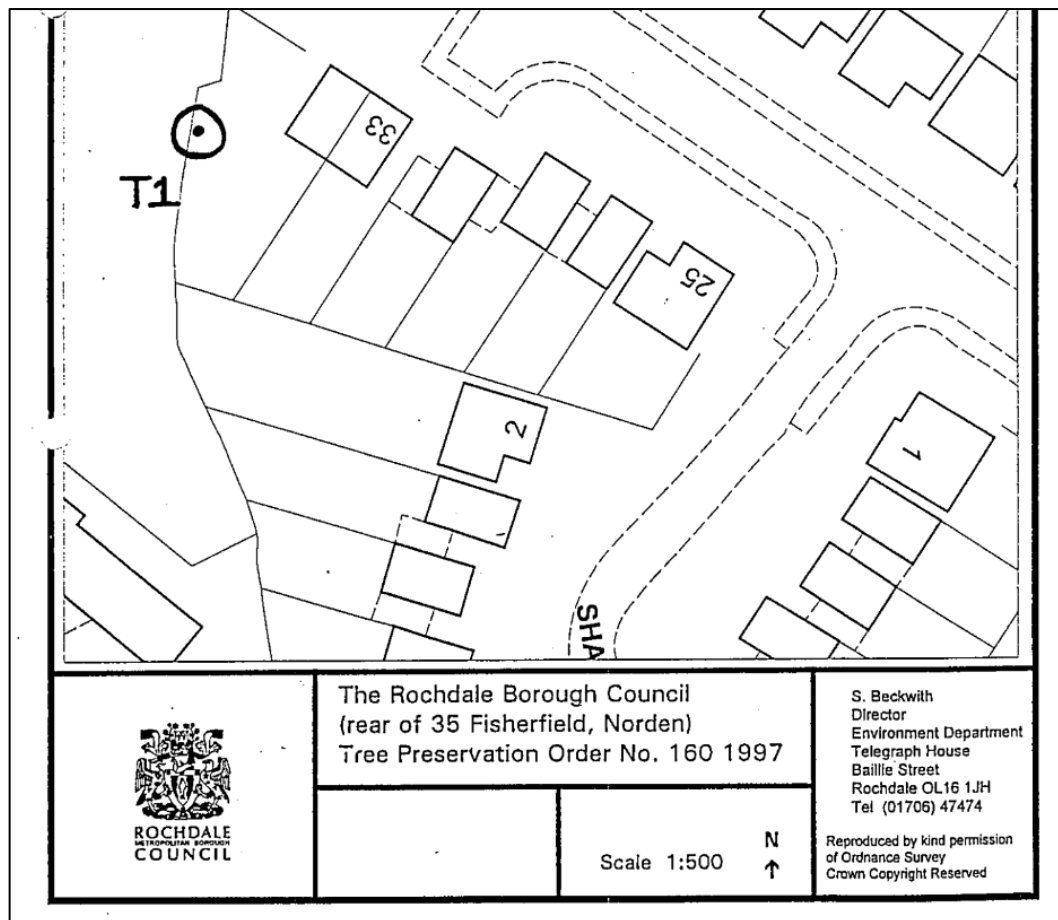
Fig 1. Document provided by Rochdale Borough Council indicating T1 and Tree Preservation Order number 160 1997.

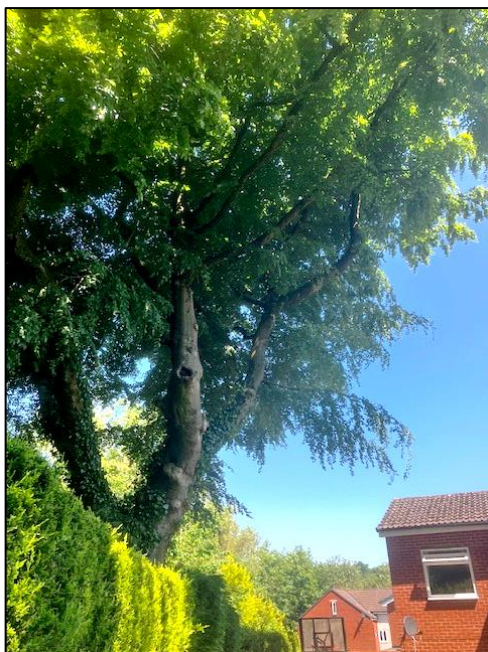
| Tree No. | Species | Age Range | Cond. | Height (m) | Crown Spread (m) | Diameter (mm) | Dist.to Structure (m) | Ownership |
|---|---|---|---|---|---|---|---|---|
| <b>Comments and description:</b><br>A large mature beech tree located on the north boundary hedge line of number 35 Fisherfield. There are 2 cavities evident, one at approximately 3 metres and another in a major limb at 5 metres. Both are shallow with no signs of decay. The trunk was struck by a sounding hammer and there were no audible signs of decay. The tree is well- balanced with a broad and dense crown. | | | | | | | | |

Plate 1. T1 – large beech tree located in north boundary hedge line of number 35 Fisherfield.

| Tree No. | Species | Recommendation | Category |
|---|---|---|---|
| T1 | American Beech | It is recommended that the tree has a crown reduction of 20% (approximately 3m) and a crown thin of 15%. The tree is protected by a Tree Preservation Order number 160 1997. Any tree works would require an application to Rochdale Council. | 2 |

| Tree No. | Species | Age Range | Cond. | Height (m) | Crown Spread (m) | Diameter (mm) | Dist.to Structure (m) | Ownership |
|---|---|---|---|---|---|---|---|---|
| <b>Tree work:</b> It is recommended that the tree has a crown reduction of 20% and a crown thin of 15% to maintain the size and shape of the tree and lessen the risk of failure. | | | | | | | | |

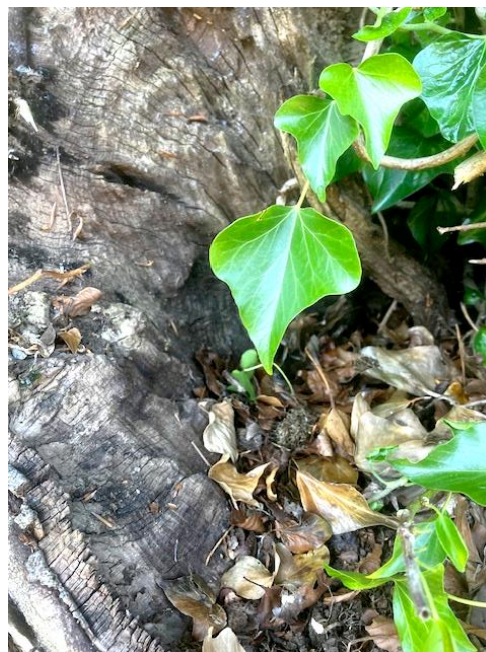
The American beech tree (T1) is located within the west hedge boundary line at number 35 Fisherfield, Rochdale. (11.6 metres from the house). There is a cavity from a past lower limb removal. The cavity is shallow with no decay evident. There are no surface roots evident on the lawn.

Plate 2. A large cavity at 3 metres which is shallow with no signs of decay.

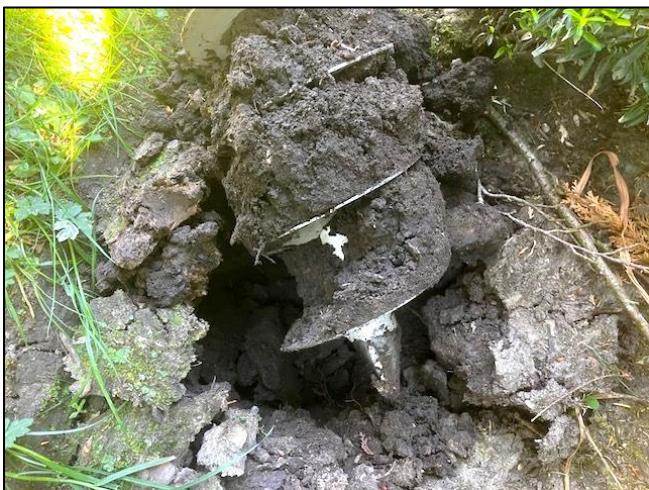
The soil on site was assessed to a depth of 1200mm, in two locations (see Location Plan 1, Fig 2) using a manually operated soil auger. This revealed a moist clay loam to 300mm, overlying sandy clay to 1200mm. This soil is likely to be free draining, allowing rapid rehydration of the clay component. The local geography, geology, soil characteristics and climate are all conducive to stable soil conditions and persistent soil moisture deficits are not anticipated.

Plate 3. A borehole indicating that the soil is dark and loamy, well-draining and has very low clay content.
