S1/MPG/02/CSB/LM/1.0/104/R1

**PARKFIELD HOUSE, MANCHESTER OLD ROAD, MIDDLETON**

Muller Property Group have requested a structural appraisal and a pre-demolition assessment of Parkfield House which was built as a replacement for the original Middleton Town Hall. The previous Town Hall house was demolished in the mid 1970's and only the gateposts and the wall along Manchester Old Road remain.

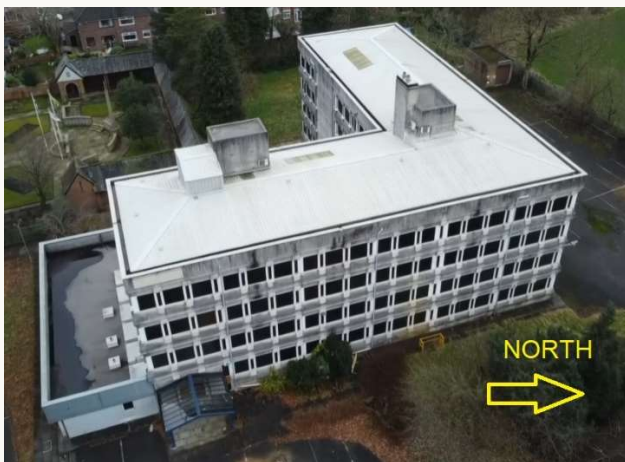
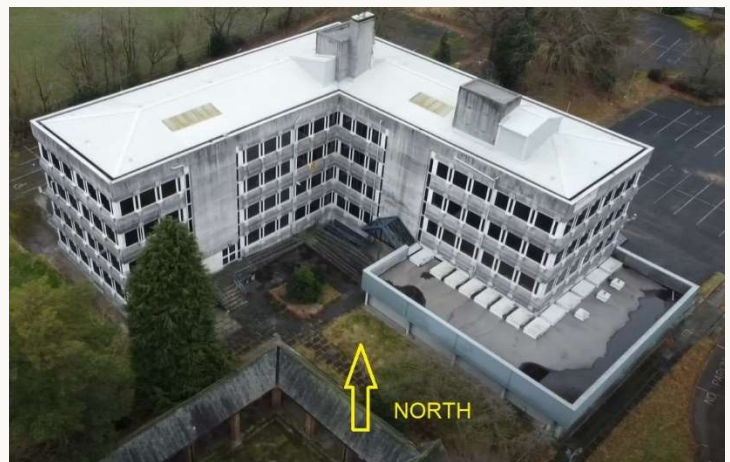
The original building had a flat roof however due to water leakage a steel pitched roof has been added. Roof drainage has been provided by new downpipes around the building perimeter.

The structures noted above the steel roof are the lift shaft over-run, water tank room, and sky lights to stairwells.

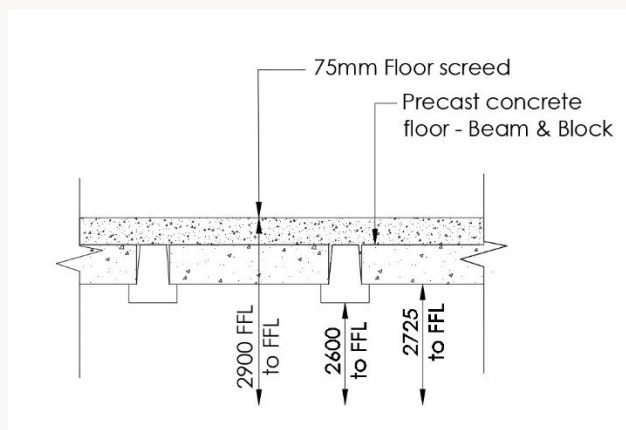
The floor construction on the upper storeys was precast concrete floor beams with infill concrete blocks (beam and block). The precast beam centres varied with the maximum centres at approximately 600mm.

The floor would appear to have a 75mm concrete screed overlying the beam and block floor making a floor to floor height of approximately 2.9m (possibly 9.5 ft imperial).

Suspended Ceiling Omitted for Clarity  
but height = 2500mm above FFL

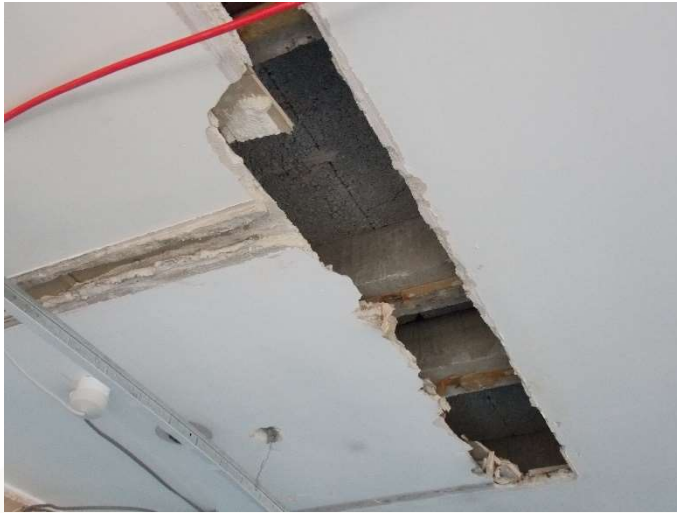
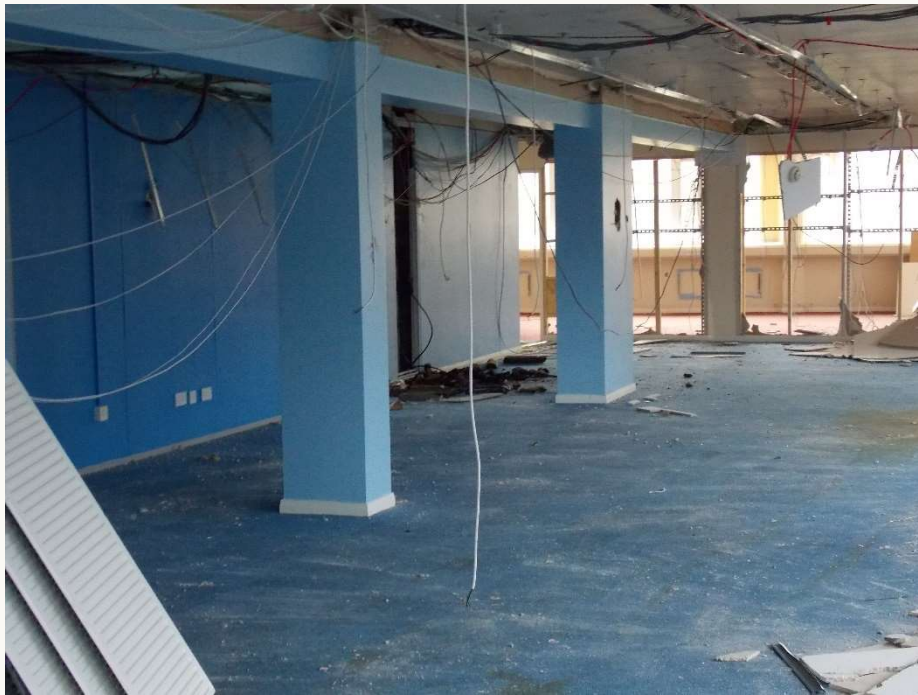
No intrusive investigation of materials has been undertaken and dimensions noted are approximate only. All concrete beams and columns have plasterboard fire protection.

The precast floor beams are supported along the middle of the building by a concrete spine beam which is approximately 250mm wide by 500mm deep below the floor infill block. Around the perimeter of the floor a downstand beam can be observed with a depth of 225mm below the floor infill block.

At each grid location a 250mm x 250mm (approx.) reinforced concrete column supports the downstand beams.

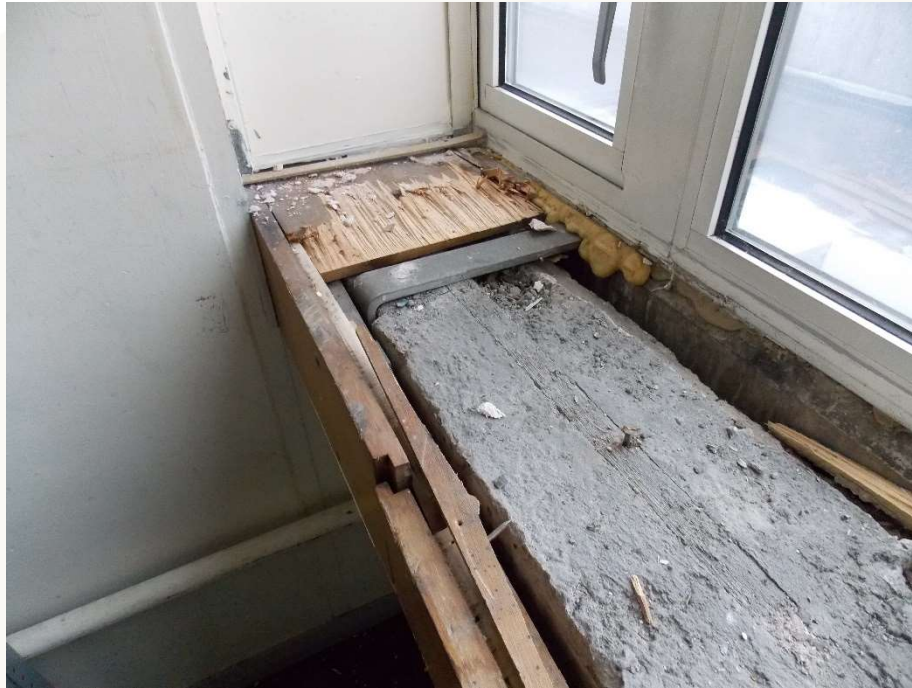
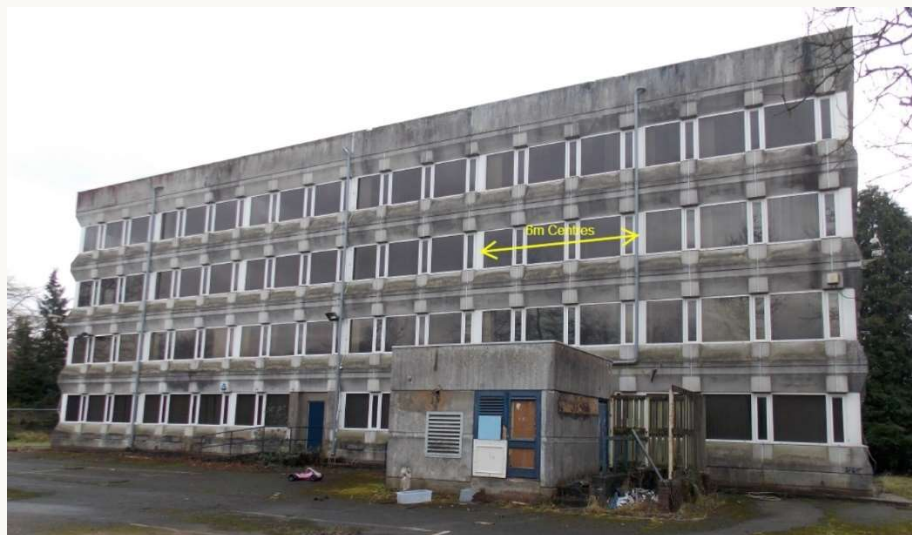
North Elevation

The elevations to the building are clad with precast concrete panels. In one area adjacent to the stairwell a perimeter beam at cill level has been exposed which shows a simple hanger fixing detail for the precast panel. Further fixings will be utilized below this and dowel connections between adjacent panel units.

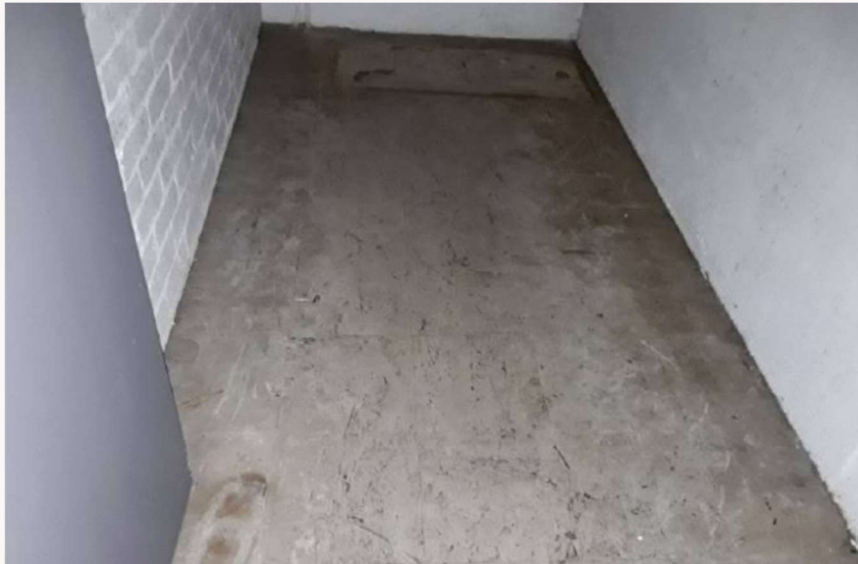
No access was available to the basement. Due to the higher loads at this level and retaining forces we would expect the walls and floors to be reinforced concrete. Photographs of the basement included in the Asbestos Report show internal partition walls constructed in brickwork.
