# ASBESTOS REINSPECTION SURVEY

Silverhill Farm, Kingsway Industrial Estate, Lower  
Lane, Rochdale

TYPE OF DOCUMENT (ISSUE 22) CONFIDENTIAL

DATE: July 2020

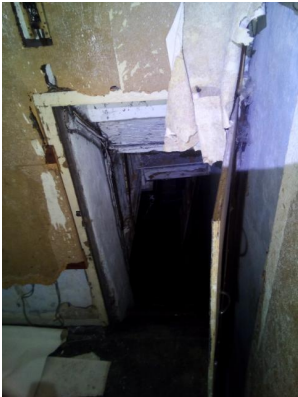
| Location | Item Description | Extent / Quantity | Product Type | Damage Extent | Surface Treatment | Asbestos Type | Material Assessment Total | Material Risk Rating | Accessibility | Sample Reference | Asbestos Identification | Recommendations | Photographs |
|---|---|---|---|---|---|---|---|---|---|---|---|---|---|
| 1 Farm House<br>Basement<br>001 Basement | No access | - | - | - | - | - | - | - | - | Presumed | - | Further investigation required, presume asbestos present until accessed | |

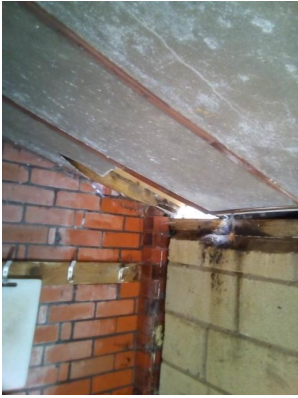
| Location | Description | Extent | Recommendation |
|---|---|---|---|
| 1 Farm House<br>Ground Floor<br>001 Entrance Lobby | Cement panels to ceiling | 3 m <sup>2</sup> | Label and reinspect - The corner of the cement ceiling has been damaged since previous inspection. |

| Location | Item Description | Extent / Quantity | Product Type | Damage Extent | Surface Treatment | Asbestos Type | Material Assessment Total | Material Risk Rating | Accessibility | Sample Reference | Asbestos Identification | Recommendations | Photographs |
|---|---|---|---|---|---|---|---|---|---|---|---|---|---|
| 1 Farm House<br>Ground Floor<br>001 Entrance Lobby | Cement panels to ceiling | 3 m <sup>2</sup> | 1 | 2 | 1 | 1 | 5 | Low | High | 40194/MH001 | Chrysotile | Label and reinspect<br><br>The corner of the cement ceiling has been damaged since previous inspection. | |

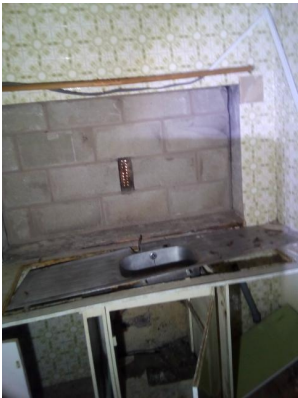
| Location | Description | Extent | Recommendation |
|---|---|---|---|
| 1 Farm House<br>Ground Floor<br>002 Kitchen | Sink Pad | 2 No. | Label and reinspect - Condition remains unchanged since previous inspection. |

| Location | Item Description | Extent / Quantity | Product Type | Damage Extent | Surface Treatment | Asbestos Type | Material Assessment Total | Material Risk Rating | Accessibility | Sample Reference | Asbestos Identification | Recommendations | Photographs |
|---|---|---|---|---|---|---|---|---|---|---|---|---|---|
| 1 Farm House<br>Ground Floor<br>002 Kitchen | Sink Pad | 2 No. | 1 | 0 | 0 | 1 | 2 | Very Low | High | 40194/MH002 | Chrysotile | <b>Label and reinspect</b><br><br>Condition remains unchanged since previous inspection. | |

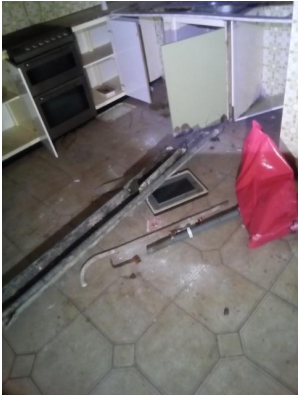
| Location | Item Description | Extent / Quantity | Product Type | Damage Extent | Surface Treatment | Asbestos Type | Material Assessment Total | Material Risk Rating | Accessibility | Sample Reference | Asbestos Identification | Recommendations | Photographs |
|---|---|---|---|---|---|---|---|---|---|---|---|---|---|
| 1 Farm House<br>Ground Floor<br>002 Kitchen | Cement Gutter | 4 lm | 1 | 2 | 1 | 1 | 5 | Low | High | As40194/MH006 | Chrysotile | <b>Remove</b> | |

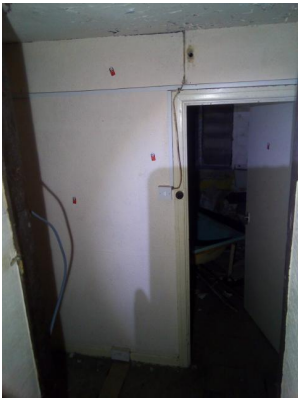
| Location | Description | Extent | Recommendation |
|---|---|---|---|
| 1 Farm House<br>1st Floor<br>004 Landing | Cement partition walls to rear rooms | 4 m <sup>2</sup> | Label and reinspect - Condition remains unchanged since previous inspection. |

| Location | Item Description | Extent / Quantity | Product Type | Damage Extent | Surface Treatment | Asbestos Type | Material Assessment Total | Material Risk Rating | Accessibility | Sample Reference | Asbestos Identification | Recommendations | Photographs |
|---|---|---|---|---|---|---|---|---|---|---|---|---|---|
| 1 Farm House<br>1st Floor<br>004 Landing | Cement partition walls to rear rooms | 4 m <sup>2</sup> | 1 | 1 | 0 | 1 | 3 | Very Low | High | 40194/MH003 | Chrysotile | <b>Label and reinspect</b><br><br>Condition remains unchanged since previous inspection. | |

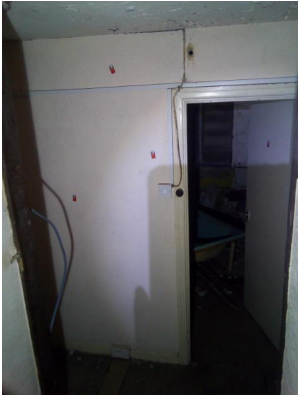
| Location | Description | Extent | Recommendation |
|---|---|---|---|
| 1 Farm House<br>1st Floor<br>005 Small Bedroom | Cement partition walls to room 1/006 | 6 m <sup>2</sup> | Label and reinspect - Condition remains unchanged since previous inspection. |

| Location | Item Description | Extent / Quantity | Product Type | Damage Extent | Surface Treatment | Asbestos Type | Material Assessment Total | Material Risk Rating | Accessibility | Sample Reference | Asbestos Identification | Recommendations | Photographs |
|---|---|---|---|---|---|---|---|---|---|---|---|---|---|
| 1 Farm House<br>1st Floor<br>005 Small Bedroom | Cement partition walls to room 1/006 | 6 m <sup>2</sup> | 1 | 1 | 0 | 1 | 3 | Very Low | High | As40194/MH003 | Chrysotile | <b>Label and reinspect</b><br><br>Condition remains unchanged since previous inspection. | |

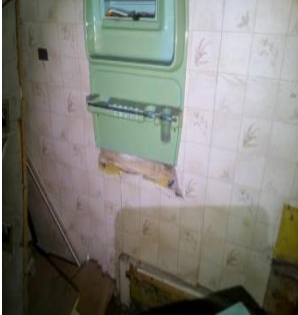
| Location | Description | Extent | Recommendation |
|---|---|---|---|
| 1 Farm House<br>1st Floor<br>006 Bathroom | Cement partition walls | 12 m <sup>2</sup> | Repair, encapsulate, label and reinspect - Condition has deteriorated since previous inspection. |

| Location | Item Description | Extent / Quantity | Product Type | Damage Extent | Surface Treatment | Asbestos Type | Material Assessment Total | Material Risk Rating | Accessibility | Sample Reference | Asbestos Identification | Recommendations | Photographs |
|---|---|---|---|---|---|---|---|---|---|---|---|---|---|
| 1 Farm House<br>1st Floor<br>006 Bathroom | Cement partition walls | 12 m <sup>2</sup> | 1 | 2 | 0 | 1 | 4 | Very Low | High | As40194/MH003 | Chrysotile | <b>Repair, encapsulate, label and reinspect</b><br><br>Condition has deteriorated since previous inspection. | |

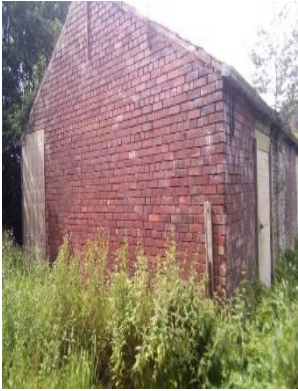
| Location | Item Description | Extent / Quantity | Product Type | Damage Extent | Surface Treatment | Asbestos Type | Material Assessment Total | Material Risk Rating | Accessibility | Sample Reference | Asbestos Identification | Recommendations | Photographs |
|---|---|---|---|---|---|---|---|---|---|---|---|---|---|
| 2 Barn / Milking Shed<br>Ground Floor<br>001 Store | No access | - | - | - | - | - | - | - | - | Presumed | - | <b>Further investigation required, presume asbestos present until accessed</b><br><br>No safe access - Bricked up doors | |

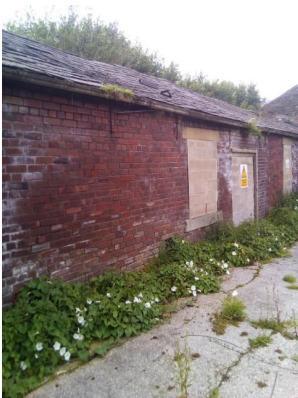
| Location | Item Description | Extent / Quantity | Product Type | Damage Extent | Surface Treatment | Asbestos Type | Material Assessment Total | Material Risk Rating | Accessibility | Sample Reference | Asbestos Identification | Recommendations | Photographs |
|---|---|---|---|---|---|---|---|---|---|---|---|---|---|
| 2 Barn / Milking Shed<br>Ground Floor<br>002 Store | No access | - | - | - | - | - | - | - | - | Presumed | - | <b>Further investigation required, presume asbestos present until accessed</b><br><br>No safe access - Bricked up doors | |

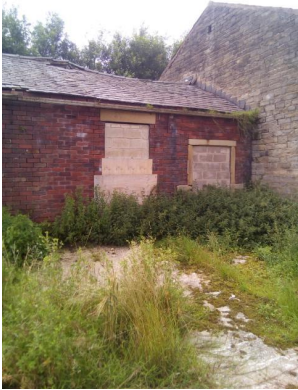
| Location | Item Description | Extent / Quantity | Product Type | Damage Extent | Surface Treatment | Asbestos Type | Material Assessment Total | Material Risk Rating | Accessibility | Sample Reference | Asbestos Identification | Recommendations | Photographs |
|---|---|---|---|---|---|---|---|---|---|---|---|---|---|
| 2 Barn / Milking Shed<br>Ground Floor<br>003 Store | No access | - | - | - | - | - | - | - | - | Presumed | - | <b>Further investigation required, presume asbestos present until accessed</b><br><br>No safe access - Bricked up doors | |

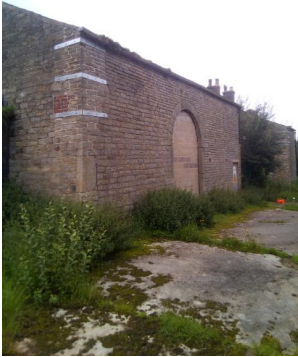
| Location | Item Description | Extent / Quantity | Product Type | Damage Extent | Surface Treatment | Asbestos Type | Material Assessment Total | Material Risk Rating | Accessibility | Sample Reference | Asbestos Identification | Recommendations | Photographs |
|---|---|---|---|---|---|---|---|---|---|---|---|---|---|
| 2 Barn / Milking Shed<br>Ground Floor<br>004 Barn | No access | - | - | - | - | - | - | - | - | Presumed | - | <b>Further investigation required, presume asbestos present until accessed</b><br><br>No safe access - Bricked up doors | |

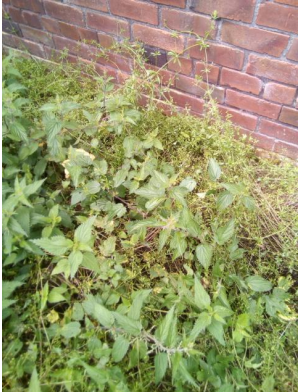
| Location | Item Description | Extent / Quantity | Product Type | Damage Extent | Surface Treatment | Asbestos Type | Material Assessment Total | Material Risk Rating | Accessibility | Sample Reference | Asbestos Identification | Recommendations | Photographs |
|---|---|---|---|---|---|---|---|---|---|---|---|---|---|
| 2 Barn / Milking Shed<br>External<br>001 External | Cement debris to rear of building | 5 m² | 1 | 2 | 1 | 1 | 5 | Low | | As40194/MH006 | Chrysotile | Remove<br><br>Area overgrown but asbestos cement has been bagged and stored in Farmhouse kitchen. | |

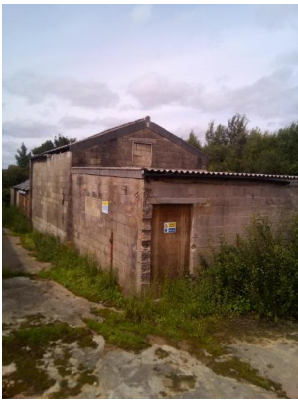
| Location | Description | Extent | Recommendation |
|---|---|---|---|
| 3 - Milking Building<br>External<br>001 Milking Building | Cement Roof & Fascia to 001, 002, 003 & 006 | 200 lm | Label and reinspect - Condition remains unchanged since previous inspection. |

| Location | Item Description | Extent / Quantity | Product Type | Damage Extent | Surface Treatment | Asbestos Type | Material Assessment Total | Material Risk Rating | Accessibility | Sample Reference | Asbestos Identification | Recommendations | Photographs |
|---|---|---|---|---|---|---|---|---|---|---|---|---|---|
| 3 - Milking Building External<br>001 Milking Building | Cement Roof & Fascia to 001, 002, 003 & 006 | 200 lm | 1 | 1 | 1 | 1 | 4 | Very Low | High | 40194/MH006 | Chrysotile | <b>Label and reinspect</b><br><br>Condition remains unchanged since previous inspection. | |

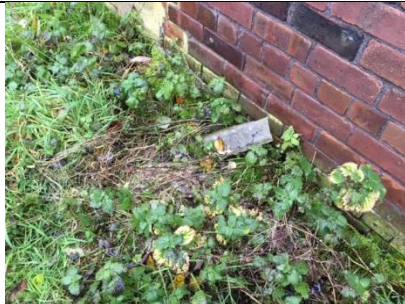
| MATERIALS REGISTER | | | | | | | | | | | | |
|---|---|---|---|---|---|---|---|---|---|---|---|---|
| External | Cement debris to rear of building. | 5 m <sup>2</sup> | 1 | 3 | 1 | 1 | 6 | Low | High | As 40194/MH006 | Chrysotile | <br>Remove |

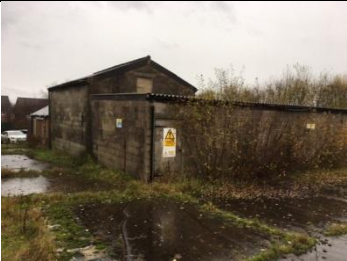
| Building 3 - Milking Building | No access to any part of this building | - | - | - | - | - | - | - | - | - | - | <br>Structure boarded-up. |

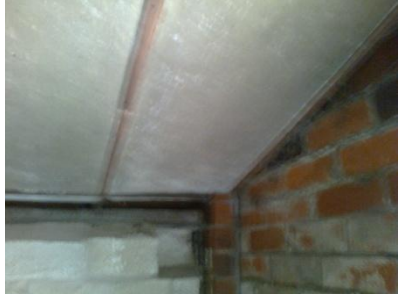
| Building 1 – Farm House | | | | | | | | | | | | |
|---|---|---|---|---|---|---|---|---|---|---|---|---|
| 0/01<br>Entrance lobby | Cement panels to ceiling | 3 Sq.M | 1 | 1 | 1 | 1 | 4 | Very Low | High | 40194/MH001 | Chrysotile | <br>Manage and reinspect as part of an asbestos management program. |

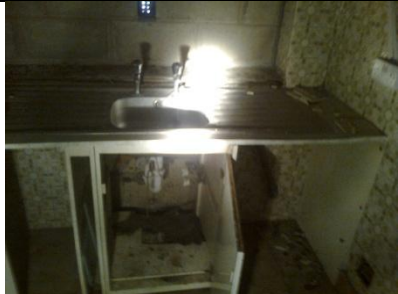
| Building 1 – Farm House | | | | | | | | | | | | |
|---|---|---|---|---|---|---|---|---|---|---|---|---|
| 0/02 Kitchen | Bitumen pad to underside sink pad | 1 item | 1 | 0 | 0 | 1 | 2 | Very Low | High | 40194/MH002 | Chrysotile | <br>No access above timber ceiling.<br>Manage and reinspect as part of an asbestos management program. |

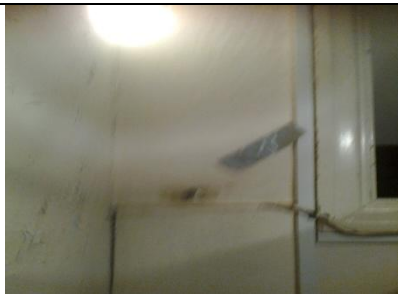
| 1/04 Landing | Cement partition walls to rear rooms | 4 Sq.M | 1 | 1 | 1 | 1 | 4 | Very Low | High | 40194/MH003 | Chrysotile | <br>Manage and reinspect as part of an asbestos management program. |

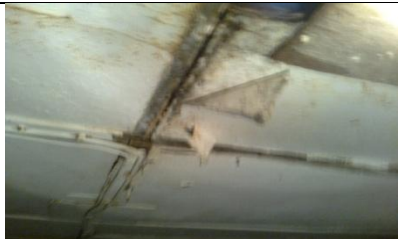
| Building 3 – Milking Building | | | | | | | | | | | | |
|---|---|---|---|---|---|---|---|---|---|---|---|---|
| 0/04<br>Refrigeration<br>room | Cement ceiling panels | 10 Sq.M | 1 | 3 | 1 | 1 | 6 | Low | Medium | Sampled/40194/MH004 | Chrysotile | <br>Remove debris and decontaminate area,<br>repair, encapsulate and manage ceiling<br>panels |

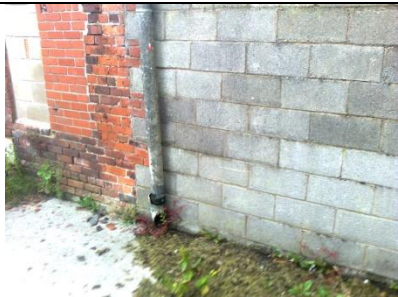
| External | Cement guttering and downpipes | 20 Lin. M | 1 | 2 | 1 | 1 | 5 | Low | High | 40194/MH006 | Chrysotile | <br>Manage and reinspect as part of an asbestos management program. |
