## GAS MEMBRANE VALIDATION

**Site: Boothroyden Road, Middleton**

| Date: 12-10-2021 | Project Number: 13-500 |

Ground Gas Risk Assessment: **Amber 2**

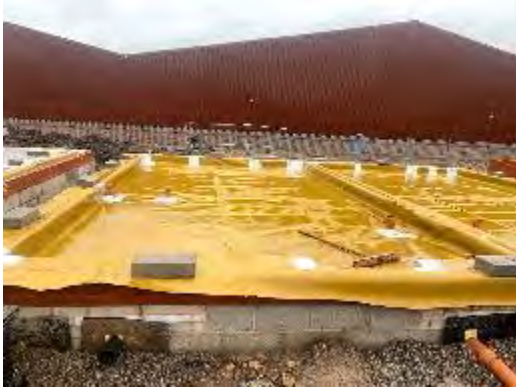
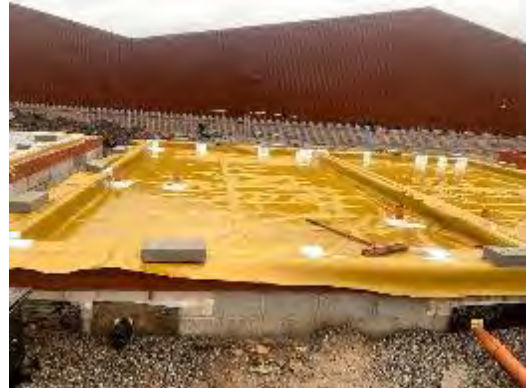
**Plot – 26**

**General Condition of Membrane-Good Condition**

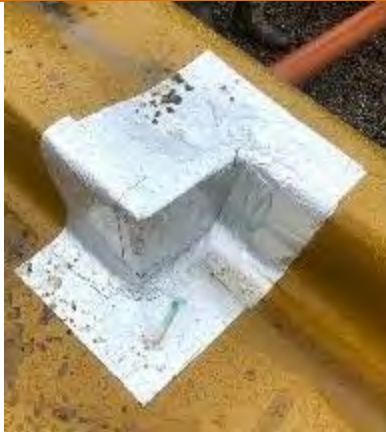
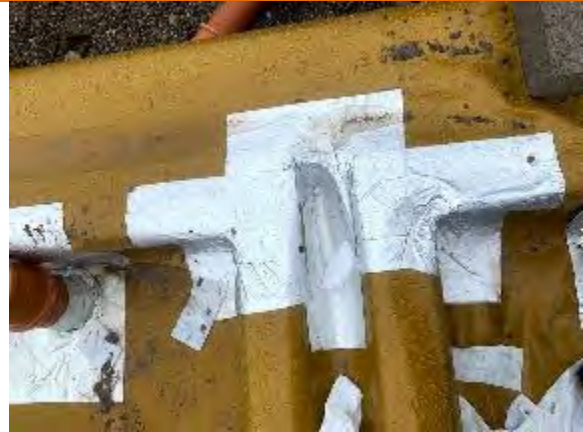
**Verification of Joints and Seals-Good Condition**

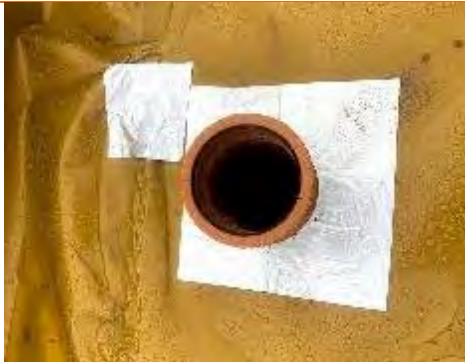
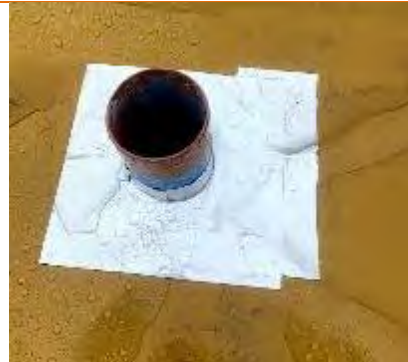
**Verification of Service Penetrations-Good Condition**

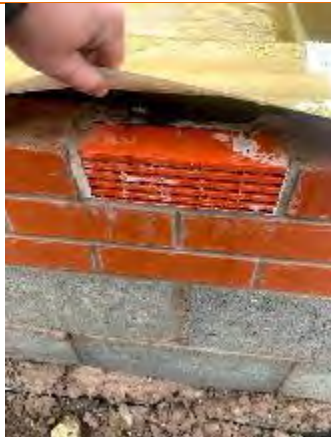
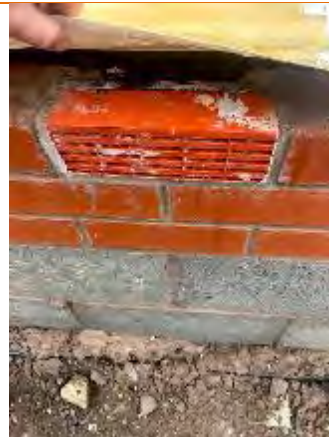
**Verification of Ventilation-Good Condition**

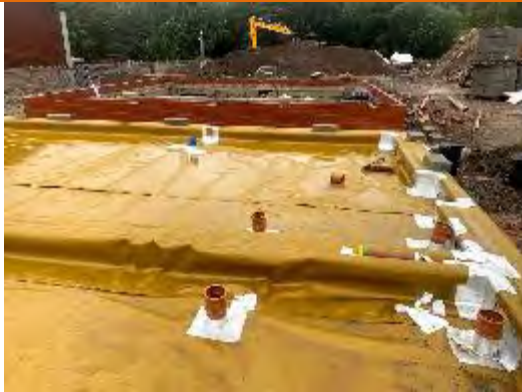
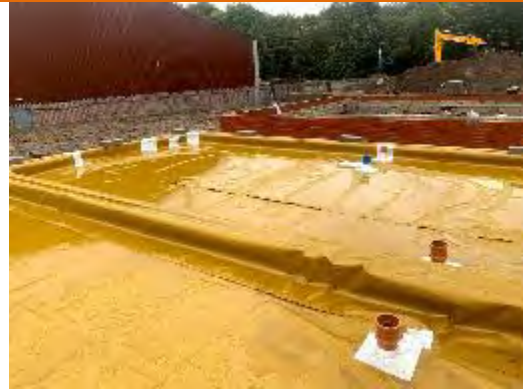
**Plot - 27**

**General Condition of Membrane-Good Condition**

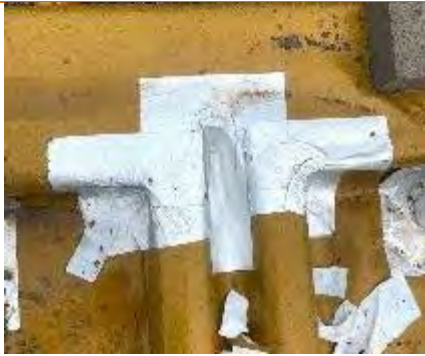
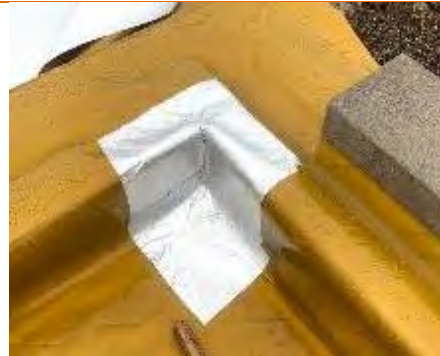
**Verification of Joints and Seals-Good Condition**

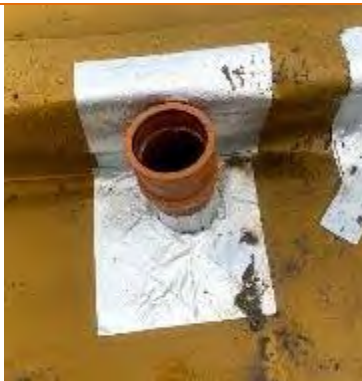
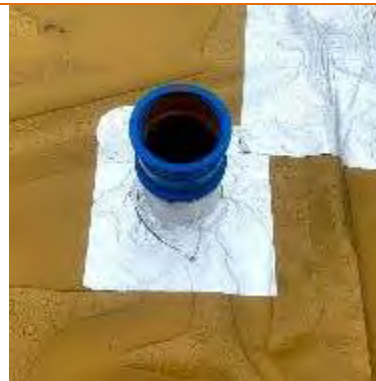
**Verification of Service Penetrations-Good Condition**

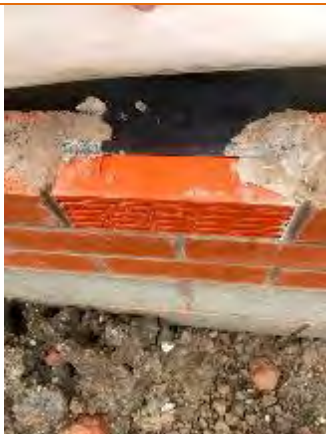
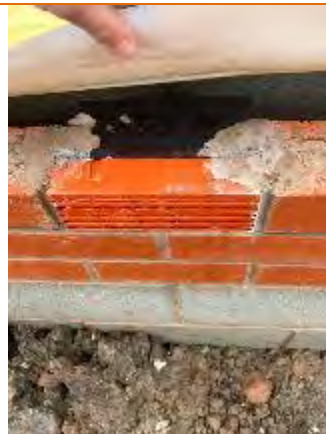
**Verification of Ventilation-Good Condition**
