Re: 4 MOORGATE EAST FARM – THE OLD STABLE,  
BROAD LANE, ROCHDALE, OL16 4QL

# METHOD STATEMENT

MOORGATE EAST FARM, BURNEDGE LANE,  
ROCHDALE – OL16 4QL

# REPORT ON STRUCTURE

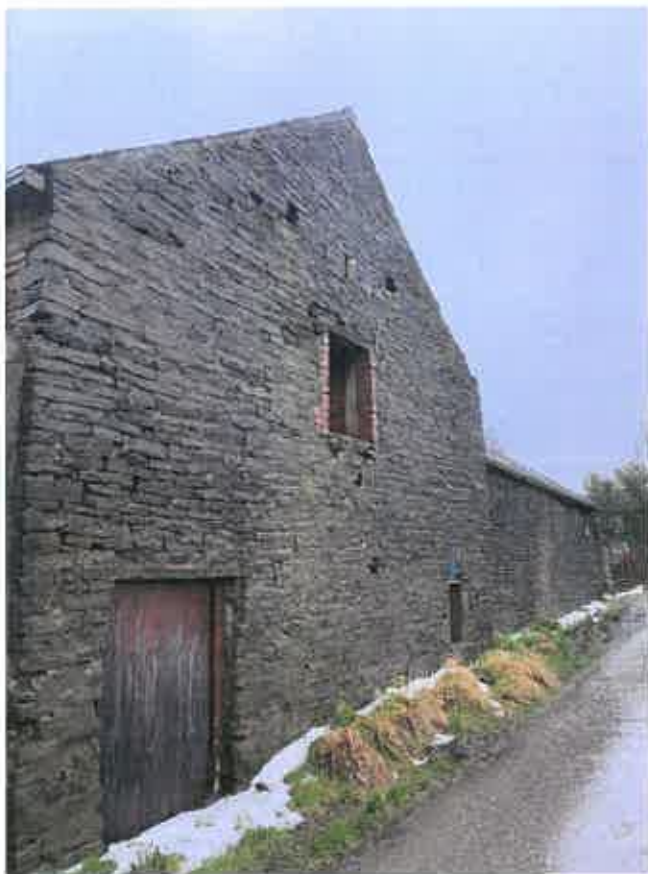
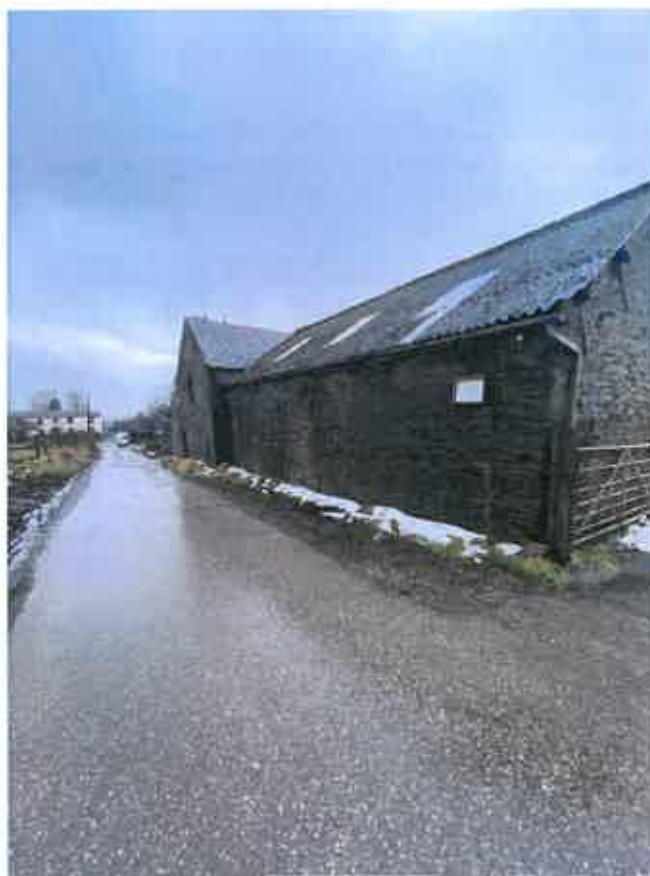
The South-East elevation is shown in photographs 1 & 2. The North-East elevation is shown in photographs 3 & 4.

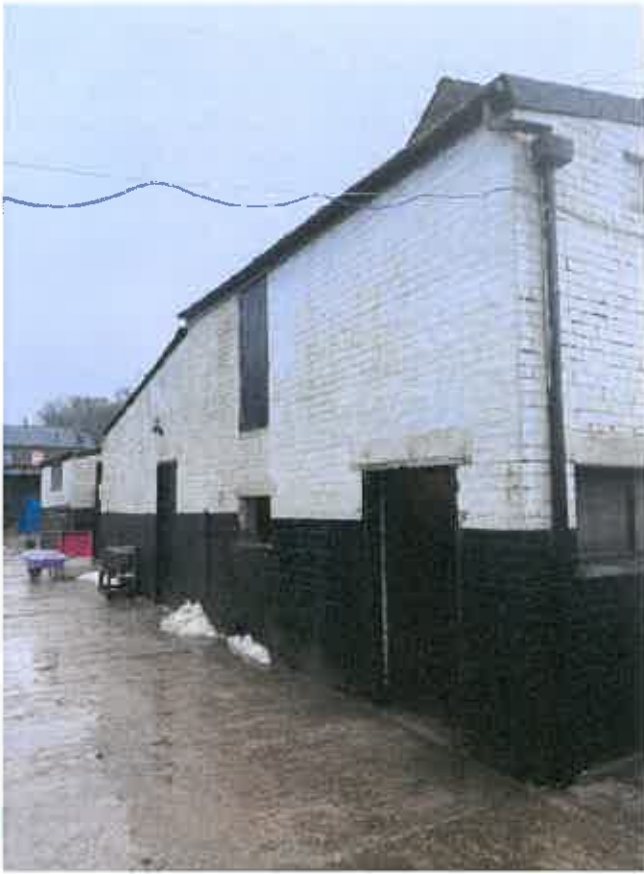
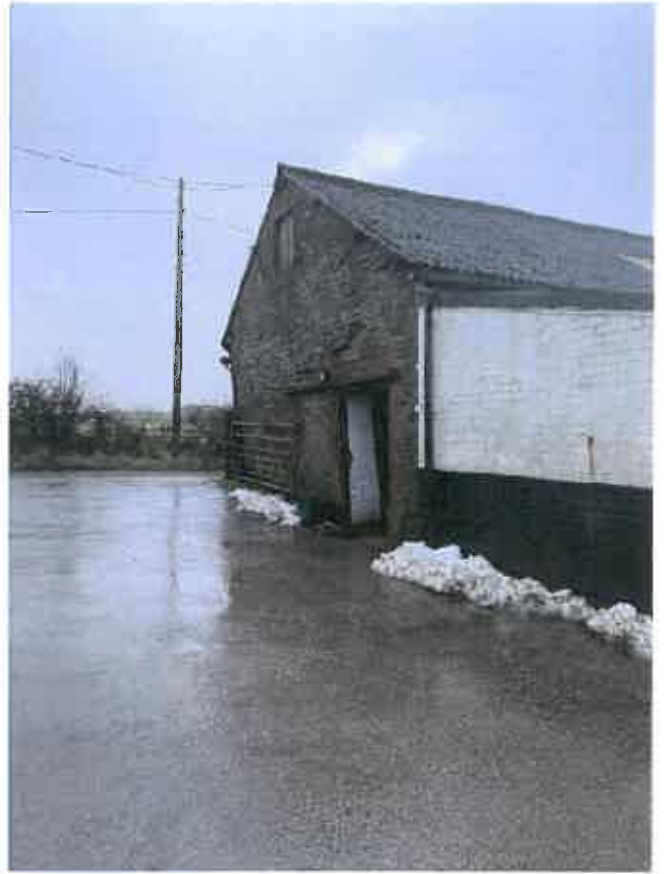
The two minor structures comprising of stable blocks and stores are to be removed from the North-West elevation. See Appendix C and photographs 5 & 6.

These structures do not form part of the original structure and are simple additions. Their removal does not affect the stability of the remaining structure.

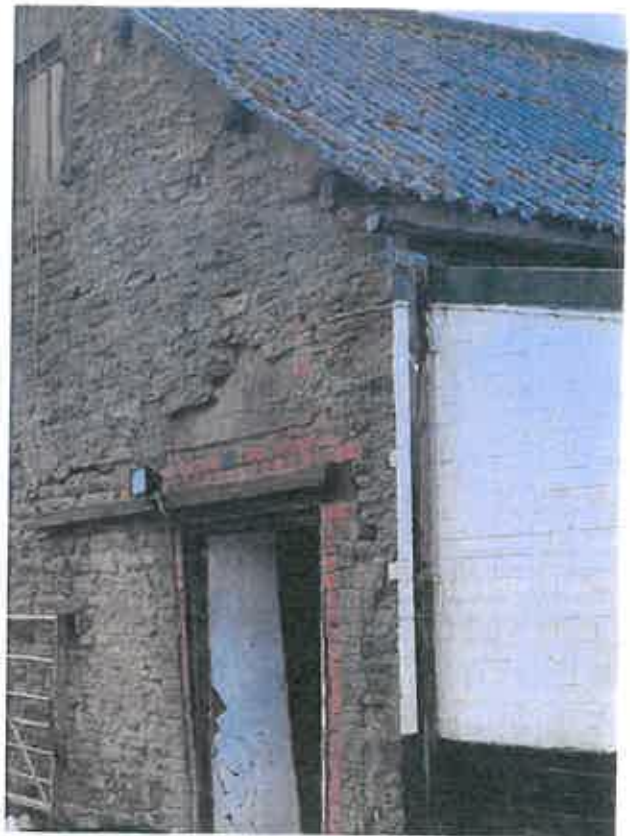
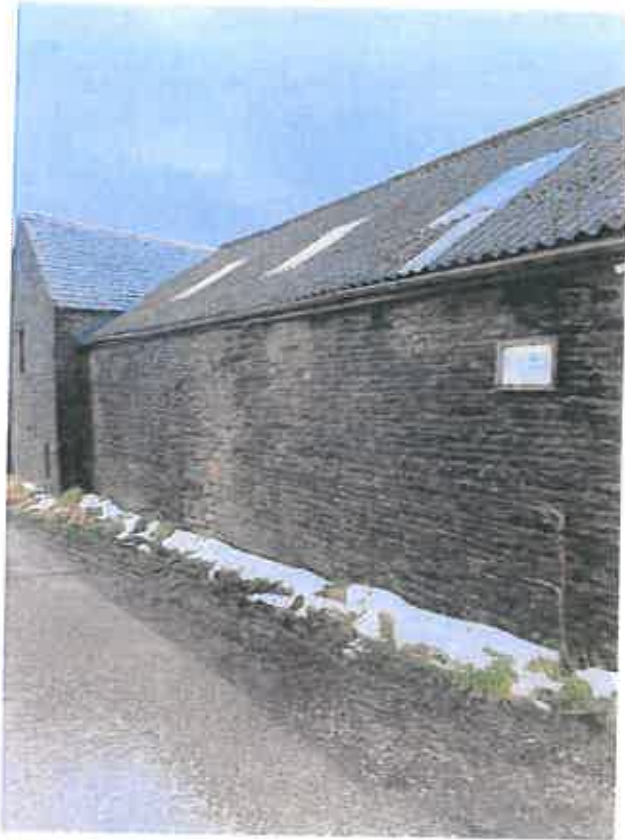
- 2.06** Internally, Barn 1 has a first-floor hay loft. This is serviced by a fixed ladder.
- 2.07** The second barn, Barn 2, has an asbestos cement roof covering. See photographs 8 & 9. The Burnedge Lane elevation has no openings and the ground floor is partially below the level of Burnedge Lane. See photograph 9.

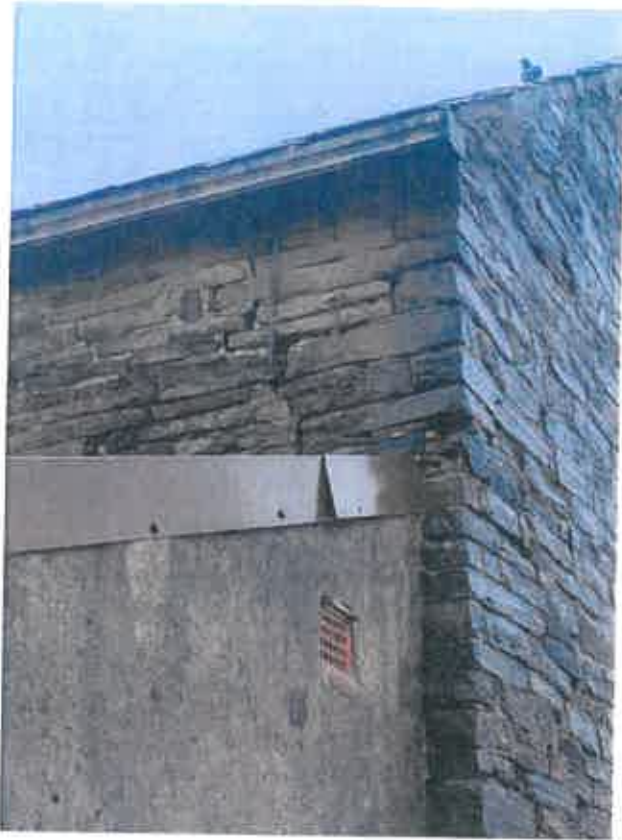
Photograph 13

The forward gable elevation of Barn 1 is of random stone. The elevation is badly twisted with the right-hand corner projecting outwards towards the lane and the left-hand corner bulging towards the left. See photograph 13. There is associated opening of the joints within the stone masonry relative to both these.

The stonework is badly pointed and is approximately 500mm thick. There is no damp-proof course to the property and the external ground levels rise from left to right giving slight retained conditions.

The left-hand buttress wall of the brick lean-to is, we understand, to be removed and some local stitching of the gable and left-hand side elevations will be required. The elevations will also require tying into the new floor to maintain the stability and integrity of the wall.

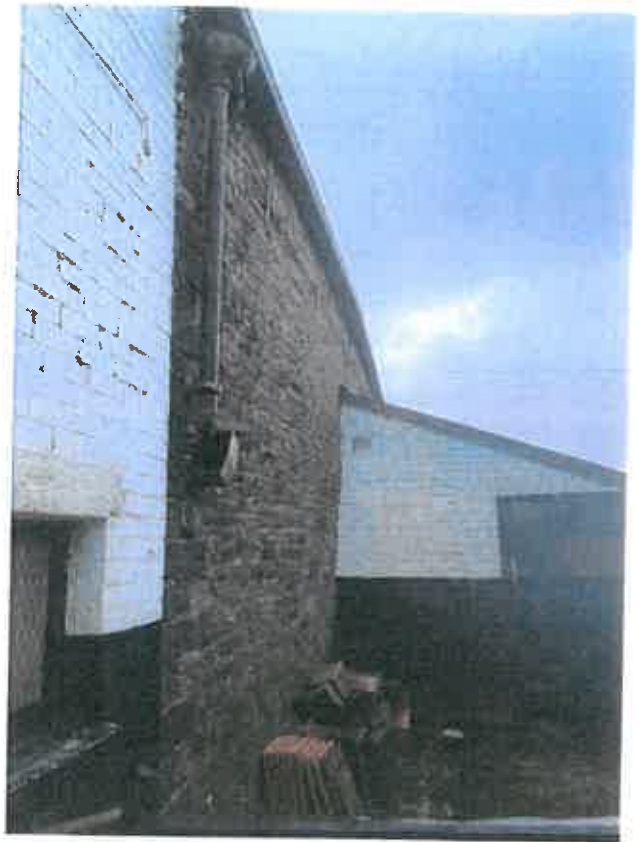
Photograph 14

The left-hand side elevation of this barn is again of random stone and is extremely uneven. This can be seen by the shape of the brick lean-to – see photograph 14. The out of plumb of the wall is considered to be within acceptable tolerances for a property of this age and type.

Notwithstanding this, the elevation will require stitching and strapping to the internal floor.

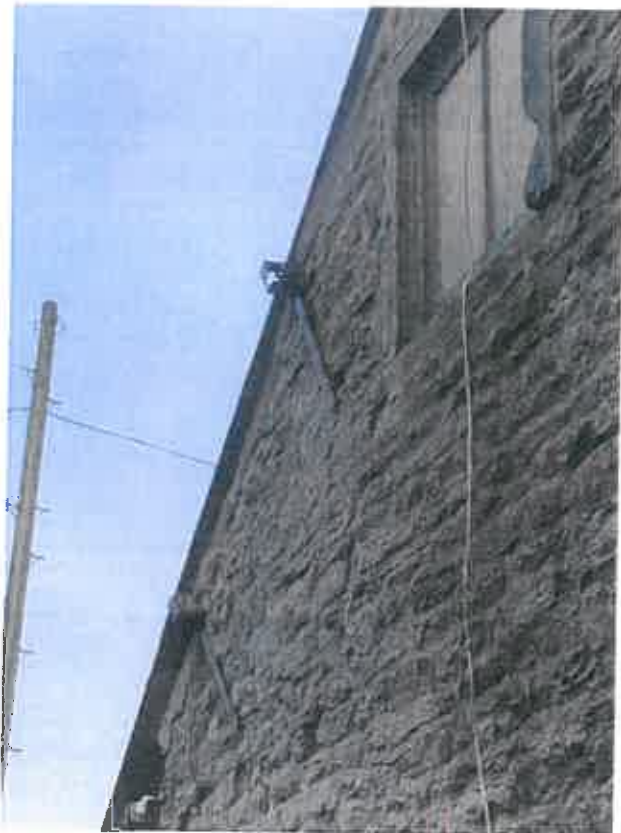
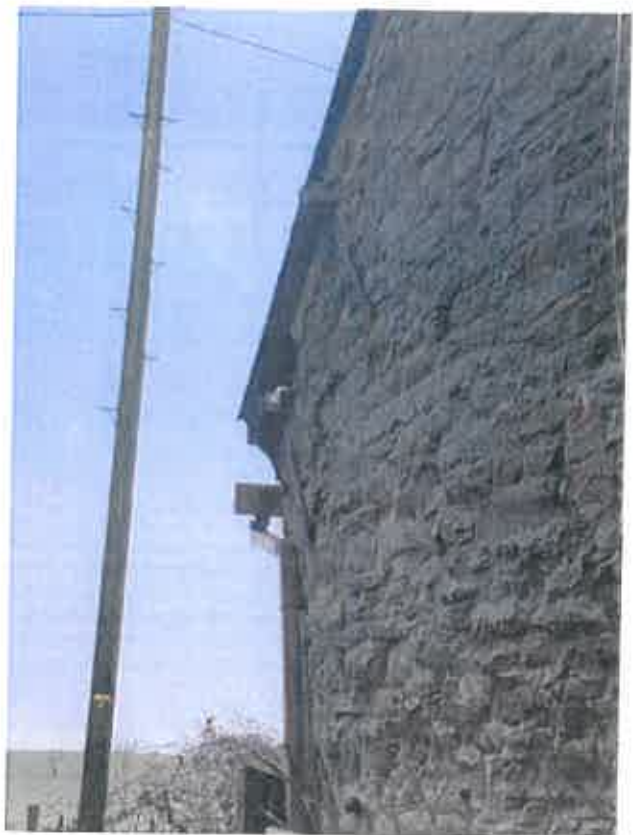
The right-hand gable of Barn 2 - photographs 15 & 16, has a significant bulge. This elevation is likely to require rebuilding. Ideally the whole elevation would be rebuilt but if this contravenes the planning requirements then it would be possible to take down the wall to ground floor lintel height and to rebuild above this level.

- 4.02** The right-hand gable to Barn 2, will require rebuilding. Ideally, this would be full height but this could be reduced.
- 4.03** An internal leaf to create cavity walls to the external elevations would be a bonus. These could be built off the new ground floor slab.

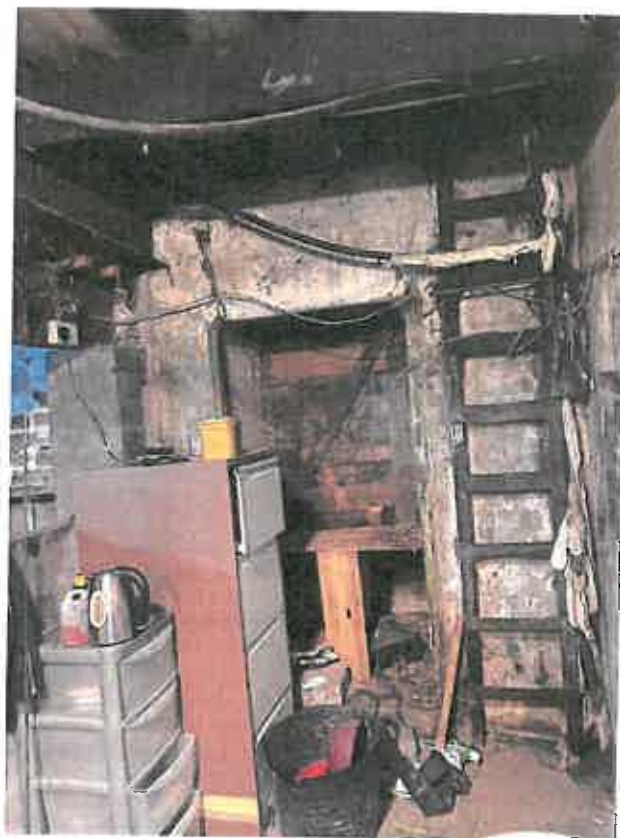
Photograph 20

The internal walls have been generally rendered within Barn 1, with the exception of the right-hand party wall which is now a series of infill sections of poor quality masonry. See photograph 20.

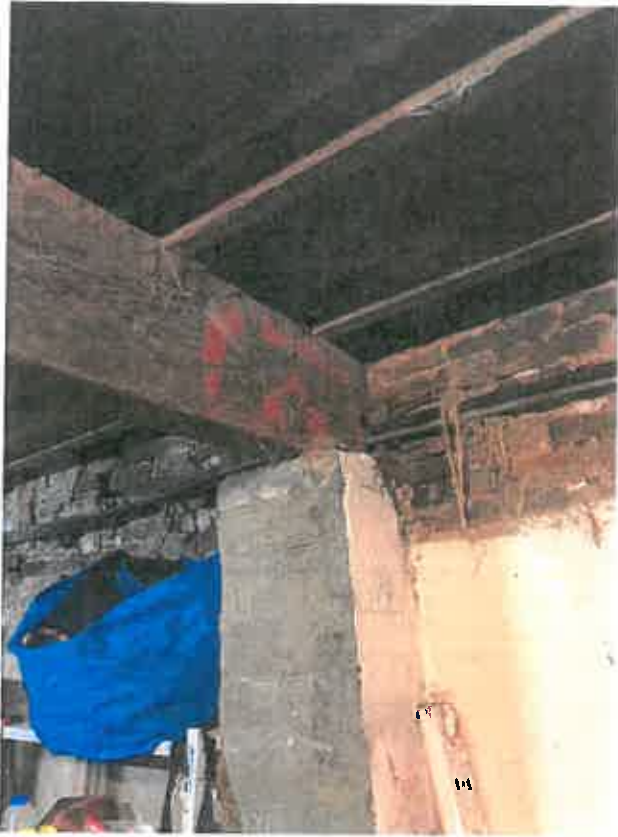
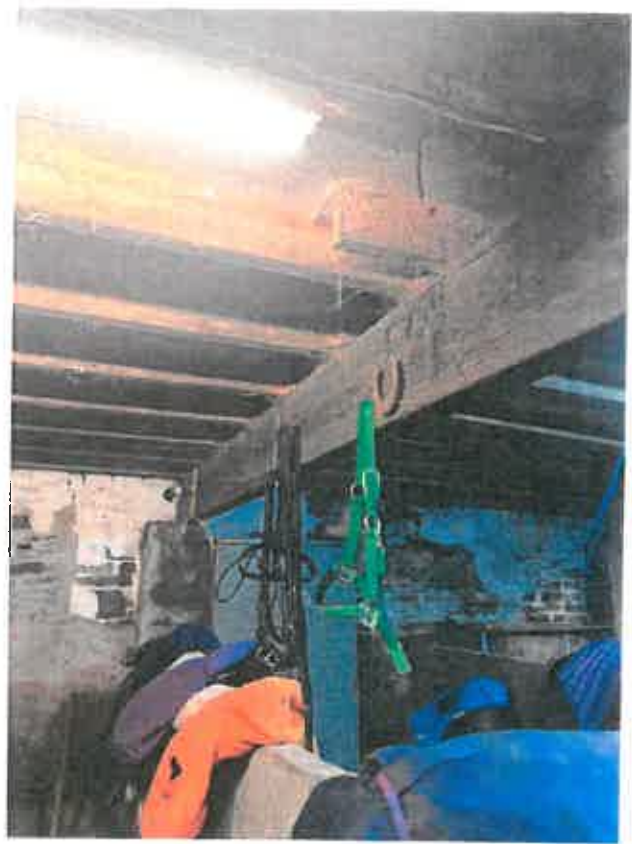
The floor structure serving the hay loft of Barn 1, is not structurally adequate for domestic use and strengthening will be required. The floor consists of a large timber beam supported on brick piers which in turn are probably built off the existing floor. See photographs 21 & 22.

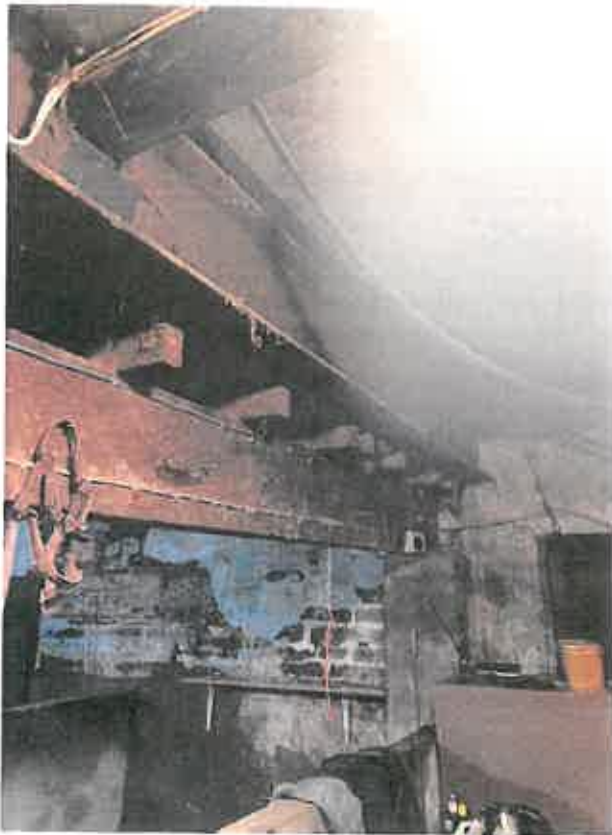
Photograph 23

There are some areas where steel beams have been introduced. See photograph 23. These may be reused if appropriate.
