**ROCHDALE BOROUGH COOUNCIL**

**MILNROW LIBRARY  
CONDITION SURVEY & REPAIRS  
TO THE ROOF AND WINDOWS  
PHOTOGRAPHS**

**January 2021**

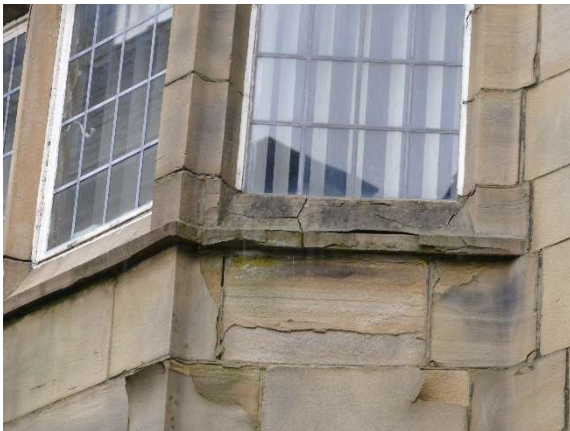
STR1- The oriel window cill is split and the surrounding masonry displaced suggesting structural movement.

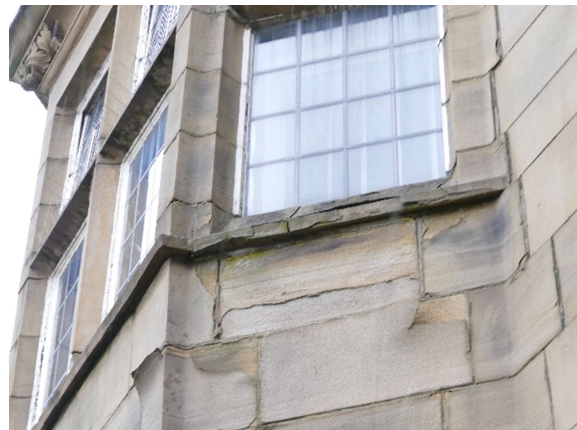
STR4- There is a visible bow in the line of the lower cill of the oriel window and a fracture line where it has started to pull away from the face of the adjacent walling.

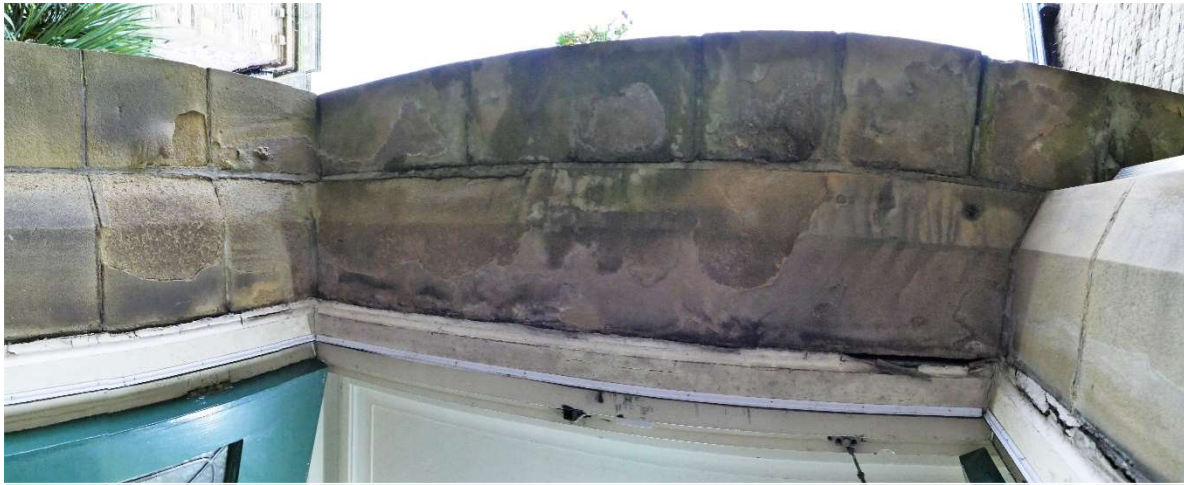
STR5- The external facing of the stone panel over the entrance bows out from the internal structure. This is exaggerated in the photograph above by the wide-angle lens but can be seen in the variation in the width of the joint. The gap has been pointed in the past but has some new hairline cracking.

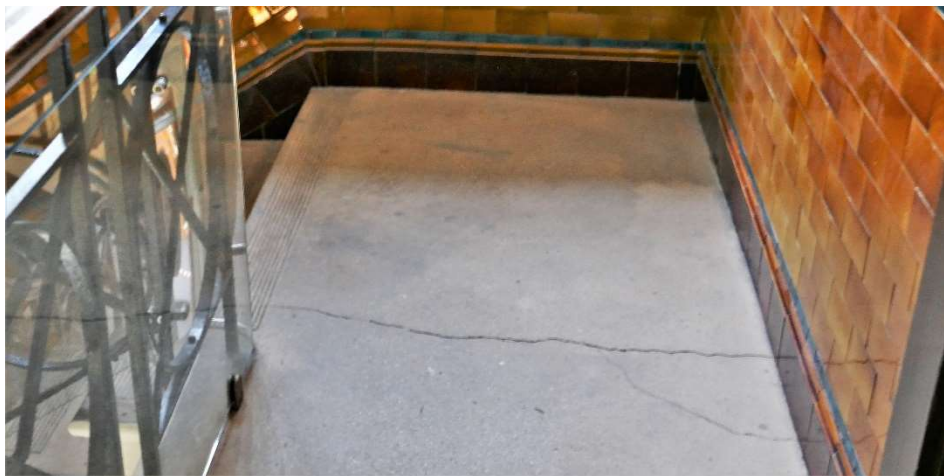
STR6- There is a crack in the landing of the stairway directly above the entrance area. It is not clear if this is new or progressive but would warrant further structural investigation and monitoring

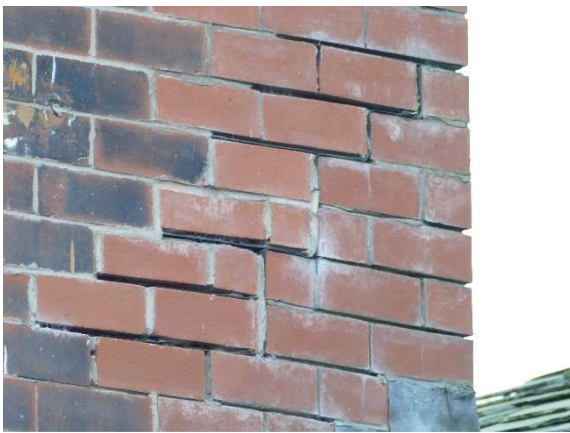
STR7- Brickwork to the west corner of the library appears to have become vertically displaced along the line of a step dpc. This corner was re-built as part of the 2002 refurbishment. The upper brickwork appears to be corbelled off the existing while the lower section has settled/rotated.

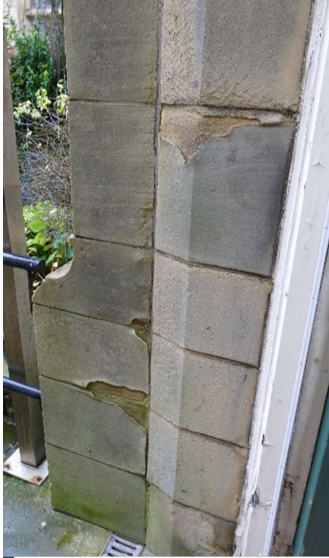
ST1&2- Spalling of face bedded stone around the entrance area. The spalling of the facing to the stone has started at the joints where hard mortar has held water and ice against the outer face of the stone. When this is addressed, a lime mortar should be used to minimise the chance of further spalling.

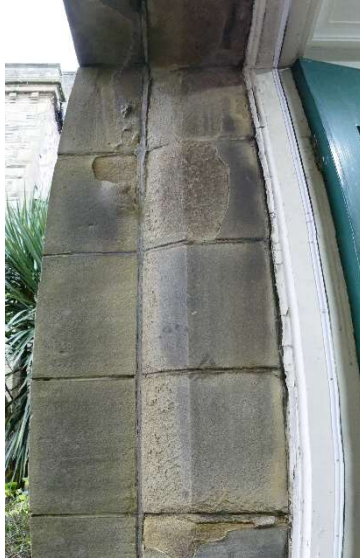
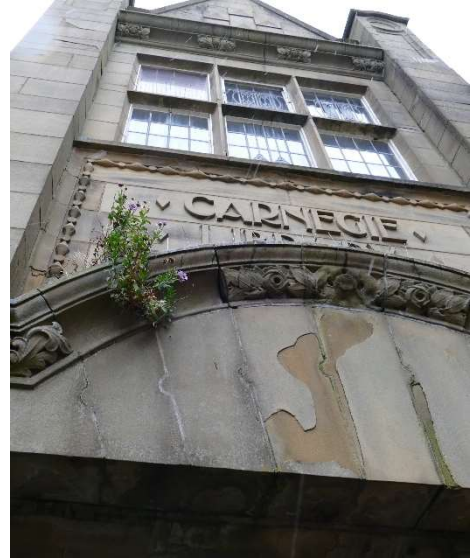
ST3- Spalling of face bedded stone over the doorway and vegetation in the open joints of the label moulding. Loose spall should be removed and the stone re-dressed and pointed in lime mortar.

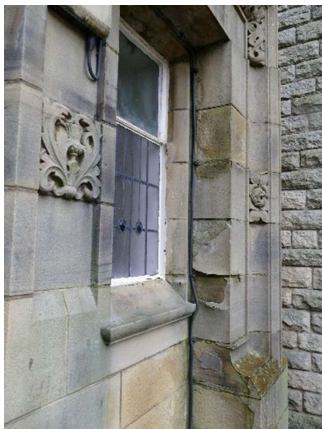
ST4- Spalling of stone around the reveal of the entrance and to the plinth

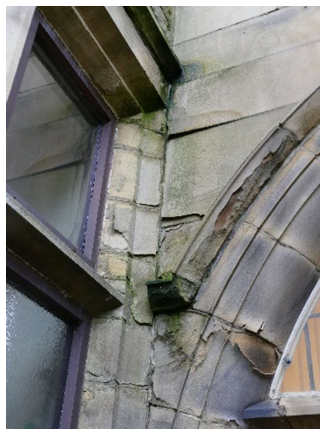
ST5- Spalling of the facing following saturation from run off from the roof abutment with the old town hall above.

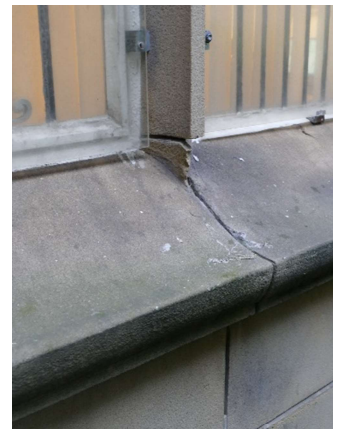
ST6- Open joint and spalled stooling to the mullion of the Diocletian window. An iron dowel may need to be removed before an indent repair is carried out.

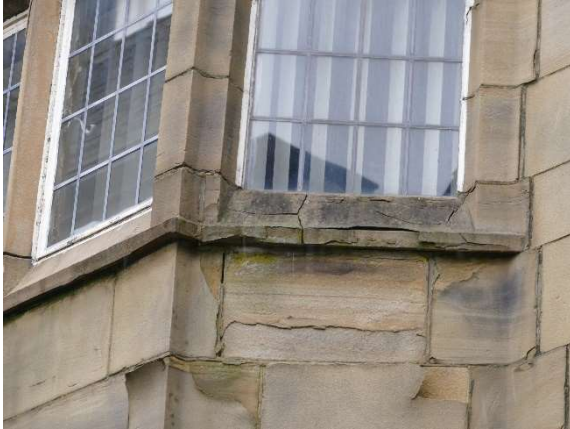
ST7- The stonework to this cill has spalled and fractured and requires an indent repair or replacement once the movement has been arrested.

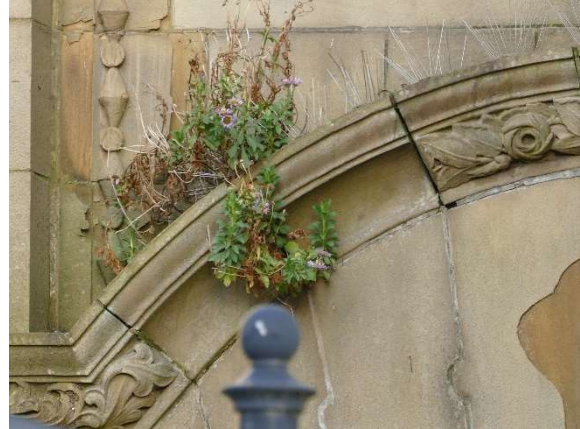
ST8- Open joints in the label mould over the entrance have led to vegetation taking hold. This should be removed and the joints fully re-pointed.

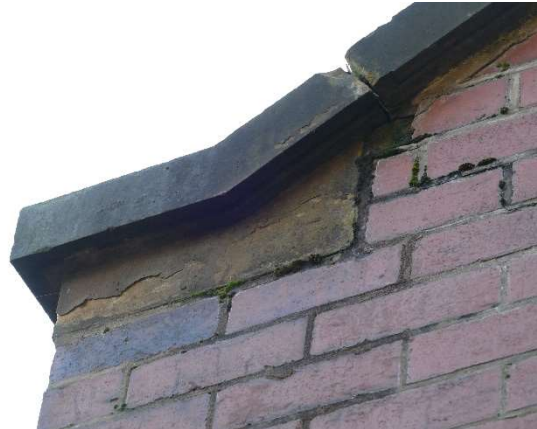
ST10- An open joint to the kneeler on the east corner of the library has allowed moisture to penetrate and mould to take hold. Moisture will penetrate to the interior of the building if this is not addressed..

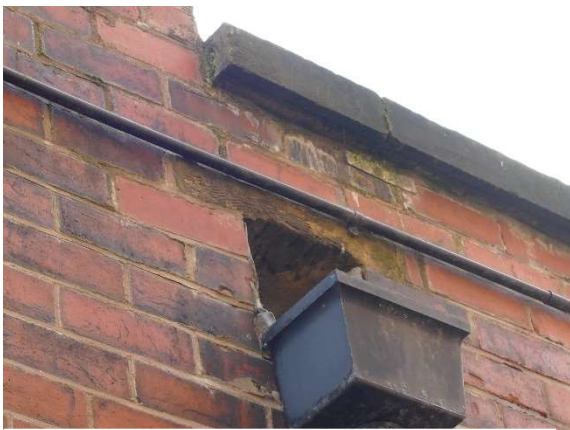
ST11- Open joints in the coping require re-pointing. The outlet chute requires re-dressing to protect the timber liner.

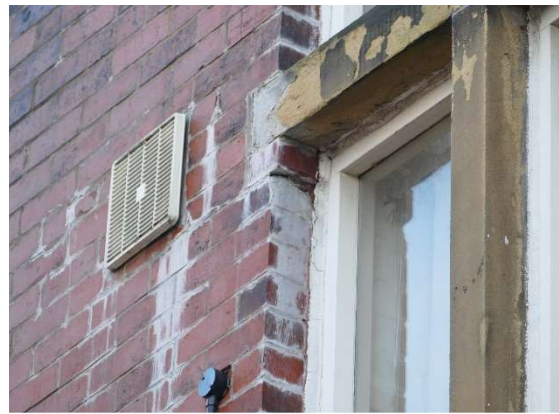
ST12- Salt staining to the end gable of the upper meeting room may be from a high salt content in mortar used for re-pointing. This will need to be removed and possible raked out and replaced to address the issue.

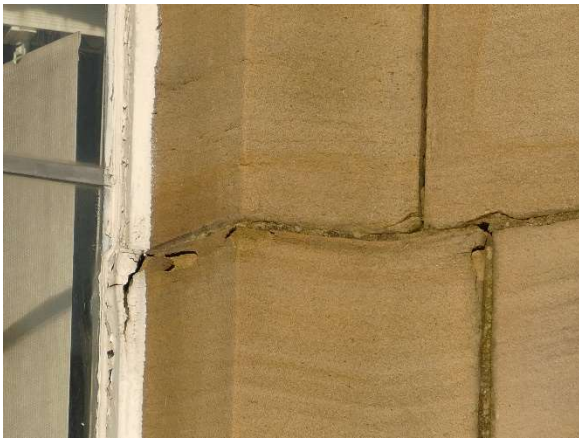
W1- The displacement of the stone to the side of the front oriel window has caused it to split and spall. This has not fractured the glass yet but is allowing moisture to penetrate around the lead glass panel.

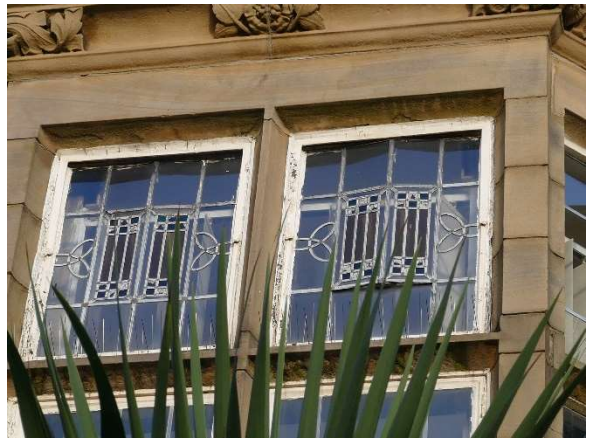
W2- Leaded glass panels to the upper front oriel window have buckled and require careful specialist conservation and re-leading. The swivel hopper vents also require repair.

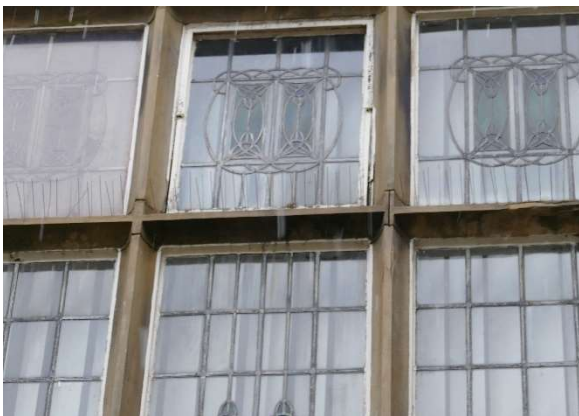
W3- Leaded lights over the main entrance retain their original glass and leading. Comes are oxidised and some welds split and conservative specialist repair is now required. The left hand panel has five broken quarries. In-situ repair might limit the loss of historic glass. The sealed protective sheet should be replaced with polycarbonate with a ventilated perimeter and non ferrous fixings.

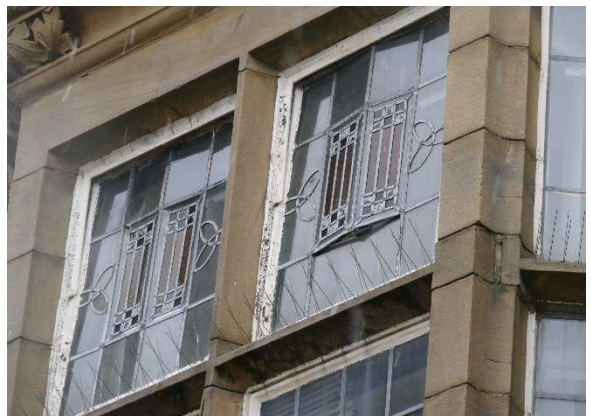
W4- The quality and character of the leaded panels is visible above but the level of buckling and the open joint are visible in this image. The central panel is vulnerable to wind damage as the lead came is completely displaced.

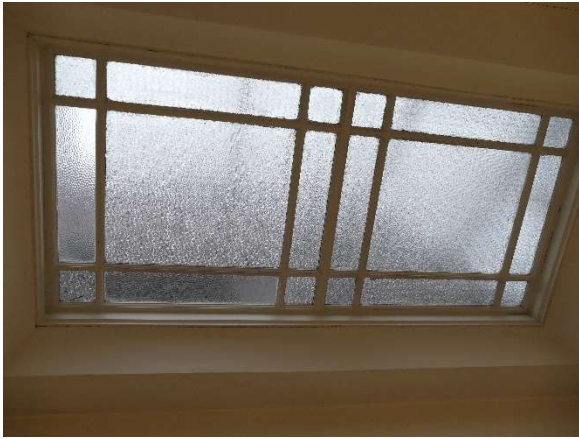
W5- laylights below the library skylight are timber framed with textured glass panels to a geometric design. These appear to be in reasonable condition but consideration could be given to installing safety film to prevent shards falling if they break.

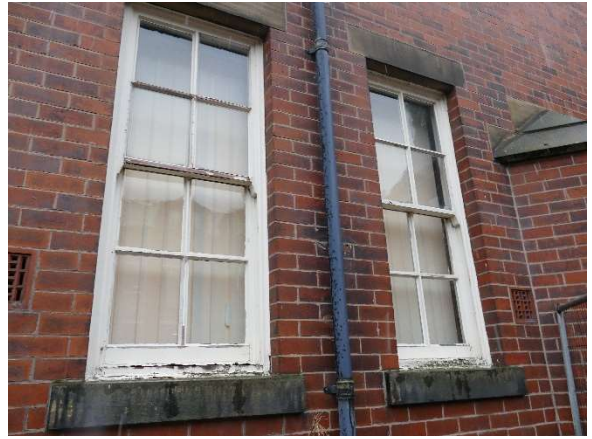
W6- The sash windows show signs of rot within the cills and bottom rails where decoration and seals have failed. Some cutting out and replacement will be required.

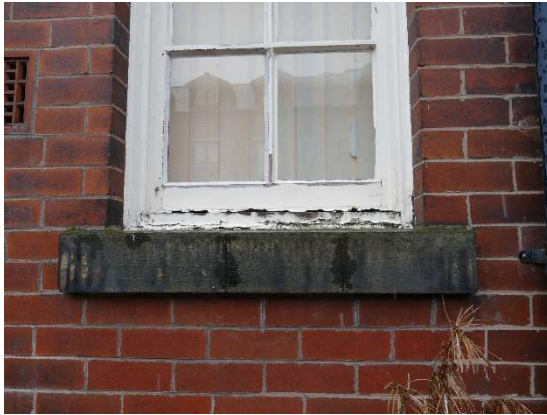
W7- The sashes are seated on stone cills and open joints around the frame have allowed water to lodge in the timber.

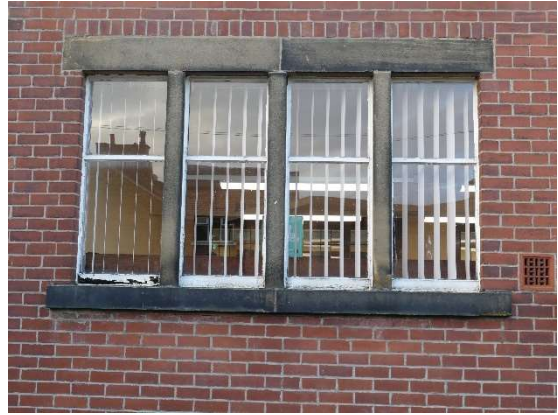
W8- The windows to the library east side are fixed and exhibit the same deterioration of the cill and some open joints to the transom.

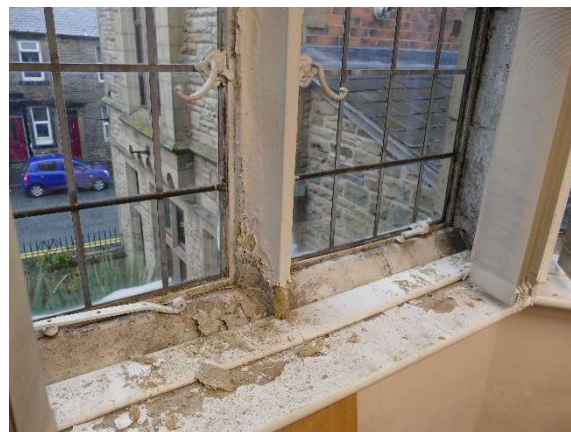
W9- Saturation of the window stonework, through open joints and exposure has led to extensive deterioration in the matrix of the stone and to spalling as seen here in the oriel window to the upper reception/meeting room. Corroding dowels are also likely to have contributed

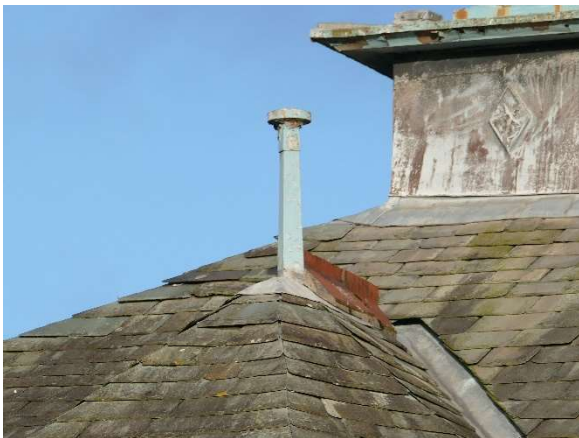
R1- Mitred hips are a little uneven following wind uplift and warrant closer inspection and possible re-laying to prevent against slips. The finial is painted to look like copper but is showing signs of rust and spalling. A central pin to the lead clad base of the turret has lost its weld.

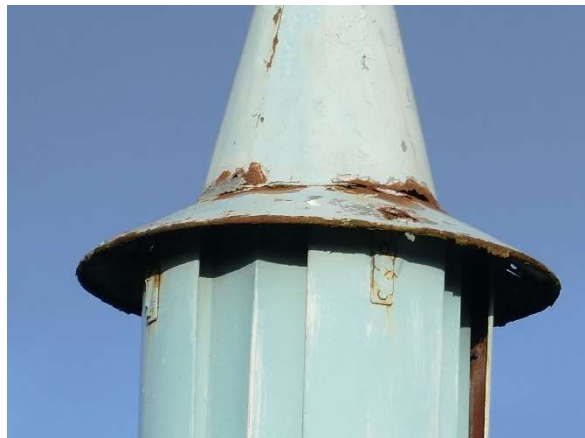
R2- The ventilation turret at the apex of the roof is mild steel, painted to look like lead. The decoration has now failed and the flue is corroded and possibly in danger of collapse in high winds. Repair and probable replacement are now necessary.

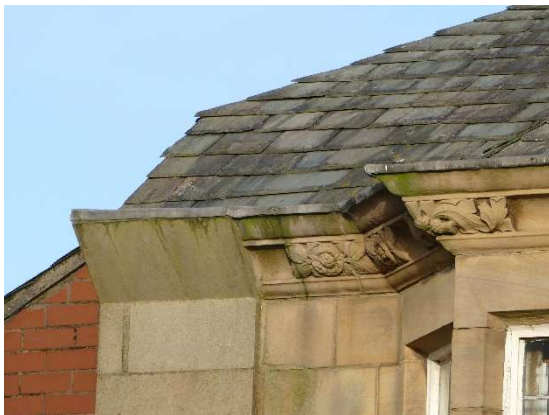
R3-A lead lined gutter to the perimeter of the oriel window bay has lifted to one end and should be inspected and repaired/re-dressed. An increased drip overhang may help to prevent green algae staining.

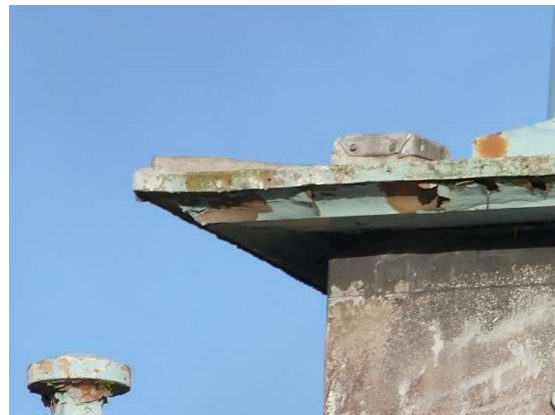
R4- The painted turret is seated on a lead flashed and clad base which is showing signs of oxidation and some of the welded corner seams appear to have parted. Closer inspection is recommended and of the underlying timbers.

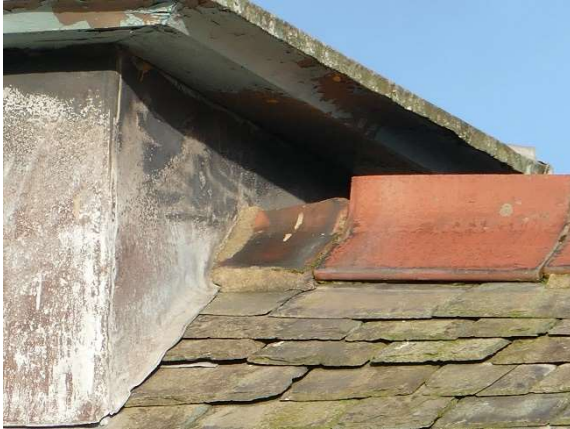
R5- The corner seam of the turret base cladding appears to have opened at the top. Red clay ridge tiles have open joints.

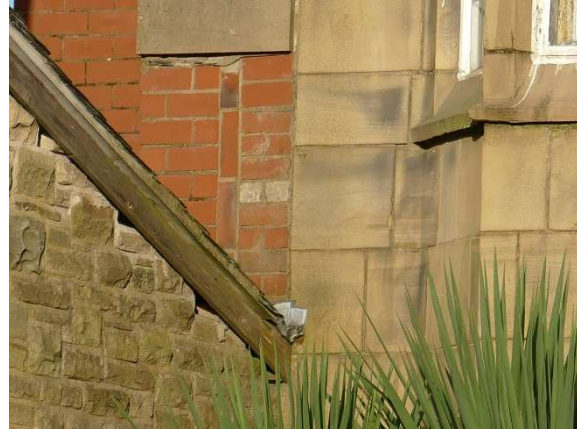
R6- The abutment of the old town hall roof to the library has a very shallow upstand and an open end. Overflow from this detail has significantly damaged the stonework below, to the front of the library.

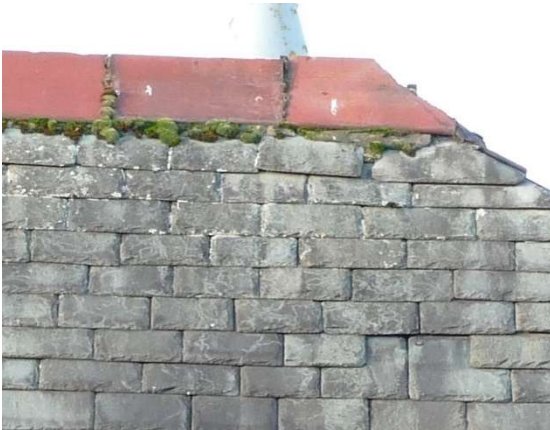
R7- The joints and bedding of the ridge tiles have weathered and they are now allow in need of re-pointing and bedding. A slate is missing below this section.

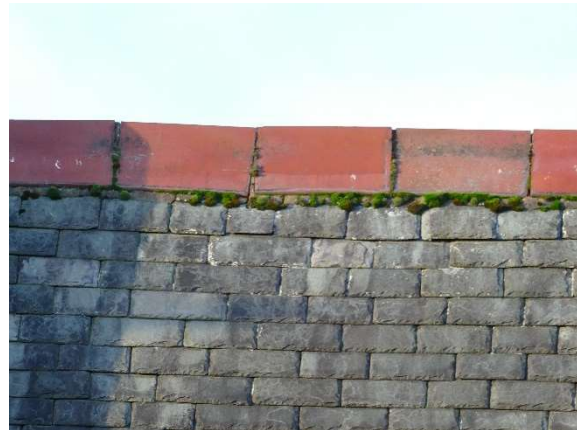
R8- The line of the ridge is uneven and some levelling is required in the bedding when it is replaced and the tiles re-pointed.

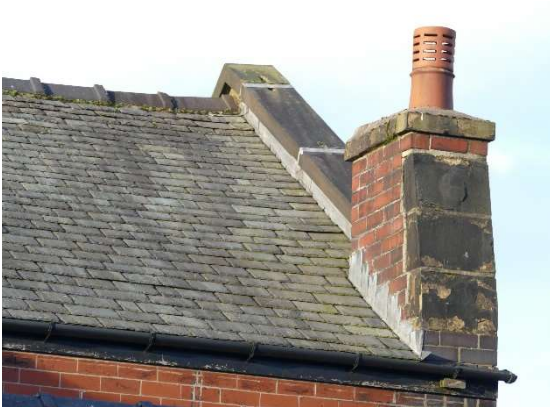
R9- A chimney to the east corner of the library exhibits a number of issues that may be contributing to moisture staining in the ceiling below

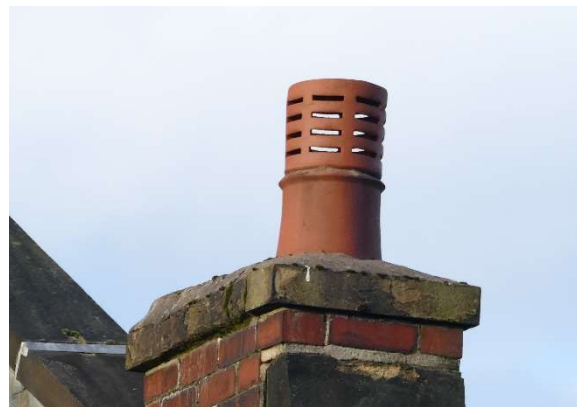
R10- The flaunching to the chimney is split and lifting and the pot appears to have a slight lean. Open joints may be allowing water ingress. There is also a significant gap between the brickwork and the stone slabs that face the east face.

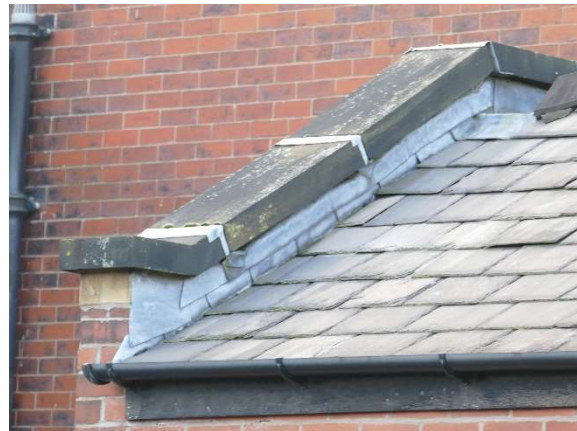
R14- The flashings to this coping, to the lower library roof, are not clipped and may be loose where they dress under the copings. Closer inspection is required.

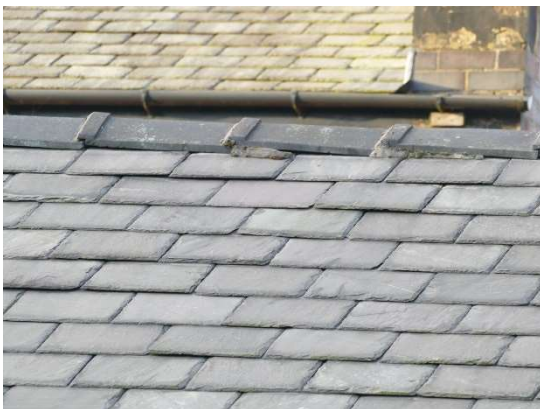
R15- The bedding to the concrete ridge tiles of the lower library roof require re-bedding and pointing.

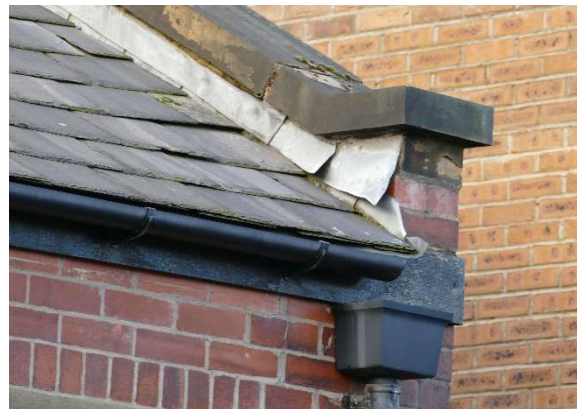
R16- Flashings to the coping of the east corner of the lower library roof have lifted and require to be re-dressed and clipped. The coping joints are open and should be re-pointed and the gutter outlet and dropper into the hopper are missing.

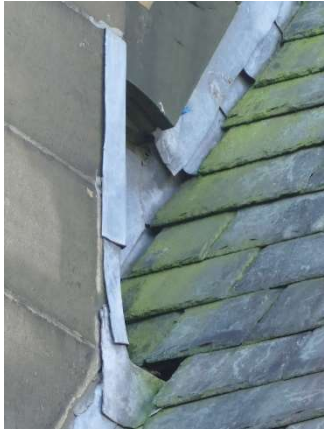
R17- Where the abutment detail of the entrance gable dresses around the rear piers the upstand and laps appear to be minimal and may be being inundated in heavy rainfall conditions.

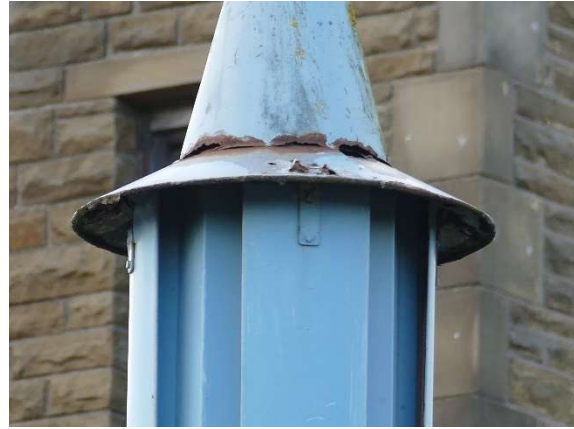
R18- When viewed from the back of the library, the ventilation turret can be seen to be heavily compromised by the corrosion. This will be allowing water into the ductwork below

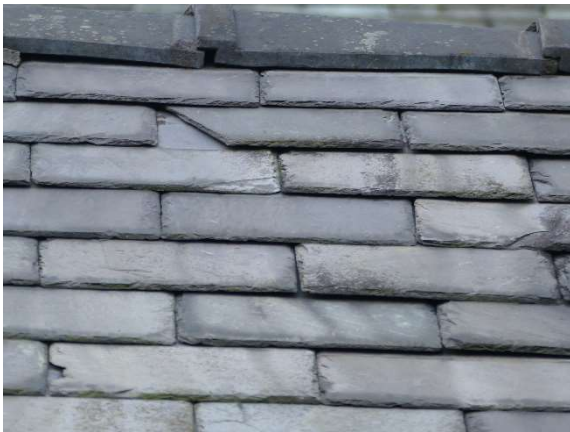
R19- The slate is showing signs of spalling and of splitting and those most compromised will need to be replaced to extend the life of the roof.

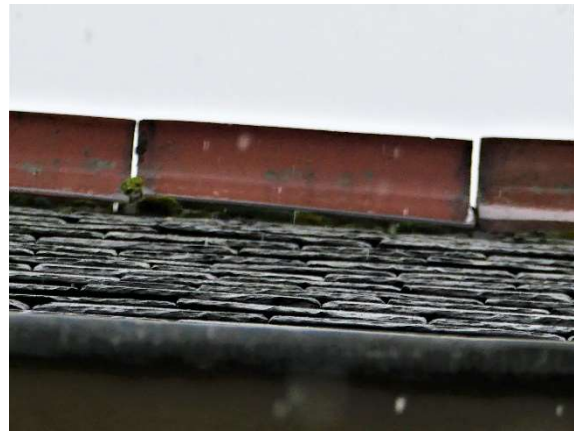
R20- There are significant gaps between the red clay ridge tiles and some could soon be displaced in windy conditions.

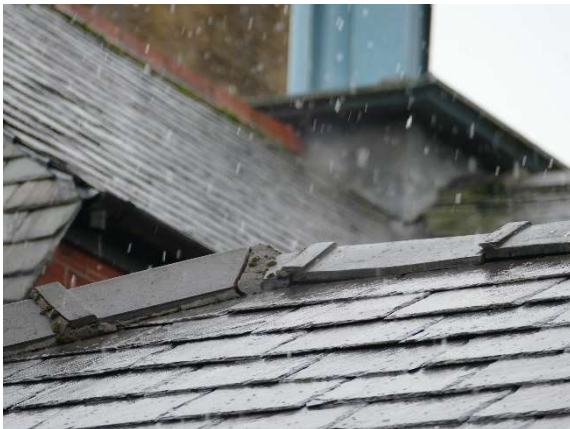
R21- Open joints are also visible in the line of the grey ridge tiles to the lower library wing.

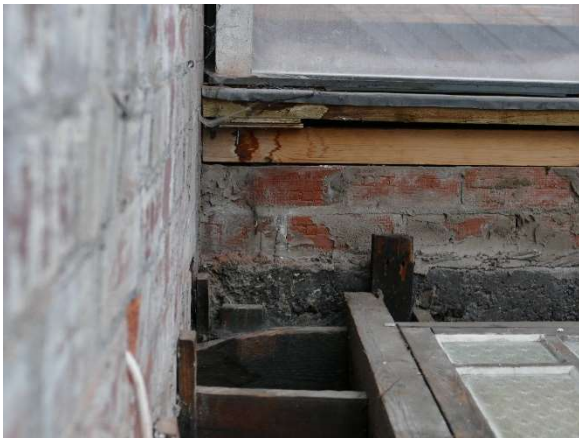
SK1- Staining is visible to the wall plate and may be run off from the end of the condensation tray above or from past water ingress at the head of the skylight.

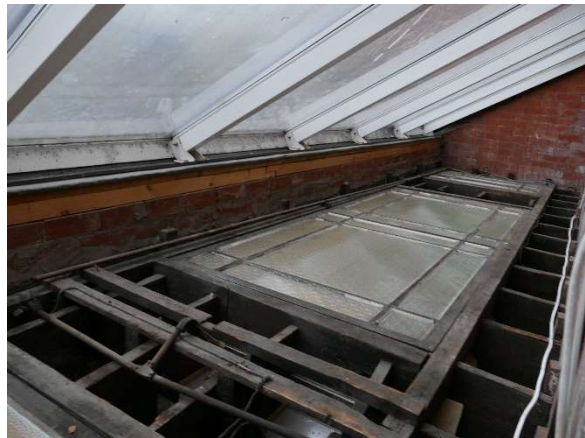
SK2- The dried timber frame spans between the beamed structure of the library and supports the timber laylights. Putty to the lay lights has cracked and spalled and consideration should be given to removing the putty and installing safety film before re-puttying the textured glass panels.

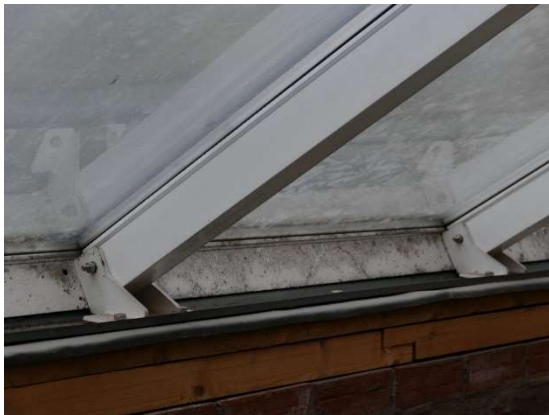
SK3. The frame and glazing of the skylight and the laylights below all require to be cleaned. It is not clear if the drip tray around the perimeter has outlets or is sealed..

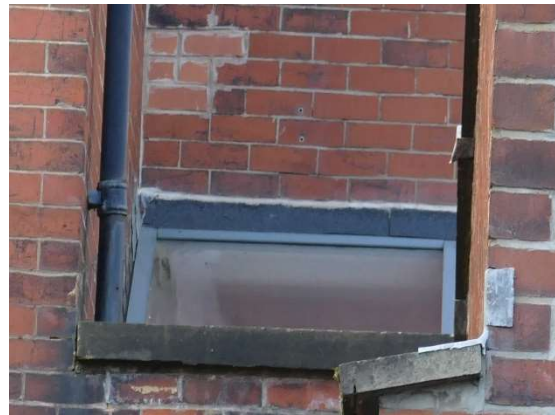
SK4- Where visible from ground level, the top flashing of the skylight can be seen to be a felt or artificial flashing. Cover flashings to the end profile can also be seen to be missing. This and condensation are likely to be possible sources of water ingress.

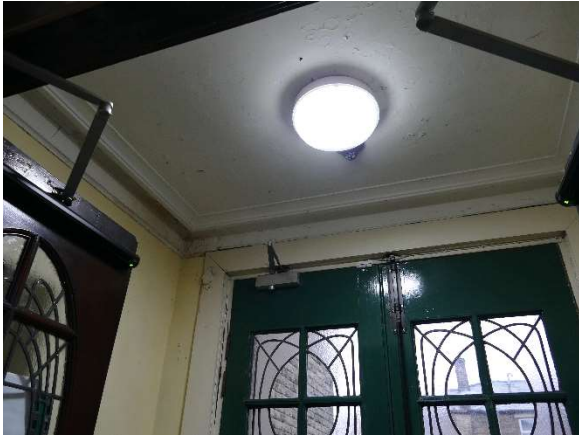
D1- Spalling paint to the ceiling of the porch is likely to be from successive overpainting curling the paint below or from incompatible paint finishes. Re-decoration is required.

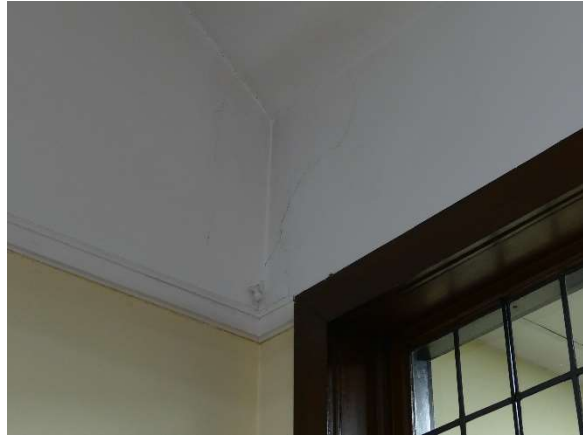
D2- Cracking to the west corner of the lower library maybe from movement of the roof structure above or from moisture behind the underlying plaster. There is a hipped roof and parapet gutter above.

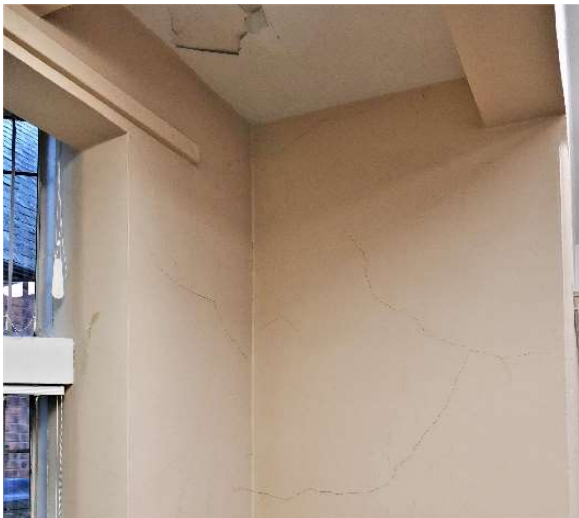
D3. Spalling paint to the ceiling of the oriel window bay may be from incompatible paint finishes or successive overpainting. Access into the void above would identify if there is a water ingress issue. Cracking on the side wall could be drying out cracking of the plaster or may relate to movement visible on the external wall.

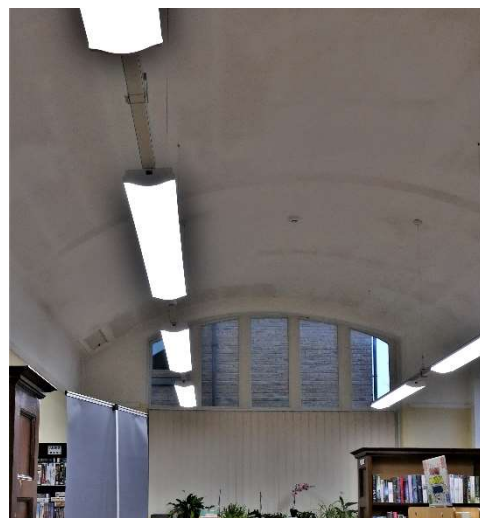
D4- There is widespread condensation staining to the barrel vault ceiling of the lower library. Improved insulation, along with an assessment of condensation risk, would help to reduce this in future but re-decoration is now required.

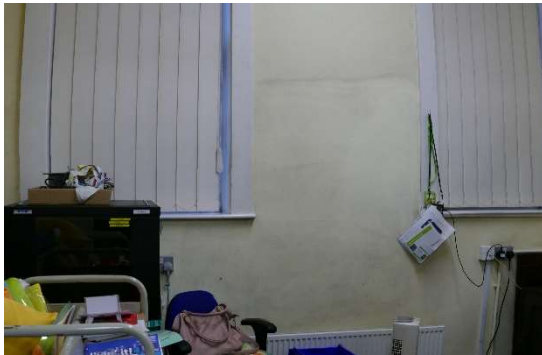
D5- There is an area of the rear wall of the office that appears to have been re-plastered in the past and that has a surface staining, possibly from dampness. This may be condensation staining from the radiator below.

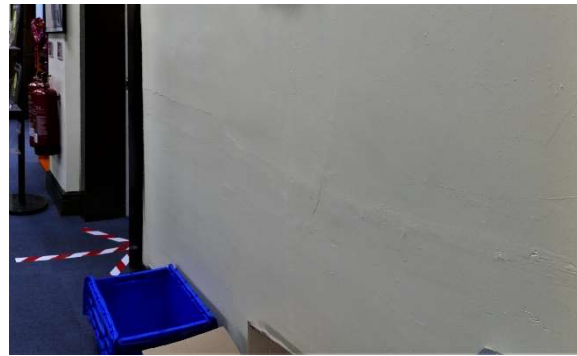
D6- The wall between the reception and the staff room is blistered and there is a line where something has been removed. Blistering may be from dampness penetrating from the chimney flue behind.

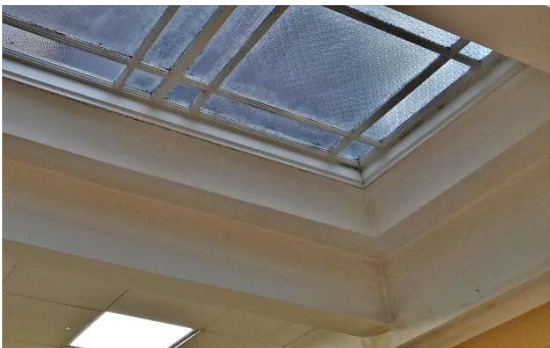
D7- Staining around the coffered reveal of the lay lights is focussed against the back wall of the meeting room above and is likely to be from water ingress where flashings have been removed. Further investigation is required.

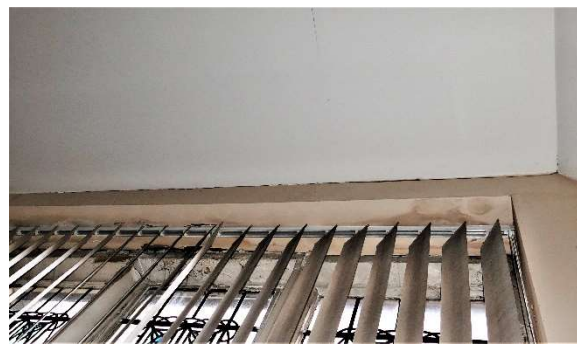
D8- Water ingress above the stair window, over the entrance, may be from the abutment flashing to the coping or through the facing stonework. The roof void above to be inspected for any signs of rot and flashings and stonework checked.

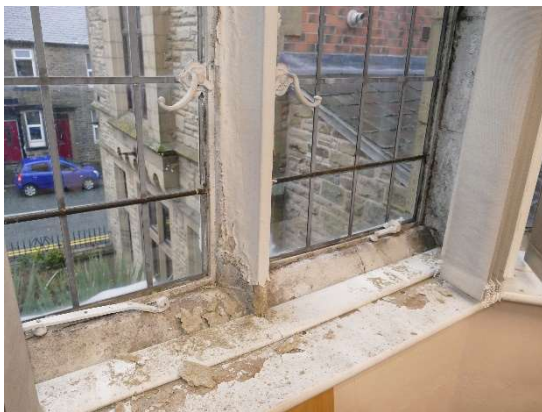
D9- Stonework and paint to the oriel window have spalled heavily. Gloss oil paint will have trapped moisture in the stone and the matrix has weakened and the paint blistered. Stonework should be uncoated or coated in a vapour open paint.

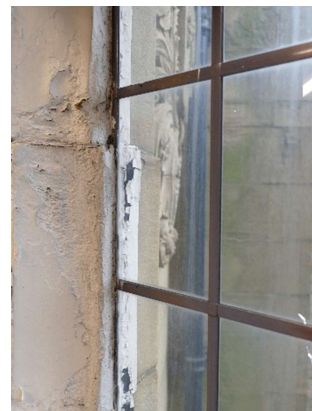
D10- Displaced external masonry to the side of the Oriel window, has created a route for water to penetrate to the interior of the reveal and the paint and plaster have blistered. External repair is required before re-plastering and decoration.

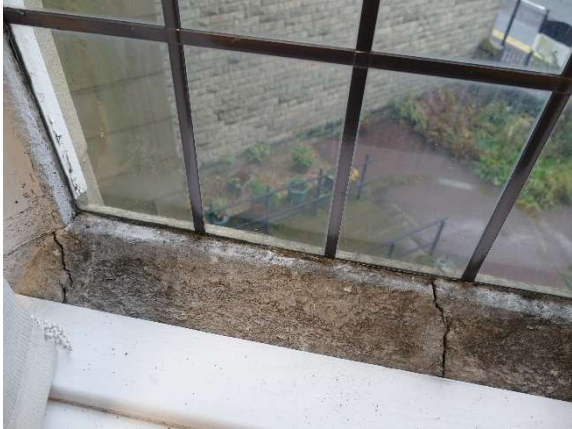
D11- The movement within the oriel window is exhibited in fractures in the stone cill and to the external head.

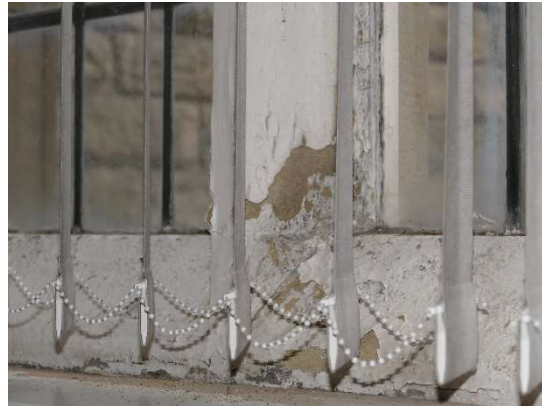
D12- Glass paint forms a barrier to the evaporation of moisture in the stonework and should be removed completely.

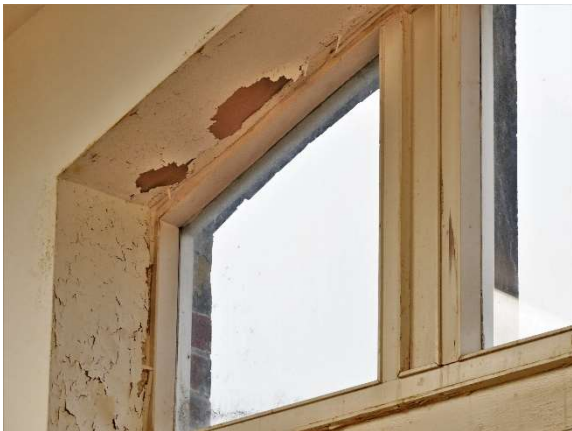
D13 The surrounds to the rear arch headed windows has been re-plastered in gypsum plaster and painted with vinyl paint. Moisture in the fabric has been trapped leading to spalling.

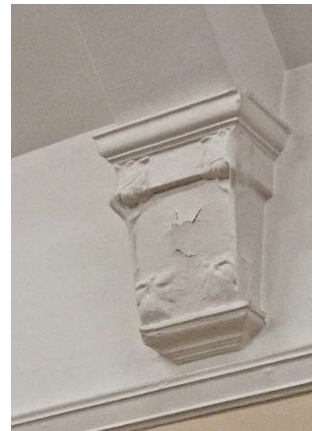
D14- Successive overcoating of paint has concealed the detail of the corbels in the meeting room and have led to the paint curling and spalling. Careful removal will uncover the original detailing.

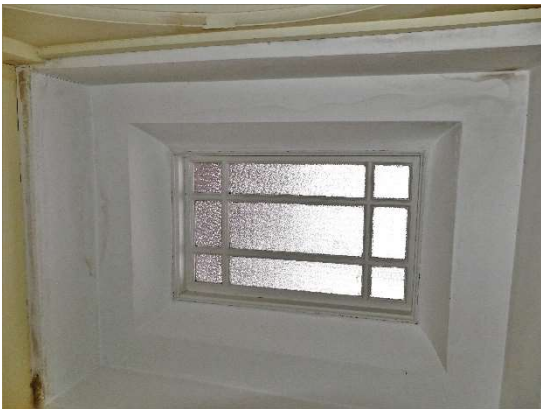
D15- The sides of the laylight that abut the continuing walls above show signs of staining where water has penetrated the flashings or over run the drip tray above. Condensation may also be forming on the underside of the uninsulated flashings.

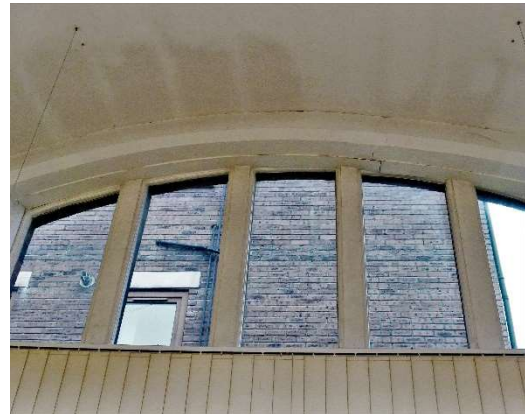
D16- Condensation staining to the ribbed ceiling structure of the library. A boarded lining to the window reveal and impervious finishes has led to spalling..

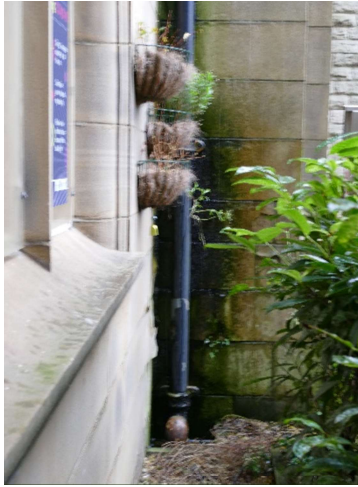
RWP1a&b- The cast iron pipe, to the side of the main entrance, is heavily corroded and leaks, saturating the adjacent wall. Water appears to back up within the pipe and the surface is encrusted with algae and rust.

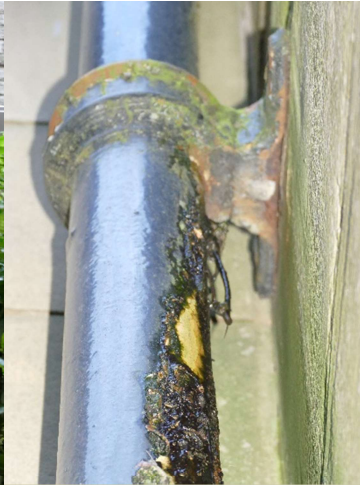
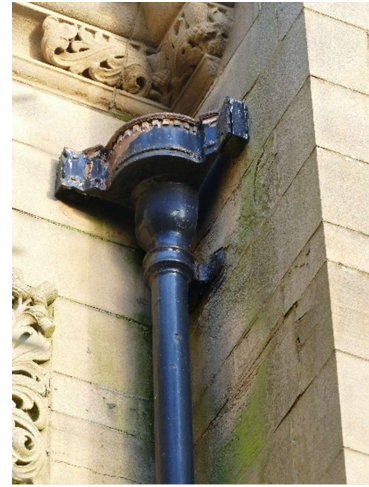
RWP2- The cast iron hopper to the head is corroded and requires de-rusting and re-decoration..

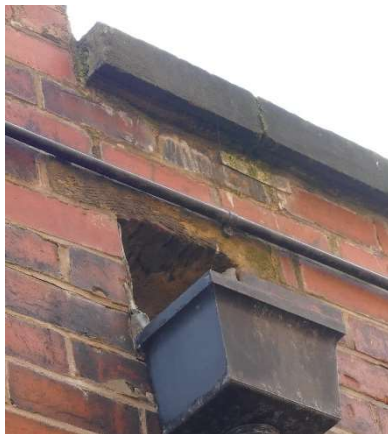
RWP4- Staining from open coping joints and exposed timber liner to the spitter. Pointing of the coping and re-dressing of the lead spitter tray are required.

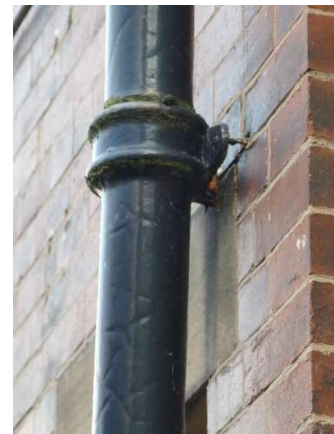
RWP5- Fixings to the cast iron foul pipe outside the children's library, are corroded and will eventually fail if not replaced.
