# TECHNICAL AUDIT SITE INSPECTION REPORT

| Planning ref Number | 23/01280/FUL | Inspections Required: | 6 Monthly |
| Address: | Longley Hey Farm<br>Halifax Rd<br>Littleborough<br>OL15 OLB | Inspection No: | 1 |
| Description: | Path Dilapidation- Ref to Condition 4 | Date: | 11/06/24 |

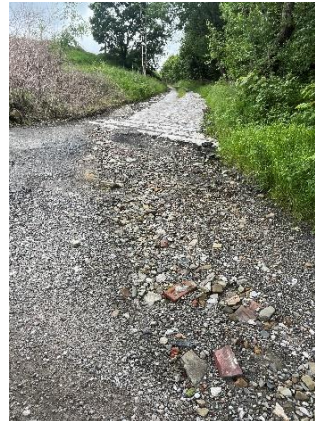
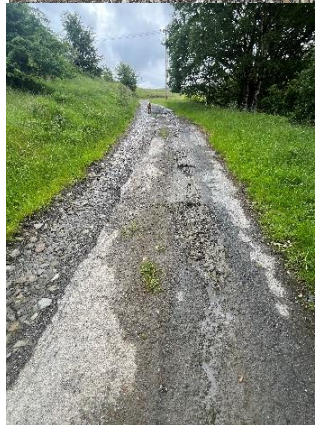
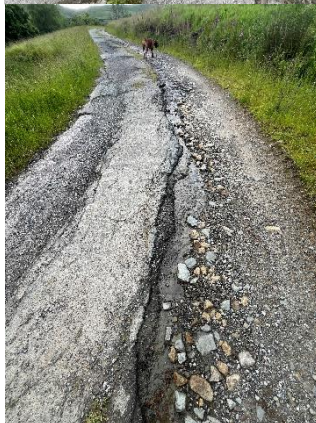
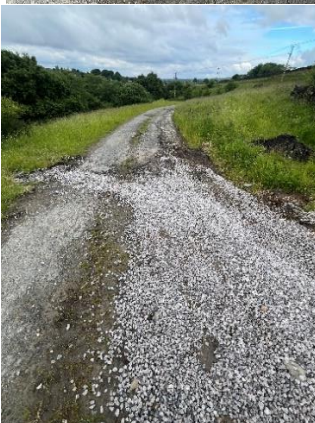
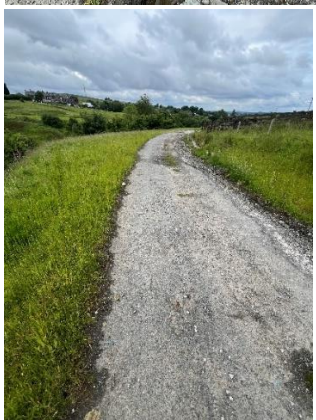
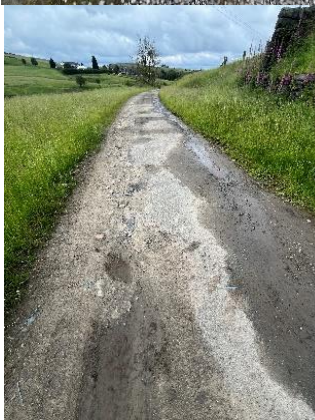
.01 Path make up and current state.

| Summary of Visit: | Farm track is used as vehicle access alongside a footpath as a right of way through part. The path is made up of hardcore in areas and existing tarmac in areas. No obstructions are apparent. | | |
