18 September 2023

**Existing Barn  
at Red Wells Farm, Rochdale, OL12 7TL**

**Structural Appraisal**

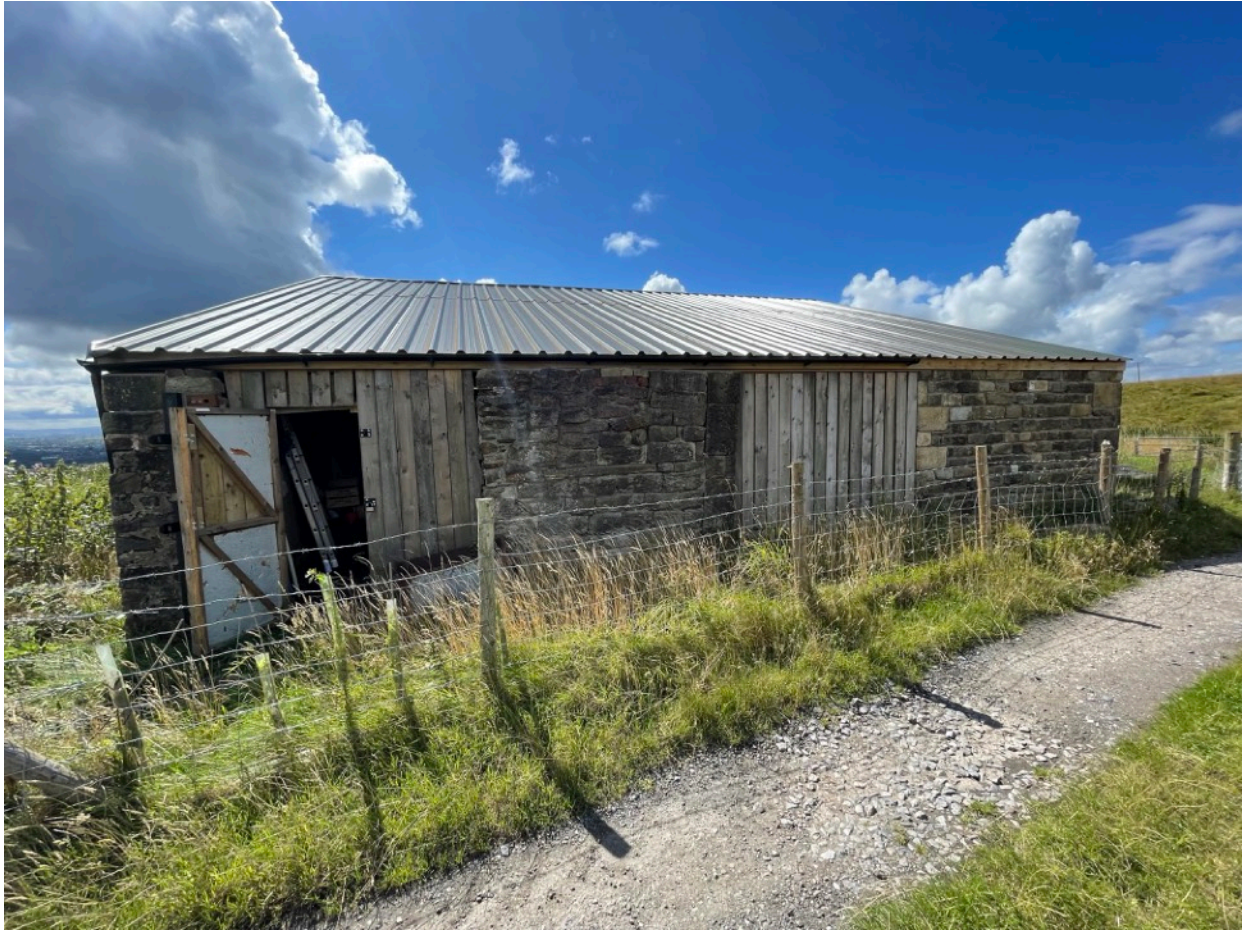
Exterior of the barn- North elevation facing Fordoe Lane
