## Week 2 – Stage Floor lifted to reveal oriel window support frame

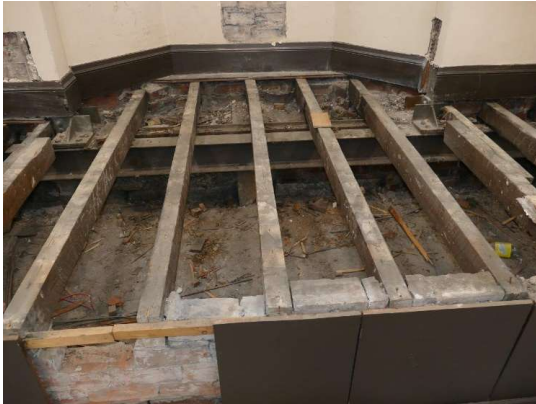
Floor boards removed and steel frame base uncovered and surveyed

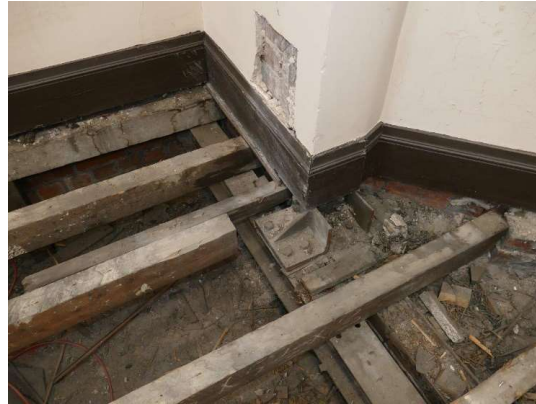
Internal beams supporting the previous remedial support frame and the original construction

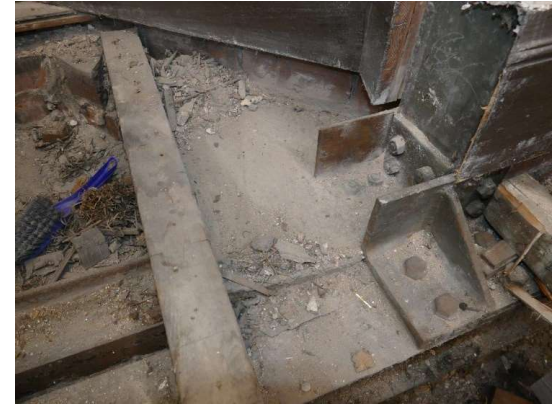
Steelwork added around 2000 to give additional support to the window

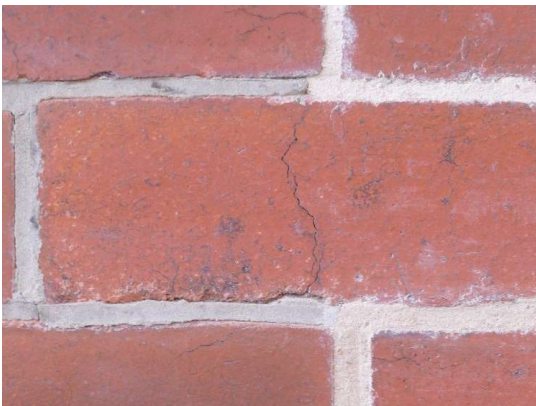
Mortar sample for the brickwork.

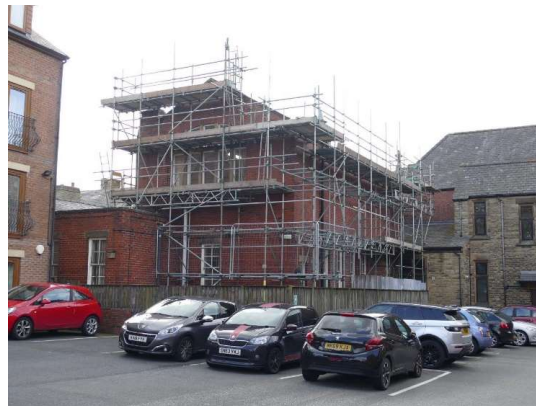
Scaffolding to the rear and side of the building

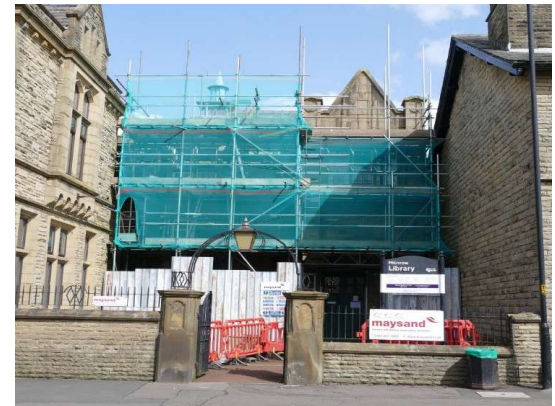
Scaffolding to the front of the building.
