## Rochdale Corner Plot

14834-BKP-V1-XX-RP-S-010

Existing Bulding Condition Report

29-31 Maclure Road, Rochdale

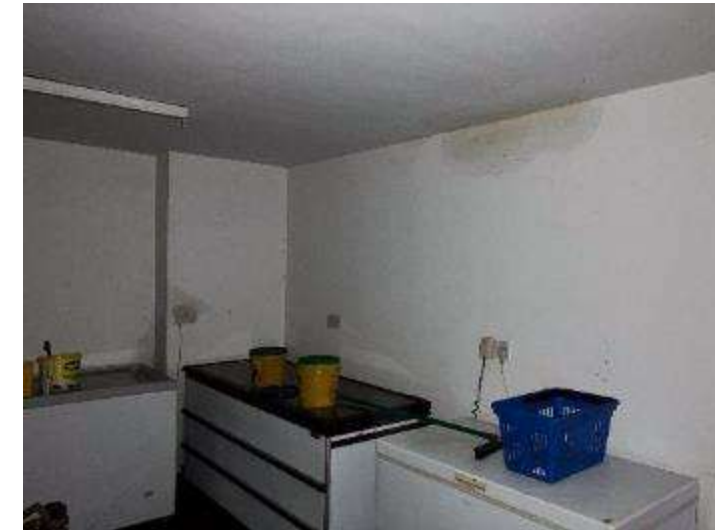
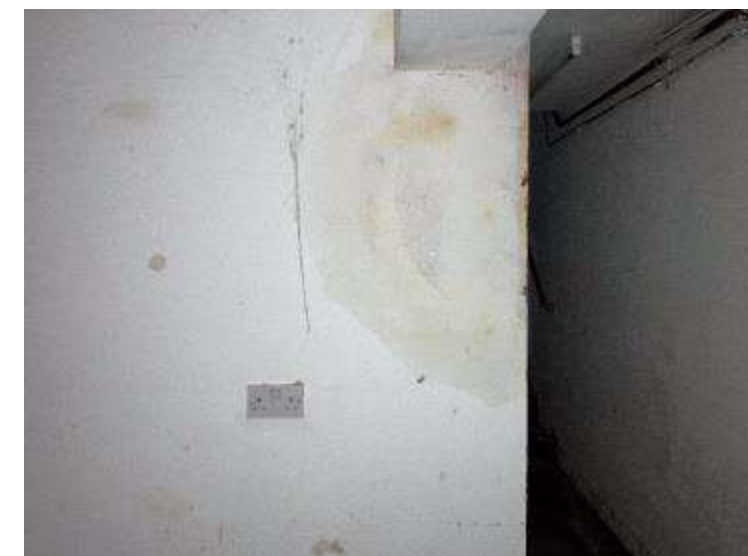
- Possible localised minor damp / water ingress witnessed to north-east wall of smaller basement room (see below Figure 6); localise removal of plaster finish and inspection is recommended.
- Possible localised minor damp / water ingress witnessed to north-east wall of smaller basement room under assumed steel beam bearing (see below Figure 7); localise removal of plaster finish and inspection is recommended.

*Figure 6 – Possible Damp Staining to Basement Wall*

*Figure 7 – Possible Damp Staining to Basement Wall*

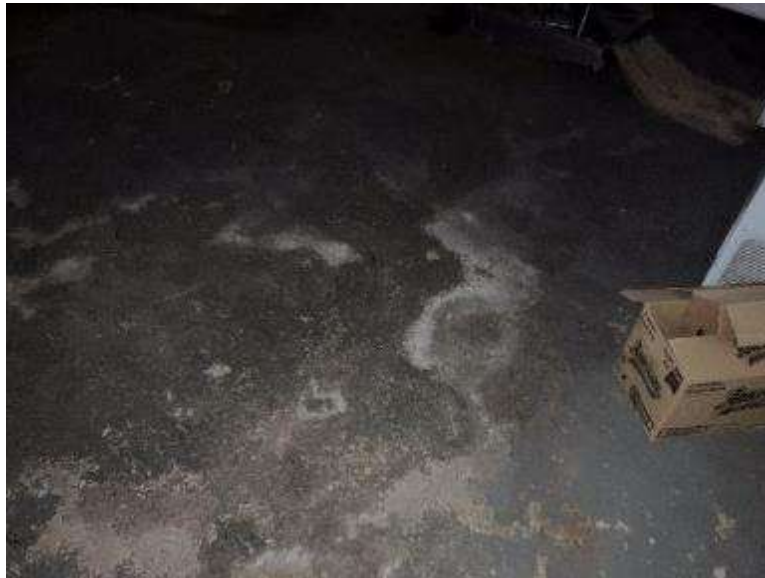
- Possible evidence of damp was noted to the ground floor slab to basement room to the north of the building (see below Figure 8); this was dry at the time of inspection and may represent localised staining, as opposed to a water ingress issue. It is recommended that this area is monitored during any further inspections / works on site and any water ingress reported to the engineer.

*Figure 8 – Possible Damp Staining to Basement Floor*

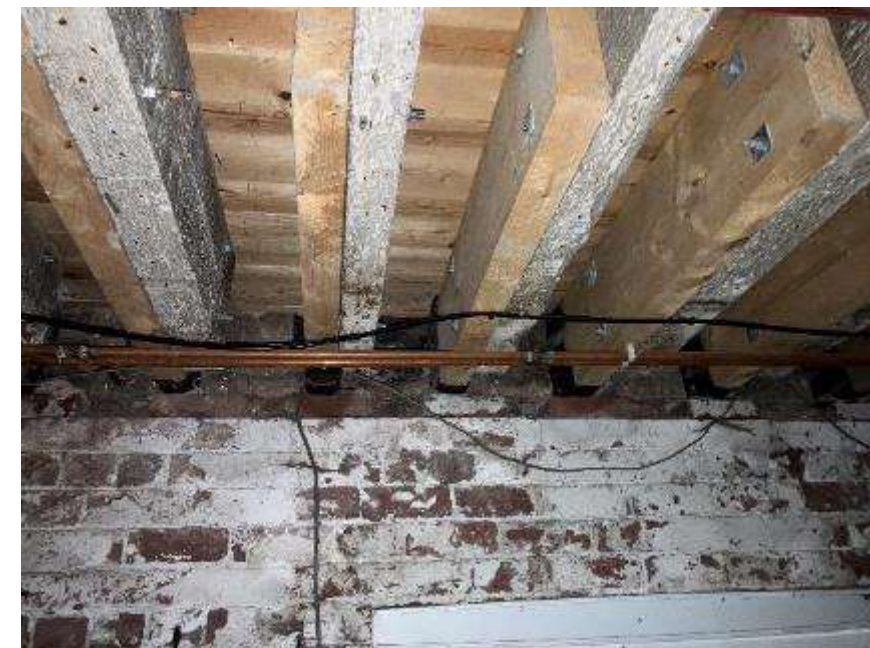
- Historic timber joist end repairs were witnessed to the south gable wall; consisting of joist ends cut back and spliced to new sections following assumed water ingress / timber rot (refer to below Figure 10). Repairs appear to be of reasonable quality, however it is unclear if any rot treatment has been applied locally to masonry wall. No signs of further water ingress were witnessed, however it is unclear if the root cause of ingress has been addressed (likely via interface between gable wall and adjacent single storey building roof). It is suggest that area wall where joist repairs have been carried out is locally cleared of any loose debris, treated with suitable rot treatment and joist ends are mortared into the wall. Root cause of water ingress will be addressed following demolition of existing single storey and construction of new build elements.

*Figure 10 – Historic Timber Repairs to South Gable Wall*

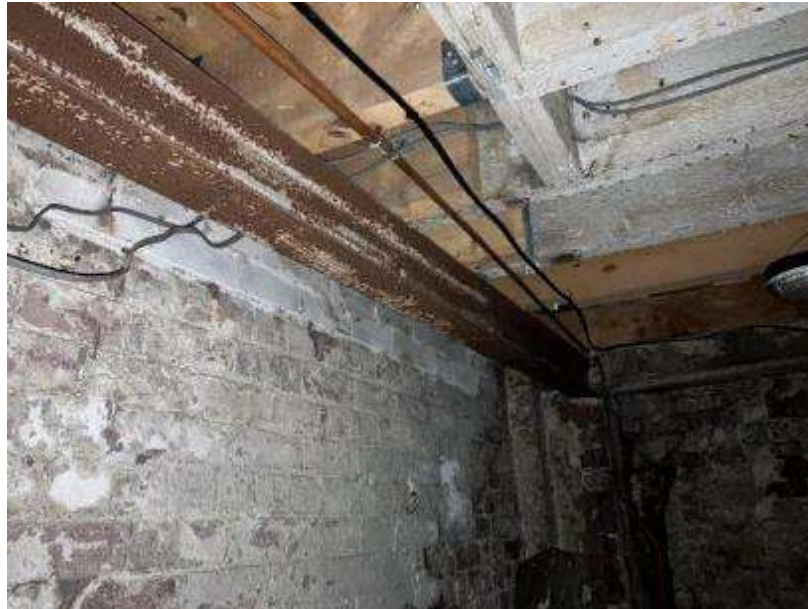
- Existing steel support beam witnessed to south gable wall supporting repaired timber joist ends noted above (see below Figure 11). Beam is showing some signs of surface rusting, but appears to be in good condition and is showing no signs of distress / damage. It is recommended that this beam is cleaned of surface rusting and end bearings onto masonry walls reviewed

*Figure 11 – Steel Beam Supporting Joist Ends*

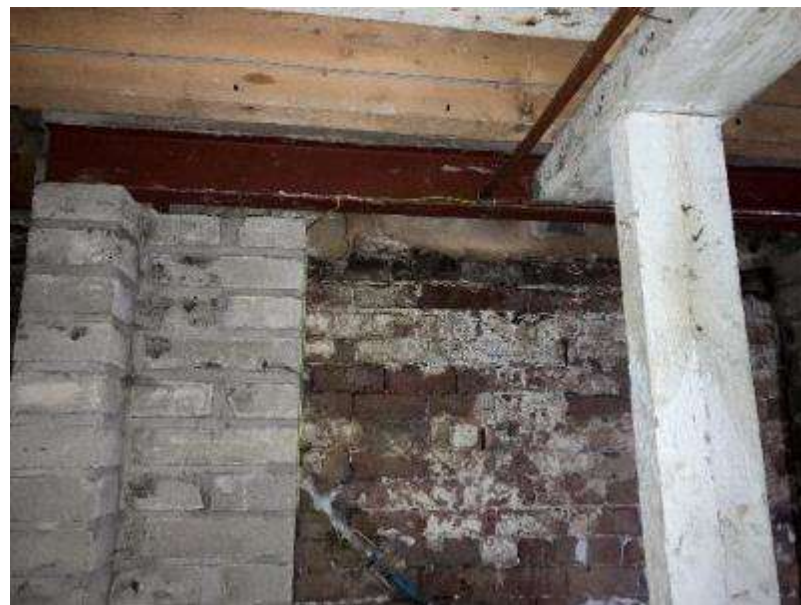
- Relatively new steelwork support members and masonry piers witnessed to front elevation of larger basement room, directly under the main entrance doorways above (refer to Figure 12 below). Steelwork and supporting masonry appeared to be in good condition.

*Figure 12 – Steel Support Under Main Entrance Above*

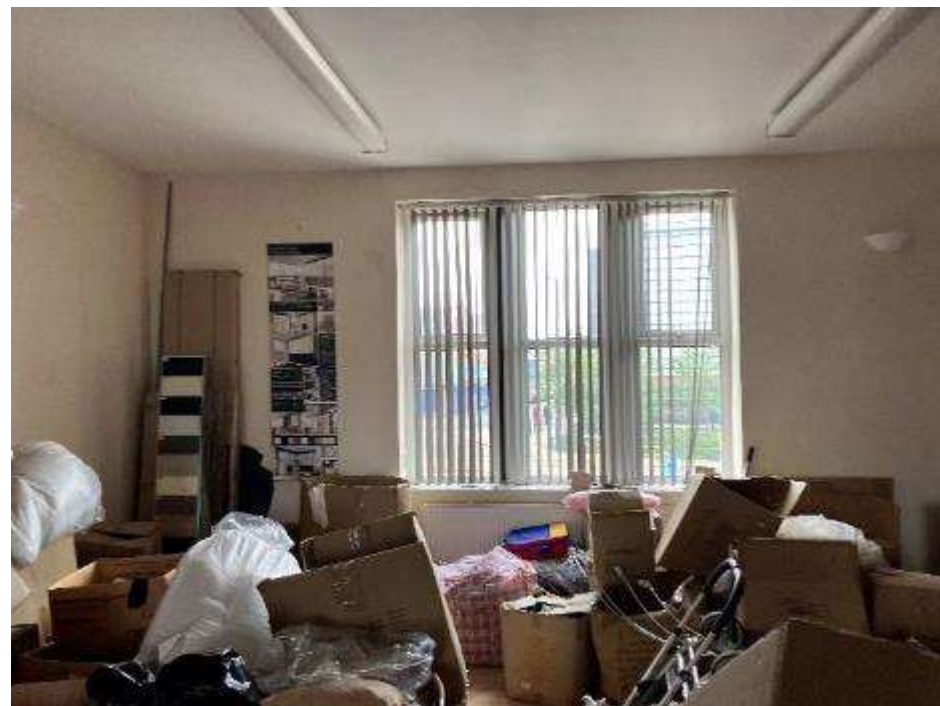
*Figure 17 – View on Front Window with Minor Cracking / Staining to Top Left Corner*

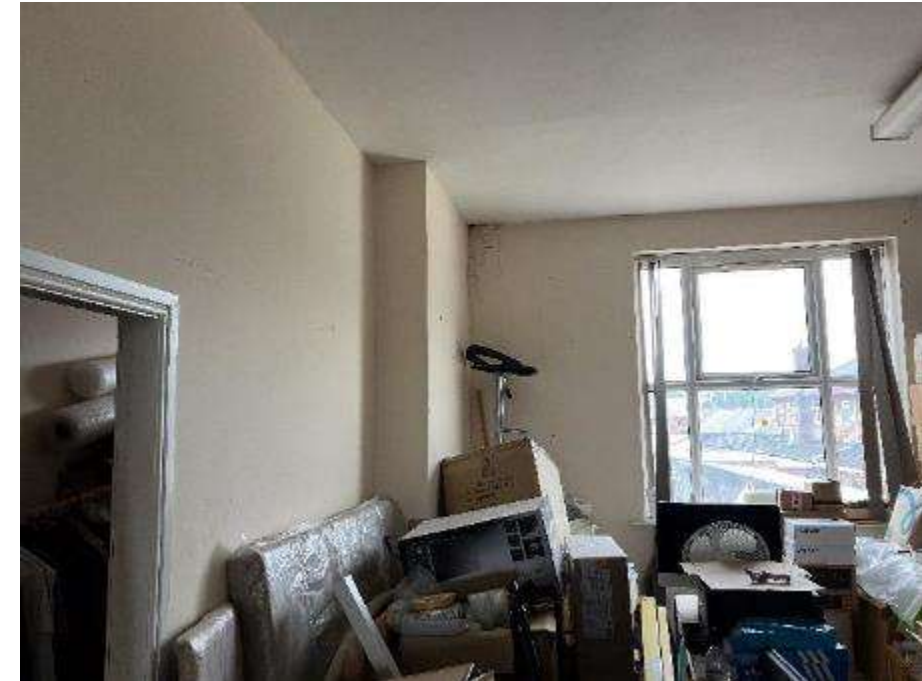
- Possible water ingress damage witnessed to corner of rear wall (refer to Figure 18 below); further investigation and possible repairs to be carried out to prevent further water ingress

*Figure 18 – View on Rear Wall with Potential Water Damage to Top Left Corner*

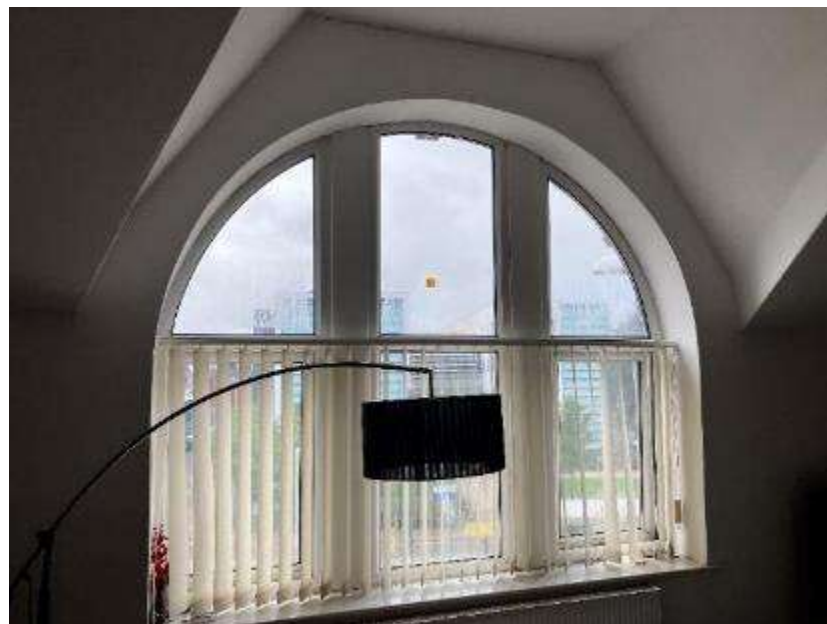
- Minor cracking and staining witnessed to top of front dormer window within main living space (refer to Figure 20 below); given relatively even staining pattern, it is anticipated that this is likely a result of internal condensation from kitchen area, as opposed to water ingress via the existing roof coverings. External inspection of roof coverings at high level is recommended however.

*Figure 20 – Minor Cracking Above Front Dormer Between Wall and Ceiling*

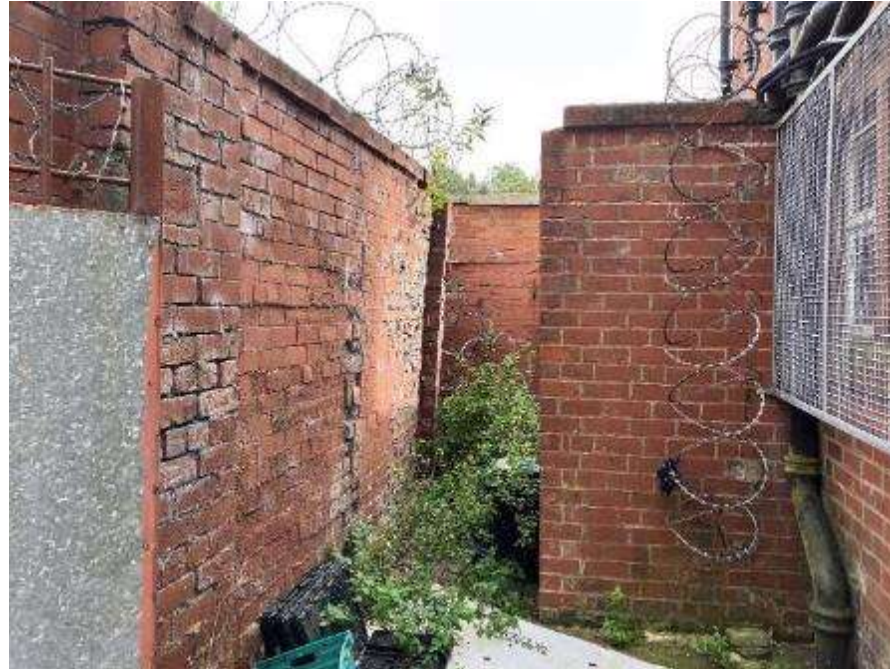
Full access to the rear courtyard (including external access to basement) was not available during this inspection due to presence of significantly leaning / potentially dangerous existing yard wall. This was witnessed as leaning significantly into the yard area and removal of this section of wall should be considered prior to any further inspection works.

*Figure 22 – View on Leaning Section of Yard Wall*
