# TREE SURVEY & REPORT

For  
Mr F Garvey  
71 Clay Lane  
OL11 5RH

## TREE SURVEY / SCHEDULE AND REPORT

TPO name: Clay Lane adjacent to 75

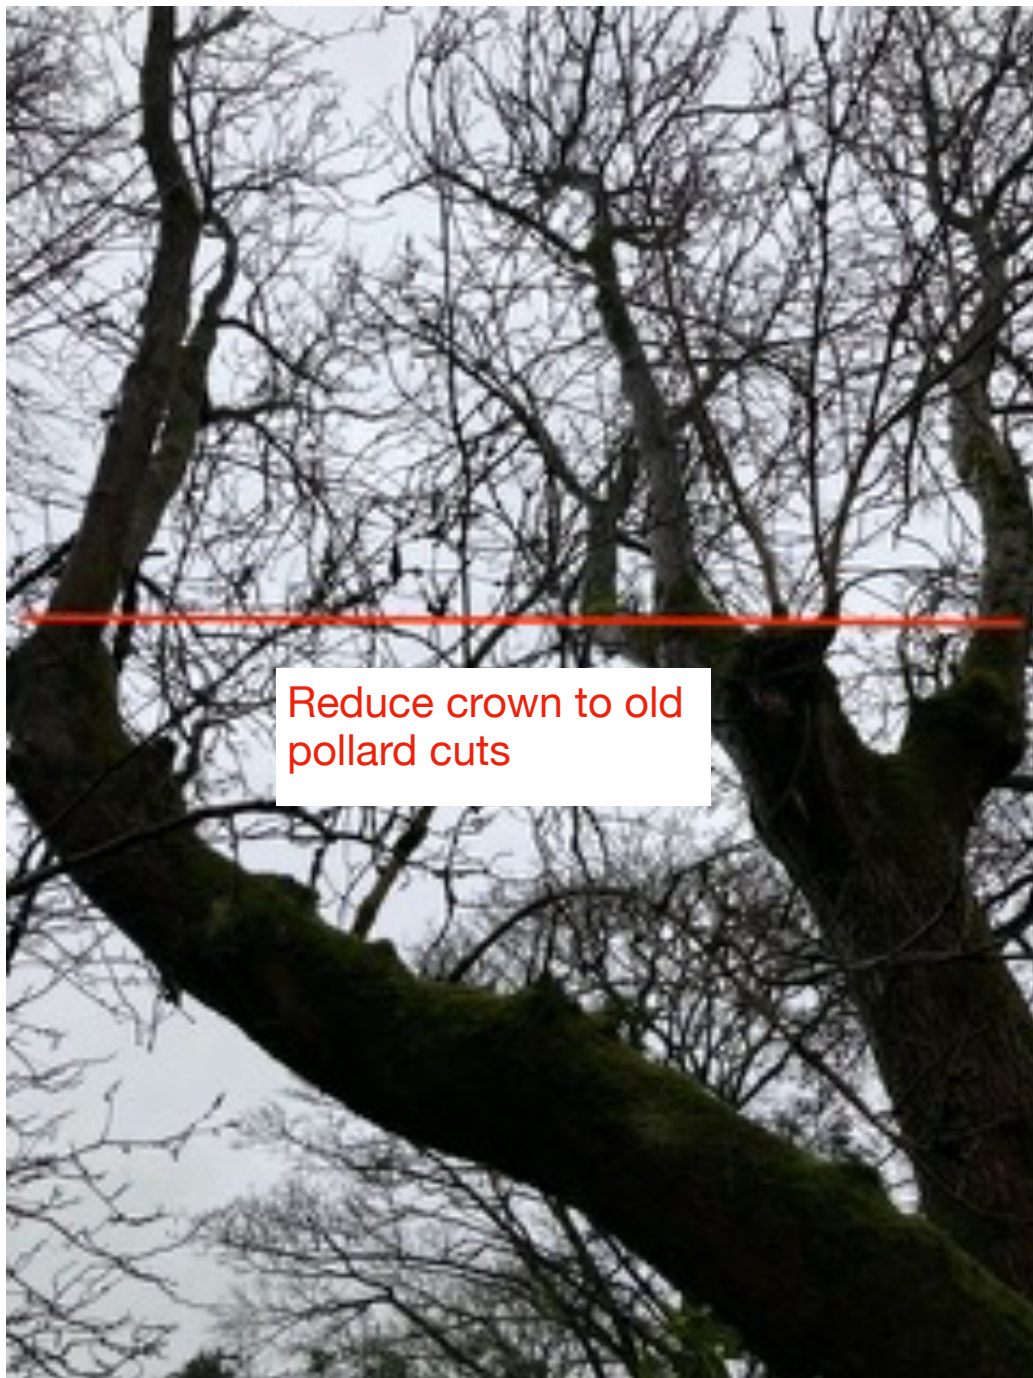
The Ash tree is suffering from Ash die-back, endemic in the area, and will inevitably decline further. As the tree declines it will become more brittle, dropping more branches and becoming more dangerous to remove or work on.

T3 - Ash- Pollard to make safe.

With the crown declining and main stems showing previous crown reductions it would be prudent to take out the crown down to the old scaffold limb cuts.

Reduce crown to old  
pollard cuts
