**BAT ROOST POTENTIAL  
SURVEY REPORT**

**at  
Harefield Hall Farm  
Chadwick Lane  
Heywood  
Lancashire  
OL10 1RN**

**JCA Ref:  
20536/EG**

**Date of Report:  
14/04/2023**

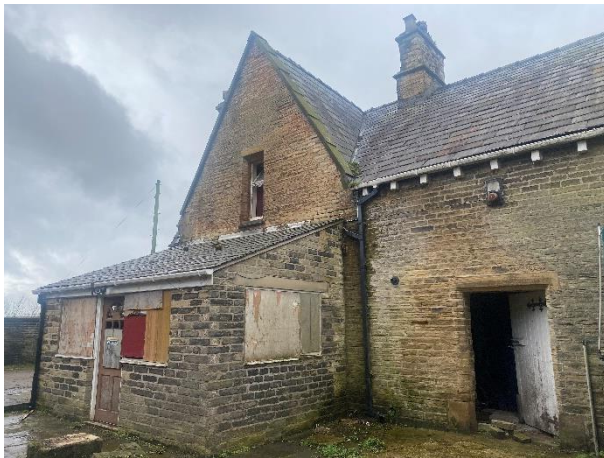
Photo 1: View of building two, showing general dilapidated nature of construction around the site.

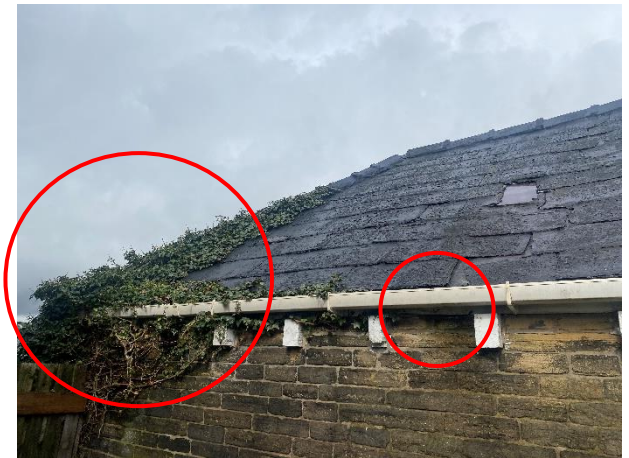
Photo 2: View of building one showing dense ivy at south western corner and gap under soffit.

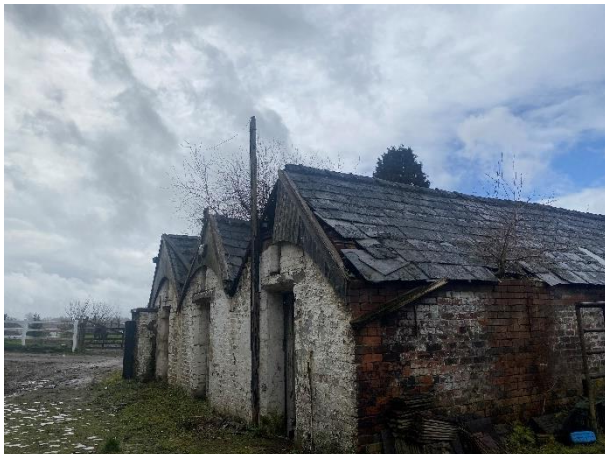
Photo 3: View of building one showing major gap in cladding, numerous areas of missing mortar, slipped roof tiles and extensive vegetation growth.

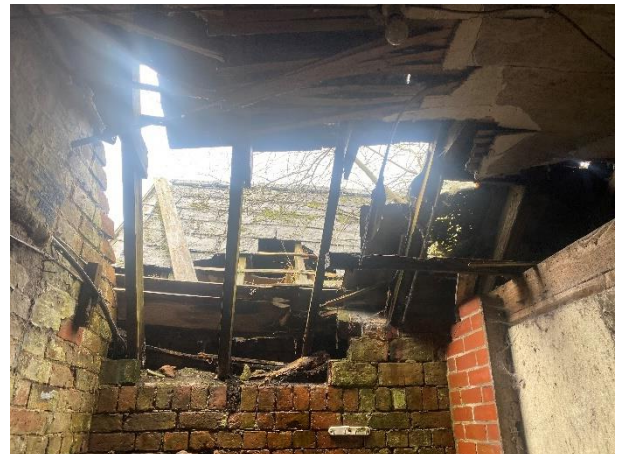
Photo 4: Major roof collapse on the central pitch of building one with numerous missing bricks and mortars.

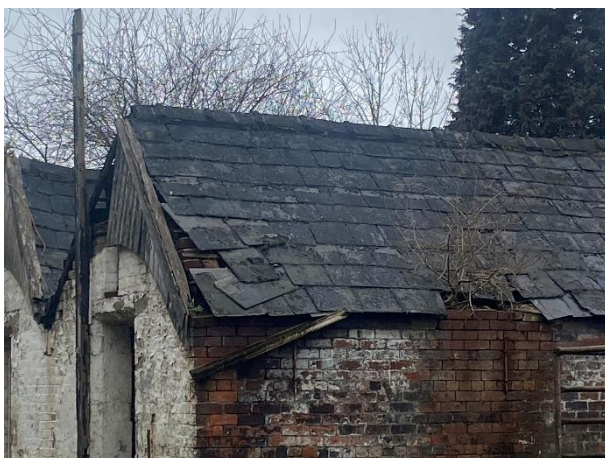
| | | <p>missing and cracked mortar, with one or two areas noted on the southern elevation (<b>Appendix 4, Photo 5</b>).</p> <ul style="list-style-type: none"> <li>- Located on the southern elevation there are several missing bricks.</li> </ul> <p><b>Internal</b></p> <ul style="list-style-type: none"> <li>- On the western wall there is a hole in the wall leading to a cavity (<b>Appendix 4, Photo 6</b>).</li> <li>- Centrally on the middle pitch there is a section of major roof collapse, allowing a large amount of light into the room (<b>Appendix 4, Photo 5</b>).</li> </ul> | |

Photo 5: View of northern elevation of building one with innumerable areas of missing mortar and many slipped roof tiles.

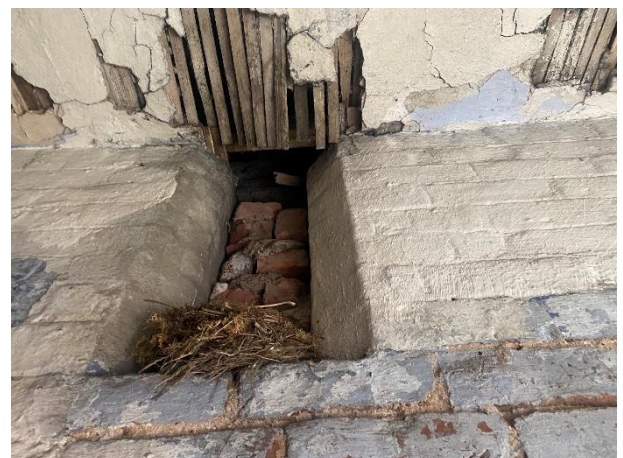
Photo 6: View of hole in the internal wall of building one leading to cavity wall, with birds nest also present.

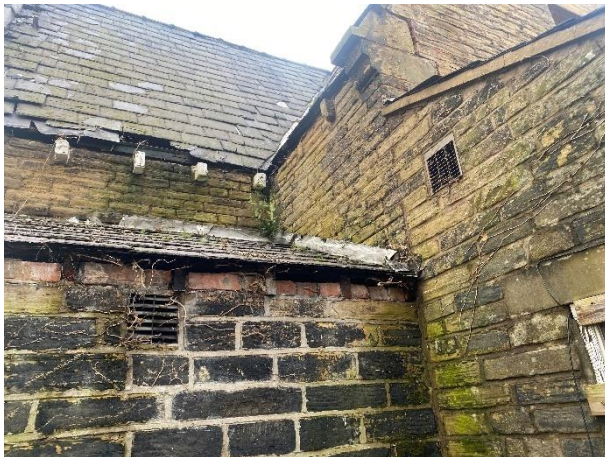
Photo 7: View of the ventilation grilles present at the south eastern corner of building two.

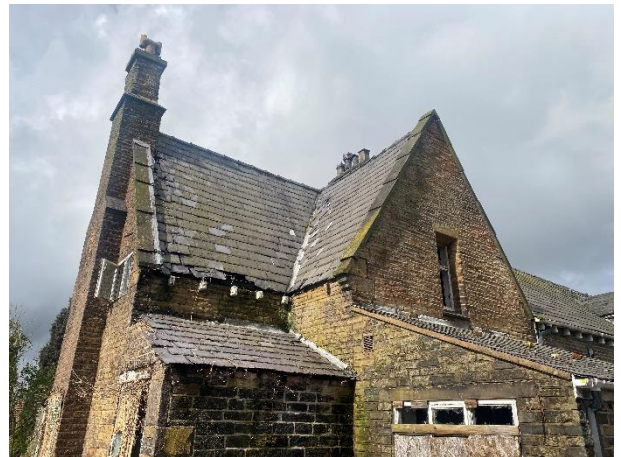
Photo 8: View from the south of building two showing numerous missing, lifted and slipped roof tiles.

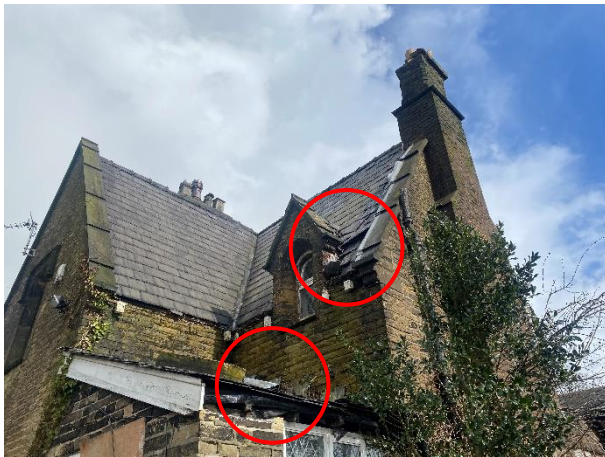
Photo 9: View from the west of building two showing areas of major roof collapse.

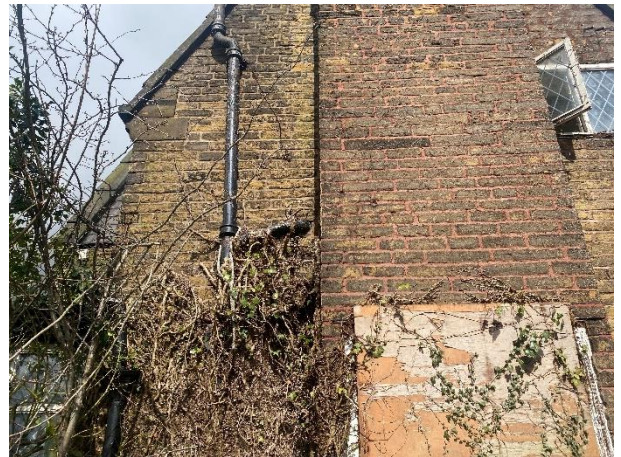
Photo 10: Area of dense ivy on the southern elevation of building two.

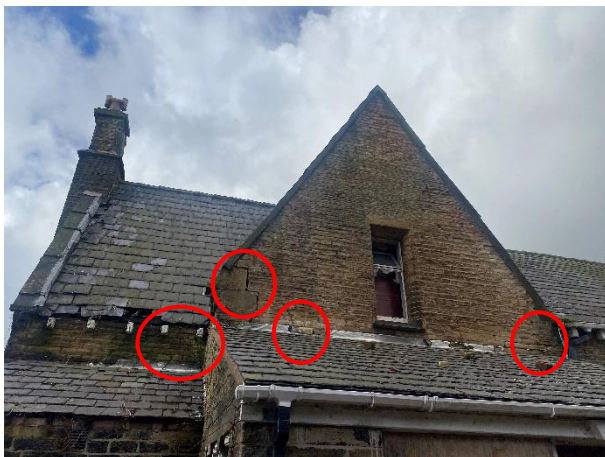
Photo 11: View of the eastern elevation of building two with missing mortar and damaged flashing.

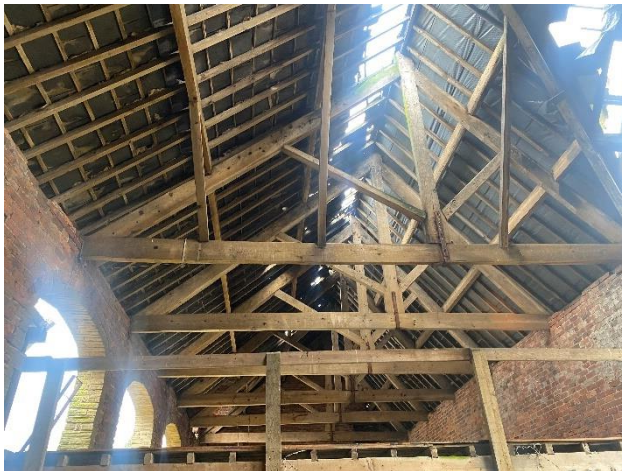
Photo 13: Internal view of major roof collapse on the western wing of building three.

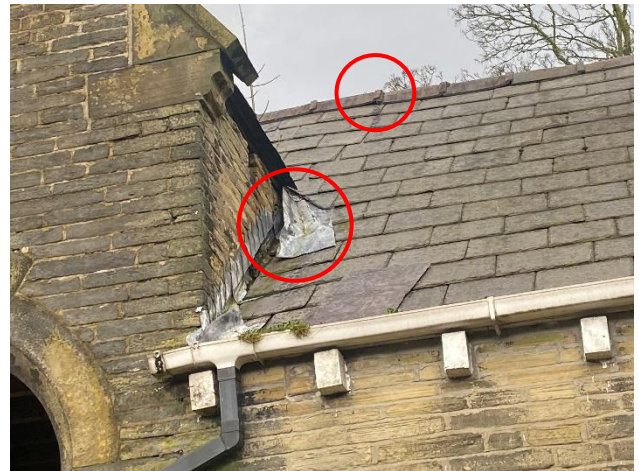
Photo 14: View of gap in ridge tile and lifted flashing on central dormer of the northern wing of building three.

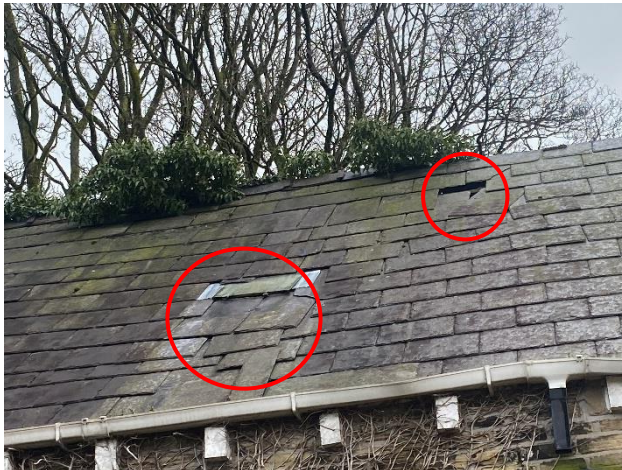
Photo 15: View of the eastern wing of building three with numerous lifted, slipped and missing roof tiles.

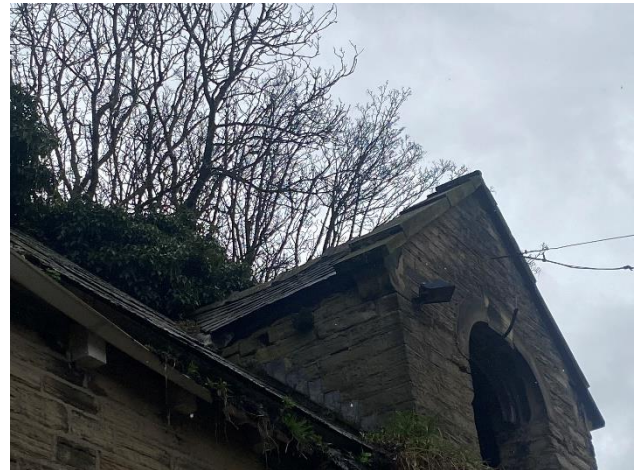
Photo 16: View of the dormer on the eastern wing showing dense ivy encroaching from the east.

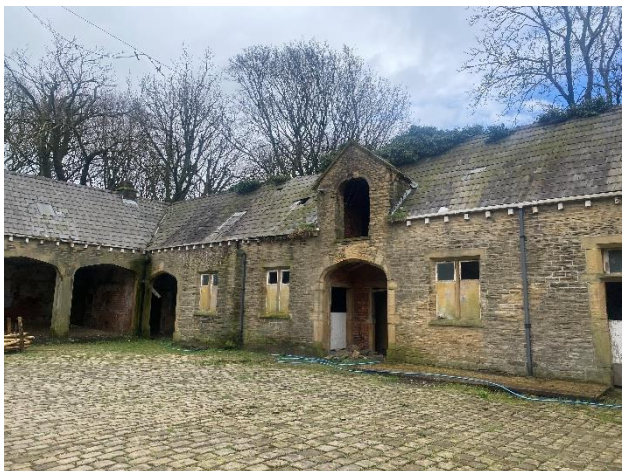
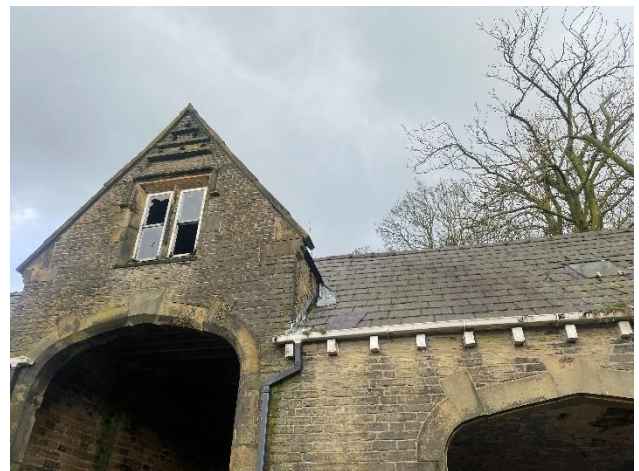
Photo 17: View of the north eastern corner of building three showing several areas of missing mortar.

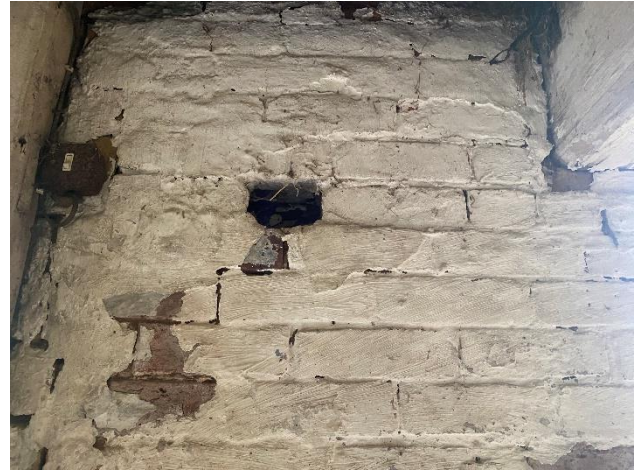
Photo 19: View internally of gaps around the beams located in the western wing of building two.

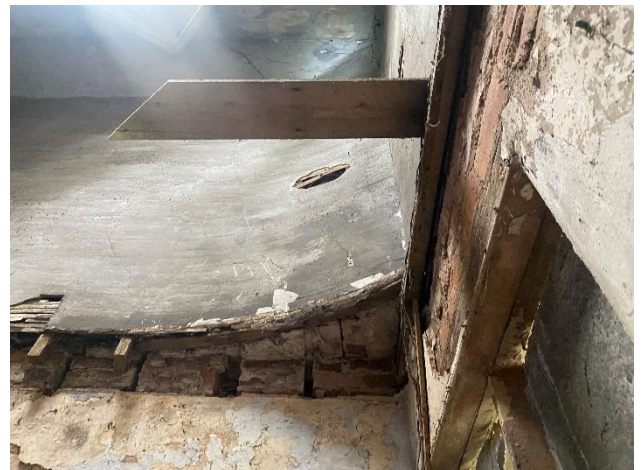
| | | <ul style="list-style-type: none"> <li>- There are innumerable areas of missing mortar, leading to cavity walls (<b>Appendix 4, Photo 21</b>).</li> <li>- There are three major holes in the ceiling on the north and east of the building leading to the upper floor (<b>Appendix 4, Photo 21</b>).</li> <li>- On the north eastern corner, there is a major hole in the plaster wall leading to a cavity (<b>Appendix 4, Photo 22</b>).</li> </ul> | |

Photo 21: View of one of the stable bays located on the northern section of building two with innumerable areas of missing mortar and major hole in ceiling leading to upper floor.

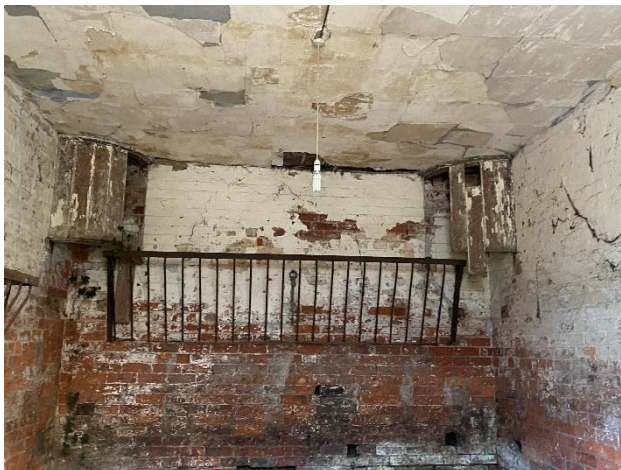
Photo 22: View of the major hole in plaster at north eastern corner of building two at high level.

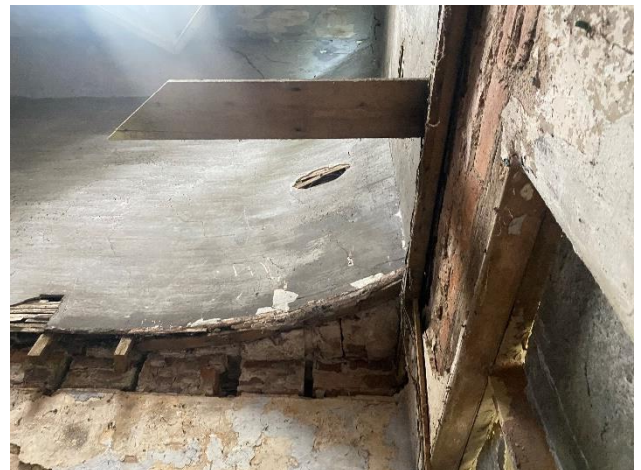
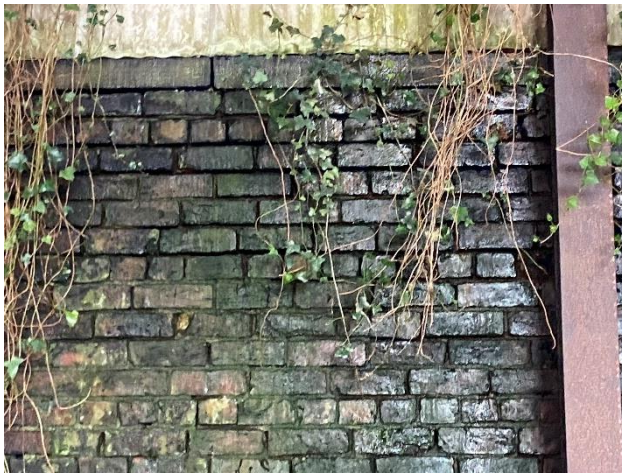
Photo 23: Close up of the eastern wall of building four showing extensive area of missing mortar.

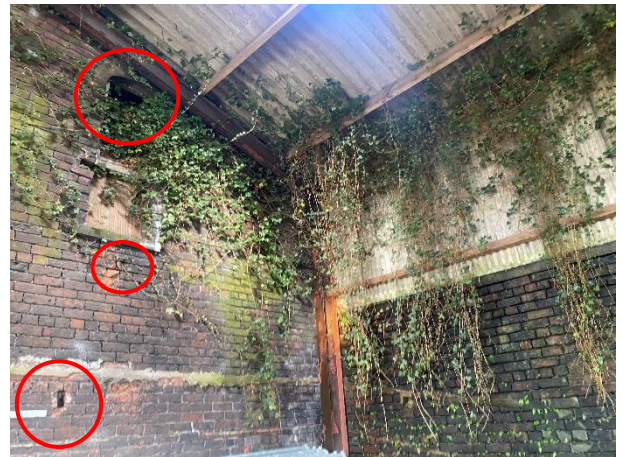
| 4 | <p>The building is the cowshed, located at the south eastern corner of the site. It is in current use as a cow shed, the structure is open to the west. It has a gently pitched roof, made out of corrugated metal roof. The structure is open to the west, and enclosed on all other sides, to the north and east by brick walls and to the south by corrugated metal siding.</p> | <p><b>External</b></p> <ul style="list-style-type: none"> <li>- No external PRFs were identified.</li> </ul> <p><b>Internal</b></p> <ul style="list-style-type: none"> <li>- Along the eastern and northern walls internally in the cowshed, there are innumerable areas of missing mortar (<b>Appendix 4, Photo 23</b>).</li> <li>- There is a large patch of dense ivy on the eastern wall (<b>Appendix 4, Photo 24</b>).</li> <li>- There are numerous missing bricks on the northern and eastern walls (<b>Appendix 4, Photo 24</b>).</li> <li>- There is a major hole in the wall on the northern elevation leading to the upper floor of building three (<b>Appendix 4, Photo 24</b>).</li> </ul> | Moderate |

Photo 24: View of north eastern corner of building four showing dense ivy, missing bricks and major hole leading to building three.

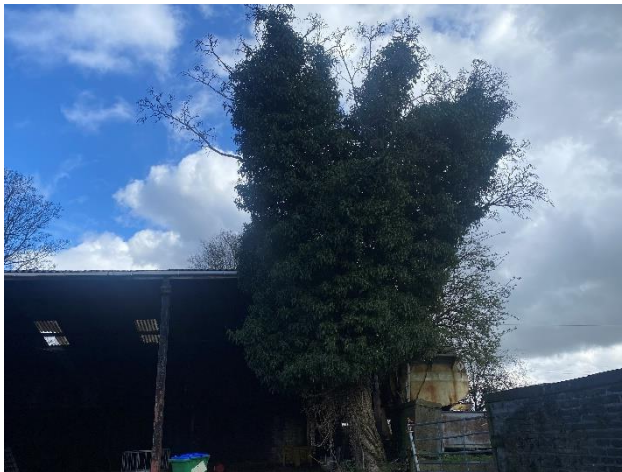
The tree is a medium willow *Salix* spp., located at the south west corner of the cow shed. The tree was almost entirely covered in dense ivy, obscuring any potential roosting features from view (**Appendix 4, Photo 25**).

Photo 25: View of tree one, densely covered to west of building four.

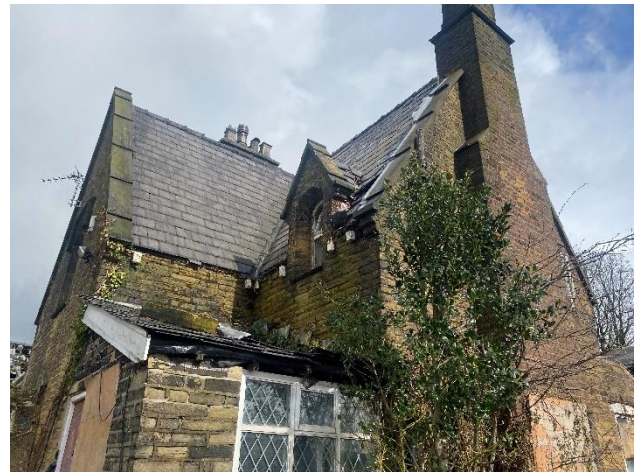
Photo 26: View of building two showing small holly tree adjacent.

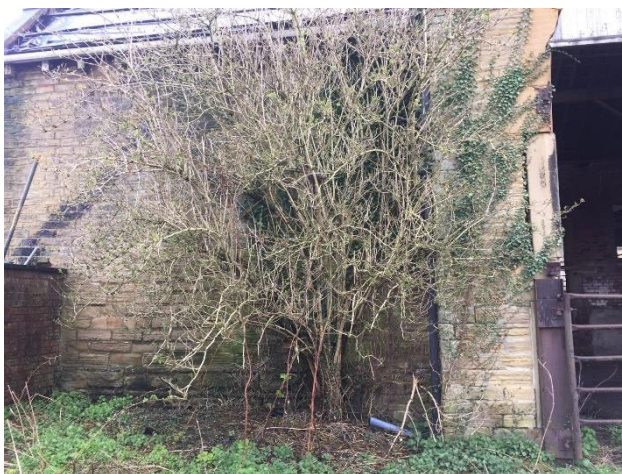
Tree four is a medium semi-mature elder located on the west of the stable building at the northern boundary of the site. There was a crack present on this tree, however it did not appear to lead to a cavity (**Appendix 4, Photo 27**).

Photo 27: View of tree four located at northern boundary.

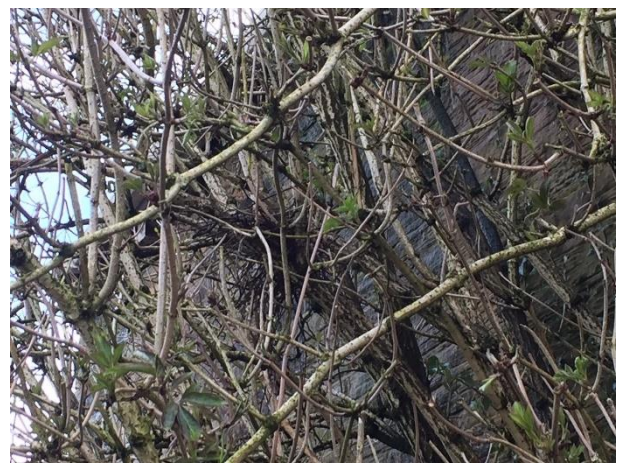
Photo 28: View of birds' nest within tree four, located at northern boundary.
