Our Ref: BEK/22019/220801/SD Rev A

1 August 2022

**BANK TOP FARM**

## Desktop Coal Mining Risk Assessment – Bank Top Farm, Hollingworth

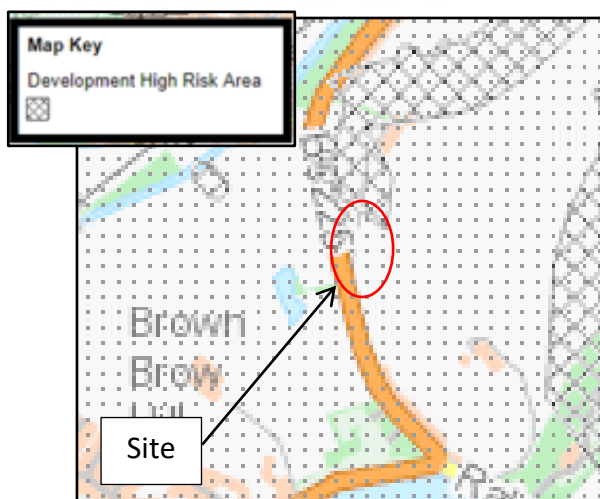
**Figure 5: Development High Risk Area**

Several maps extracted from the Coal Authority website are presented below. The Coal Authority Interactive Map indicates that there is an area in close proximity to the north of the site which is denoted as a 'Development High Risk Area'. It is possible that the north of the site is located within a 'Development High Risk Area'. Such areas are shown in Figure 5 below. Figure 6 (below) shows that a coal outcrop is situated in close proximity to the north of the site.

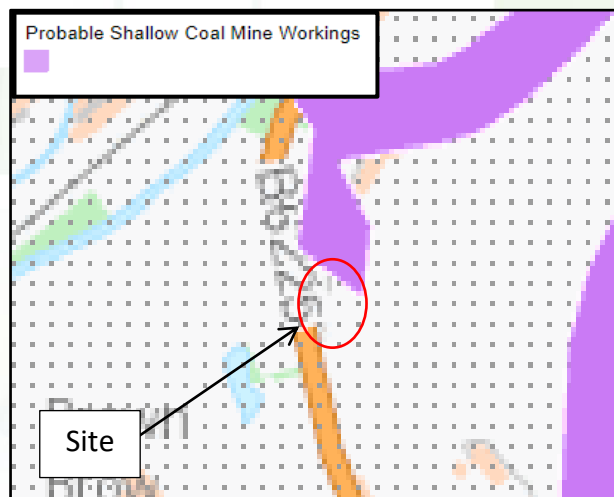
**Figure 8: Probable Shallow Coal Mine Workings**

Figure 7 shows that the site is not located within an area where 'past shallow coal mine workings' are present. Figure 8 shows that the site is located close to an area of 'probable shallow coal mine workings'.

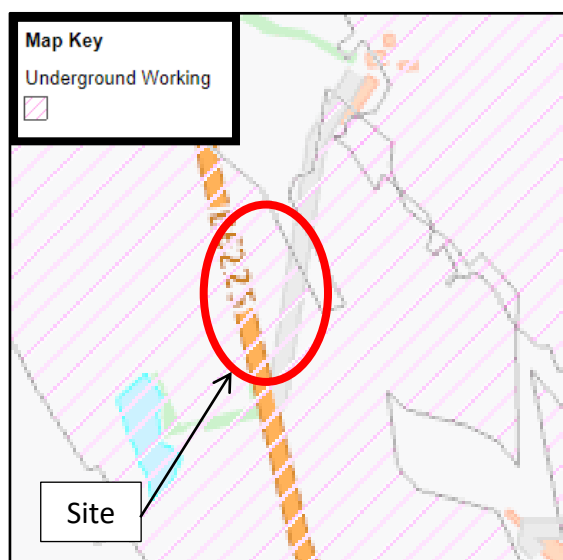
**Figure 11: Underground Workings**

The site is shown to be located within an area of underground workings and the site has not been served by legal notices as shown within Figures 10 and 11 below.

A Consultants Coal Mining Report confirms that past coal mining has taken place below the site with a depth of the working of 115 m associated with the 'Lower Mountain' coal seam. This correlates with the BGS borehole located some 234 m west of the site which identified 'Mountain Mine Coal' some 115 m beneath ground surface. This is outside the 30 m zone of influence of the depth of shallow coal mine workings. As such, BEK does not consider the workings to represent a potential risk at the surface from subsidence.

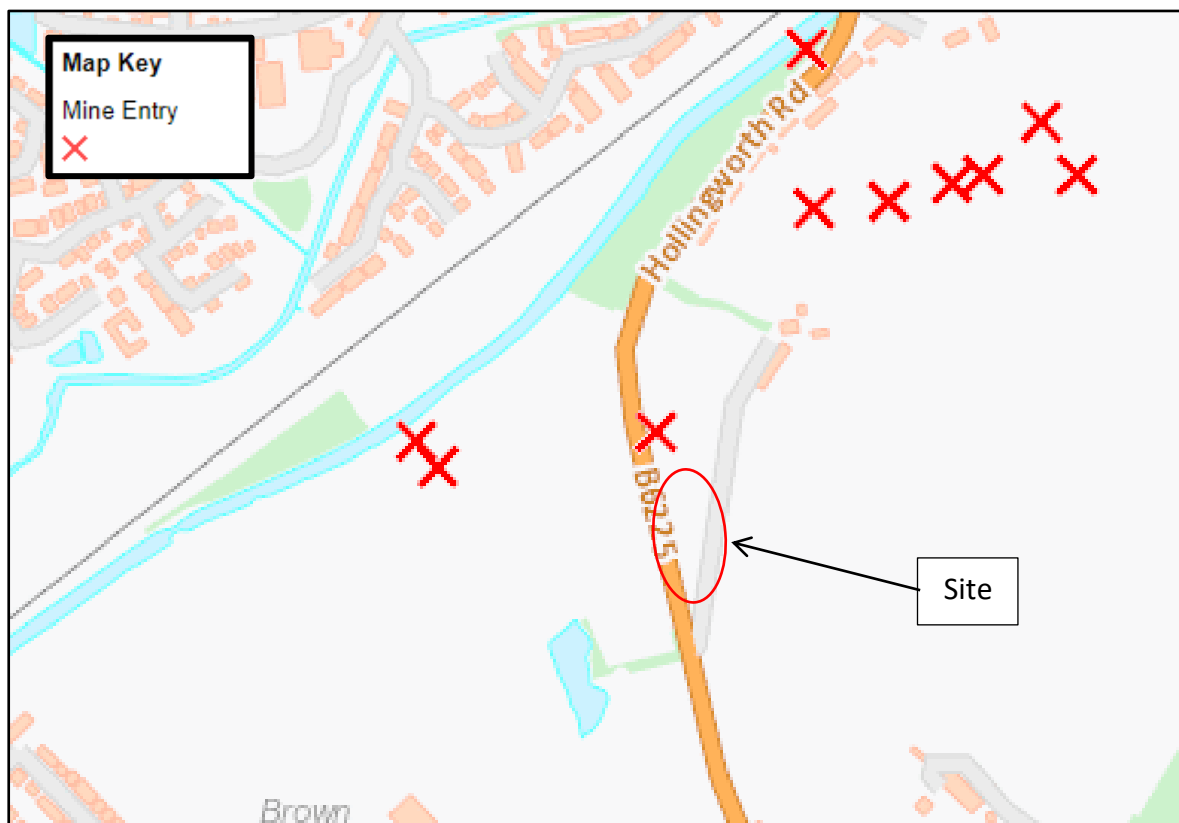
**Figure 13: Mine Entry Map**

It can be seen from Figure 13 that a mine entry (adit) is located close to the north of the site (Shaft Ref No: 393415-010). Further shafts are located in the area however, these are of sufficient radial distance from the site to be considered to not pose a risk to the site (with consideration to the zone of influence (20 m)).

Further consideration has been given to an adit (Ref No: 393415-010) located to the north of the site (NGR: 393570, 415773). It is noted that the adit is located approximately 55 m north of the site, as such the mine entry and its zone of influence does not infringe on the site.

The adit (Ref No: 393415-010) is shown to be located approximately 55 m north of the site and approximately 70 m north of the proposed building on site.

The bearing of the adit is 74° as such due to the location and the bearing of the adit it would not be anticipated to interact with the proposed development site.

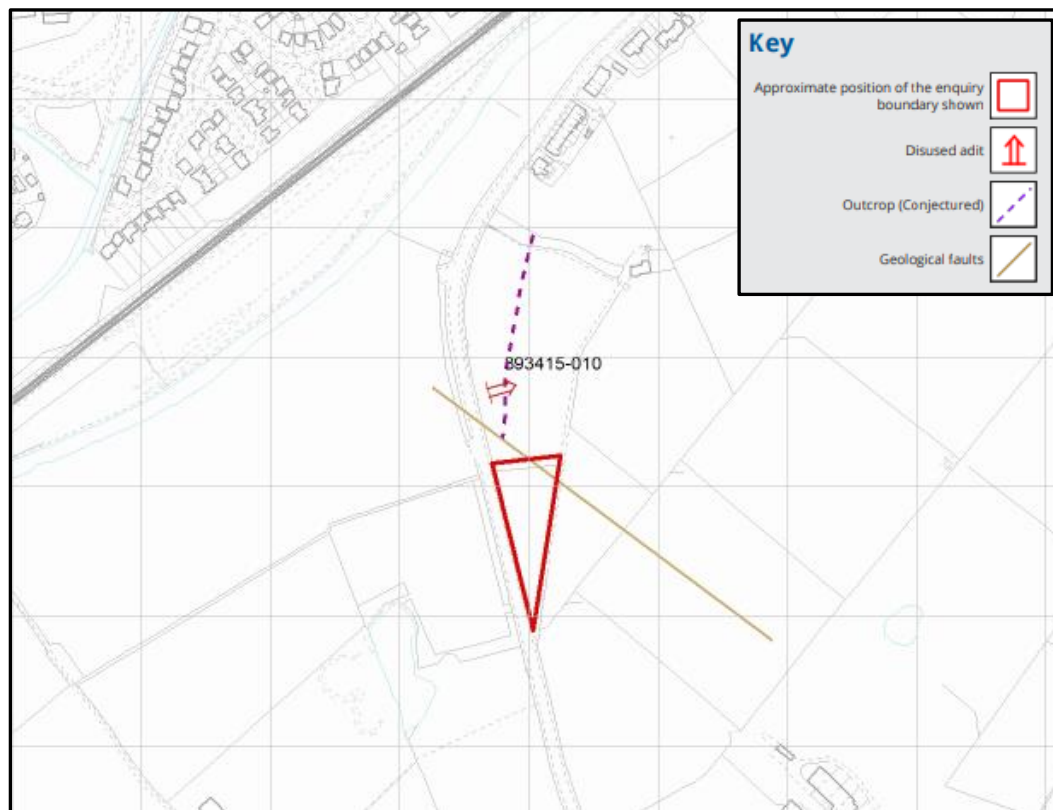
**Figure 14:** Coal Authority Summary of Findings

In addition to the presence of the adit to the north of the site, a geological fault is located in the north-eastern corner of the site and a coal outcrop (conjectured) is located to the north of the site as shown within the figure below:

A review of the bedrock geology of the site indicates that the site is underlain by Milnrow Sandstone with the north-eastern corner of the site shown to be Pennine Lower Coal Measures Formation. This correlates with the geological fault identified within Figure 14. Furthermore, the conjectured coal outcrop terminates at the geological fault line to the north of the site. The outcrop is identified to be the 'Upper Mountain' seam located some 18 m north of the development site with a bearing of 186°.

An adit and coal outcrop are located to the north of the site however the distance (55 m) and bearing of the adit away from the development site (74°) and the distance of the coal outcrop from the site (17.6 m) indicates that the proposed development is outside the zone of influence of the adit.
