# Tree Condition Survey Report (VTA)

**Site:** Highfield Hospital, Manchester Road, Rochdale, OL11 4LZ.

**Client:** BMI.

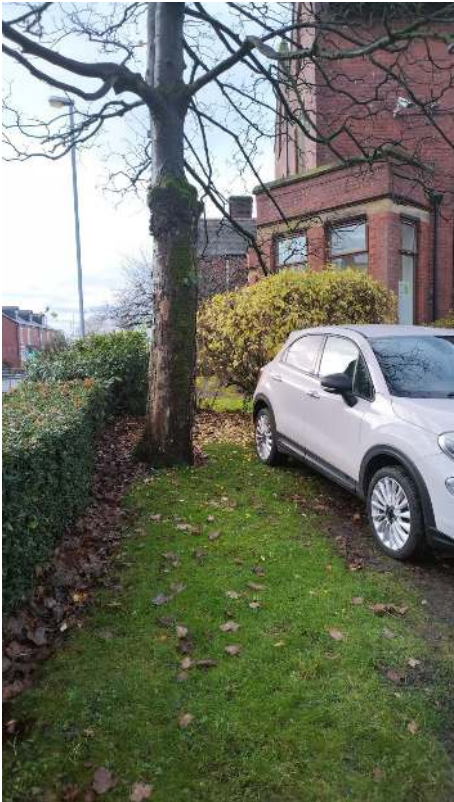
Sycamore Tree ID #6

| Tree Survey Schedule | | | | | | | | | | | | | | | | |
|---|---|---|---|---|---|---|---|---|---|---|---|---|---|---|---|---|
| 6 | No tag | Sycamore | Acer pseudoplatanus | 5-10m | Mature | Good | Good | Compaction | None Significant | Bark Wounding/Damage, Included Co-Dominant Stem, Occluding Tissues/Wood | Minor Dead Wood Under 50mm Diameter | None Observed | Building, Car park, Road | High | Good | Client |

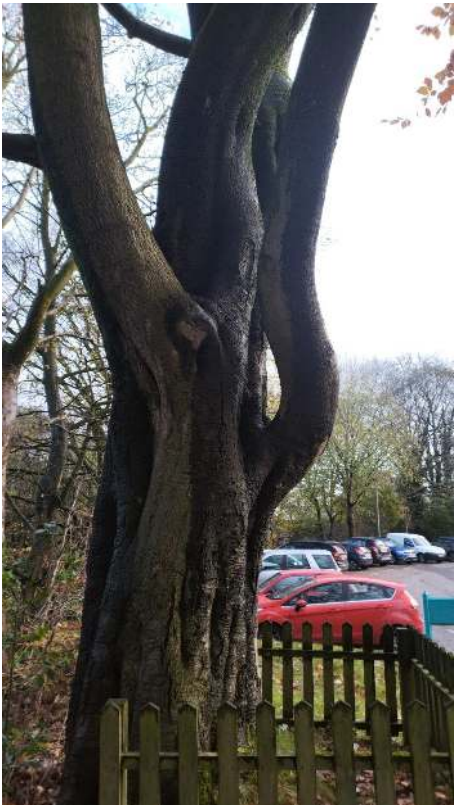
Common beech Tree ID #7

| Tree Survey Schedule | | | | | | | | | | | | | | | | |
|---|---|---|---|---|---|---|---|---|---|---|---|---|---|---|---|---|
| 7 | 1505 | Common beech | Fagus sylvatica | 16-20m | Over-mature | Fair | Good | Minor change in sound resounonce in stem to photo to the right above Union.<br><br>Historical large stem removal or failure.<br><br>Heart wood exposed | None Significant | Bark Wounding/Damage, Included Co-Dominant Stem, Multi-Stem, Occluding Tissues/Wood | Crossing/Rubbing Branches, Included Bark, Minor Dead Wood Under 50mm Diameter | None Observed | Building, Car park | High | Good | Client |

| Tree / Group ID | Common Name | Work Task | Work Priority | Description | Tag No |
|---|---|---|---|---|---|
| 7 | Common beech | Re-Inspect by Arb (Within Specified Timeframe) - Specify reasoning | Within 12 - 18 Months | Re-Inspect by Arb (Within Specified Timeframe) | 1505 |
