## Tree Surgeons Ltd

### Mini Tree Report

Date: 01/02/23

Hopwood Hall College (Middleton Campus)  
Rochdale Road,  
Middleton.  
M24 6XH

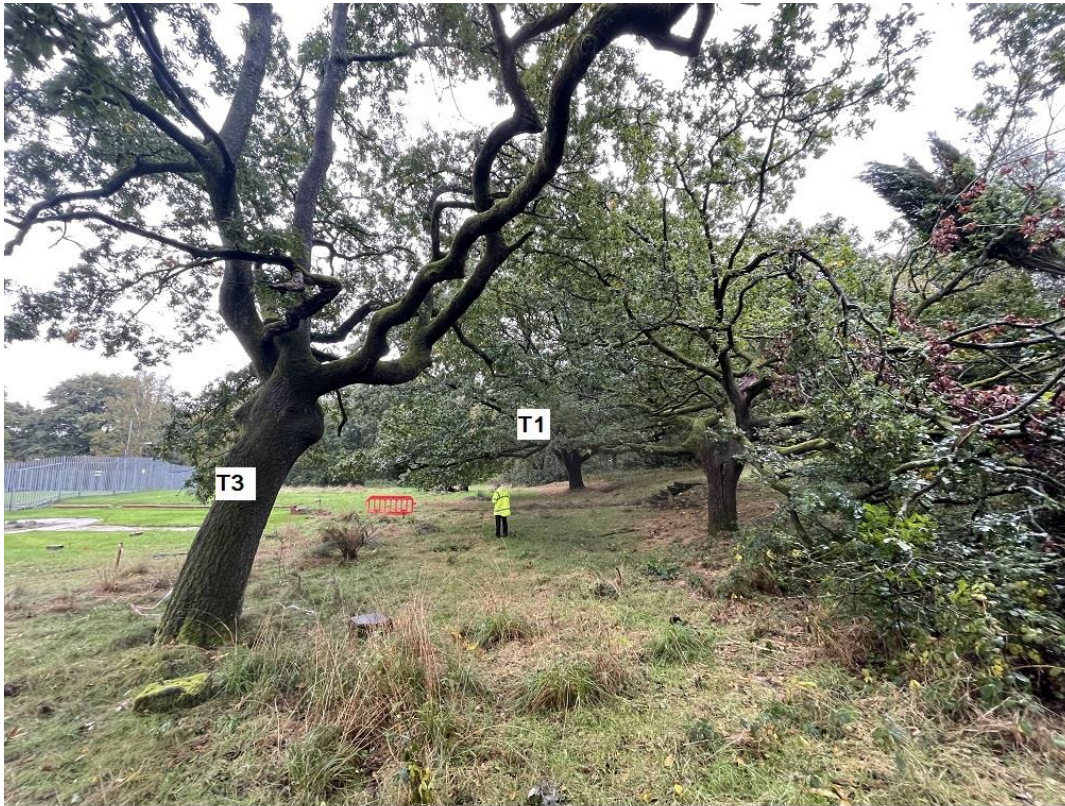
T1 & T3 Oaks Crown lift to 3 meters & deadwood the crowns

Both T1 and T3 ( Oak Trees) have extensive dead wood with in the canopy and both have relatively low branches which are starting to become an obstruction.

We would recommend removing all of the deadwood and crown lifting both trees by only removing the smaller intrusive secondary branches. We do not expect this to have a detrimental effect on the tree's health or amenity value.

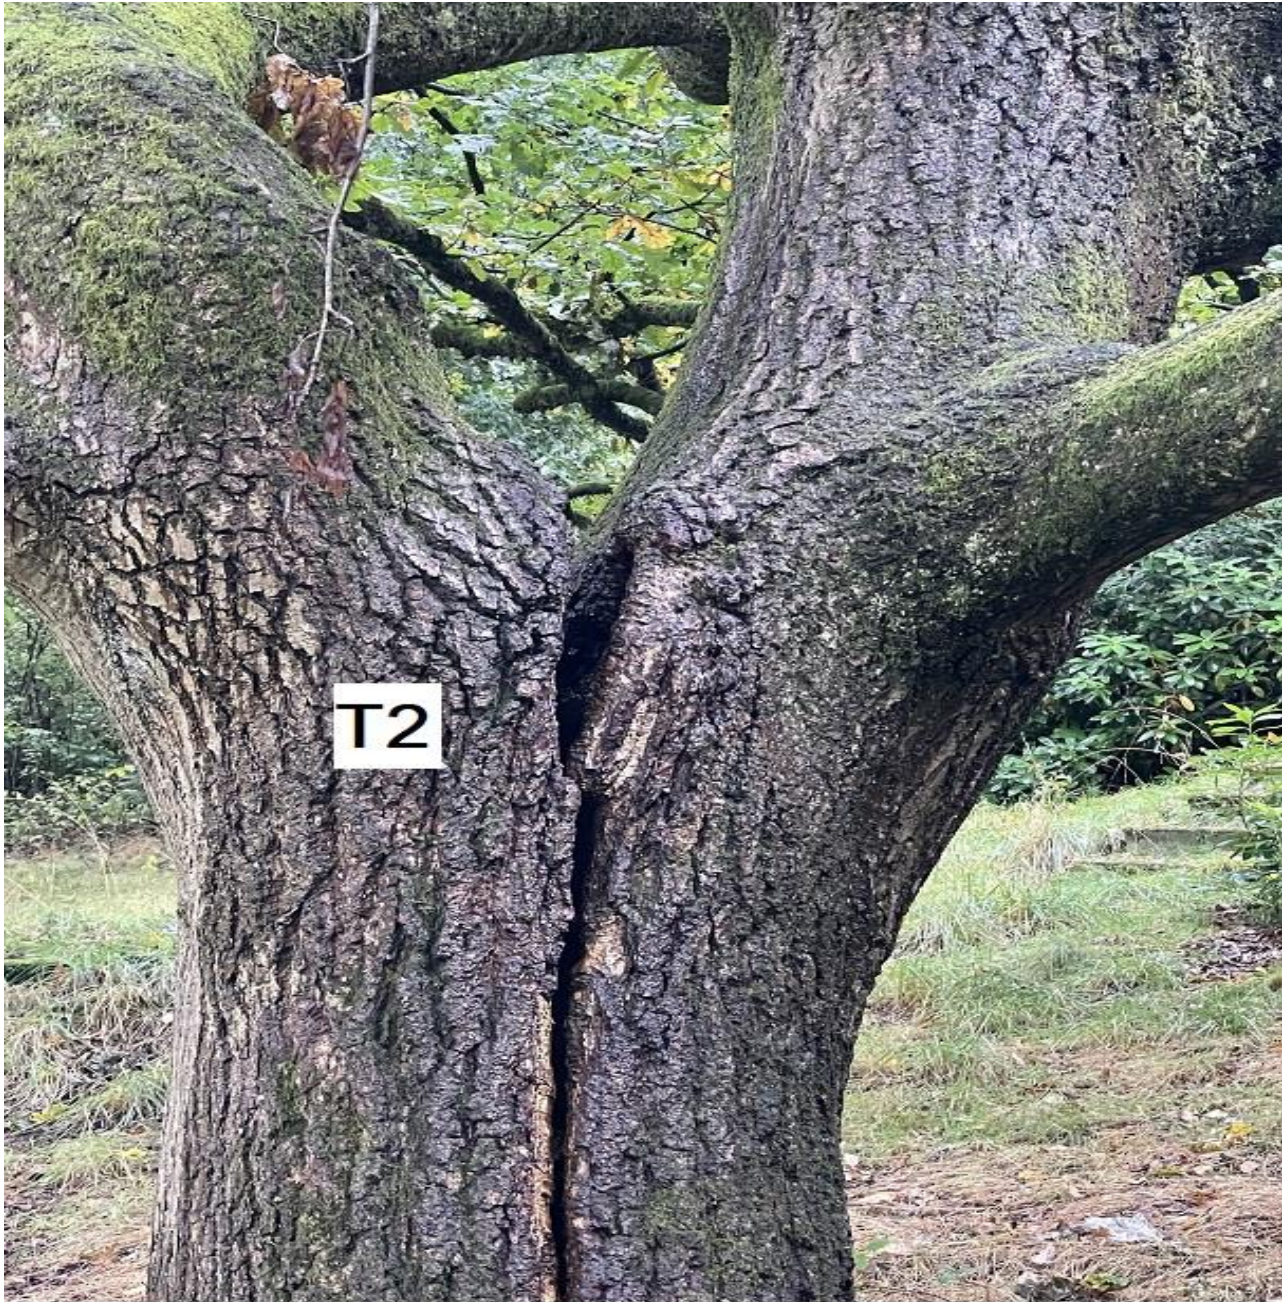
**T2 Removal of the split oak, Chip into woods stack the heavy timber in the woods.**

T2 – Oak.

This tree has a major split down the main trunk due to included bark where the tree bifurcates.

We would recommend removal of the Oak tree because where the tree is situated and the risk involved.

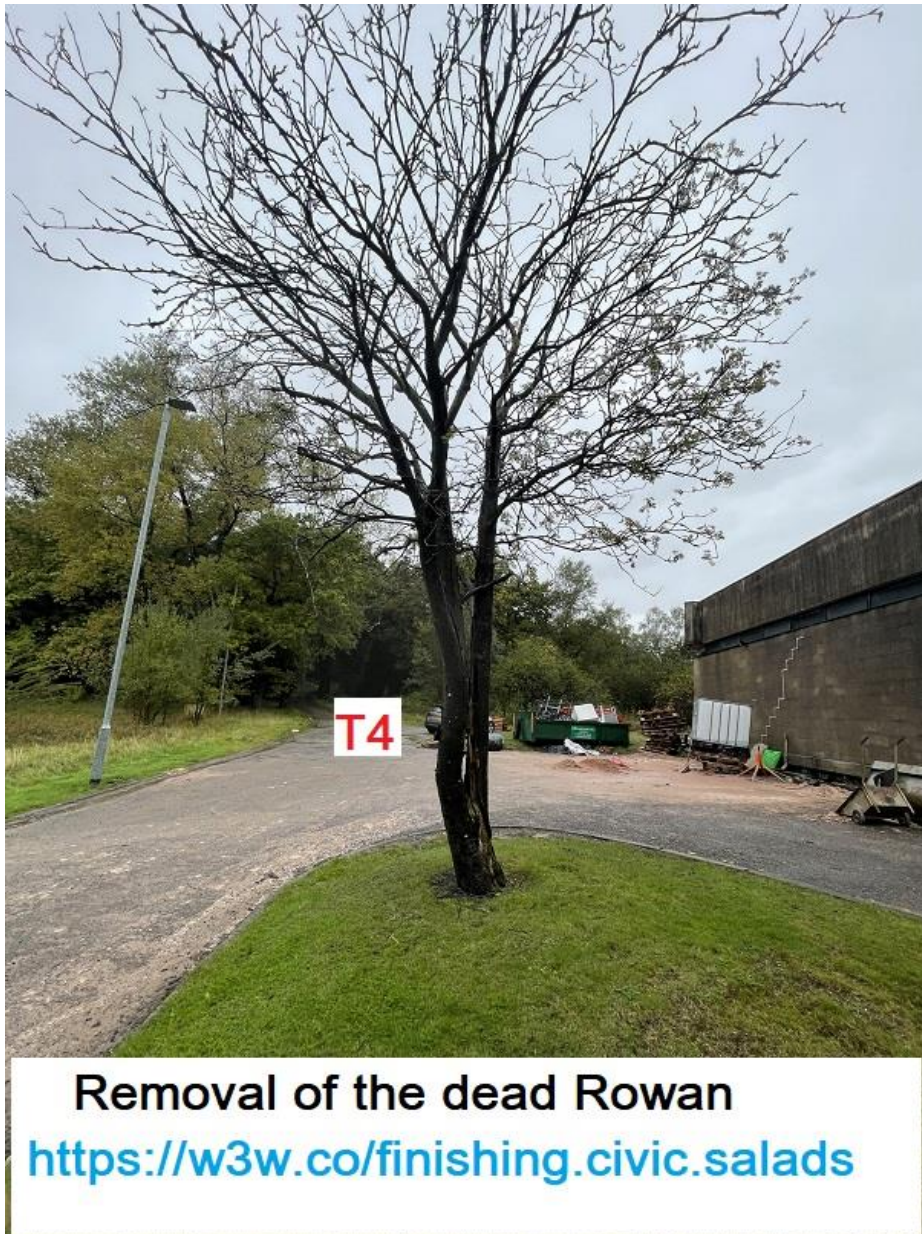
T4 – Mountain Ash (Rowan).

This tree is in poor health and poses risks to life and property.

We would recommend removal of the Mountain Ash tree because where the tree is situated and the risk involved.

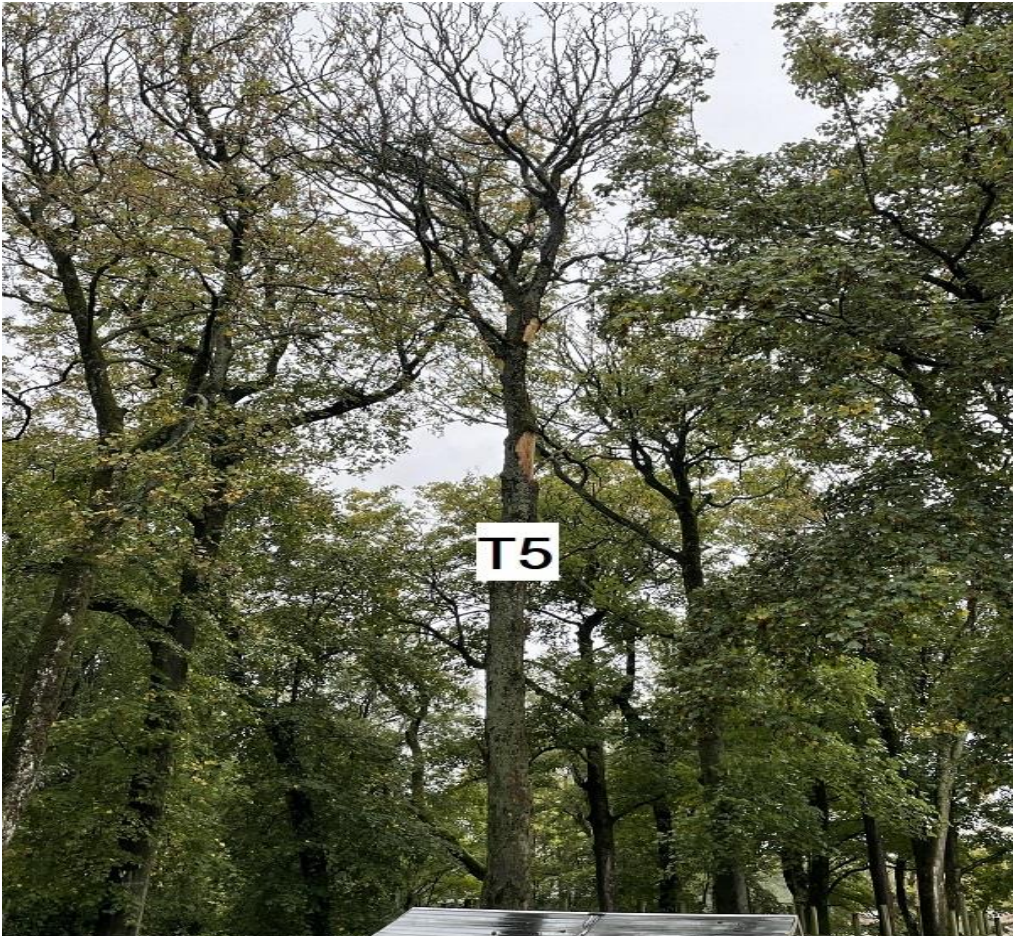
T5 Dead Maple removal, bark coming off the stem and branches falling.

T5 – Maple

This tree is in poor health and poses risks to life and property.

We would recommend removal of the Maple tree because where the tree is situated and the risk involved.

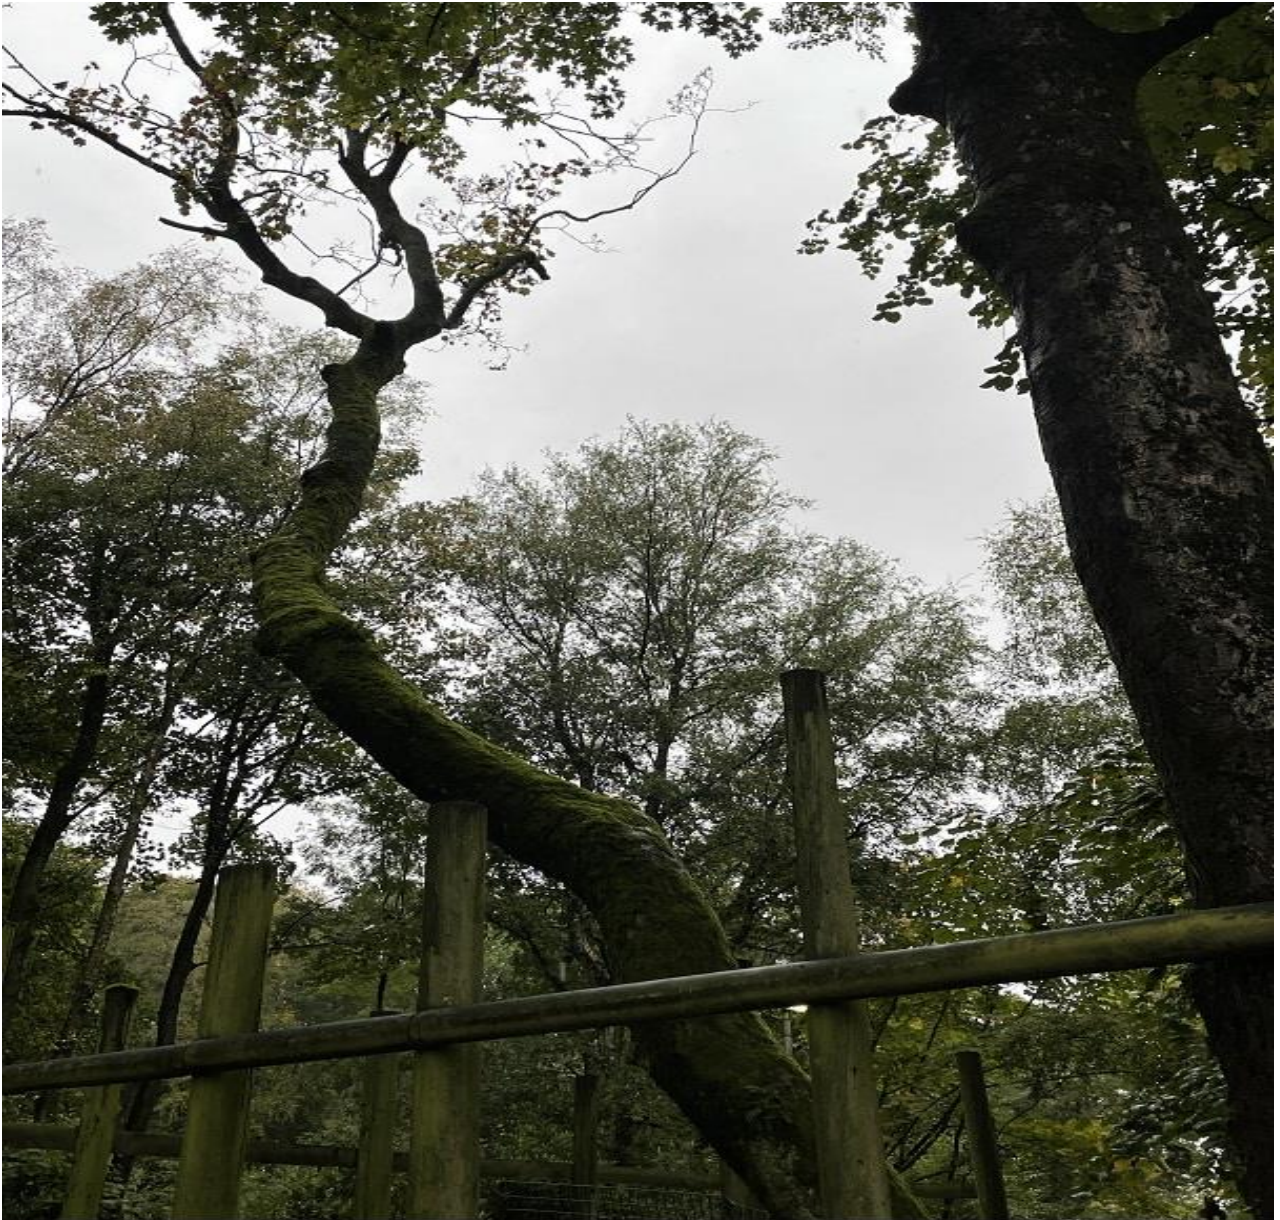
**T7 Heavily leaning Sycamore that is in decline, Removal  
Smallbridge monkey enclosure.**

T7 – Sycamore.

This tree is in poor health and poses risks to life and property.

We would recommend removal of the Sycamore tree because where the tree is situated and the risk involved.

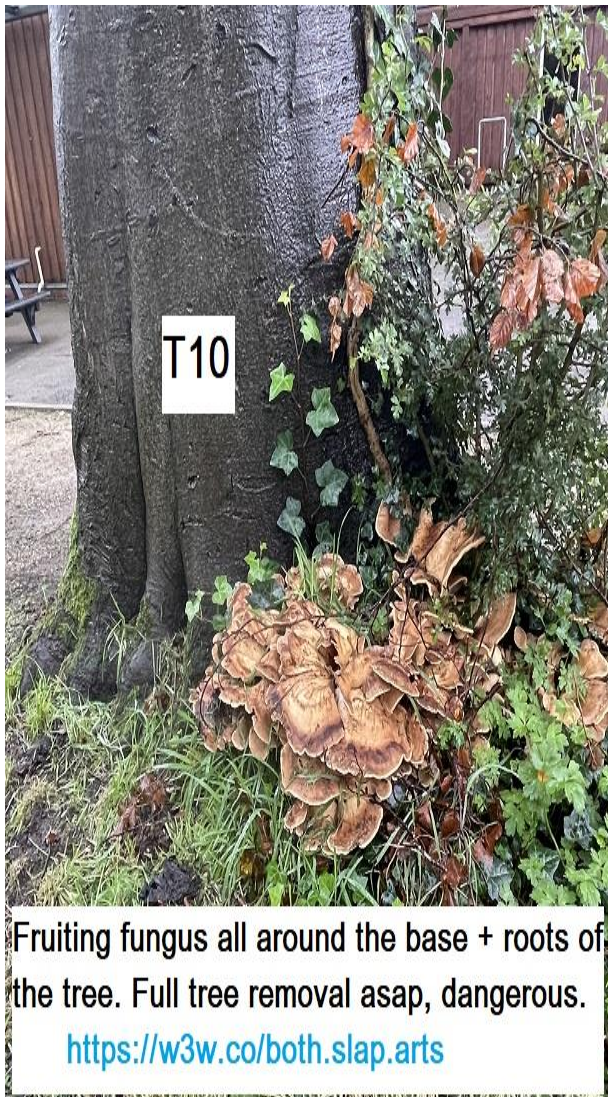
Fruiting fungus all around the base + roots of the tree. Full tree removal asap, dangerous.

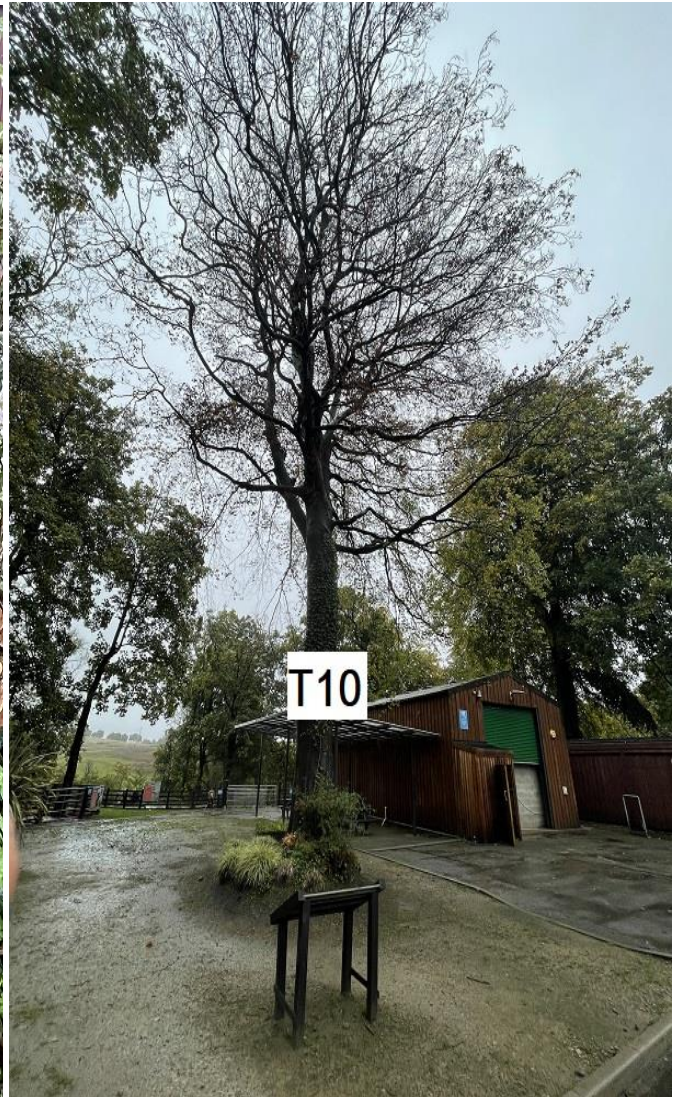
T10 – Beech.

This tree is in poor health and has fungus growing at the base. poses risks to life and property.

We would recommend removal of the Beech tree because where the tree is situated and the risk involved.

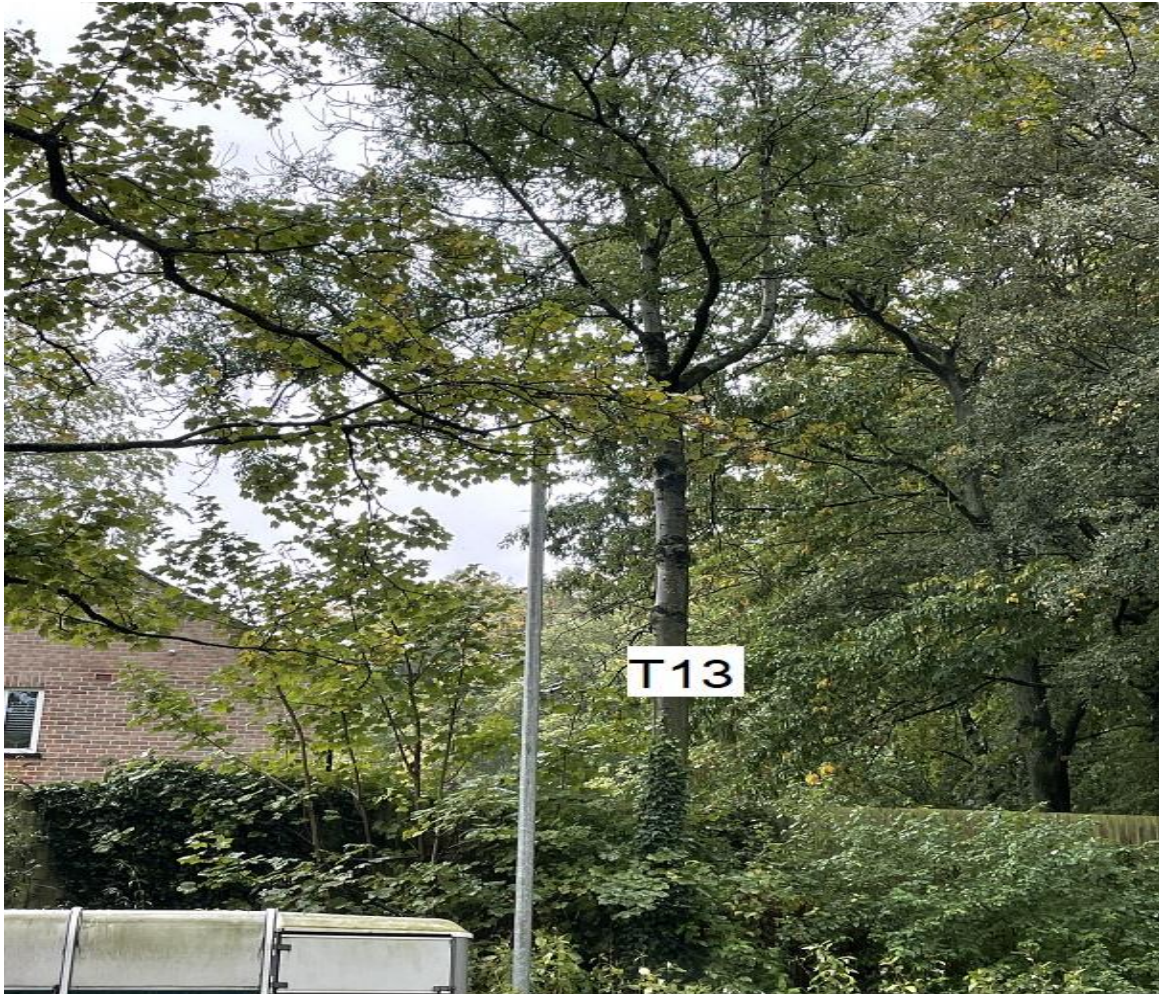
T13 Ash Recomend removal due to Ash die back disease. R/H side of lamp near caretakers house.

T13 – Ash.

This tree is only a young tree, Due to the Ash die back disease the health of the tree is increasingly deteriorating.

We would recommend removal of the Ash tree because where the tree is situated and the risk involved.

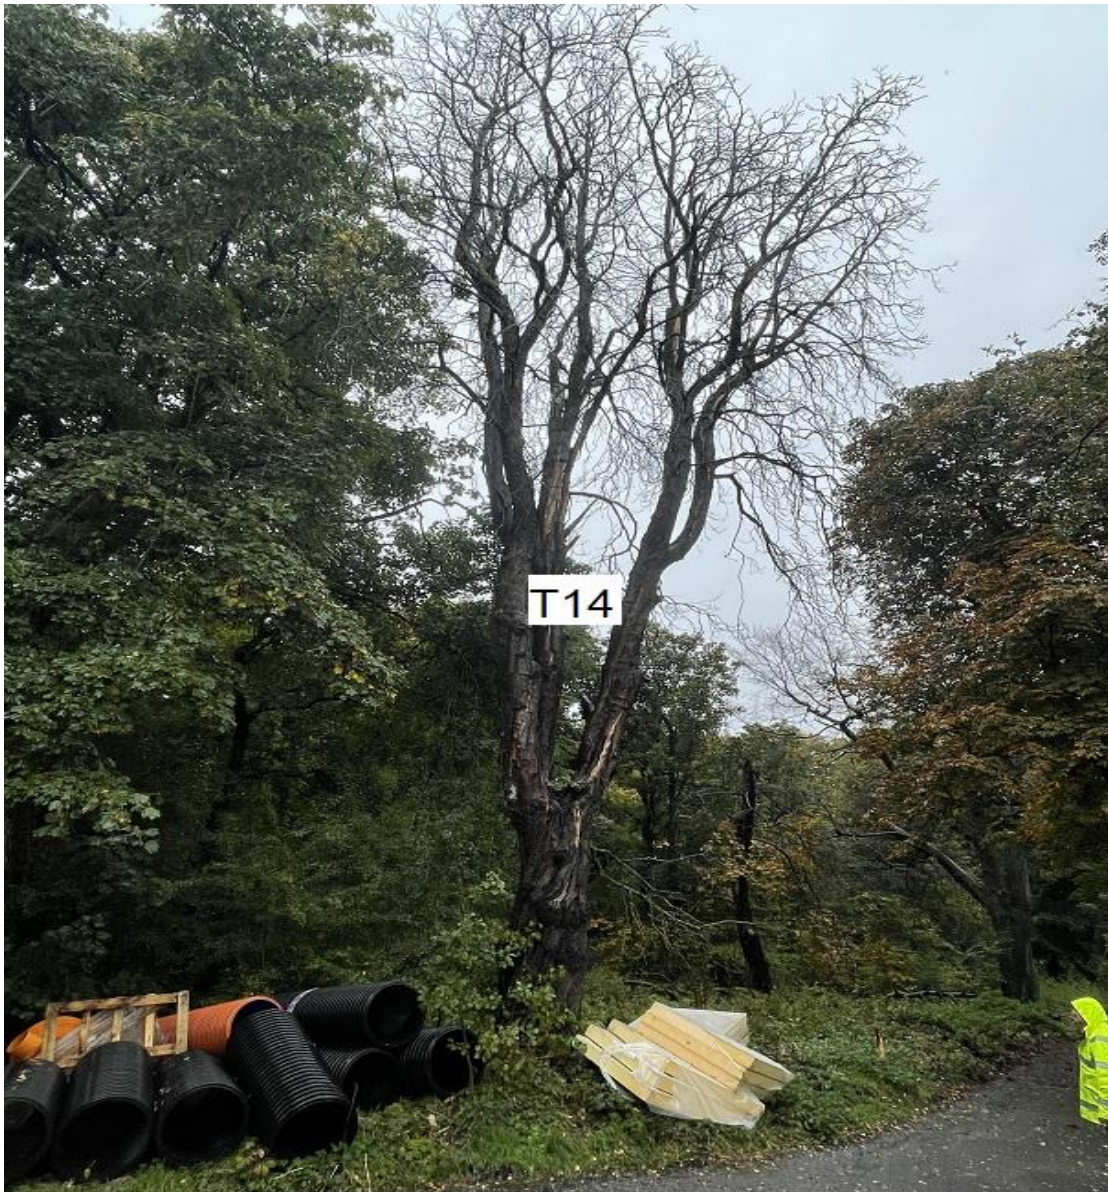
T14 large Dead Horse Chestnut, fell into the woods for safety.

T14 – Horse Chestnut.

This tree is extensively dead and needs removing as soon as possible.

We would recommend removal of the Horse Chestnut tree because where the tree is situated and the risk involved.

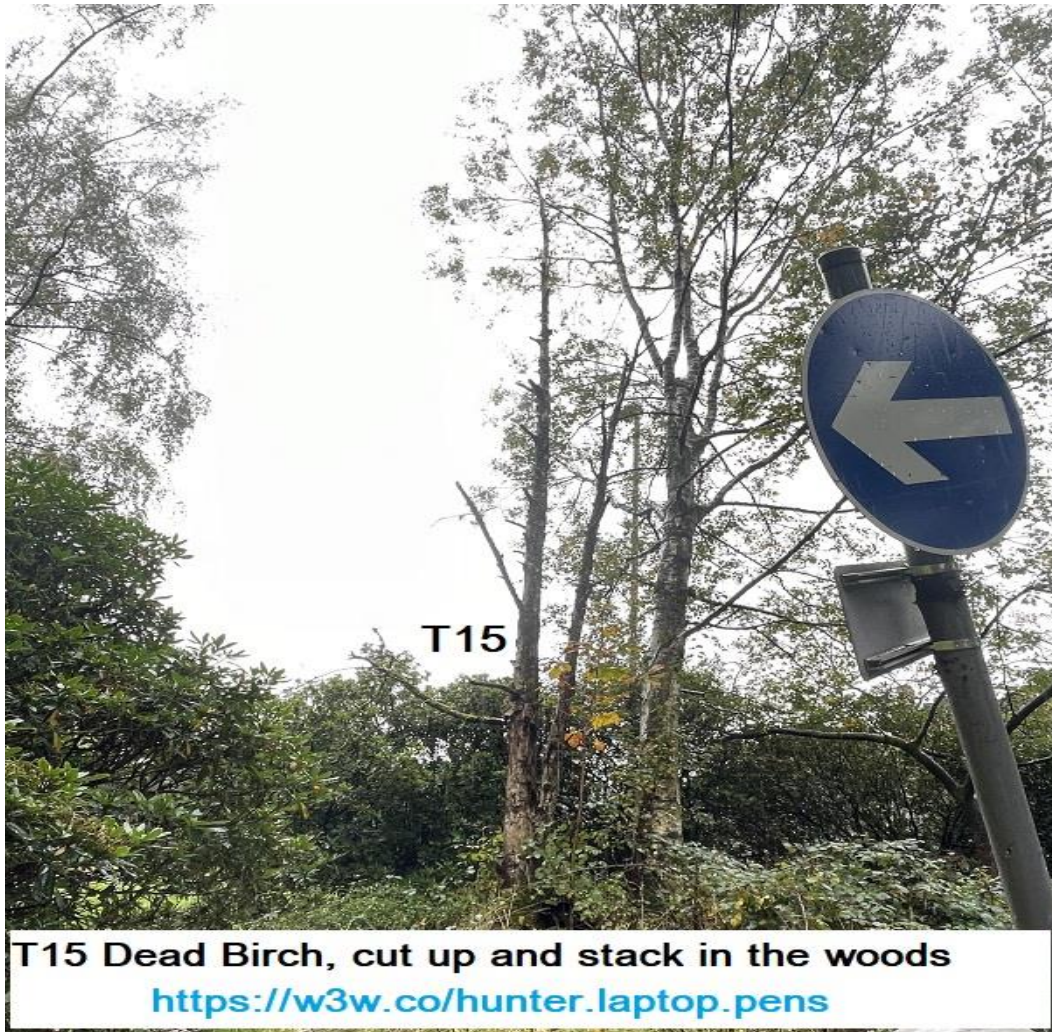
T15 – Silver Birch.

This tree is extensively dead and needs removing as soon as possible.

We would recommend removal of the silver tree because where the tree is situated, and the risk involved.

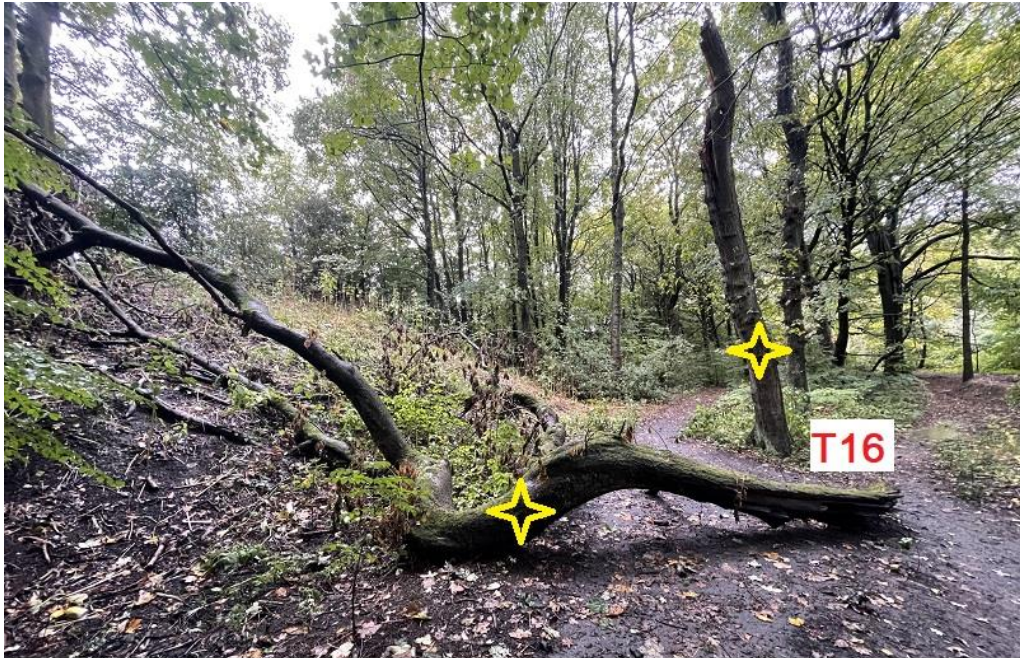
Cut up fallen tree + fell standing dead stem and stack neatly to one side

T16 – Beech.

This tree is a standing dead stem which has split out previously.

We would recommend removal of the Beech tree because where the tree is situated, and the risk involved.

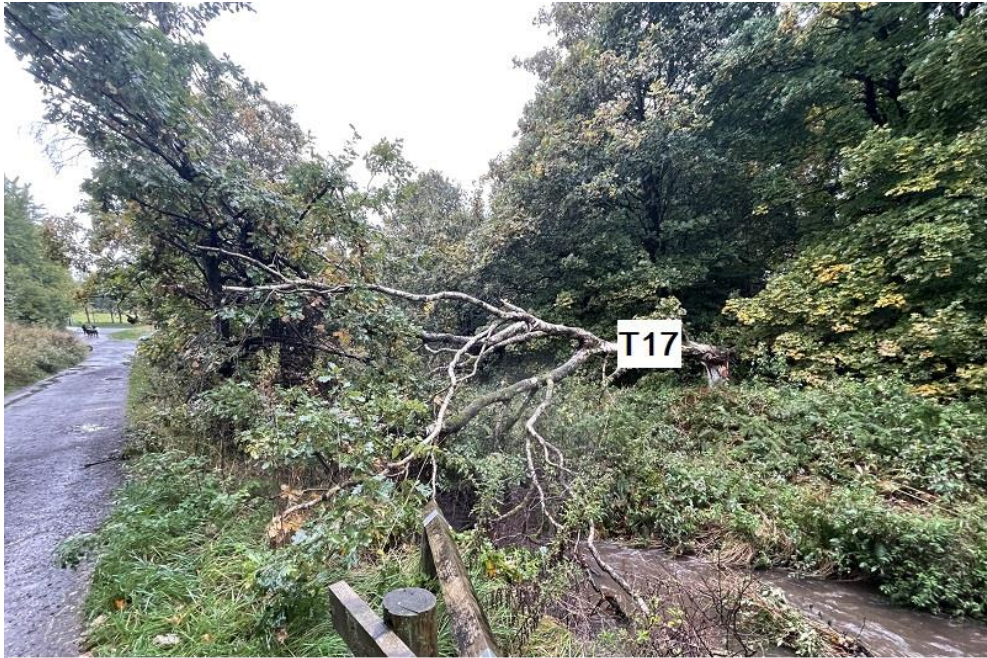
**T17 Large fallen tree across the river, Cut up, drag out and stack on the banking.**

T17 – Silver Birch.

This tree is a standing dead stem which has split out previously.

We would recommend removal of the Silver Birch tree because where the tree is situated, and the risk involved.
