## Asbestos Refurbishment Survey

### Milnrow Building - Middleton

**A & L Reference : 37263**

Rochdale Road  
Middleton  
Greater Manchester  
M24 6XH

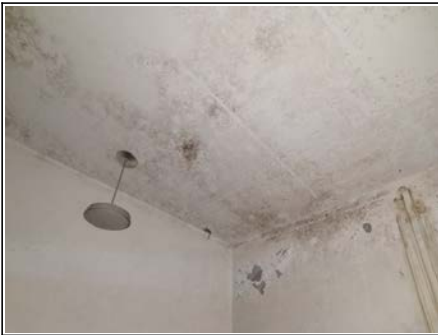
| | No Asbestos Detected | 001 | | Paint Coating | |
| | <b>Comment:</b> | No asbestos was detected in the sample of paint coating to the ceiling and top edge of the wall ref: 37263/001. | | | |

| | <b>Recommendation:</b> | No further action required. | | | |

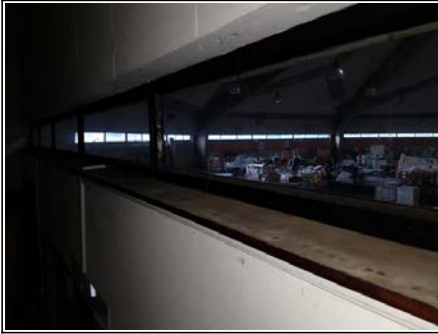
| | No Asbestos Detected | 002 | | Mastics | |
| | <b>Comment:</b> | No asbestos was detected in the sample of mastic seal to the metal window frames ref: 37263/002. | | | |

| | <b>Recommendation:</b> | No further action required. | | | |

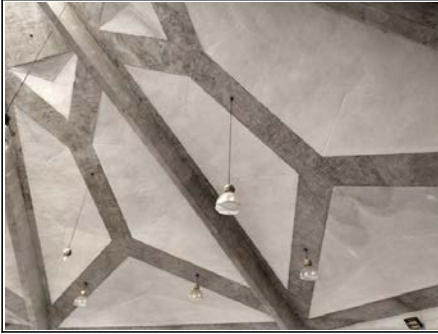
| | Asbestos Confirmed | A10492/06 | Chrysotile | Sprayed Coating | Sprayed Coating |
| | <b>Comment:</b> | The sample of the sprayed coating to the infill sections of the ceiling has been identified as containing Chrysotile (White) Asbestos. | | | |

| | <b>Recommendation:</b> | The sprayed coating should be removed prior to any refurbishment works at the site, should the materials not be disturbed during the planned refurbishment works or removed within the 3 months period stated within HSG264, then provision should be made for the continued management of the sprayed coating. | | | |

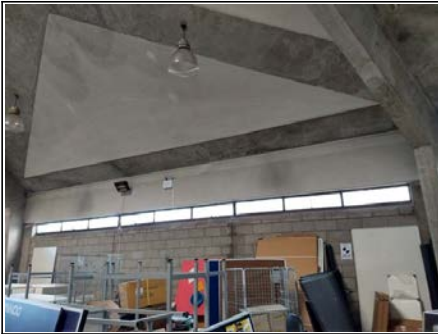
| | <b>Asbestos Confirmed</b> | 003 | Chrysotile | Textured Coating | Textured Coating |
| | <b>Comment:</b> | The sample of the textured coating to the top edge of the perimeter wall has been identified as containing Chrysotile (White) asbestos. | | | |

| <b>Recommendation:</b> | | The textured coating should be removed prior to any refurbishment works at the site, should the materials not be disturbed during the planned refurbishment works or removed within the 3 months period stated within HSG264, then provision should be made for the continued management of the textured coating. | | | |

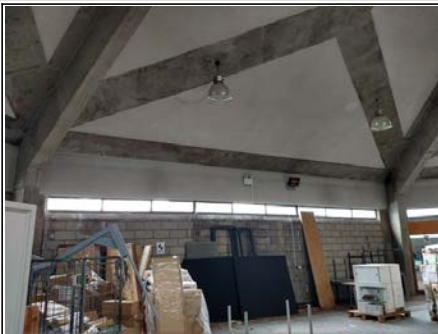
| | <b>Asbestos Confirmed</b> | 004 | Chrysotile | Textured Coating | Textured Coating |

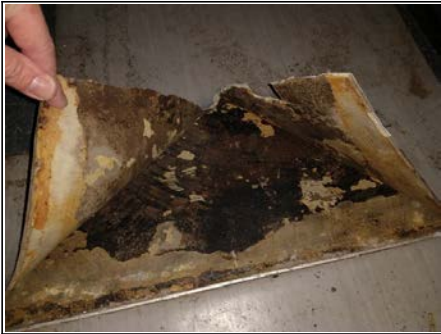
| Room Reference<br>Product Type | Risk Score | Comment | Recommendation |
|---|---|---|---|
| 0-004 Vestry<br>Bitumen Adhesive | 2 | The sample bitumen adhesive under the vinyl floor covering and carpet has been identified as containing Chrysotile (White) asbestos. | The bitumen adhesive should be removed under controlled conditions prior to the planned works. Should the materials not be disturbed during the planned refurbishment works or removed within the 3 months period stated within HSG264, then provision should be made for the continued management of the materials. |

| | <b>Asbestos Confirmed</b> | 005 | Chrysotile | Bitumen Adhesive | Bitumen |
| | <b>Comment:</b> | The sample bitumen adhesive under the vinyl floor covering and carpet has been identified as containing Chrysotile (White) asbestos. | | | |

| | <b>Recommendation:</b> | The bitumen adhesive should be removed under controlled conditions prior to the planned works. Should the materials not be disturbed during the planned refurbishment works or removed within the 3 months period stated within HSG264, then provision should be made for the continued management of the materials. | | | |

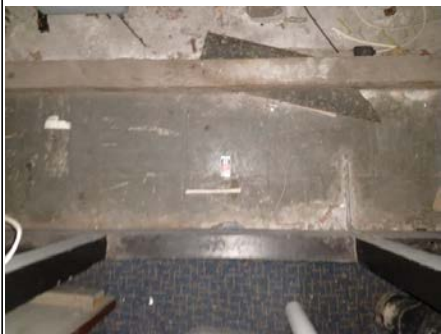
| Room Reference<br>Product Type | Risk Score | Comment | Recommendation |
|---|---|---|---|
| 0-004 Vestry<br>Floor Tiles | 2 | The sample of the grey floor tiles and bitumen adhesive found within the cupboards to the room perimeter has been identified as containing Chrysotile (White) asbestos. | The floor tiles should be removed prior to any refurbishment works at the site, should the materials not be disturbed during the planned refurbishment works or removed within the 3 months period stated within HSG264, then provision should be made for the continued management of the floor tiles. |

| | <b>Asbestos Confirmed</b> | 006 | Chrysotile | Floor Tiles | Floor Tiles. |

| | <b>Recommendation:</b> | The floor tiles should be removed prior to any refurbishment works at the site, should the materials not be disturbed during the planned refurbishment works or removed within the 3 months period stated within HSG264, then provision should be made for the continued management of the floor tiles. | | | |

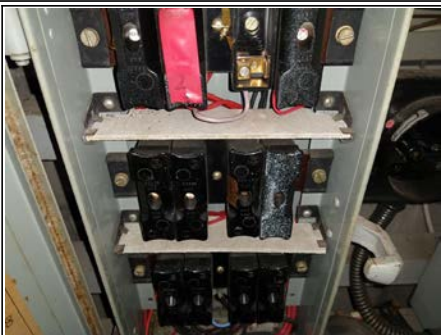
| | <b>Asbestos Confirmed</b> | 007 | Chrysotile | Cement Panel(s) | Cement |

| | <b>Recommendation:</b> | If the electrical system is to be decommissioned and removed from site, then the whole unit should be removed with the cement still in situ and disposed of as asbestos waste. | | | |

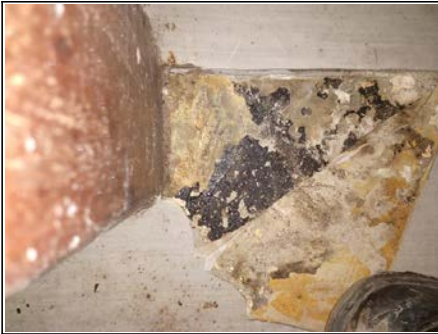
| Room Reference<br>Product Type | Risk Score | Comment | Recommendation |
|---|---|---|---|
| 0-005 Toilet<br>Bitumen Adhesive | 2 | The sample bitumen adhesive under the vinyl floor covering has been identified as containing Chrysotile (White) asbestos. | The bitumen adhesive should be removed under controlled conditions prior to the planned works. Should the materials not be disturbed during the planned refurbishment works or removed within the 3 months period stated within HSG264, then provision should be made for the continued management of the materials. |

| | <b>Asbestos Confirmed</b> | As005 | Chrysotile | Bitumen Adhesive | Bitumen |

| <b>Recommendation:</b> | | The bitumen adhesive should be removed under controlled conditions prior to the planned works. Should the materials not be disturbed during the planned refurbishment works or removed within the 3 months period stated within HSG264, then provision should be made for the continued management of the materials. | | | |

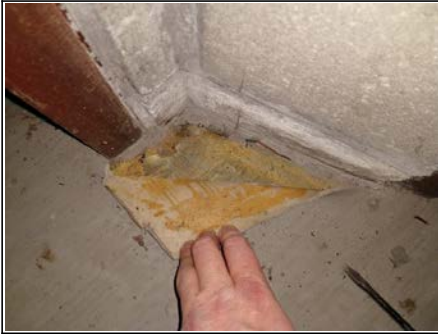
| Room Reference<br>Product Type | Risk Score | Comment | Recommendation |
|---|---|---|---|
| 0-006 Lobby<br>Bitumen Adhesive | 2 | The sample bitumen adhesive under the vinyl floor covering has been identified as containing Chrysotile (White) asbestos. | The bitumen adhesive should be removed under controlled conditions prior to the planned works. Should the materials not be disturbed during the planned refurbishment works or removed within the 3 months period stated within HSG264, then provision should be made for the continued management of the materials. |

| | <b>Asbestos Confirmed</b> | As005 | Chrysotile | Bitumen Adhesive | Bitumen |

| <b>Recommendation:</b> | | The bitumen adhesive should be removed under controlled conditions prior to the planned works. Should the materials not be disturbed during the planned refurbishment works or removed within the 3 months period stated within HSG264, then provision should be made for the continued management of the materials. | | | |

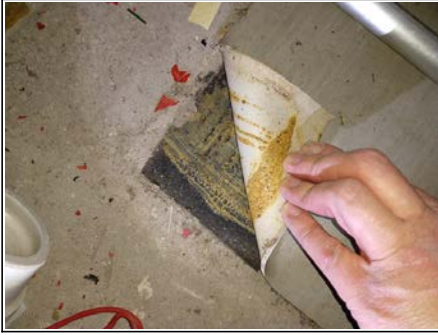
| Room Reference<br>Product Type | Risk Score | Comment | Recommendation |
|---|---|---|---|
| 0-007 Store<br>Bitumen Adhesive | 2 | The sample bitumen adhesive under the vinyl floor covering has been identified as containing Chrysotile (White) asbestos. | The bitumen adhesive should be removed under controlled conditions prior to the planned works. Should the materials not be disturbed during the planned refurbishment works or removed within the 3 months period stated within HSG264, then provision should be made for the continued management of the materials. |

| | <b>Asbestos Confirmed</b> | As005 | Chrysotile | Bitumen Adhesive | Bitumen |

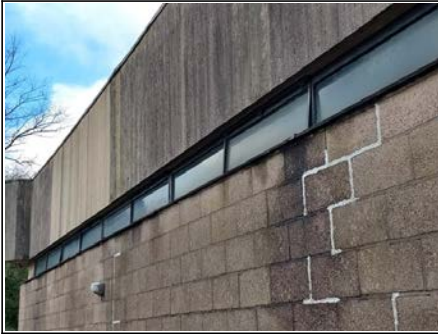
| | <b>Room Number:</b> External | | <b>Room Reference:</b> To Building | | <b>Review Date:</b> |

| | No Asbestos Detected | 008 | | Mastics | |

| | <b>Recommendation:</b> | No further action required. | | | |

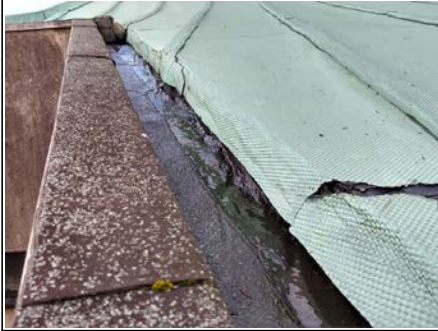
| | <b>Room Number:</b> External | | <b>Room Reference:</b> To Building | | <b>Review Date:</b> |

| | No Asbestos Detected | 009 | | Roofing Felt | |

| | <b>Recommendation:</b> | No further action required. | | | |

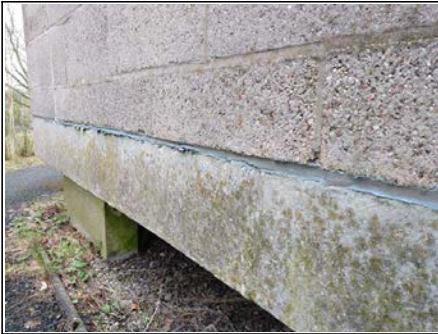
| | No Asbestos Detected | 010 | | Bitumen | |

| | <b>Recommendation:</b> | No further action required. | | | |

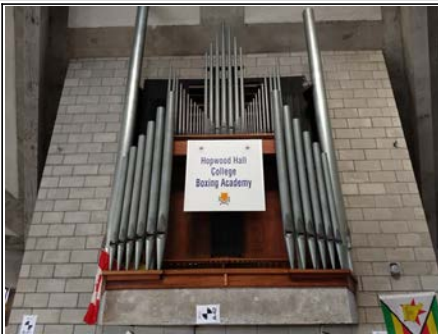
| | No Access | | | No Access | |
