# Demolition Asbestos Survey Report

Buildings A & B, Greenhill Road, Middleton, Manchester, M24 2BB

| <b>Survey Type:</b> | <b>Demolition Asbestos Survey.</b> | |
| <b>Job Reference:</b> | <b>JPR/AR/3807.</b> | |

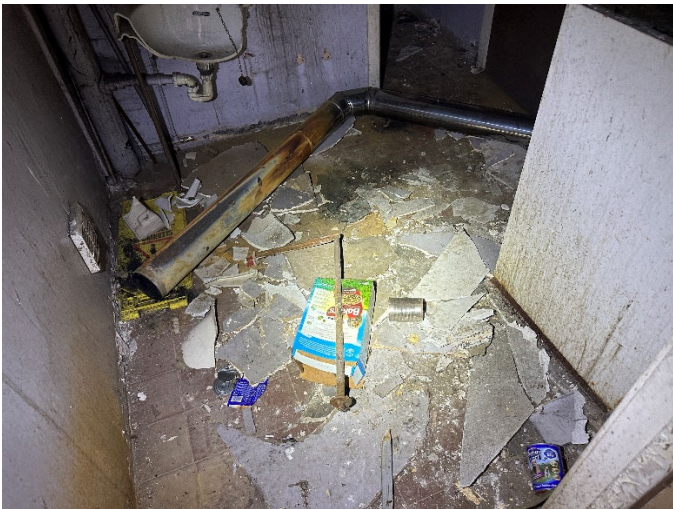
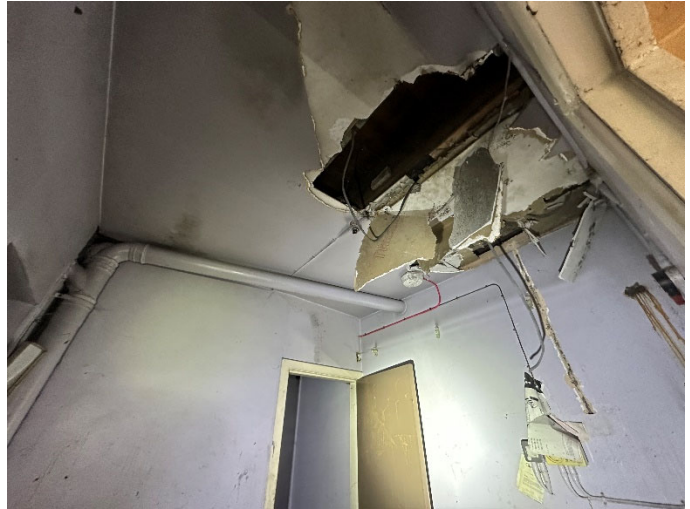
| <b>Sample Number:</b> | <b>Sample G/01</b> | | |

**Sample G/01:** Asbestos insulation board (AIB), lined ceiling, above plasterboard. The ceiling has been damaged and there is associated extensive debris within the room.

Amosite (brown) & Chrysotile (white) asbestos

Poor condition

Approx 08 Sqm

Remove all asbestos and decontaminate affected areas, prior to demolition. All works with asbestos must be undertaken in accordance with the Control of Asbestos Regulations 2012 and it's supporting approved code of practice and guidance. Deny access to the area until works are undertaken.

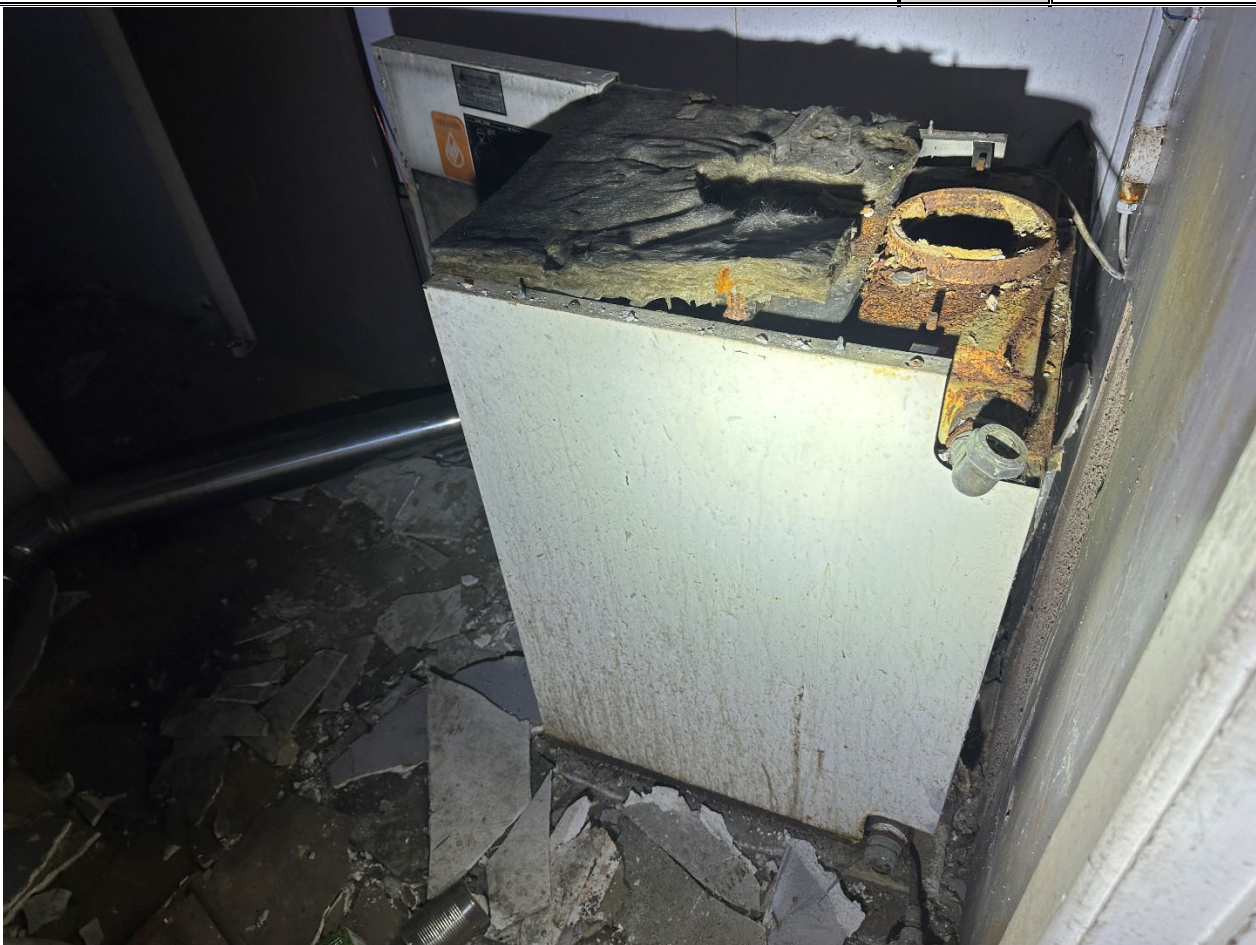
| <b>Sample Number:</b> | <b>Suspected Asbestos/01 (No access to sample)</b> | | |

**Suspected Asbestos/01 (No access to sample):** Suspected asbestos gaskets within the structure of the boiler. Due to heavy asbestos contamination within the room, we did not dismantle the boiler to assess. The boiler should be removed/disposed of whole, or be inspected further, once the area is cleared of the asbestos debris.

Chrysotile (white) asbestos  
(Typical content of possible gaskets)

Medium condition

X1 Boiler

Remove all asbestos prior to demolition. All works with asbestos must be undertaken in accordance with the Control of Asbestos Regulations 2012 and it's supporting approved code of practice and guidance.

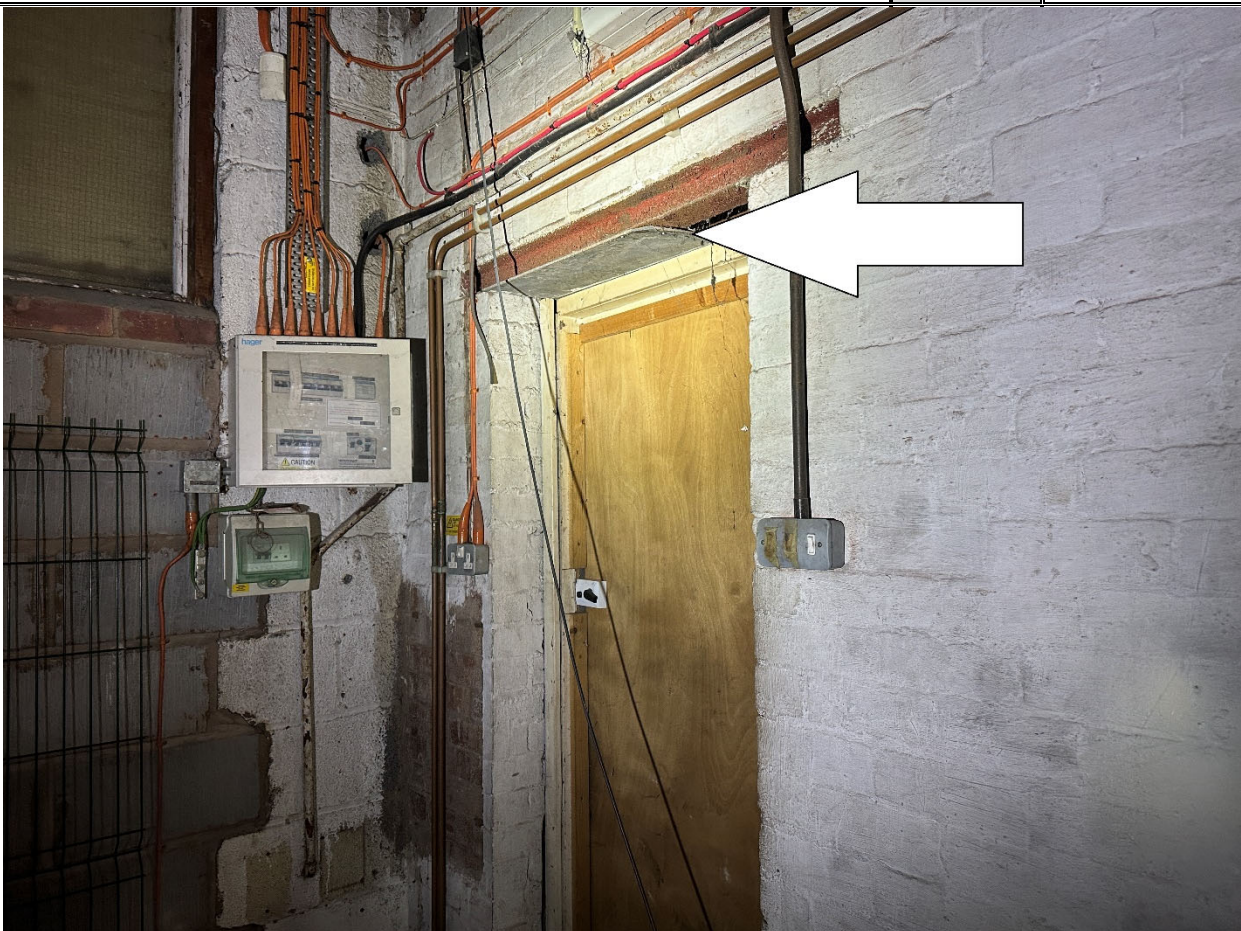
| <b>Sample Number:</b> | <b>Known Asbestos/01 (Surveyor Confirmed)</b> | | |

**Known Asbestos/01 (Surveyor Confirmed):** Small piece of asbestos cement flat sheet fixed above the door.

Chrysotile (white) asbestos

Good condition

X1 panel

Remove all asbestos prior to demolition. All works with asbestos must be undertaken in accordance with the Control of Asbestos Regulations 2012 and it's supporting approved code of practice and guidance.

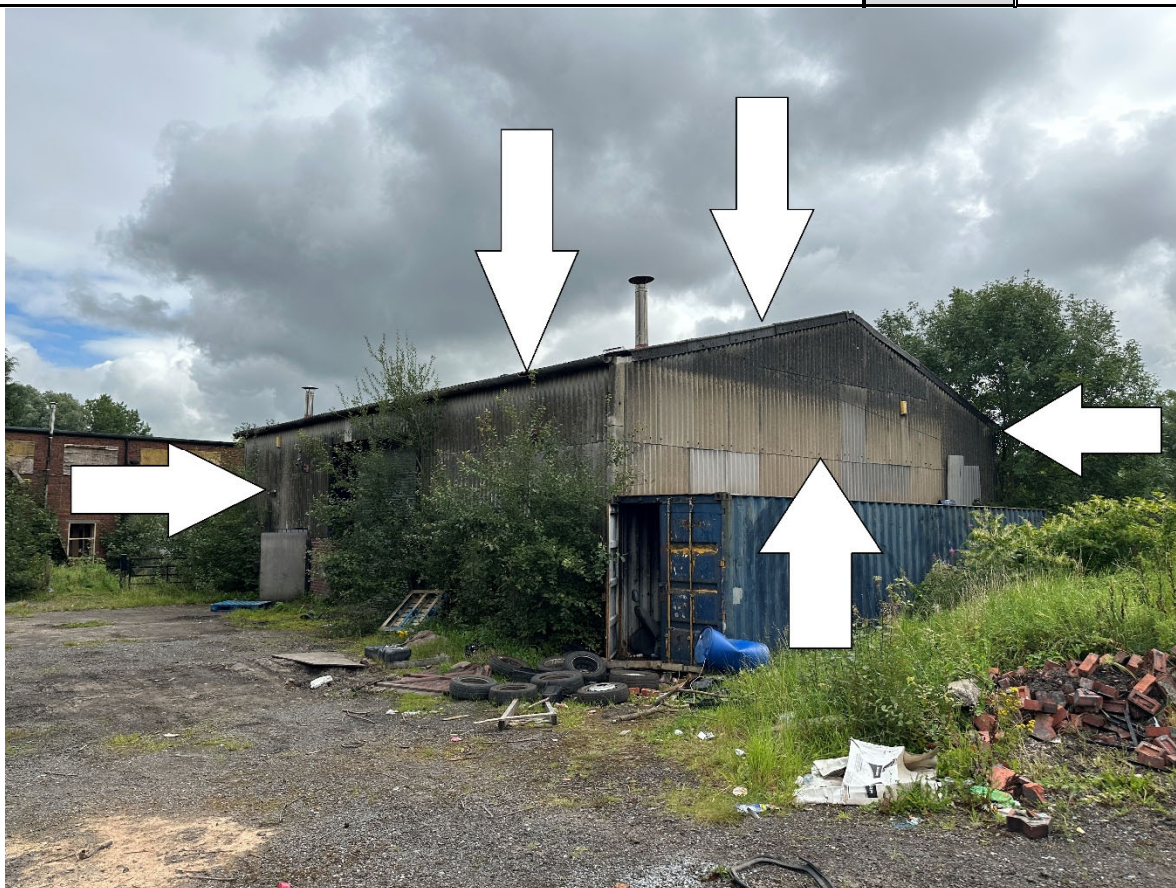
| <b>Sample Number:</b> | <b>Sample G/06</b> | | |

**Sample G/06:** Asbestos cement corrugated wall sheets, roof sheets, and associated rainwater goods, there was a loose sheet and loose asbestos downpipe in between the end of the building on the ward, and the oil tanks trims.

| <b>Asbestos Type</b> | Chrysotile (white) asbestos |
| <b>Condition</b> | Medium condition |
| <b>Approximate Quantity</b> | All corrugated roof sheets.<br>All corrugated walls.<br>All trims, gutters and downpipes. |

Remove all asbestos prior to demolition. All works with asbestos must be undertaken in accordance with the Control of Asbestos Regulations 2012 and it's supporting approved code of practice and guidance.

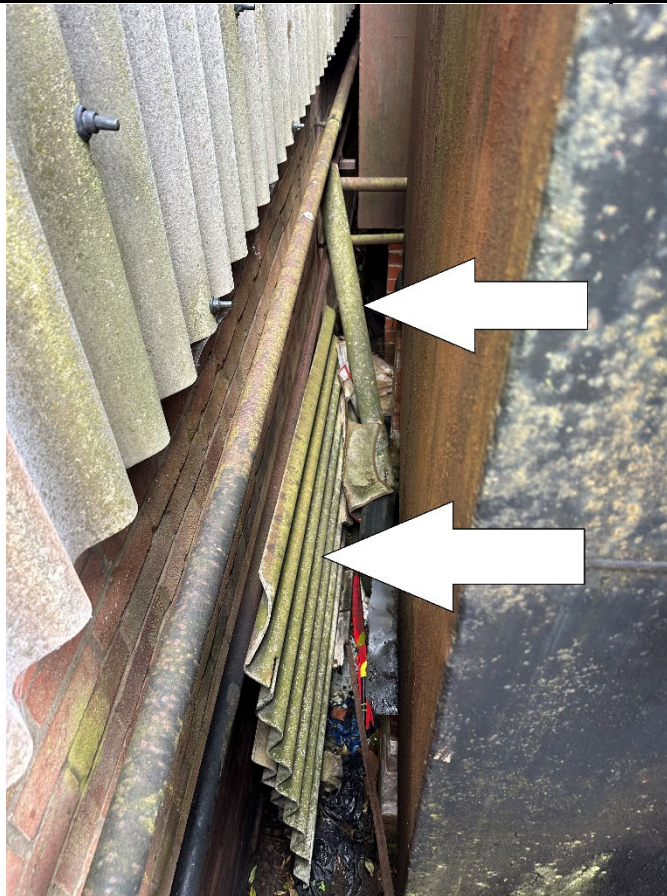
| <b>Sample Number:</b> | <b>As Sample G/06</b> | | |

**As Sample G/06:** Loose asbestos cement corrugated wall sheets and downpipe, between the unit and the oil tanks.

Chrysotile (white) asbestos

Poor condition

Two loose sheets, one loose downpipe

Remove all asbestos prior to demolition. All works with asbestos must be undertaken in accordance with the Control of Asbestos Regulations 2012 and its supporting approved code of practice and guidance.
