**ENGINEERING REPORT 8874**

**GREENGATE HILL FARM  
ASHWORTH ROAD  
ROCHDALE  
OL11 5UN**

**CLIENT: MR C CAMPBELL**

**11.04.2023 MP/CH**

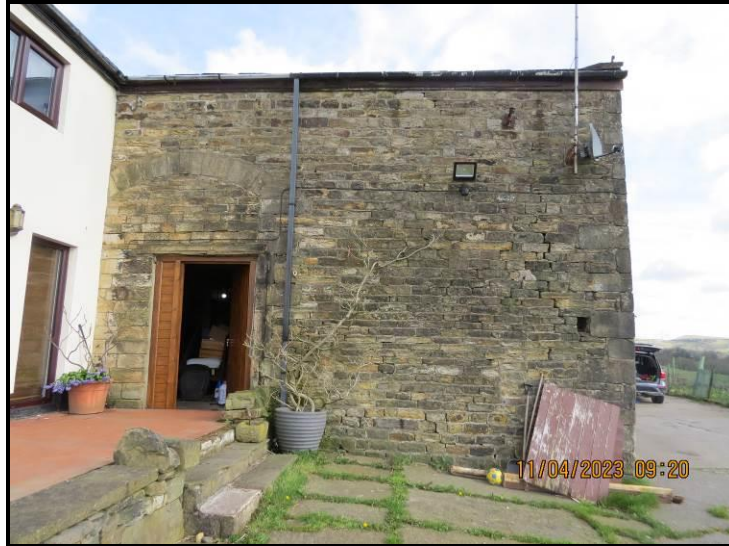
Photograph 006 South West flank wall

- 4.1 The South Western elevation extends for a length in the order of 6.4 metres incorporating the original stone arch doorway (infilled) with a personnel door formed within the infilled former 'taking-in' door, whilst retaining the natural stone quoins on the right hand aspect. (Photographs 006, 010).

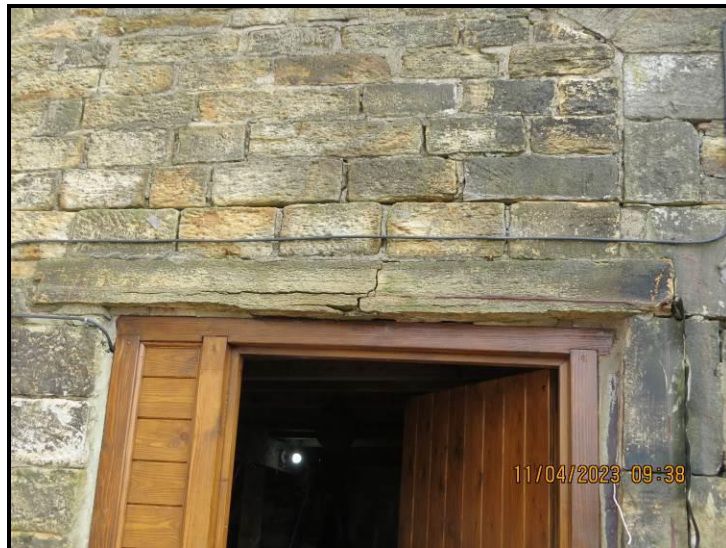
Photograph 013 Failed lintel

- 4.2 The 100mm deep stone lintel has failed in the centre, although there is minimal disturbance to the upper stone coursing. (Photograph 013).

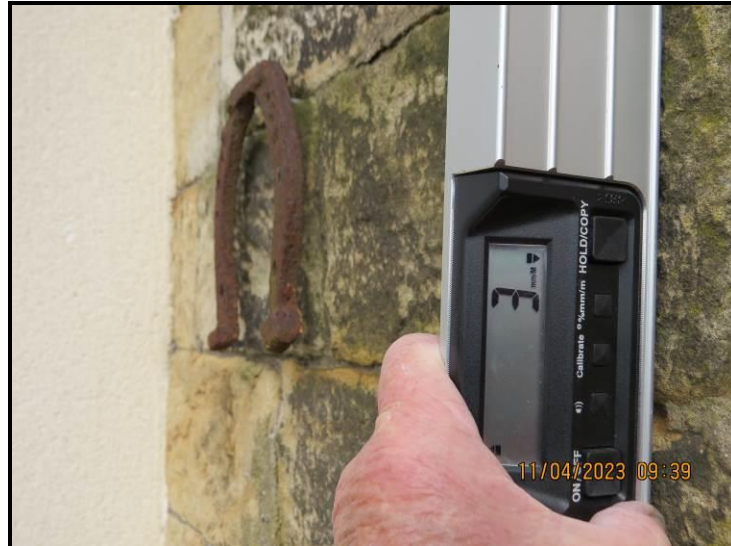
**Photograph 014 Good vertical alignment, chainage 1 metre**

- 4.3 The vertical alignment to both the left and right hand door jambs is good with irregularities less than 5mm per metre. (Photographs 014, 017, 028).

- 4.8 In the vertical plane the alignment is good with irregularities less than 5mm per metre on the South Western elevation and on the return South Eastern gable circa 25mm per metre. (Photograph 014).

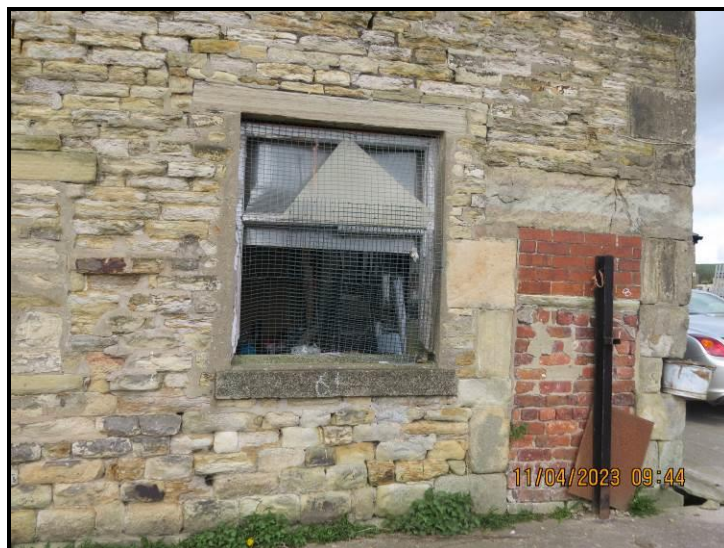
Photograph 021 Gable, ground floor, chainage 5 – 8.20 metres

- 5.1 The South Eastern gable of the original barn is completed in a randomly coursed local stonework with evidence of significant weathering particularly in the mid-section. (Photograph 001).
- 5.2 The elevation incorporates original personnel doors at the left and right hand corners, doorways supported on 300mm deep stone lintels infilled with Crowthers common brick, between chainage 0.5 – 1.5 and in seconds facing brick between chainage 7 – 8 metres. (Photographs 008, 020, 021).

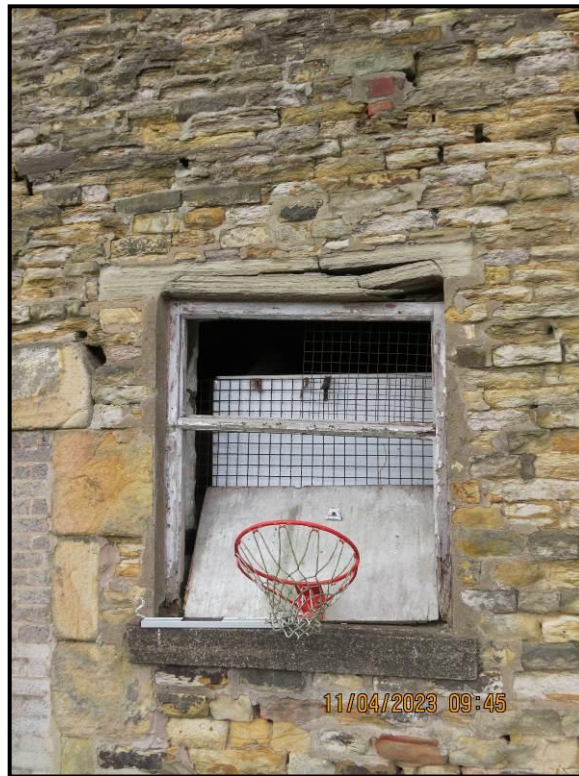
**Photograph 022 Failed lintel, chainage 2 – 3 metres**

- 5.3 The original lintel on the right hand corner (chainage 7 – 8.5 metres) has failed, a shear crack consistent with slight tilting and settlement towards the right hand North East flank wall. (Photograph 022).

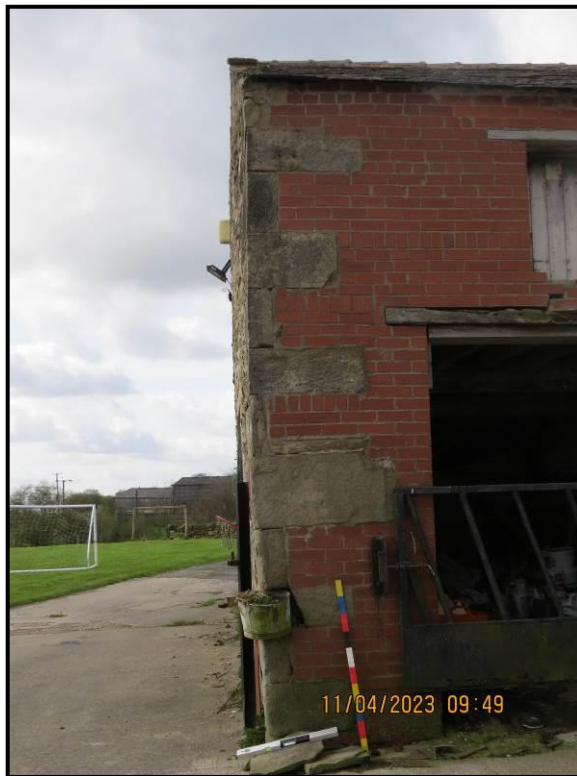
Photograph 029 Vertical profile

- 5.8 At chainage 4 – 4.6 metres a former window has been infilled in matching stonework, the vertical alignment of the wall is good with irregularities less than 5mm per metre.
- 5.9 The vertical profile of the gable is reasonable. (Photographs 026, 029).

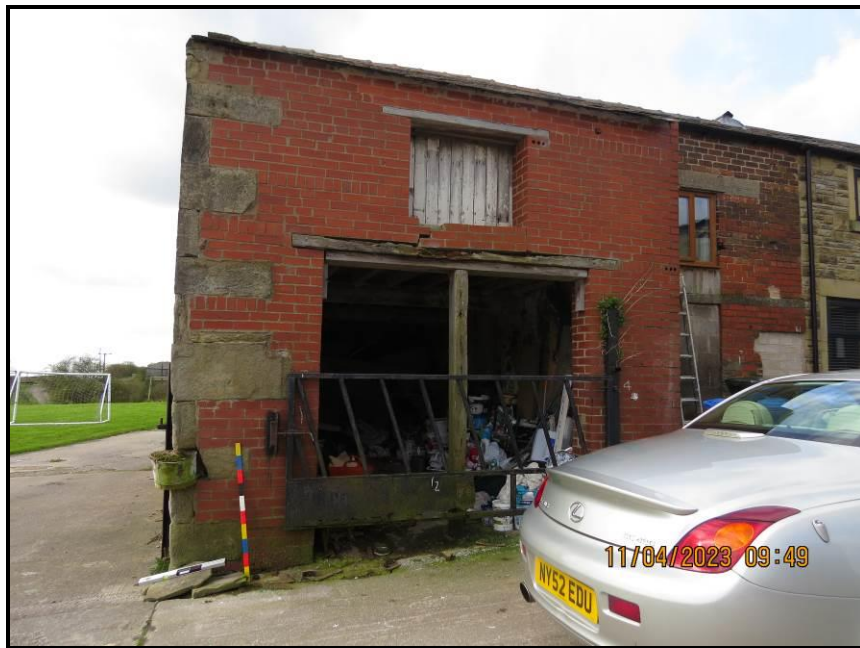
**Photograph 030 North West flank, chainage 0 – 43 metres**

- 6.1 The North Eastern flank wall follows a stepped profile on plan extending for a length of 8.5 metres (approximately) to the narrower stone faced outshoot of the farm.
- 6.2 The full length of the stepped flank wall is completed in seconds Accrington facing brick with variable sized openings, windows etc. at ground and first floor level. (Photographs 030, 003, 004).

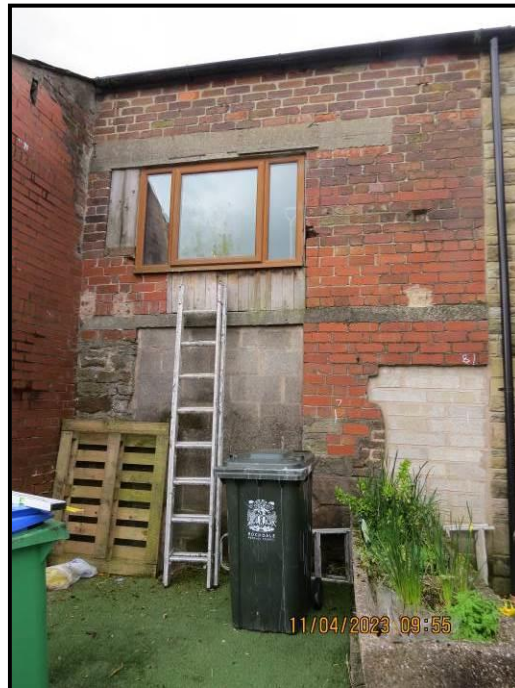
**Photograph 039 North East flank, chainage 5 – 8 metres**

- 6.7 At chainage 4.6 metres, the width of the outshoot reduces to 1.9 metres, finished in seconds Accrington facing brick. (Photograph 037).
- 6.8 There are no signs of any separation where the return rear wall adjoins the original stone flank of the original barn construction. (Photographs 038, 042).
- 6.9 The Northern flank wall continues for a further 3.4 metres adjoining the newer outshoot construction to the farmhouse. (Photograph 039).

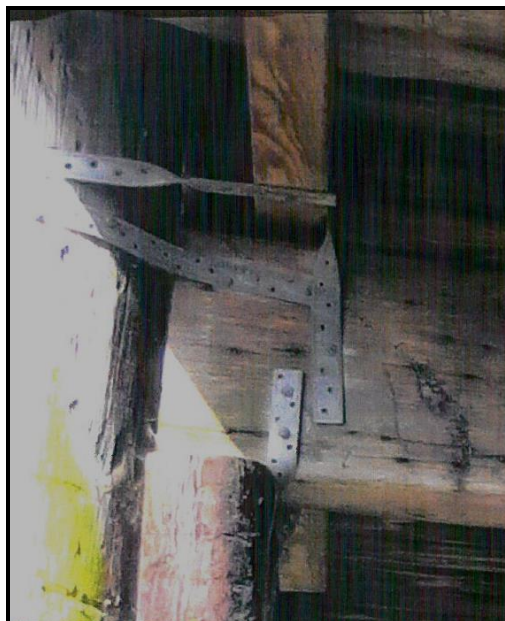
**Photograph 091E**

- 11.5 The vertical alignment of the timber columns both longitudinally and laterally is good, the mid frontage column is supplemented with an additional 250mm x 250mm timber column supporting the main central floor beam spanning between the front and rear elevations, with galvanised joist hanger restraints to the main columns and the lateral floor beam. (Photographs 091, 091E).

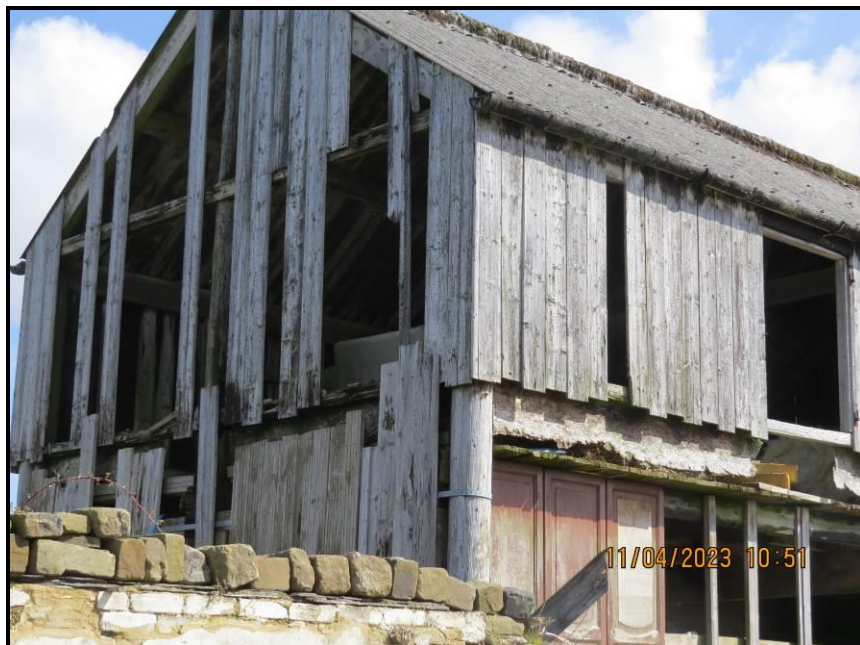
**Photograph 104 Two storey shippon – gable**

- 11.6 The floor beams spanning between the front and rear walls is a 300mm x 150mm timber section supporting 150mm x 75mm floor joists at 400mm – 450mm centres.
- 11.7 The horizontal alignment of the main beam and floor joists is good.
- 11.8 The ground floor cladding retains the six course deep concrete plinth wall to the rear and both gables with a weathered vertical boarding on the North Western gable with damage and weathering to the timber on the North West rear elevation. (Photographs 103, 104).

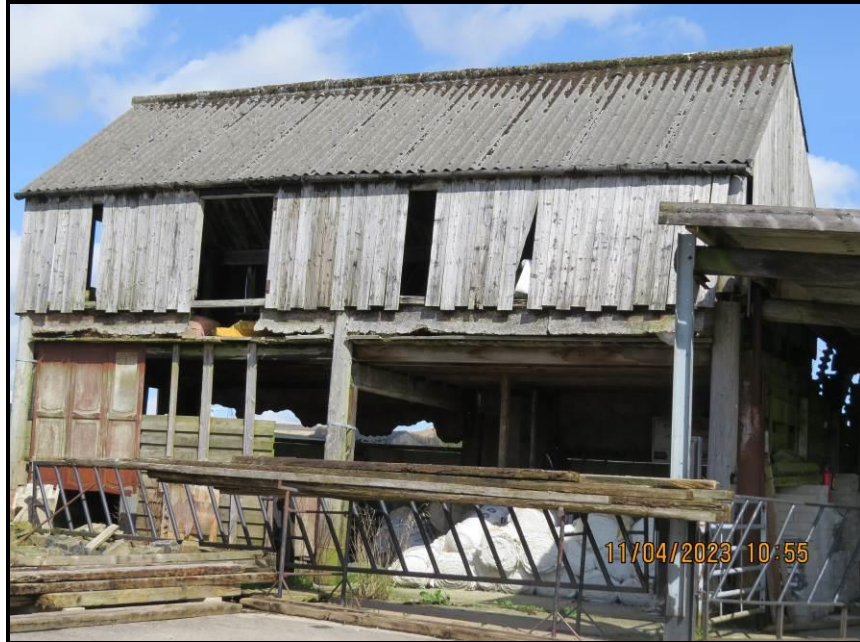
**Photograph 110 Front elevation**

- 11.12 Externally the profile of the pitched roof is good. (Photographs 109, 110).

- 11.13 The vertical cladding is in poor condition with deterioration although the vertical alignment of the main structural carcase of the building is satisfactory.

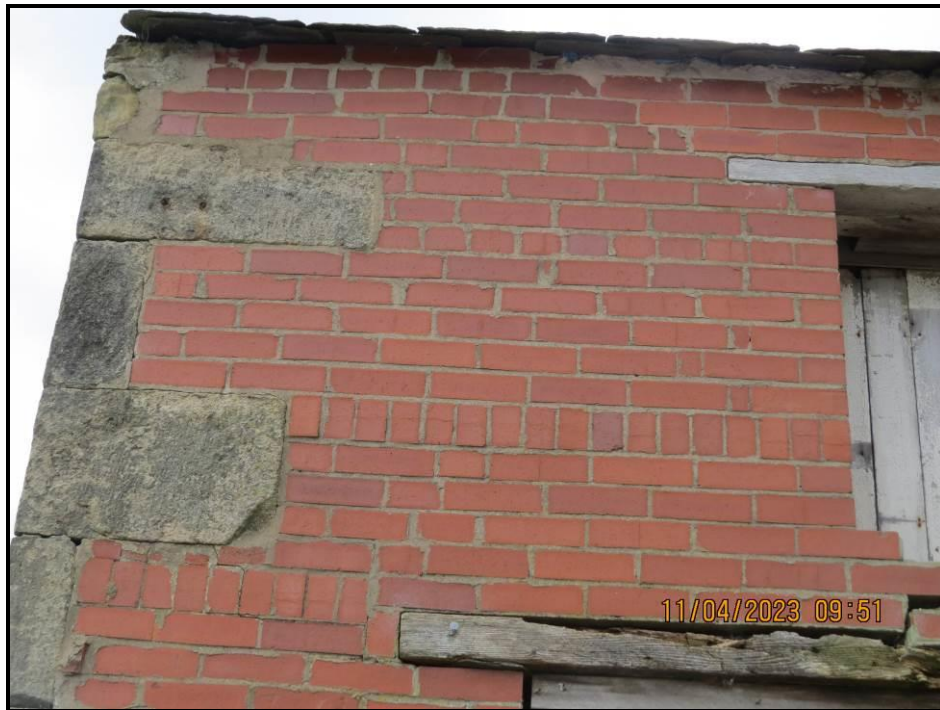
031 Lintel failure, cill collapse, chainage 0.5 – 3.3 metres

- 6.3 The “taking-in” door above the opening incorporates a three deep brick cill course which has settled given the failure of the lintel. (Photograph 031).
- 6.4 The brickwork to the wall on either side of the “taking-in” door is satisfactory. (Photographs 032, 033).
- 6.5 The stone quoins to the original barn have been retained, exhibiting some historic settlement towards the Eastern aspect.
- 6.6 In the vertical plane on either side of the main doorway, the alignment is reasonable with irregularities circa 6mm - 11mm per metre. (Photographs 034, 035).

- 10.4 The cracked brickwork above the poor lintel construction on the North East flank (right hand from gable) is caused by the inadequacy of the lintel and not by any recent movement associated with ground settlement.

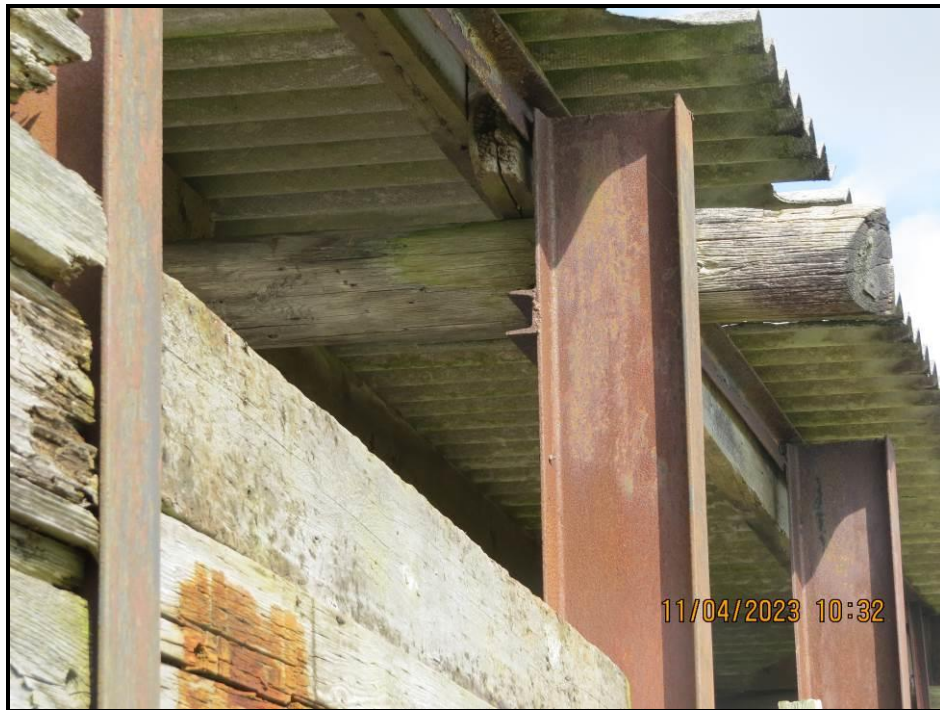
087 Typical stanchion deformation

- 12.7 The South East flank (right hand from front) incorporates the whaling sections beneath the eaves opening, the typical stanchion detail is shown in photograph 087. (Photograph 086).
