# Rochdale Borough Council

| Survey Type: | | HSG264 Refurb/Demo Asbestos Survey | |
| Building Name: | | Bowlee Bungallow | |

Original Survey Date – 19<sup>th</sup> July 2024  
Project Reference – Demo 2024

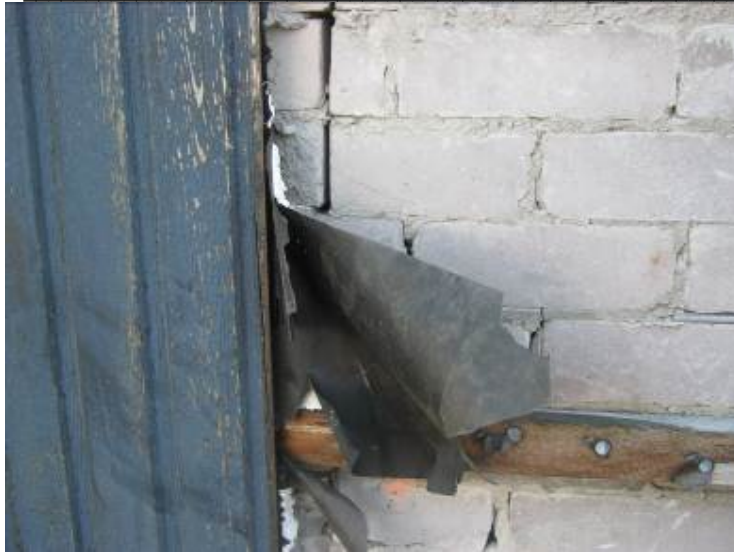
Photo Ref 297

| Paper | N/A | N/A |

**Sample Number**  
AO5580

**Chrysotile content**  
None

presumed present behind all similar timber cladding around the building

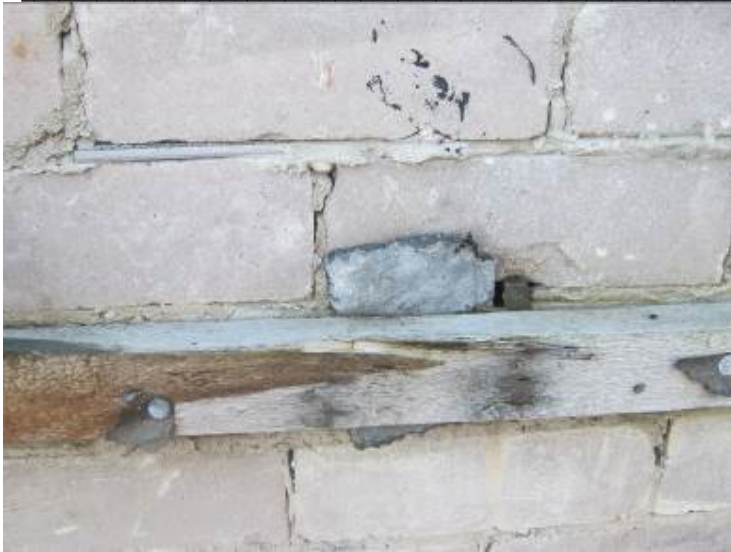
Photo Ref 298

| bitumen packer | N/A | N/A |

**Sample Number**  
AO5581

**Chrysotile content**  
None

behind timber battens

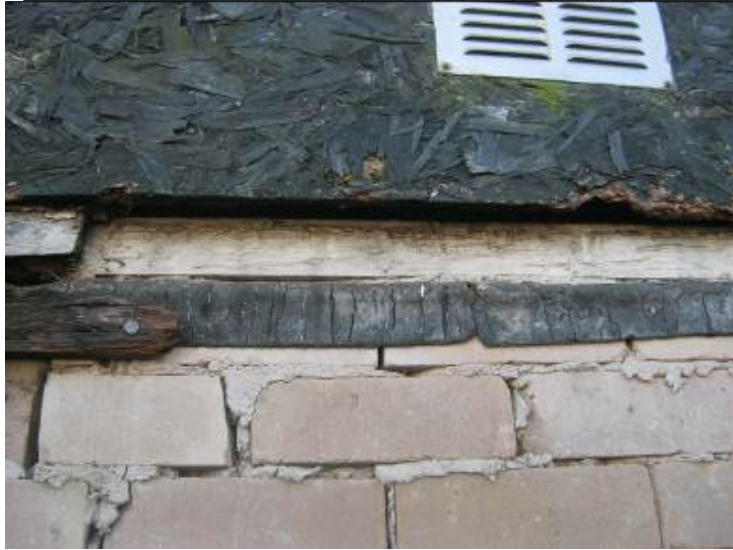
Photo Ref 299

damp proof course

None

at high level between brick and timber

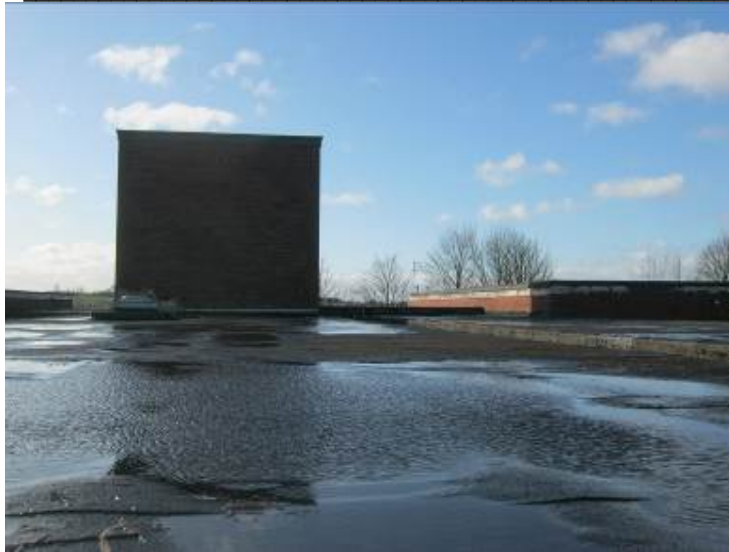
Photo Ref 300

roof felt

None
