## Spring Mill Existing Drainage summary

### Itemized actions –

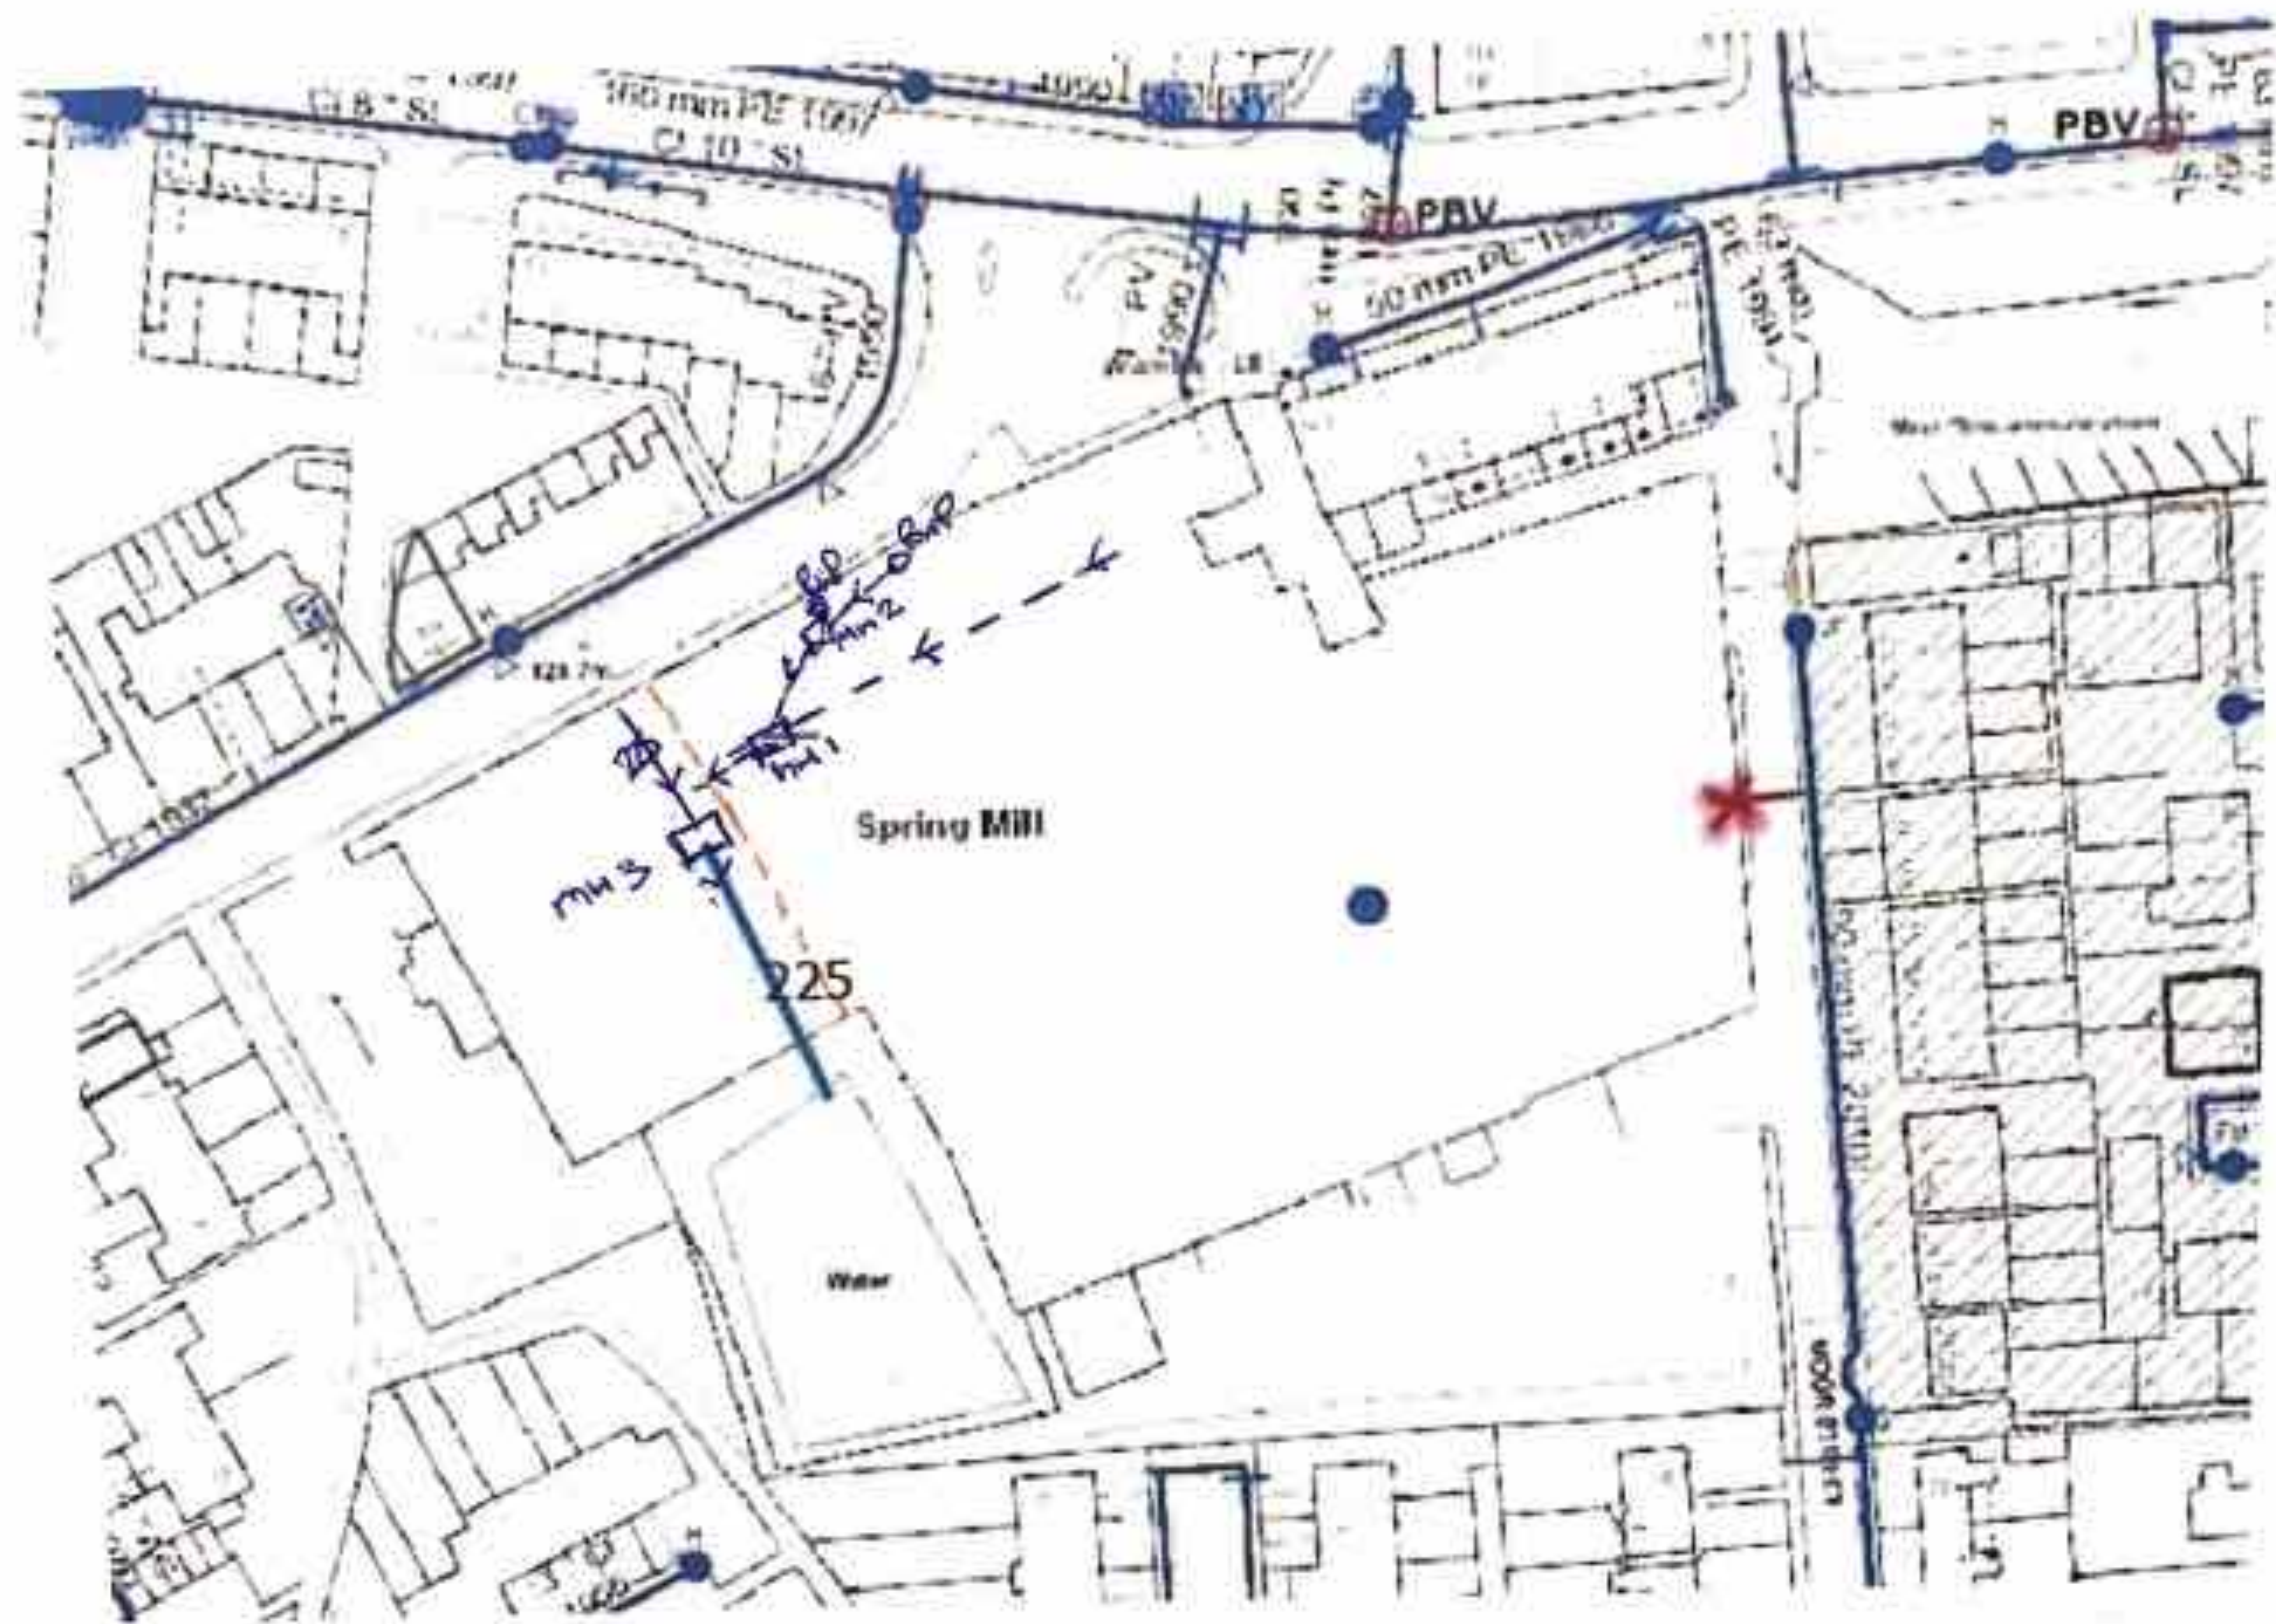
- Carried out a CCTV investigation of drain line and flow condition survey, prior to building works.
- Started survey from MHSW1 down stream the 225mm clay drainage line flows to a lateral connection shortly down stream to a mainline junction.

- Then flows to MH3.
- The drainage line and condition is in good flowing condition.
- From MH3 the survey downstream to lodge was aborted due to debris, but tested with green tracing dye, and was seen flowing into the inlet of the lodge.

- MH1 upstream mainline was CCTV and was serving rainwater drainage system of the roof, this was surveyed roughly 20 meters up stream beyond area of influence. This drainage section was in good flowing condition.

- MH1 to MH2 this survey was aborted 1 meter up stream due to a pipe defect and obstruction of flow due to debris. We would recommend a high-pressure water jetting this section and resurvey due to unknown condition of the line. But due to new construction in the area we feel it maybe better to replace the full line for new drainage.
