#### GAS MEMBRANE VALIDATION

| <b>Site: Boothroyden Road, Middleton</b> | |
| Date: 22-08-2022 | Project Number: 13-500 |
| Ground Gas Risk Assessment: Amber 2 | |

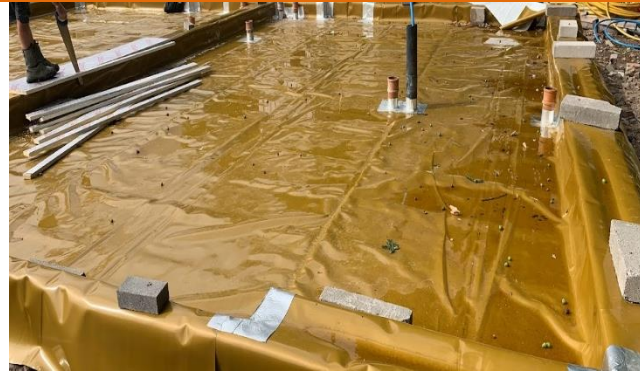
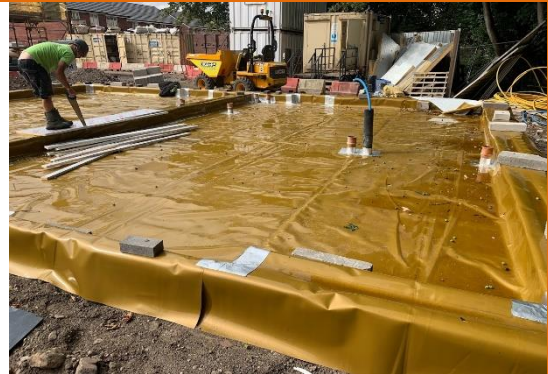
**Plot – 14**

**General Condition of Membrane-Good Condition**

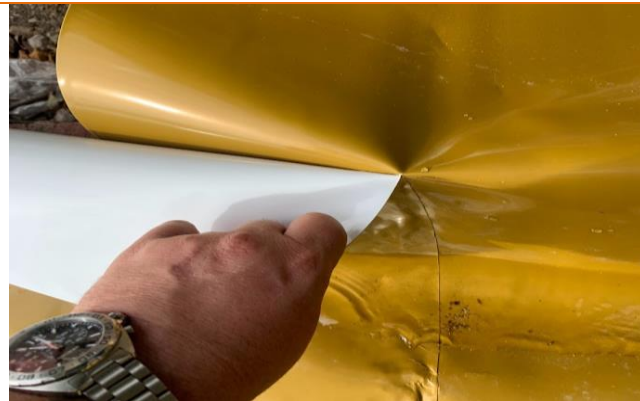
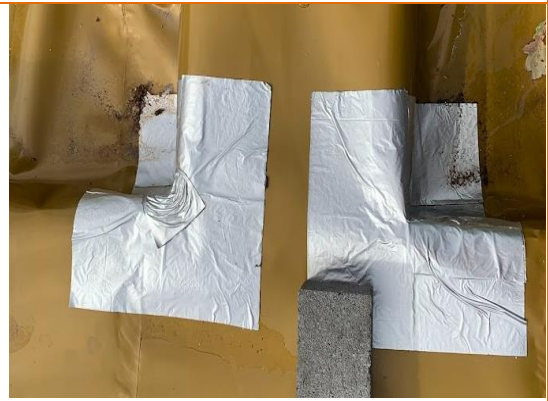
**Verification of Joints and Seals-Good Condition**

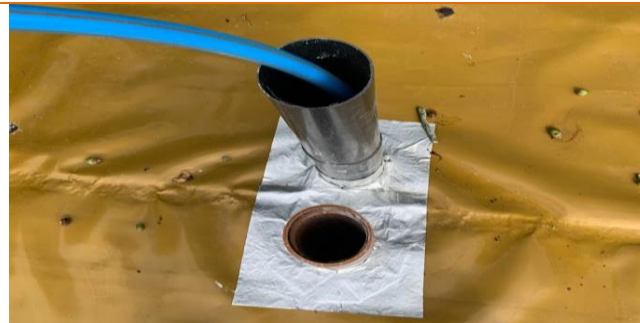
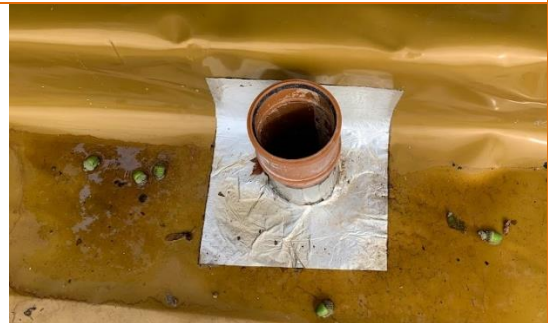
**Verification of Service Penetrations-Good Condition**

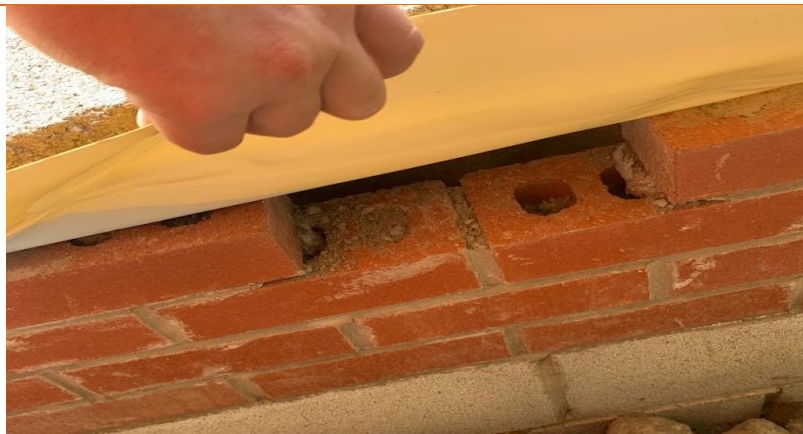
**Verification of Ventilation-Good Condition**

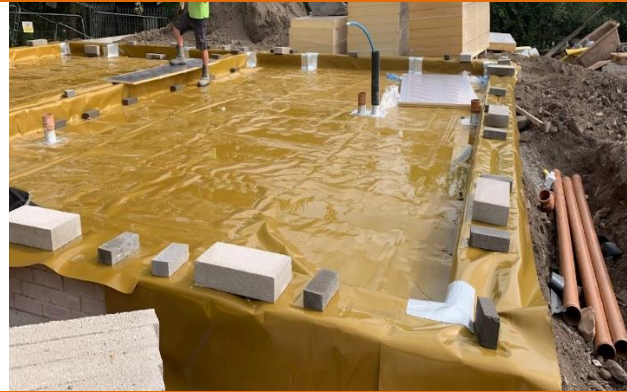
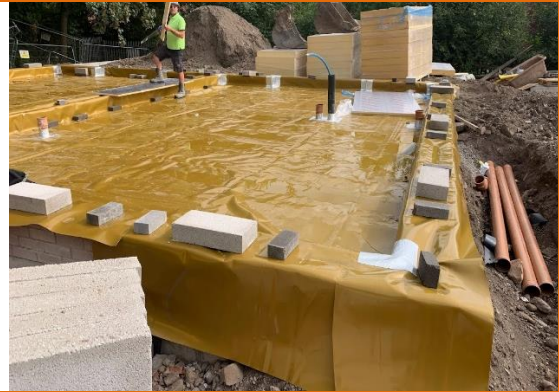
**Plot - 15**

**General Condition of Membrane-Good Condition**

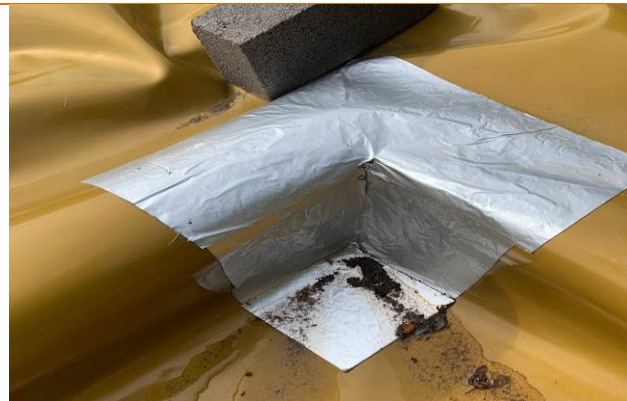
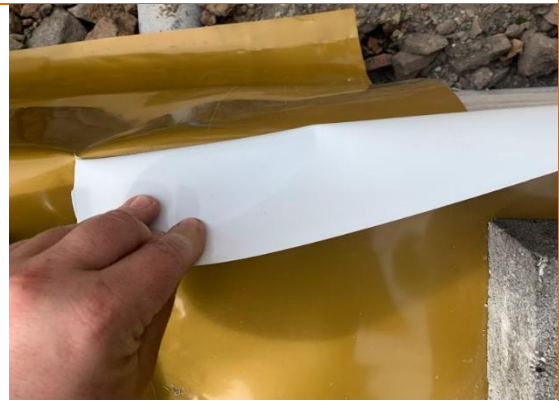
**Verification of Joints and Seals-Good Condition**

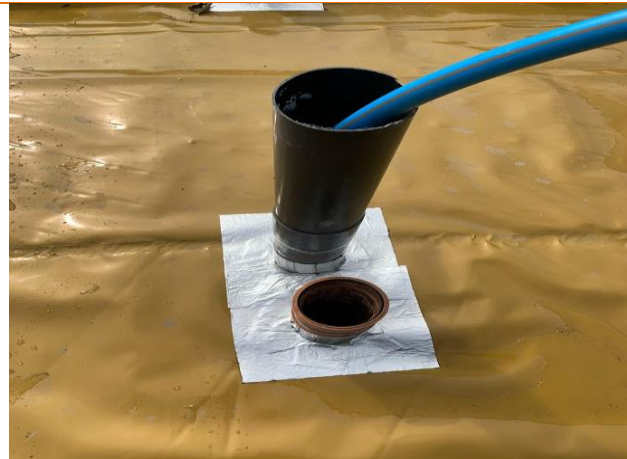
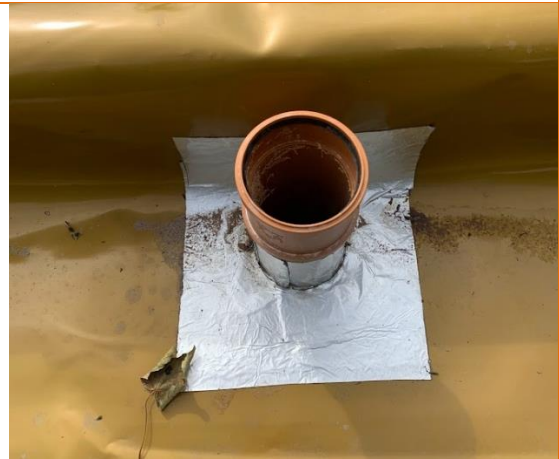
**Verification of Service Penetrations-Good Condition**

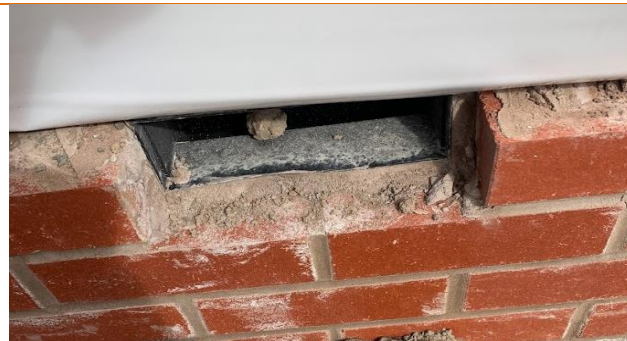
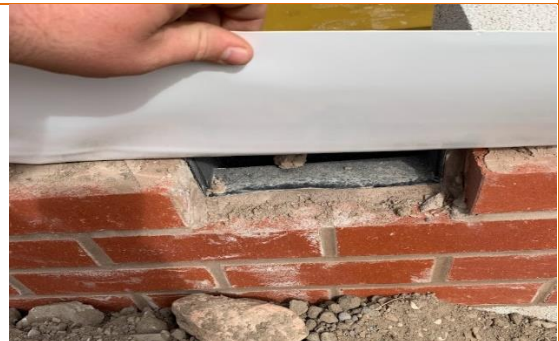
**Verification of Ventilation-Good Condition**
