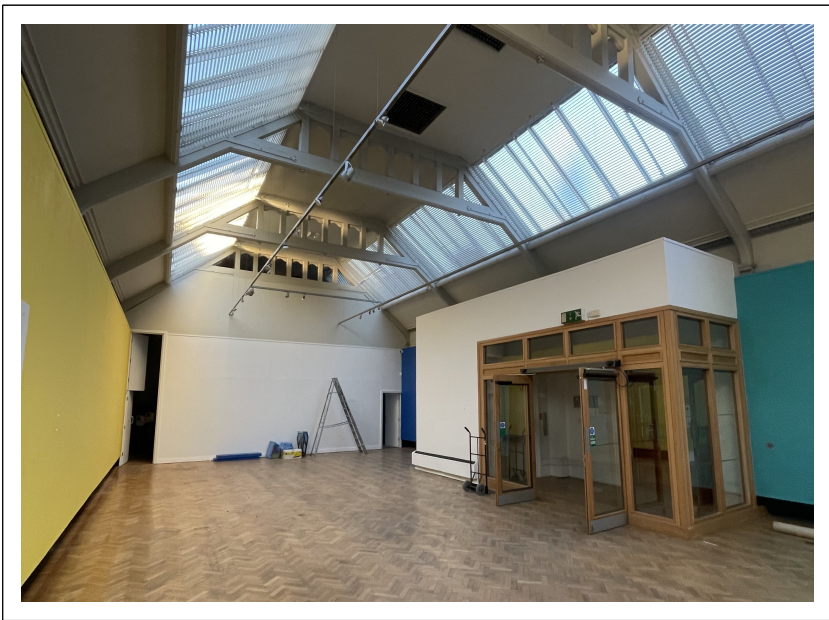
**Image 01 - Gallery 02**  
Photograph c.2024

**Notes:**  
Pipework exposed, but hidden by exhibition boards projection / shadow gap detail to base of walls. Exhibition boards are projecting further into the space than shown in historic photos. Rear partition moved to be in line with final truss to create a larger store.

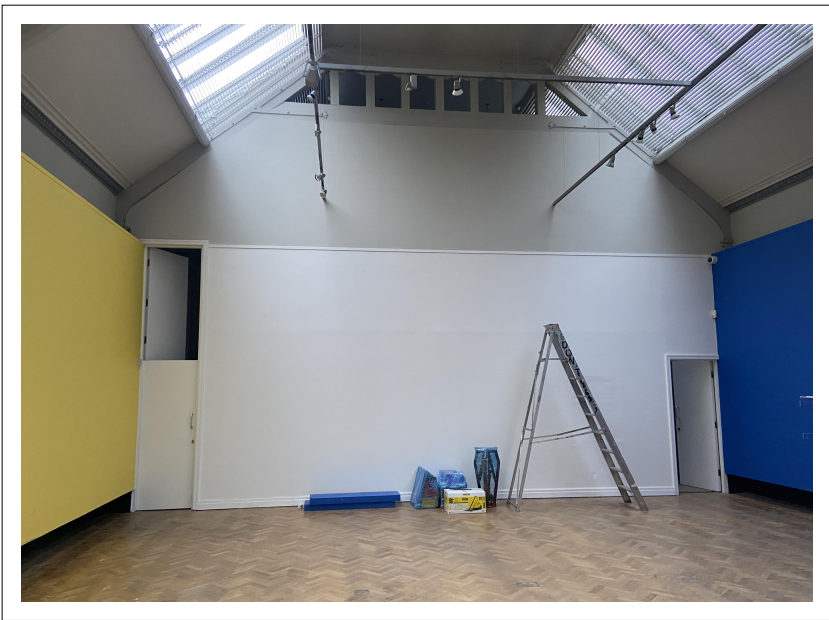
**Image 02 - Gallery 02**  
Photograph c.2024

**Notes:**  
Closer view of rear partition moved to be in line with final truss to create a larger store and additional door to the right hand side compared to the original design.

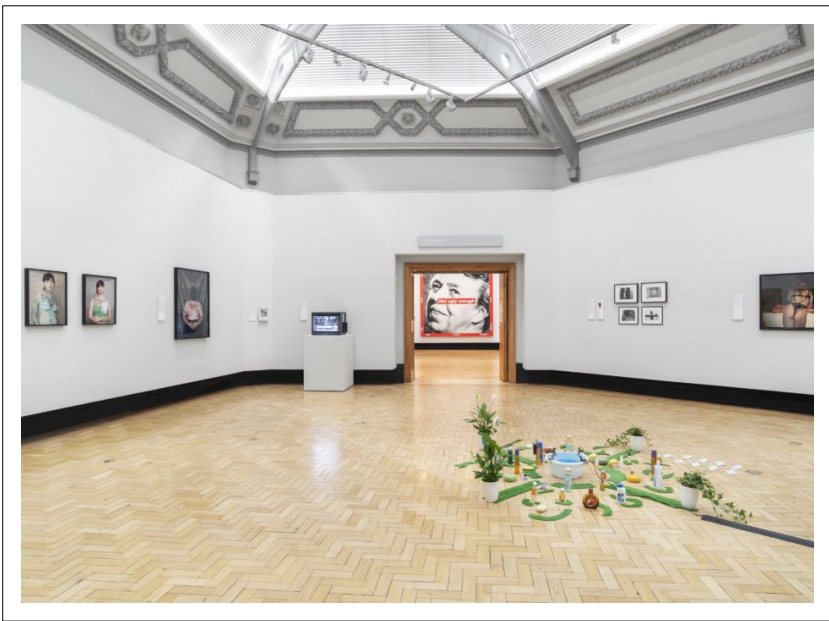
**Image 03 - Gallery 03**  
Photograph c.2024

**Notes:**  
Pipework exposed, but hidden by exhibition boards projection / shadow gap detail to base of walls. No sign of the original heating panelling detail.

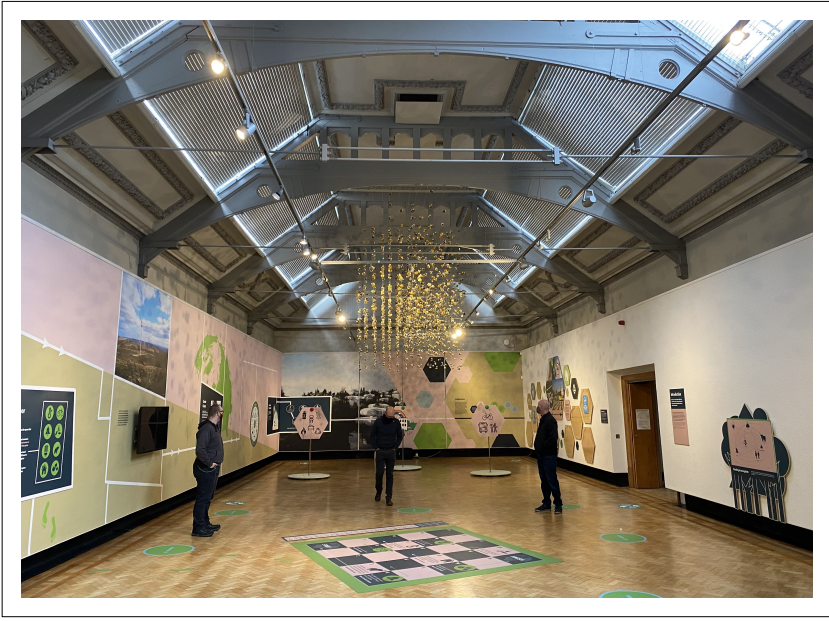
**Image 04 - Gallery 04**  
Photograph c.2024

**Notes:**  
Pipework exposed, but hidden by exhibition boards projection / shadow gap detail to base of walls. Existing extract ventilation visible at roof level.
