# Tree Condition Survey

AT 70 BOLTON ROAD, OLDHAM  
FOR EJAZ SHAH

Undertaken by Hugh Wilson MSc BSc M.Arbor A

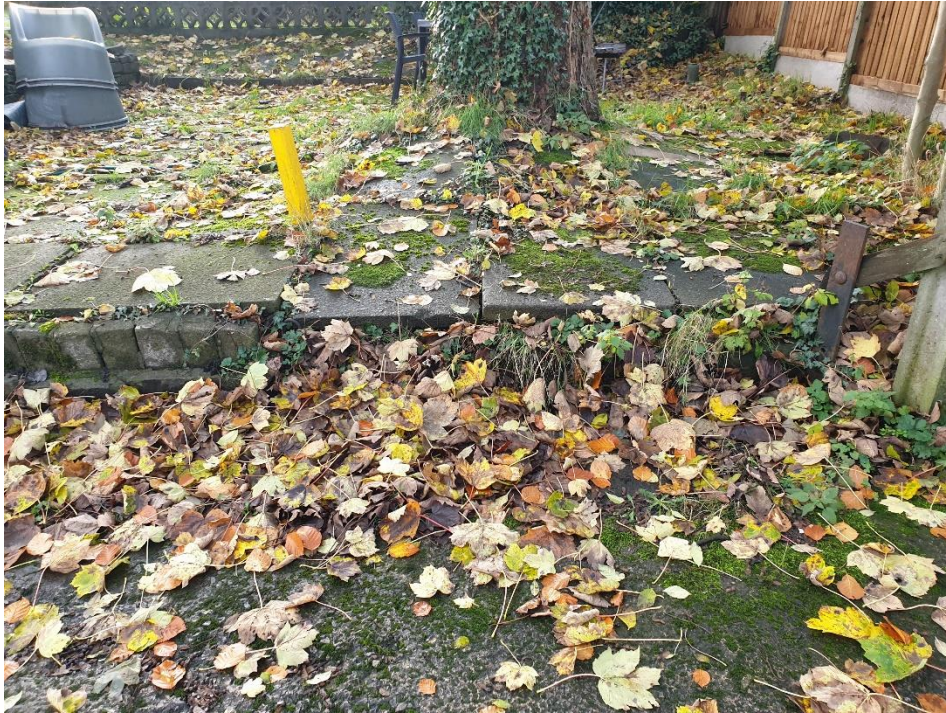
Buttress roots are lifting adjacent concrete flag stones by up to 200mm with significant cracking evident immediately adjacent to the tree. Recent and historic repairs of this area are evident.

4.2 The tree is causing movement/damage of paving slabs immediately adjacent to the tree, this can be seen in photo 1 below:

Photo 1 – Lifting of slabs adjacent to trunk, cracked mortar, uneven surfaces

4.3 This damage has been repaired at least once in the movement and further damage has occurred that appears to be newer .

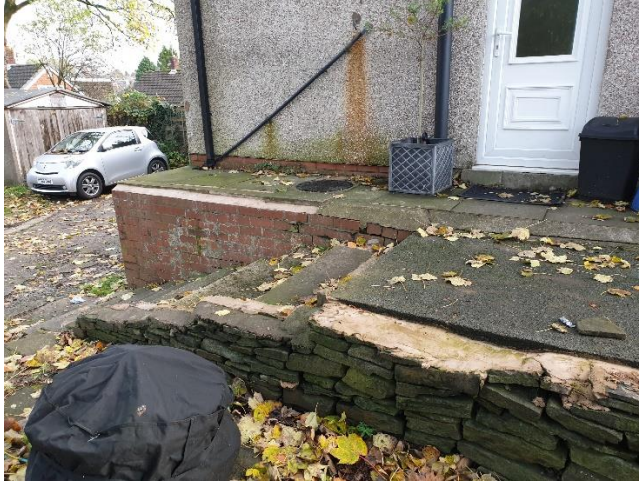
Stone/concrete steps at 3.4m from trunk of tree show signs of recent repairs where cracks have been filled.

Photo 2: Repairs to edge of steps

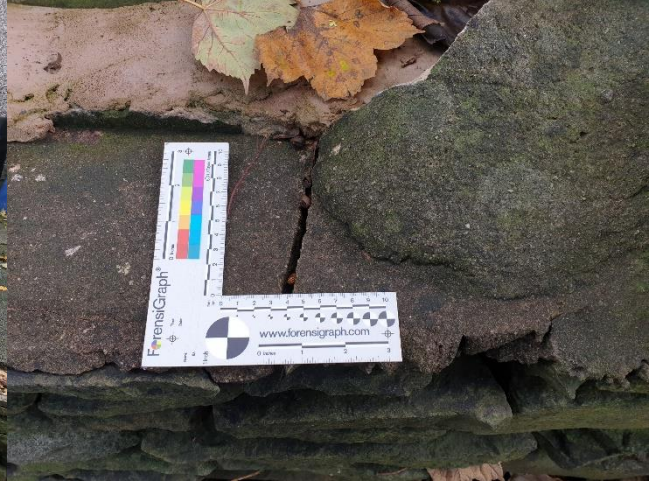
Photo 3: Crack in edge of steps

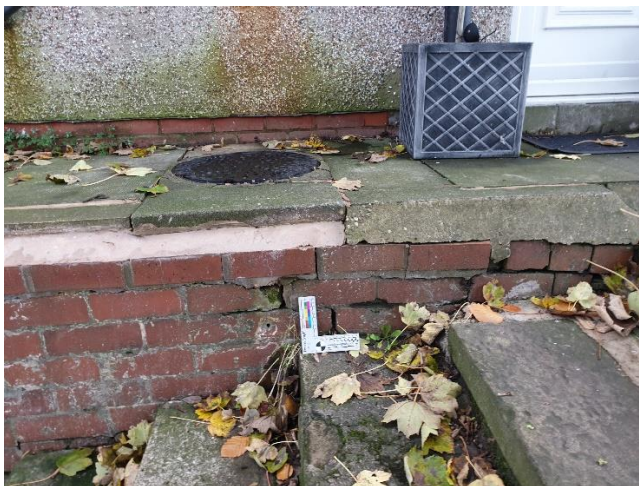
Brick wall at 5m from trunk has cracked/lost mortar in several locations and the top surface, where a large drain is present, shows signs of movement with a distinct slope formed from the central point in line with the drain.

Photo 4: Repairs to brickwork adjacent to drain

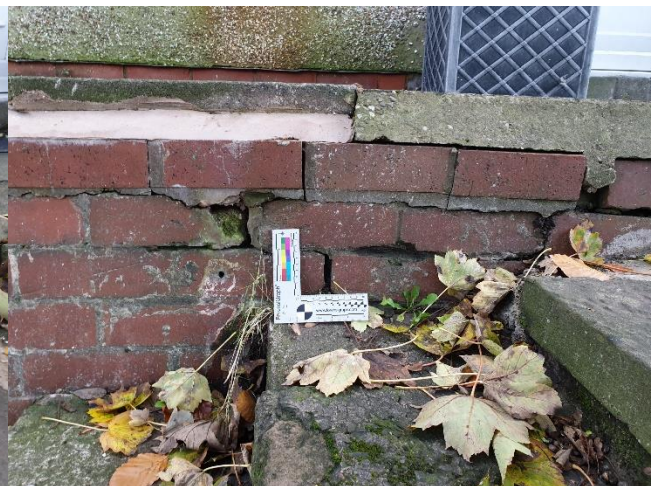
Photo 5: Existing cracks in brickwork

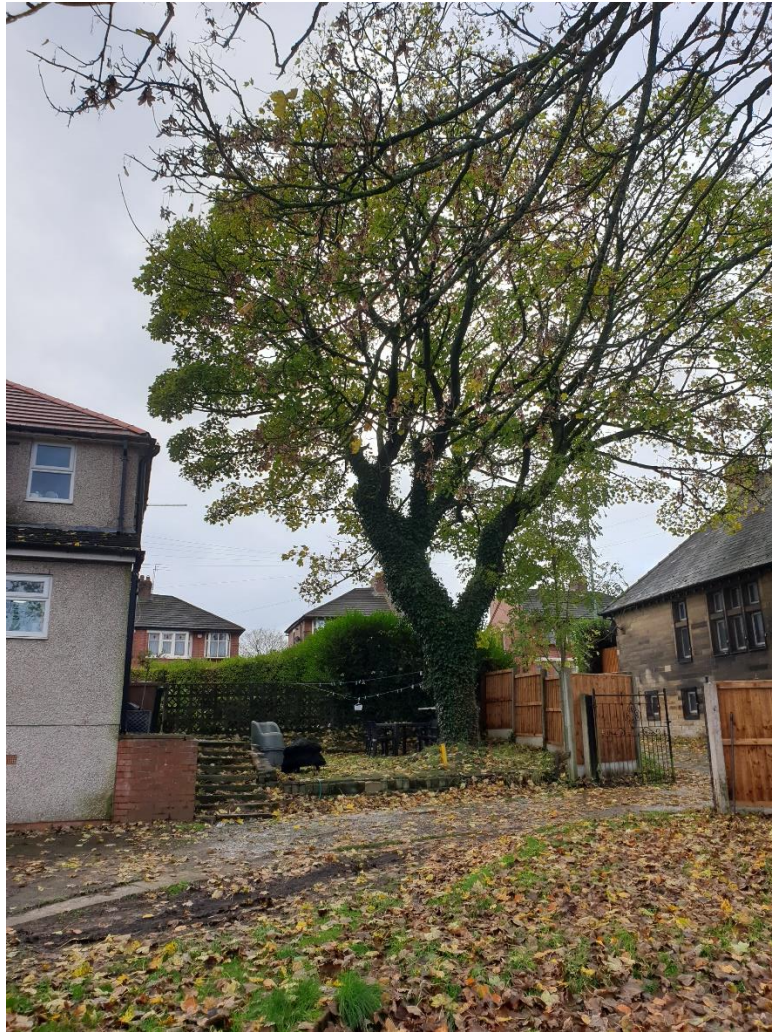
4.5 Photo 6 shows the tree in context with the adjacent structures, showing that there is a lack of any other vegetation nearby, beyond that of grass and a privet hedge at approximately 8-10m from the structures. Although I cannot say for absolutely certain that the tree is the cause of the movement/cracking of the structures it is highly probable that it is most significant cause. This is based on the evidence shown that the tree is moving paving and slabs immediately adjacent to it and growing significant roots into the adjacent drain at a distance of 4-5m from the stem. A copy of a receipt in appendices shows the removal of these roots earlier this year.

Photo 6: Tree in wider context garden setting.

Fell tree to as low as reasonably practicable. Grind stump to below ground level. Plant up to 4 trees elsewhere on property away from the position of this tree, either within the existing line of trees at the garden boundary or within the lawn area opposite. Recommended species would include whitebeam (*Sorbus aria*), yew, (*Taxus baccata*), common holly (*Ilex aquifolium*) and rowan (*Sorbus aucuparia*).

4.6 I have recommended that the tree be felled and replaced with suitable planted trees due to likelihood of the issues with the drains being repeated, as well as future and expanded damage to the structures described being likely also.
