#### GAS MEMBRANE VALIDATION

| <b>Site: Boothroyden Road, Middleton</b> | |
| Date: 20-06-2022 | Project Number: 13-500 |

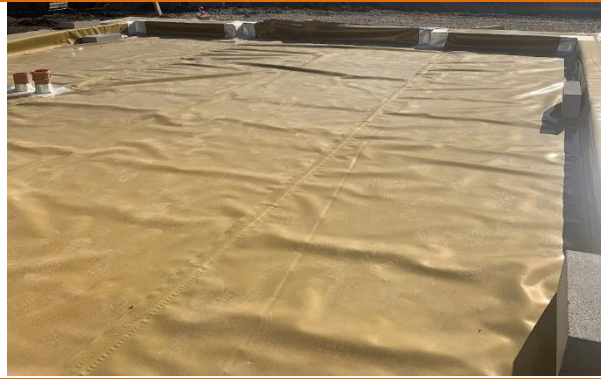
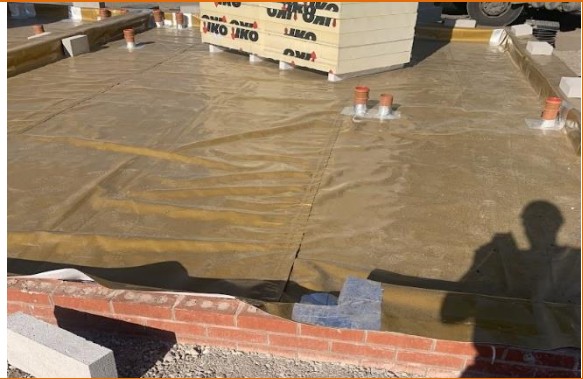
**Plot – 17**

**General Condition of Membrane-Good Condition**

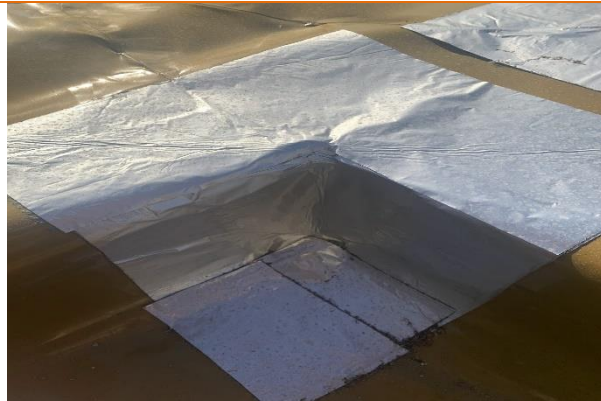
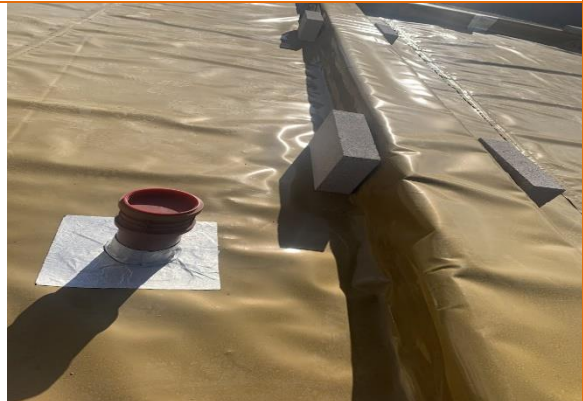
**Verification of Joints and Seals-Good Condition**

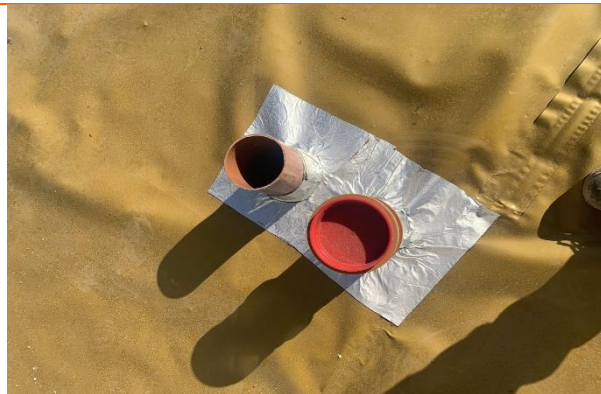
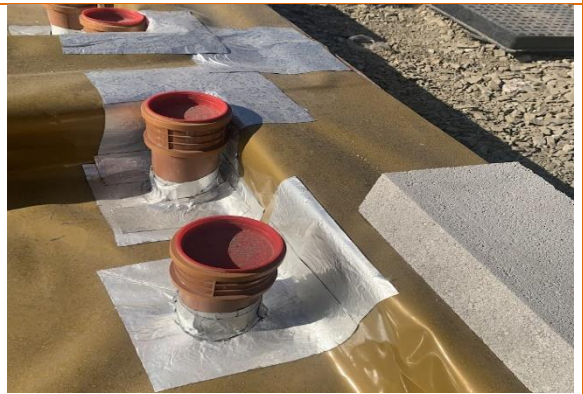
**Verification of Service Penetrations-Good Condition**

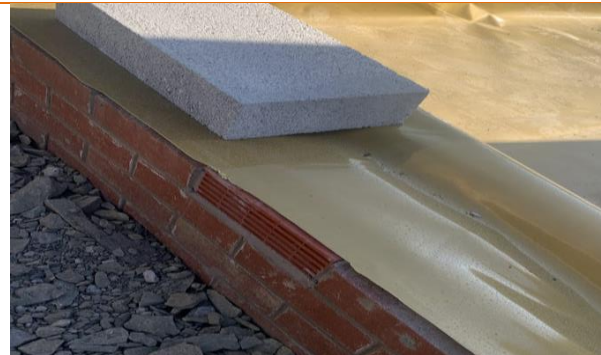
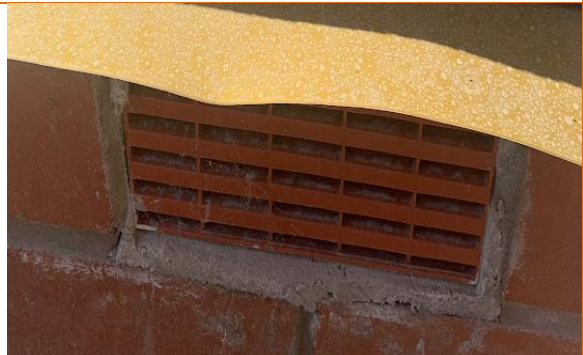
**Verification of Ventilation-Good Condition**

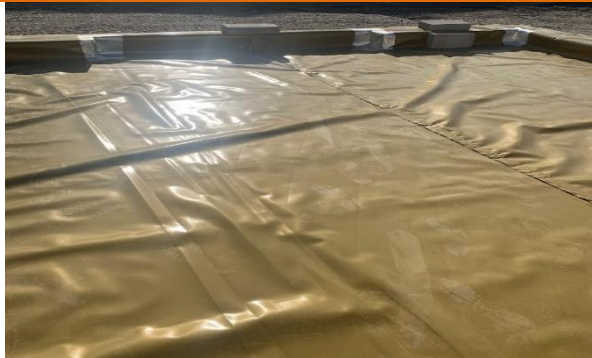
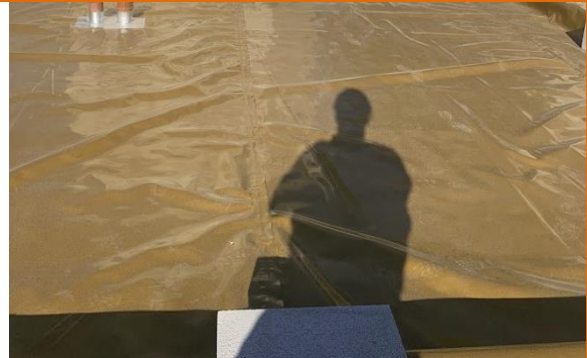
**Plot - 18**

**General Condition of Membrane-Good Condition**

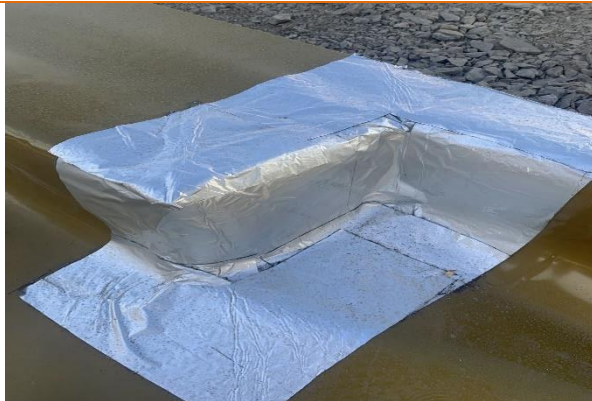
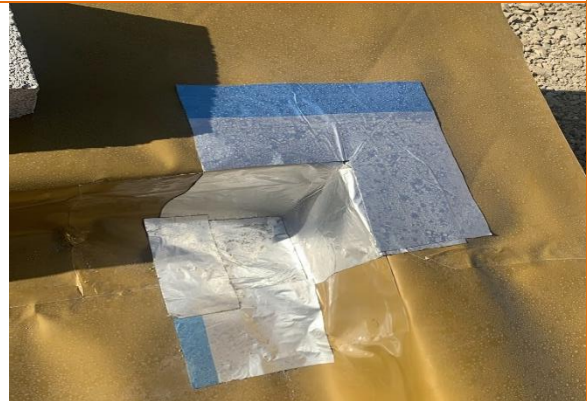
**Verification of Joints and Seals-Good Condition**

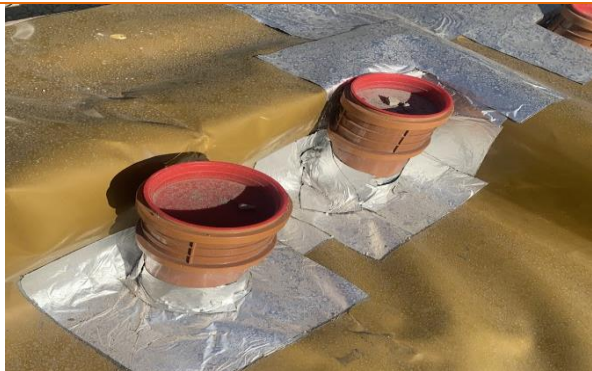
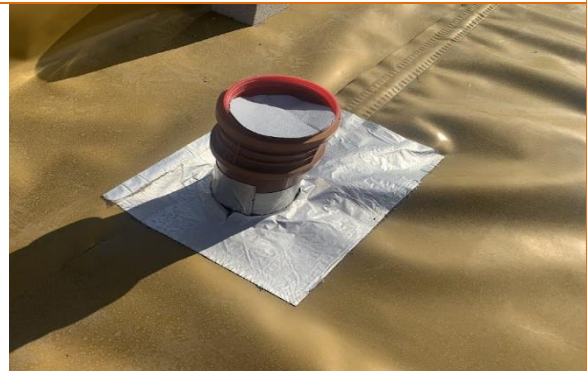
**Verification of Service Penetrations-Good Condition**

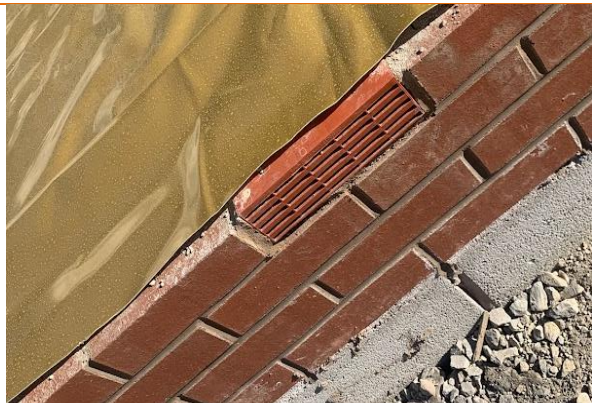
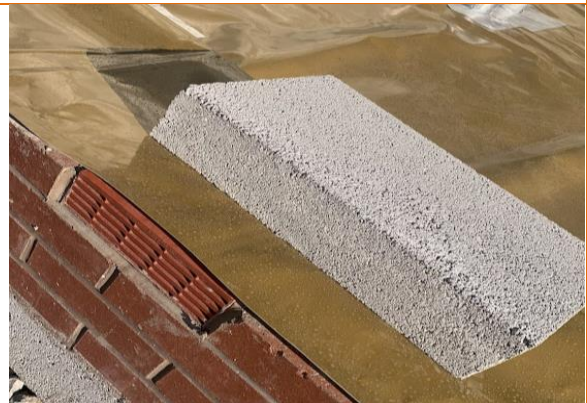
**Verification of Ventilation-Good Condition**

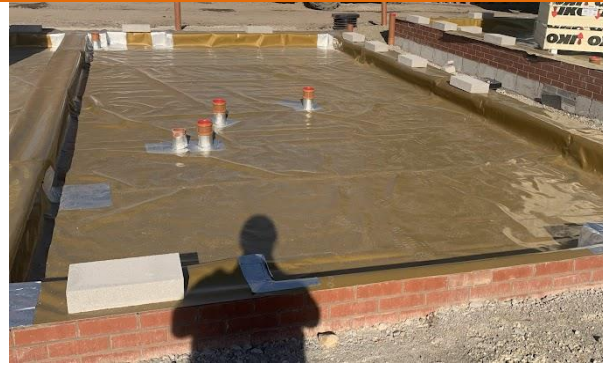
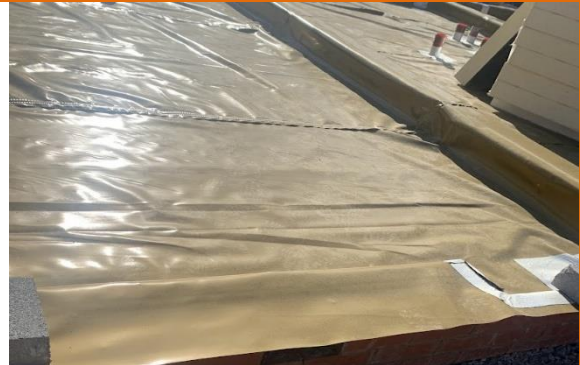
**Plot - 19**

**General Condition of Membrane-Good Condition**

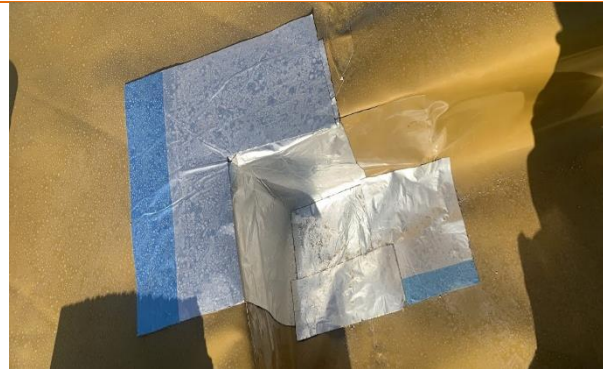
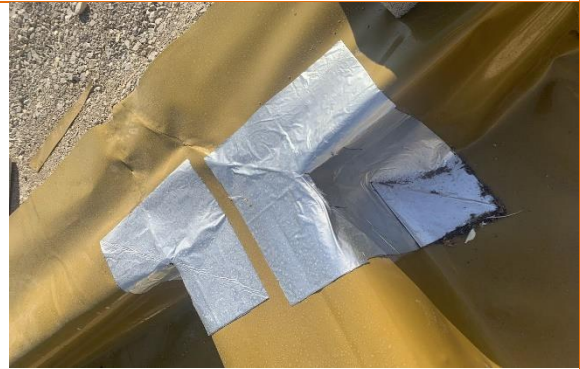
**Verification of Joints and Seals-Good Condition**

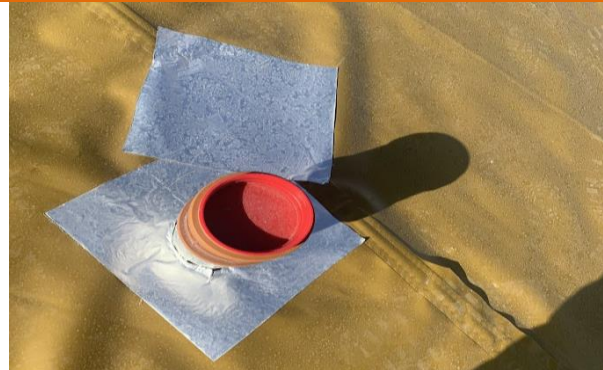
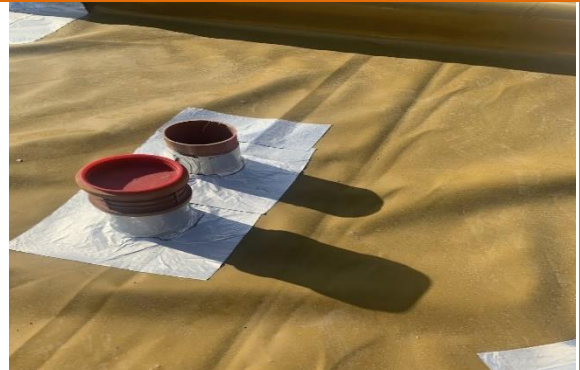
**Verification of Service Penetrations-Good Condition**

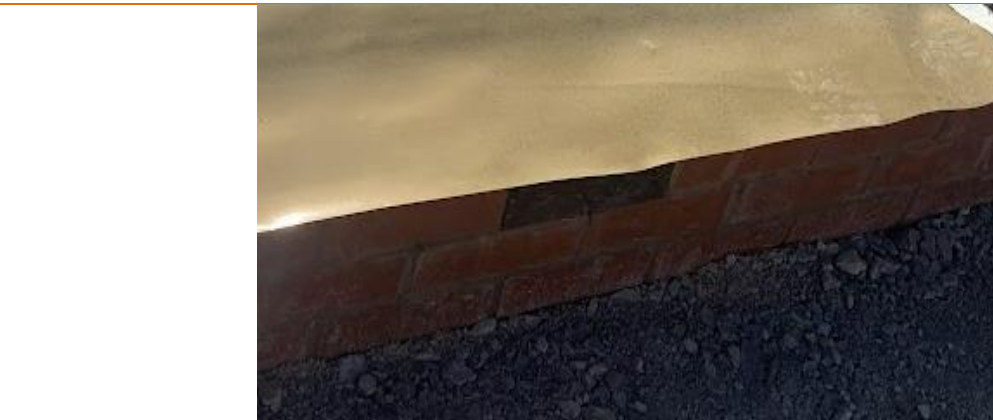
**Verification of Ventilation-Good Condition**

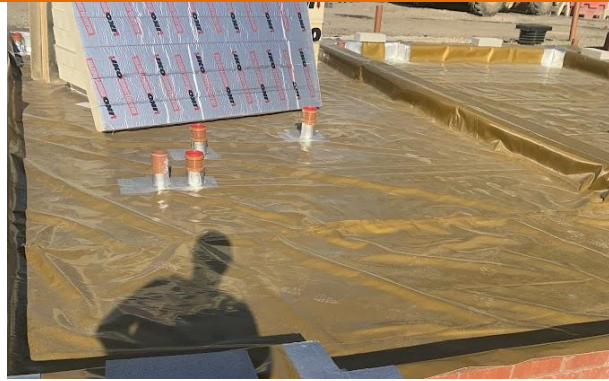
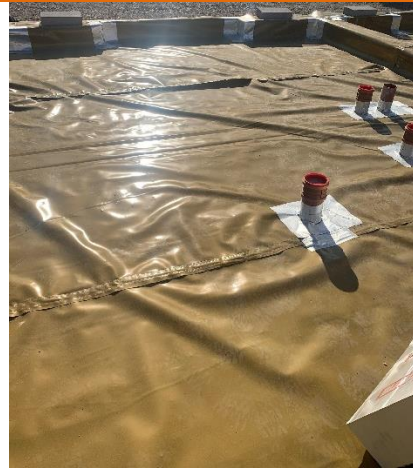
**Plot - 20**

**General Condition of Membrane-Good Condition**

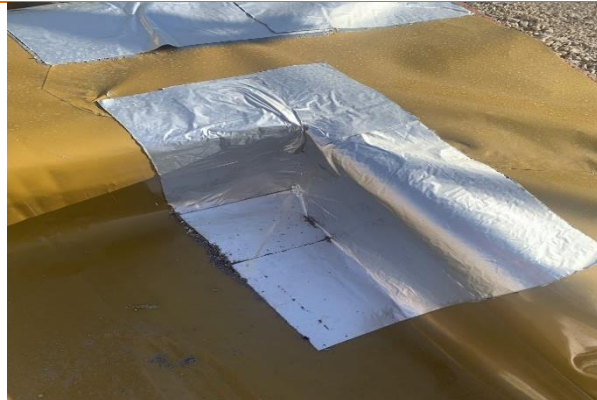
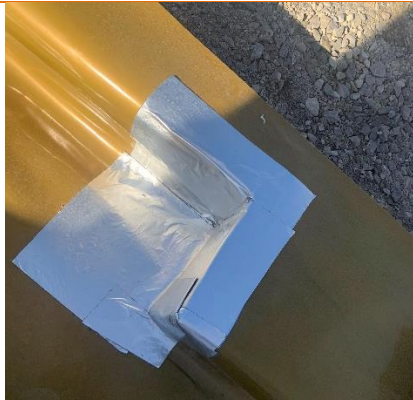
**Verification of Joints and Seals-Good Condition**

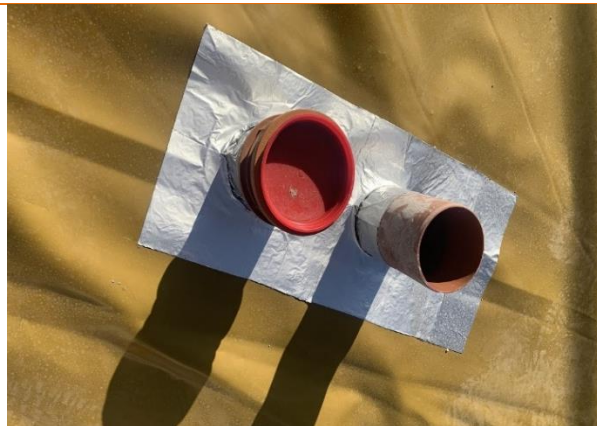
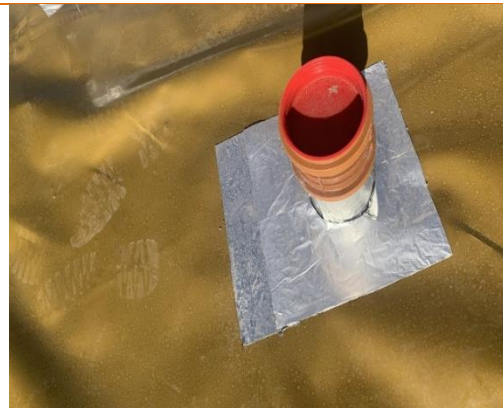
**Verification of Service Penetrations-Good Condition**

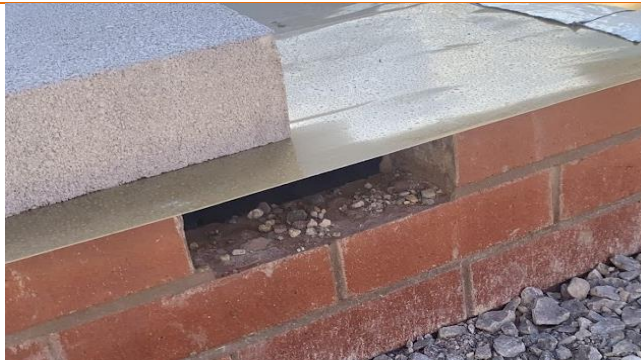
**Verification of Ventilation-Good Condition**

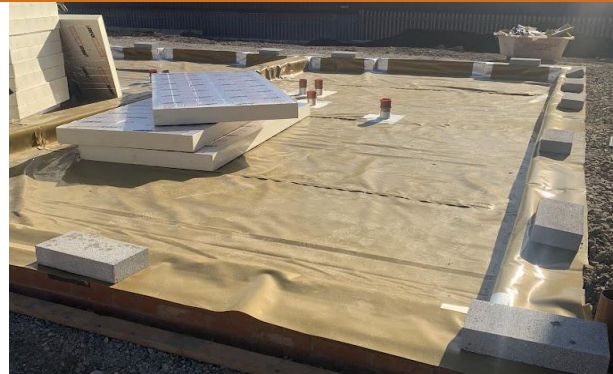
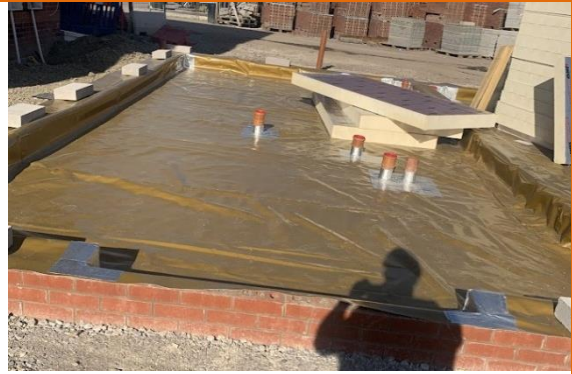
**Plot - 21**

**General Condition of Membrane-Good Condition**

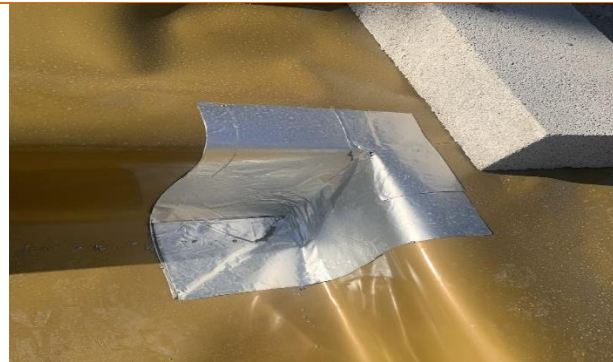
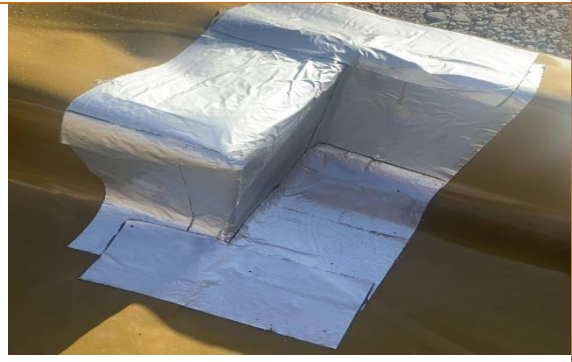
**Verification of Joints and Seals-Good Condition**

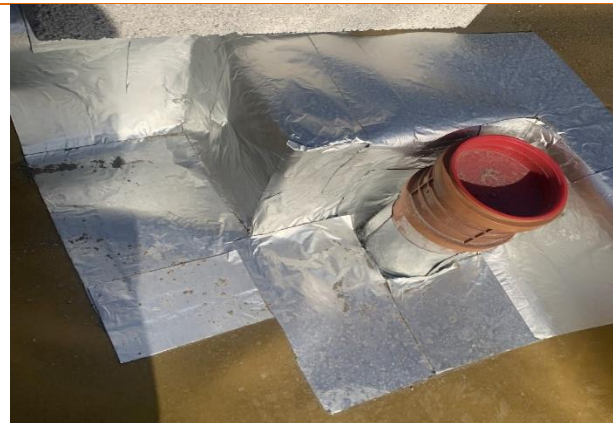
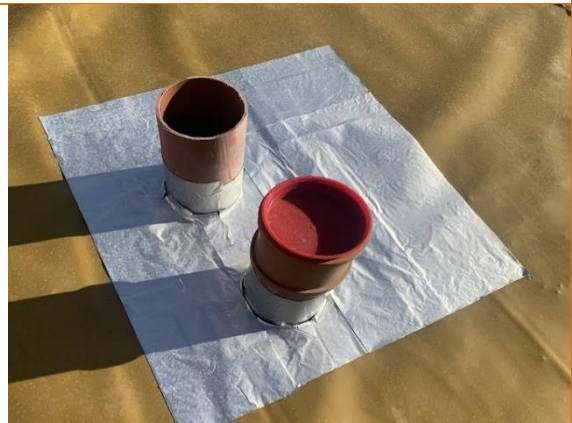
**Verification of Service Penetrations-Good Condition**

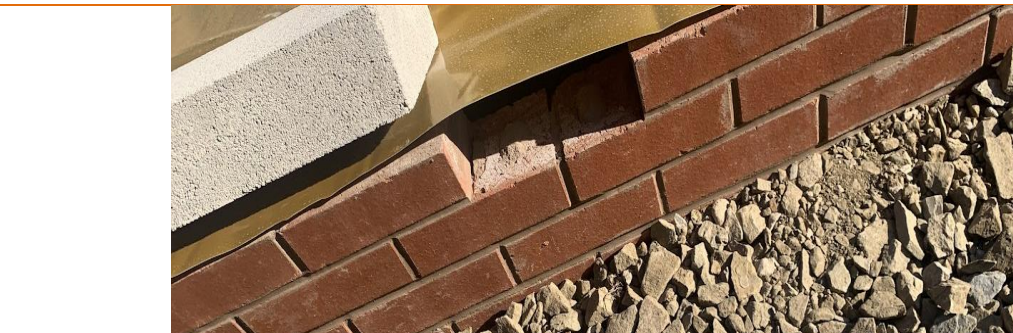
**Verification of Ventilation-Good Condition**
