**Project Name:** Geo - Bury & Rochdale old rd

**Company:** Ainsworth Projects  
**Description:** CCTV Condition Survey  
**Contact:** Nick Heywood

## Section Inspection - 01/02/2021 - INLET 1X

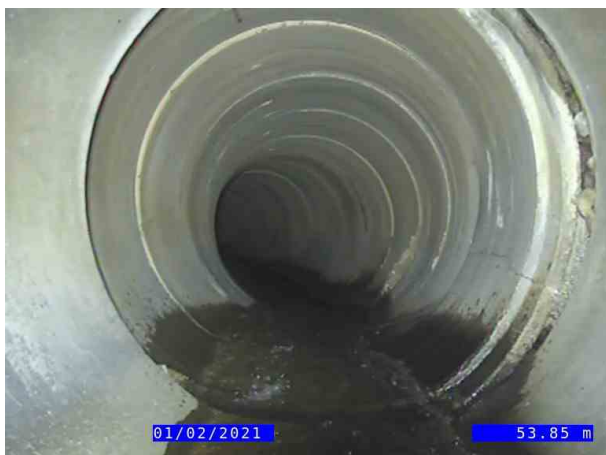
<table><tr><td>0.00</td><td>OC</td><td>Start node type, other special chamber, reference number: INLET 1</td><td>00:00:00</td><td></td><td></td></tr><tr><td>53.85</td><td>OJM</td><td>Open joint, medium</td><td>00:02:55</td><td>INLET<br/>1X_7c5fd752-22c8-4</td><td>1</td></tr></table>

INLET  
1X\_7c5fd752-22c8-4d4c-ac4a-4a40e8247a25\_20210203\_124  
047\_518.jpg, 00:02:55, 53.85 m  
Open joint, medium

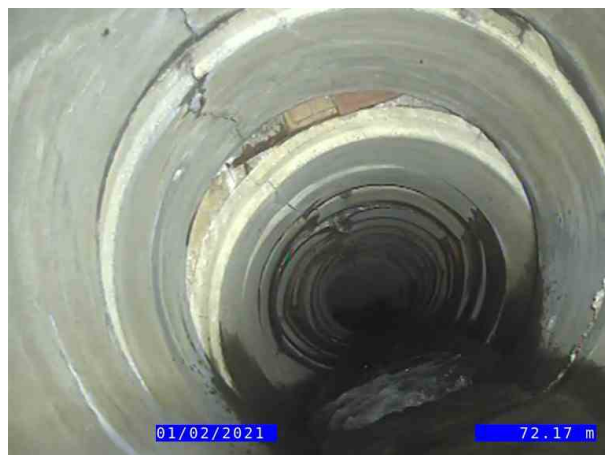
<table><tr><td>0.00</td><td>OC</td><td>Start node type, other special chamber, reference number: INLET 1</td><td>00:00:00</td><td></td><td></td></tr><tr><td>72.17</td><td>OJL</td><td>Open joint, large</td><td>00:03:43</td><td>INLET<br/>1X_c6e62192-60a6-</td><td>1</td></tr></table>

INLET  
1X\_c6e62192-60a6-490d-81de-857f7a6a7a6b\_20210203\_130  
444\_484.jpg, 00:03:43, 72.17 m  
Open joint, large

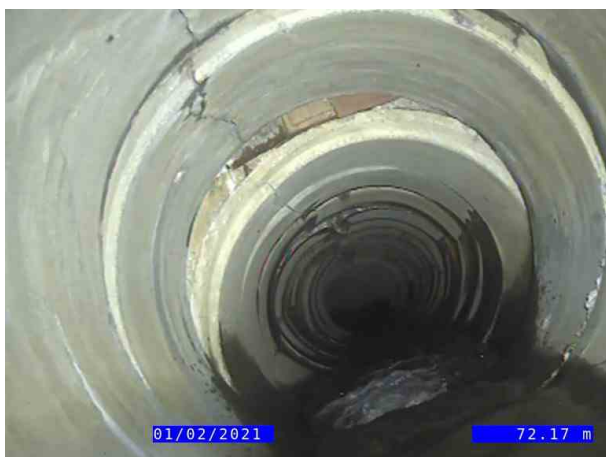
<table><tr><td>0.00</td><td>OC</td><td>Start node type, other special chamber, reference number: INLET 1</td><td>00:00:00</td><td></td><td></td></tr><tr><td>72.17</td><td>CL</td><td>Crack, longitudinal at 12 o'clock</td><td>00:03:43</td><td>INLET<br/>1X_312eb7a8-8247-</td><td>2</td></tr></table>

INLET  
1X\_312eb7a8-8247-4b52-af81-2483cd2e0f71\_20210203\_130  
453\_700.jpg, 00:03:43, 72.17 m  
Crack, longitudinal at 12 o'clock

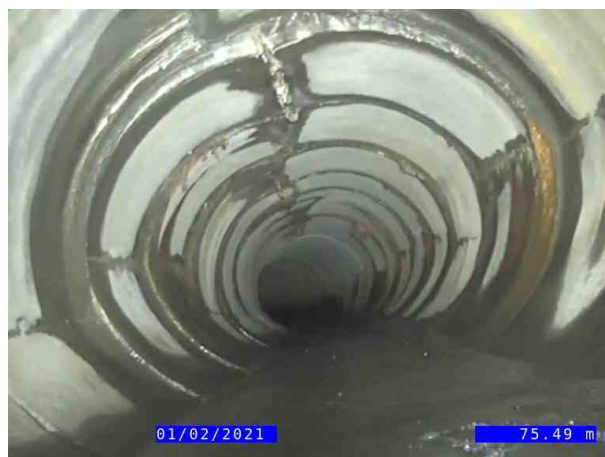
<table><tr><td>0.00</td><td>OC</td><td>Start node type, other special chamber, reference number: INLET 1</td><td>00:00:00</td><td></td><td></td></tr><tr><td>75.49</td><td>S02</td><td>FM</td><td>Fracture, multiple from 8 o'clock to 4 o'clock, start</td><td>00:03:55</td><td>INLET<br/>1X_fe46afd1-a152-4f</td><td></td></tr><tr><td>83.90</td><td>F02</td><td>FM</td><td>Fracture, multiple from 8 o'clock to 4 o'clock, finish</td><td>00:04:13</td><td></td><td>4</td></tr></table>

INLET  
1X\_fe46afd1-a152-4f45-ab7a-3a2f78f05362\_20210203\_1305  
22\_603.jpg, 00:03:55, 75.49 m  
Fracture, multiple from 8 o'clock to 4 o'clock, start

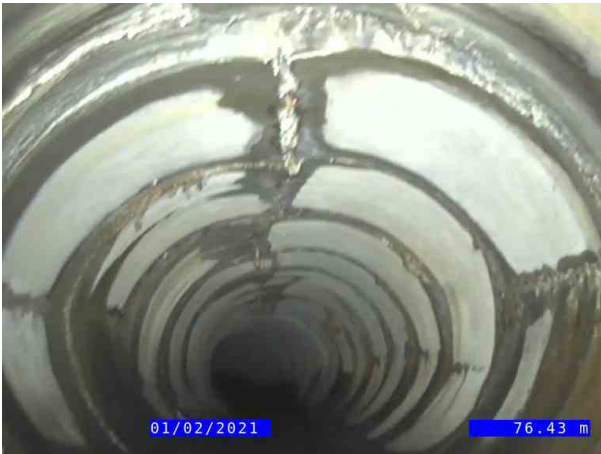
<table><tr><td>0.00</td><td>OC</td><td>Start node type, other special chamber, reference number: INLET 1</td><td>00:00:00</td><td></td><td></td></tr><tr><td>76.63</td><td>ID</td><td>Infiltration, dripping at 12 o'clock</td><td>00:03:58</td><td>INLET<br/>1X_0eb6446b-83ab-</td><td></td><td></td></tr></table>

INLET  
1X\_0eb6446b-83ab-439b-a7f2-4e50c1710dc5\_20210203\_130  
543\_451.jpg, 00:03:58, 76.63 m  
Infiltration, dripping at 12 o'clock

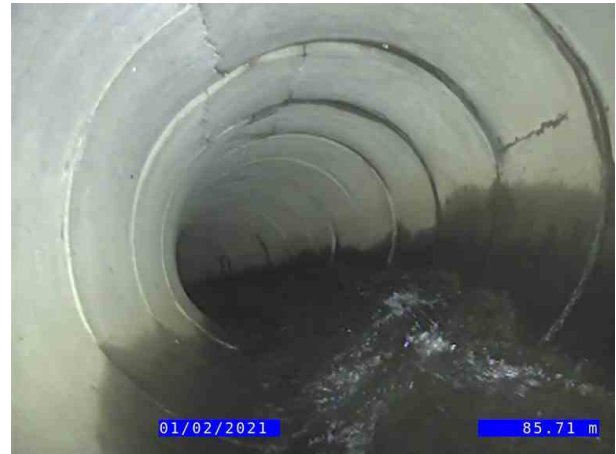
<table><tr><td>0.00</td><td>OC</td><td>Start node type, other special chamber, reference number: INLET 1</td><td>00:00:00</td><td></td><td></td></tr><tr><td>85.71</td><td>S04</td><td>CL</td><td>Crack, longitudinal at 12 o'clock, start</td><td>00:04:18</td><td>INLET<br/>1X_81bb722b-2072-</td><td></td></tr><tr><td>102.00</td><td>F04</td><td>CL</td><td>Crack, longitudinal at 12 o'clock, finish</td><td>00:05:02</td><td></td><td>2</td></tr></table>

INLET  
1X\_81bb722b-2072-4e85-8e8e-064e5d7a3a6f\_20210203\_13  
0607\_530.jpg, 00:04:18, 85.71 m  
Crack, longitudinal at 12 o'clock, start

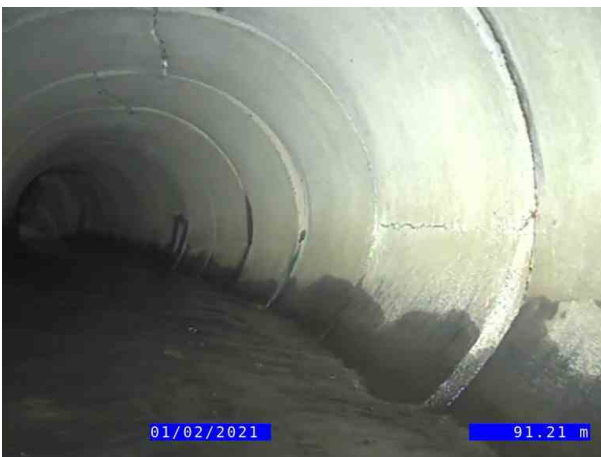
<table><tr><td>0.00</td><td>OC</td><td>Start node type, other special chamber, reference number: INLET 1</td><td>00:00:00</td><td></td><td></td></tr><tr><td>91.21</td><td>CL</td><td>Crack, longitudinal at 3 o'clock</td><td>00:04:30</td><td>INLET<br/>1X_e6707430-7b58-</td><td>2</td><td></td></tr></table>

INLET  
1X\_e6707430-7b58-4a34-af85-04722aaecef2\_20210203\_130  
628\_953.jpg, 00:04:30, 91.21 m  
Crack, longitudinal at 3 o'clock

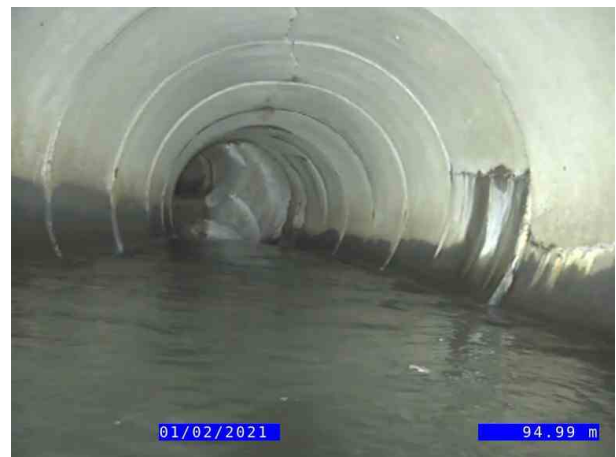
<table><tr><td>0.00</td><td>OC</td><td>Start node type, other special chamber, reference number: INLET 1</td><td>00:00:00</td><td></td><td></td></tr><tr><td>94.99</td><td>CL</td><td>Crack, longitudinal at 3 o'clock</td><td>00:04:39</td><td>INLET<br/>1X_fc4a4ff4-8edf-45a</td><td>2</td><td></td></tr></table>

INLET  
1X\_fc4a4ff4-8edf-45ab-ad75-d9d1db5816f7\_20210203\_1306  
44\_636.jpg, 00:04:39, 94.99 m  
Crack, longitudinal at 3 o'clock
