**Structural Appraisal**  
**of**  
**Heywood Library**  
**for**  
**Rochdale Borough Council**

**Ref: Y28**

**April 2022**

**Blackett-Ord Conservation Engineering**  
33 Chapel Street  
Appleby-in-Westmorland,  
Cumbria, CA16 6QR  
Tel: 017683 52572  
Email: [engineering@blackett-ordconservation.co.uk](mailto:engineering@blackett-ordconservation.co.uk)

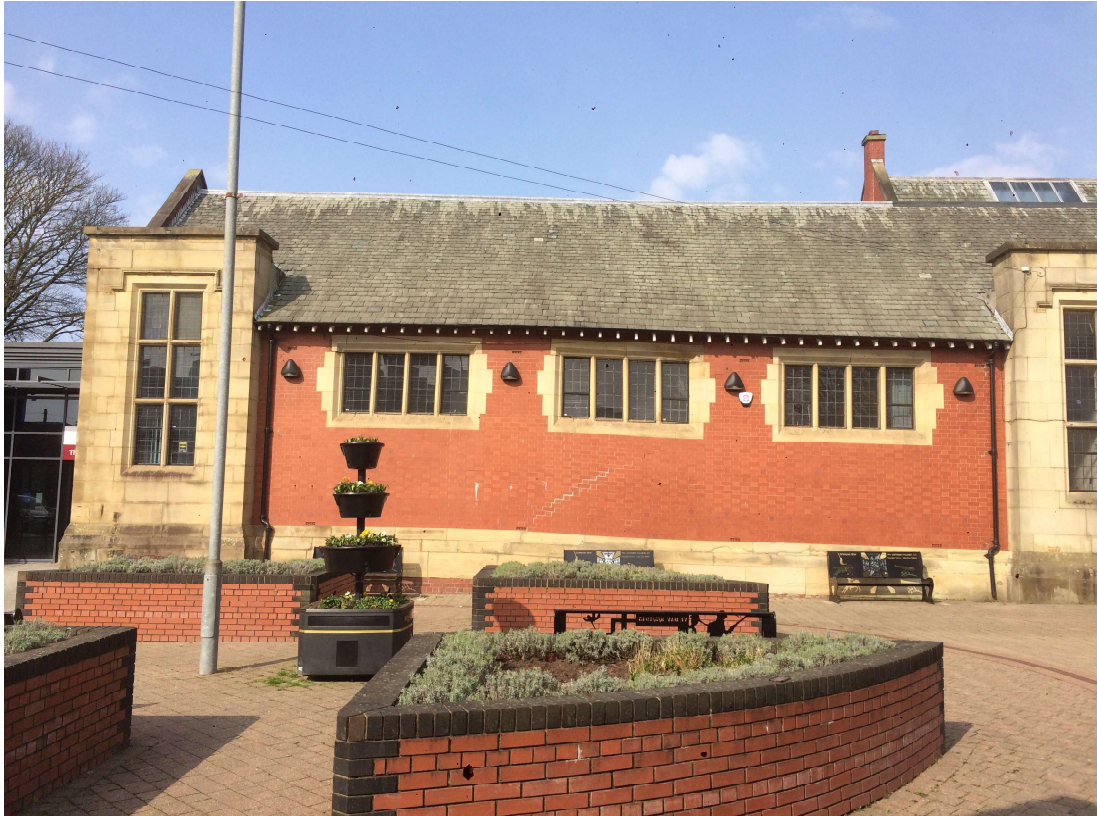
The whole building is suffering from differential foundation movement. The rear part where the basement is located appears to be most stable, but the front of the building has settled by over 300mm relative to the rear. The settlement has allowed the building to rotate downwards at the front by 1.3%. This has caused the front wall to rotate outwards and has led to cracking in the walls around the middle of the building, and cracking at some of the column heads where the steel beams are supported. These have not been detailed fully in this report and we have not carried out a detailed measured survey, which could pick up the settlement and distortions more accurately than has been possible for this study. It was noted that the west side roof ridge appears from the ground to be level, whereas the west wall has settled significantly, suggesting that some adjustments might already have been made in the roof to accommodate the movement.

**West Elevation Showing Settlement**

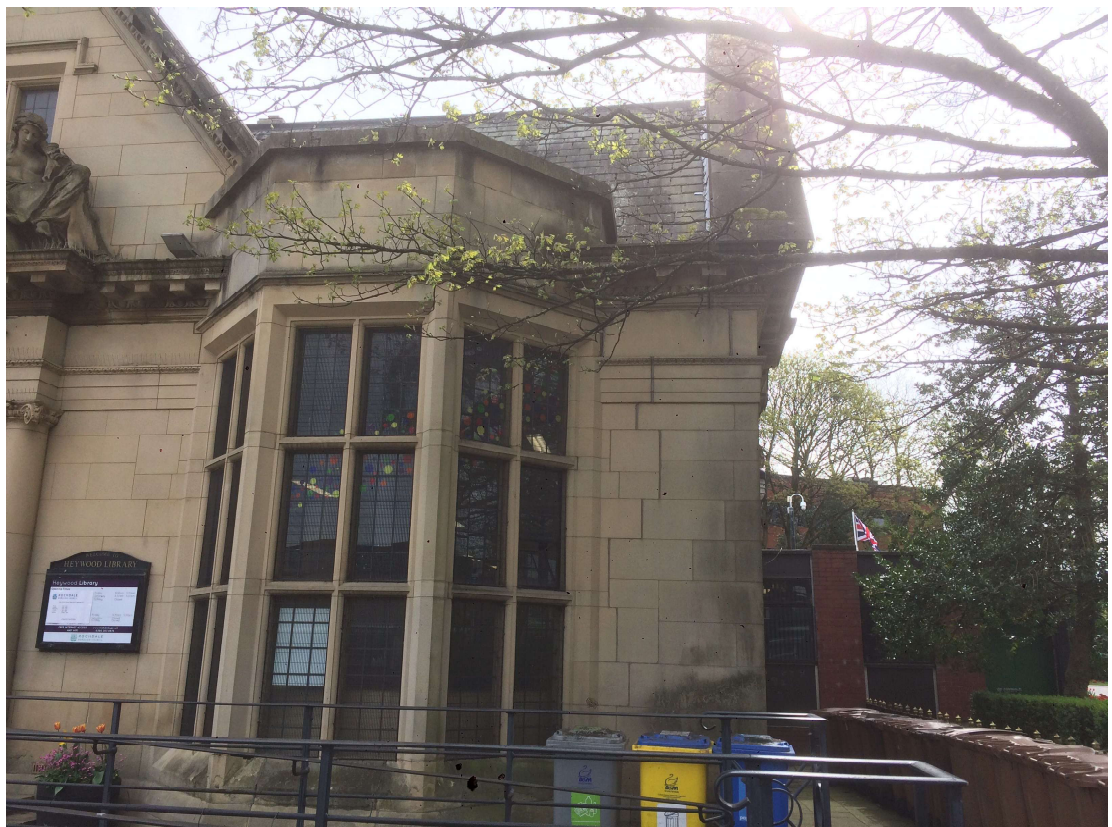
**Front Elevation Right Side, Open Joints**

- (a) A tie bar spanning between the two side gables of the front elevation at ridge level, passing over the curved central ceiling.
- (b) Ties from front to back at ceiling level in the central first floor room, hidden behind the cornice.
- (c) Cintec anchors across the open joints at the upper left and right corners of the front elevation.

The open joints in the external brick and stonework should be pointed up in lime mortar. As these joints may continue to move, no bed reinforcement should be installed because this would only lead to cracking elsewhere if the movement continues. The cracks and open joints should be monitored photographically.

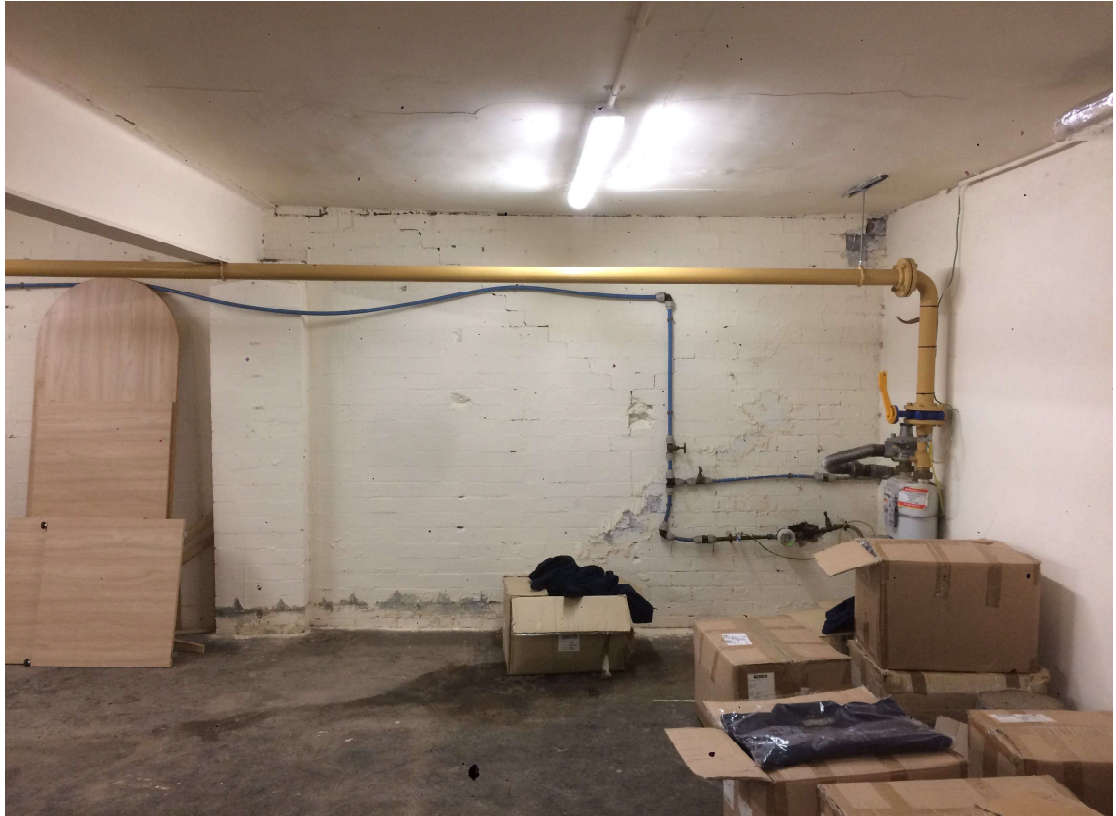
Basement Looking South

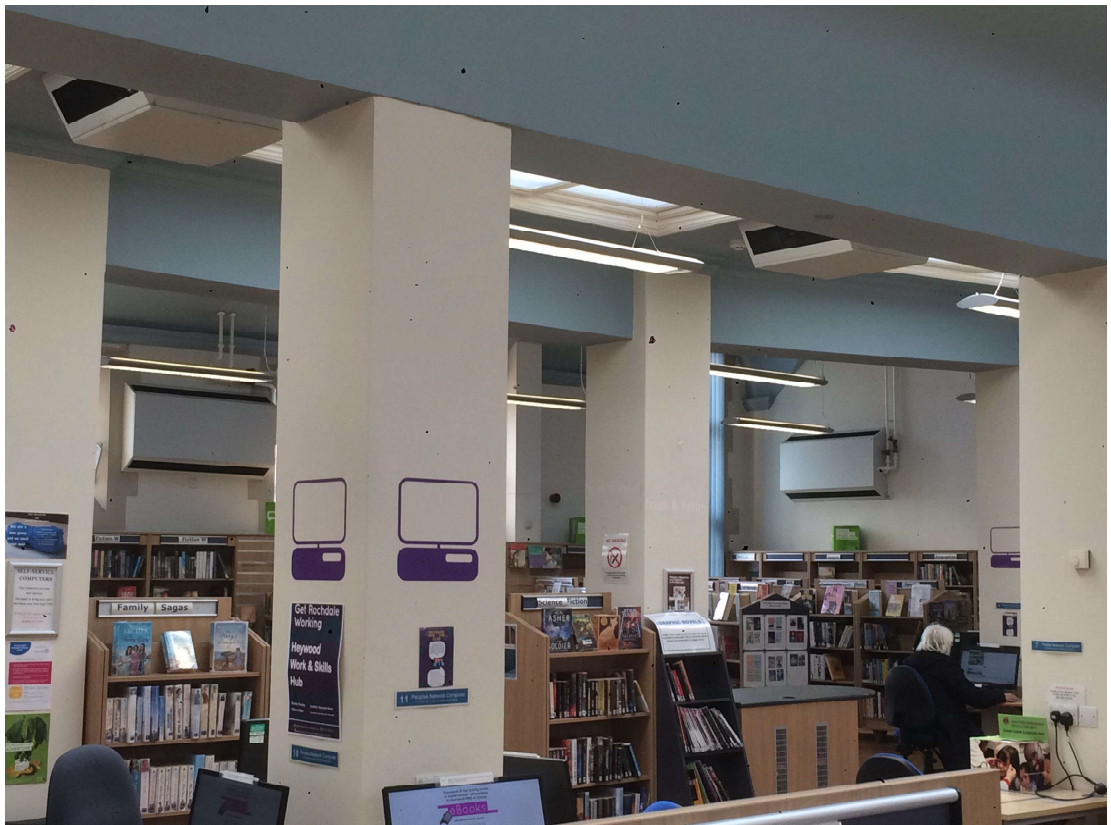
Interior, Showing Settlement of Columns

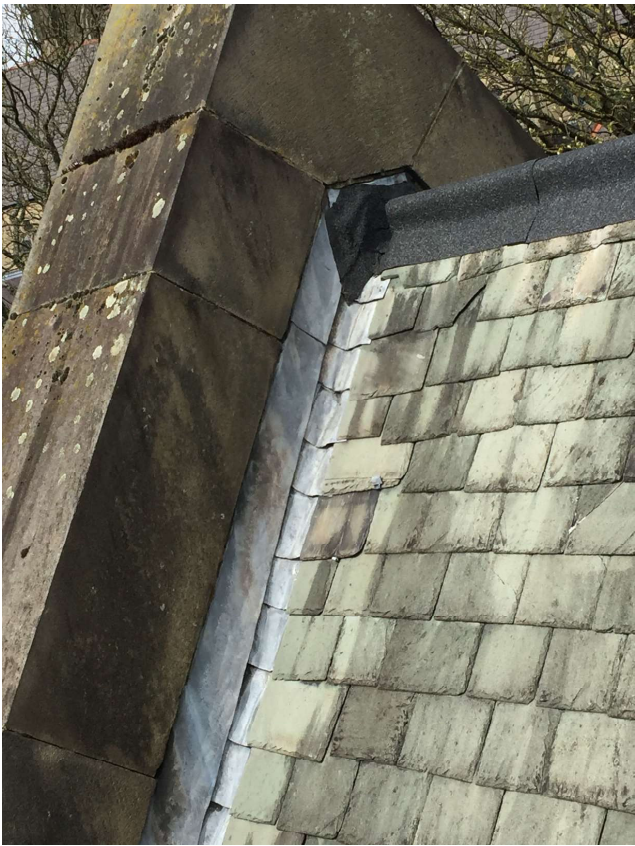
The resulting slope on the roof valleys has doubtless contributed to the leaks that are occurring. The two valley gutters flow to the rear, with a number of steps, but the backfall means that water 'ponds' below each step. Another result of movement has been the pulling out of the lead flashings at the verges, where the east and west gable walls are leaning outwards.

East Gable Verge Slating

- Ensure that the gutter falls are corrected.
- Ensure that the flashings and soakers are fitted snugly at the verges.

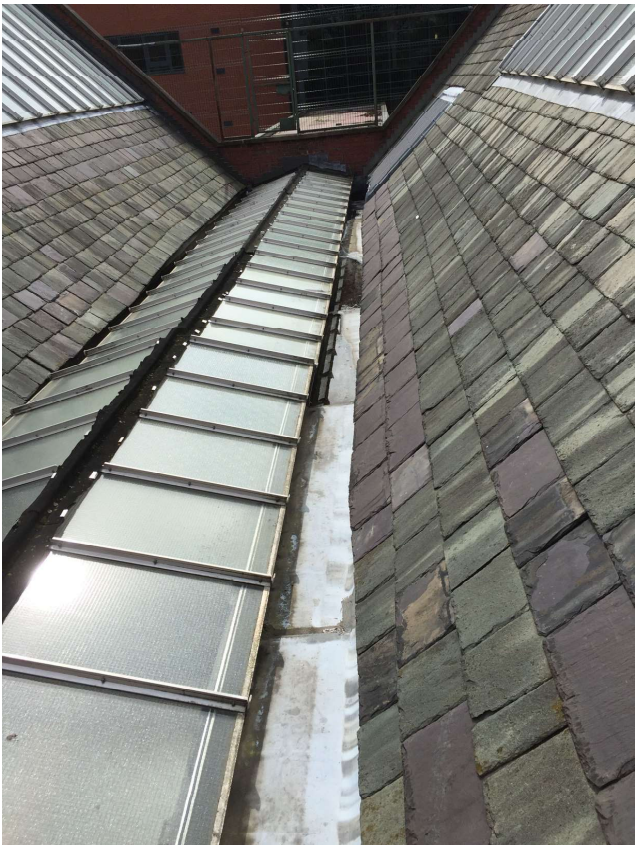
Central Valley

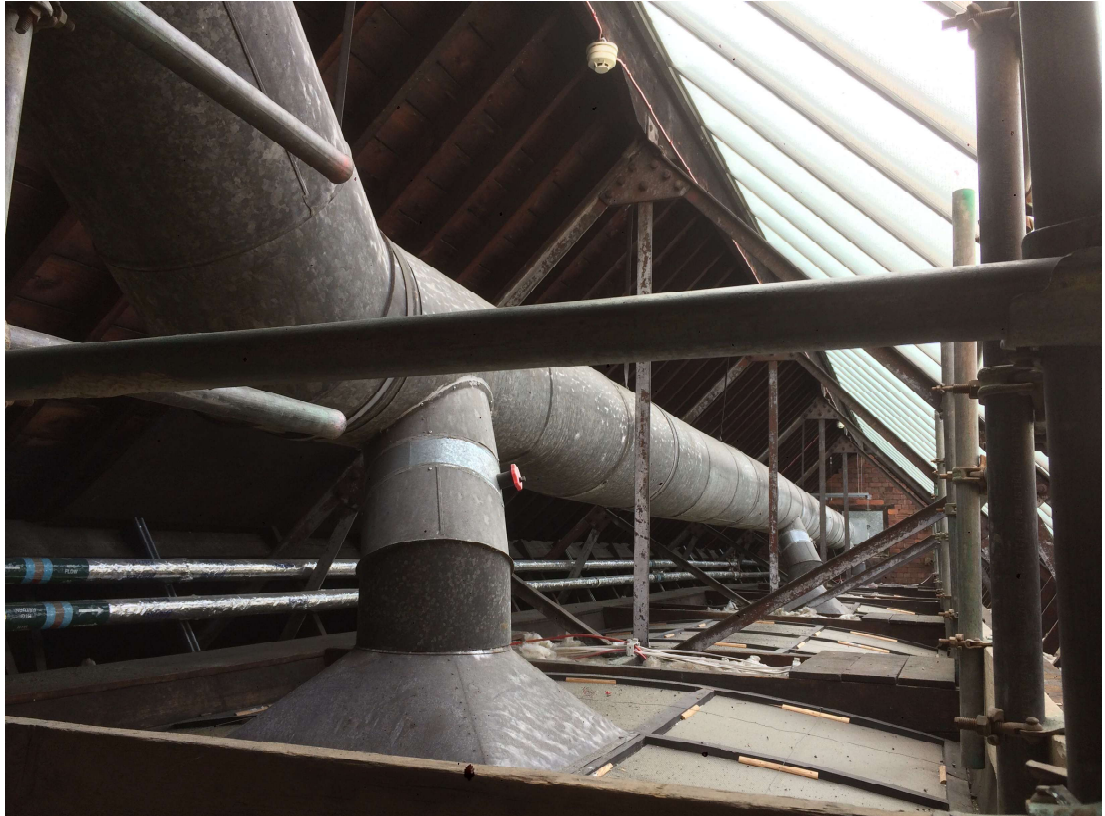
Roof Over Rear Part of Library

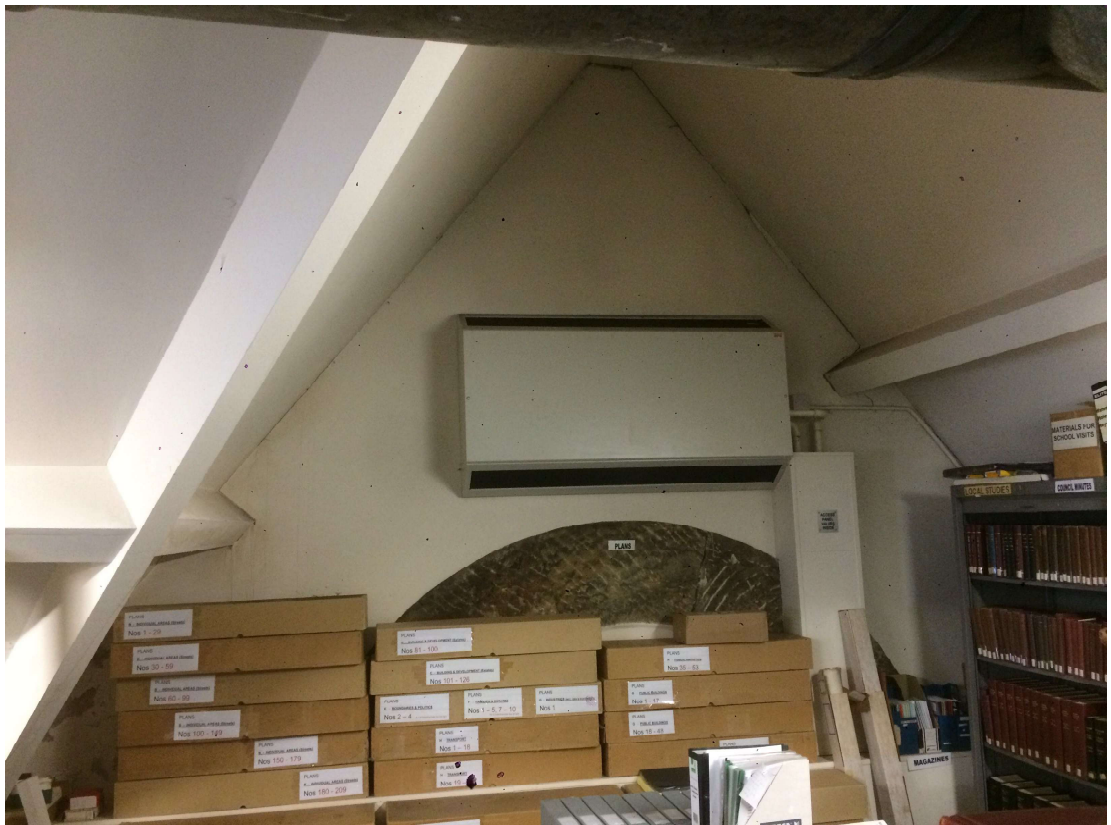
Front Right Roof Space
