**Project Name:** 2023\_11\_01 34410 Rochdale Corner Plot  
**Project Description:** CCTV Drainage Survey  
**Project Number:** 34410  
**Project Status:** Complete  
**Project Date:** 11/1/2023  
**Inspection Standard:** MSCC5 Sewers & Drainage GB (SRM5 Scoring)

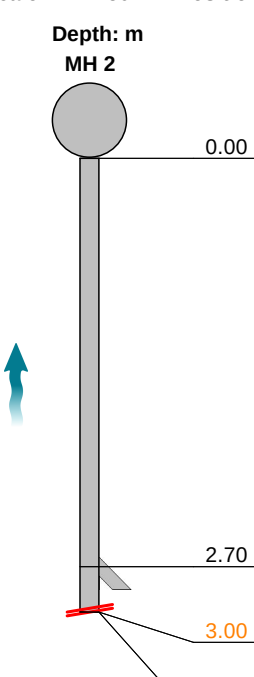
| Section | PLR | Grade | Description |
|---|---|---|---|
| 3 | Branch CX | 4 | Settled deposits, hard or compacted, 35% cross-sectional area loss |

| Scale: | 1:50 | Position [m] | Code | Observation | Grade |
|---|---|---|---|---|---|
| | 3.00 | DEC | Settled deposits, hard or compacted, 35% cross-sectional area loss: Concrete | 4 | |
| | 3.00 | SA | Survey abandoned: Due to Hard Debris | | |
