## Waterside House

Rochdale  
Heritage, Design and Access Statement

August 2023

Waterside House, Rochdale  
Condition Survey

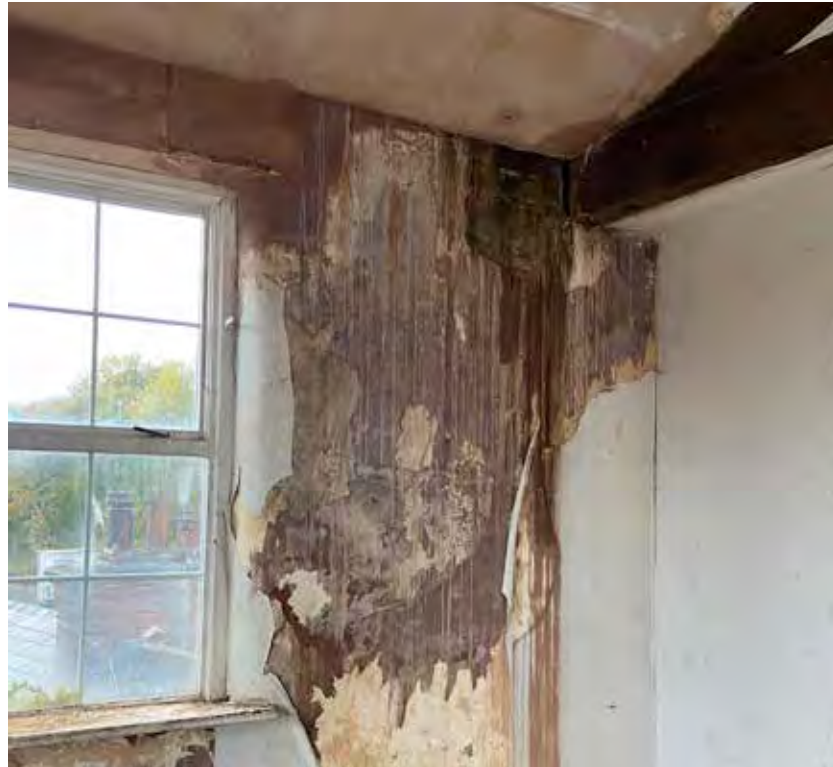
The roof is in a poor condition with multiple sections of water ingress, causing significant damage to the interior. The failure seems to be linked to the lead valleys and parapet valleys, a common issue in old buildings.

4.13a Damp in Ceiling due to roof failure

We would recommend that the roof is completely stripped and overhauled. The lead valleys should be redesigned to meet current regulations on fall, stepping, and code thickness. A new rear guttering should be oversized to increase capacity to cope with our changing weather patterns. As part of the roofing overhaul our client should take the opportunity to upgrade the roof with natural breathable insulation and membranes.

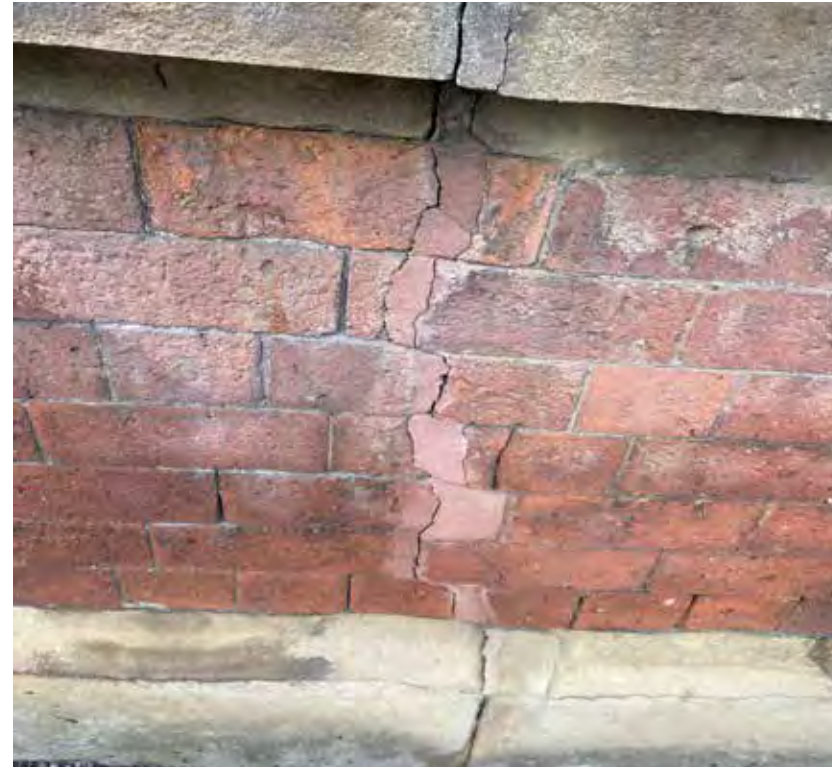
There are some visible cracks to the Water Street elevation and this has been noted in the report. A separate Structural Report has been prepared by Healey Consulting. It advises that the cracking does not cause concern but should be treated with crack stitching.

4.13b Cracking to South Elevation & friable masonry

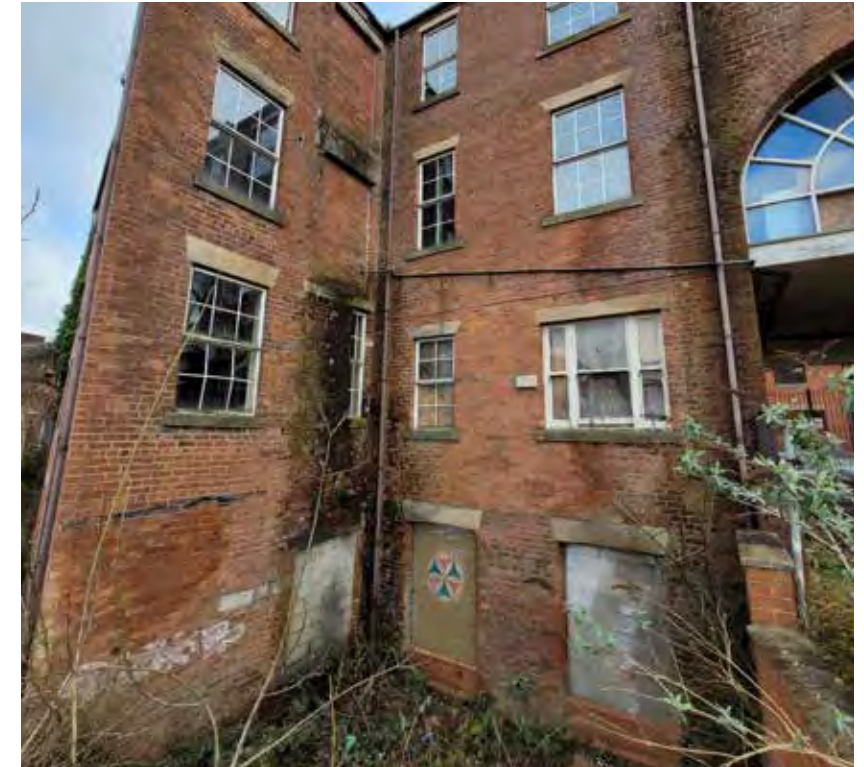
The north and east facing elevation comprise brickwork with stone lintels and cills, these elevations are utilitarian. Most defects relate to the leaking rain water goods but on the whole are cosmetic.

4.13c Water damage due to failing rainwater goods

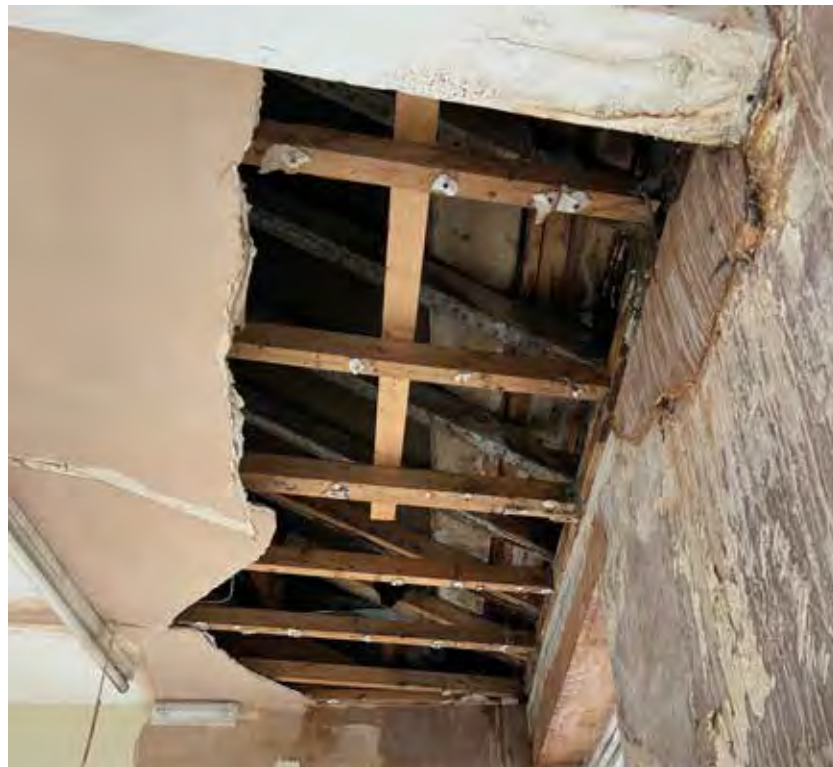
4.14 Water ingress to ceiling and rotting timbers

We would also recommend that a timber survey be carried out to establish the condition of key structural elements such as the truss, purlin and secondary timbers, in particular their seating into the solid masonry walls.

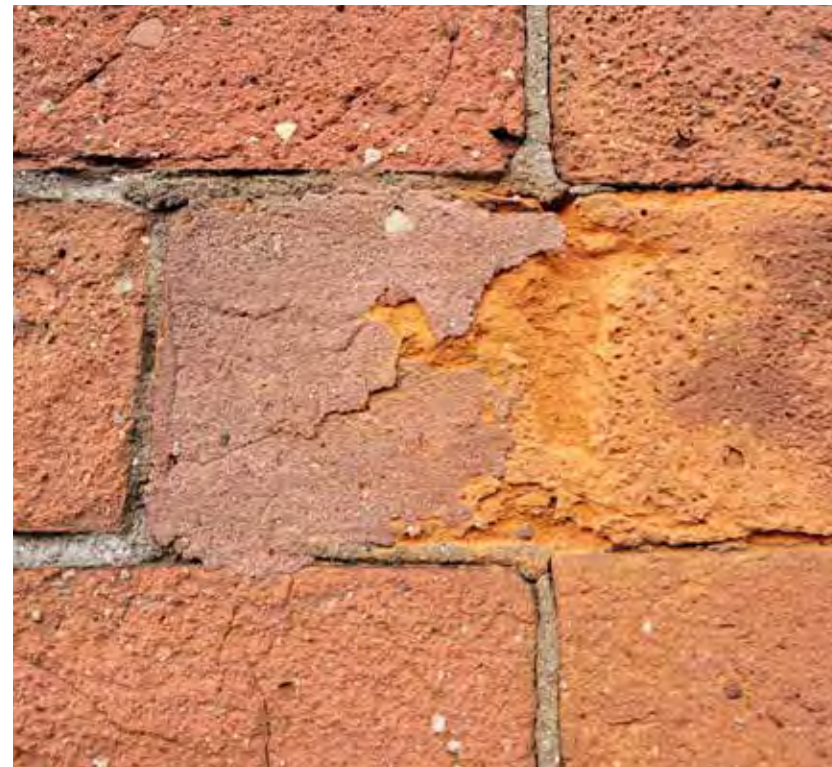
4.15 Damaging cementitious repairs to South Elevation

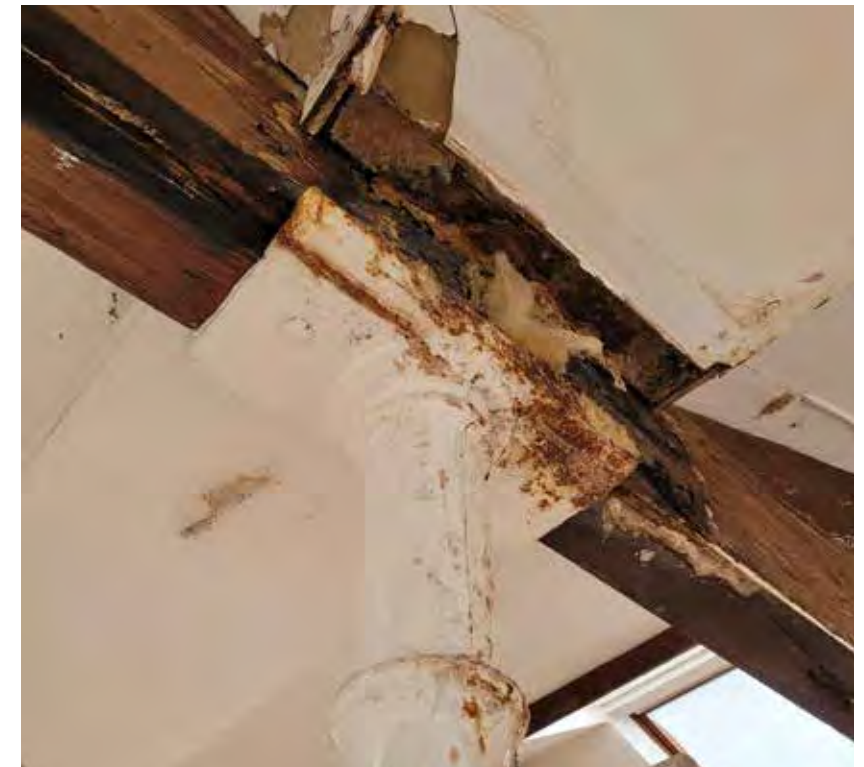
4.16 Water ingress damage to cast iron columns
