**Structural Appraisal**

**Leaches Farm**

**Mr J Farrell**

**May 2023**

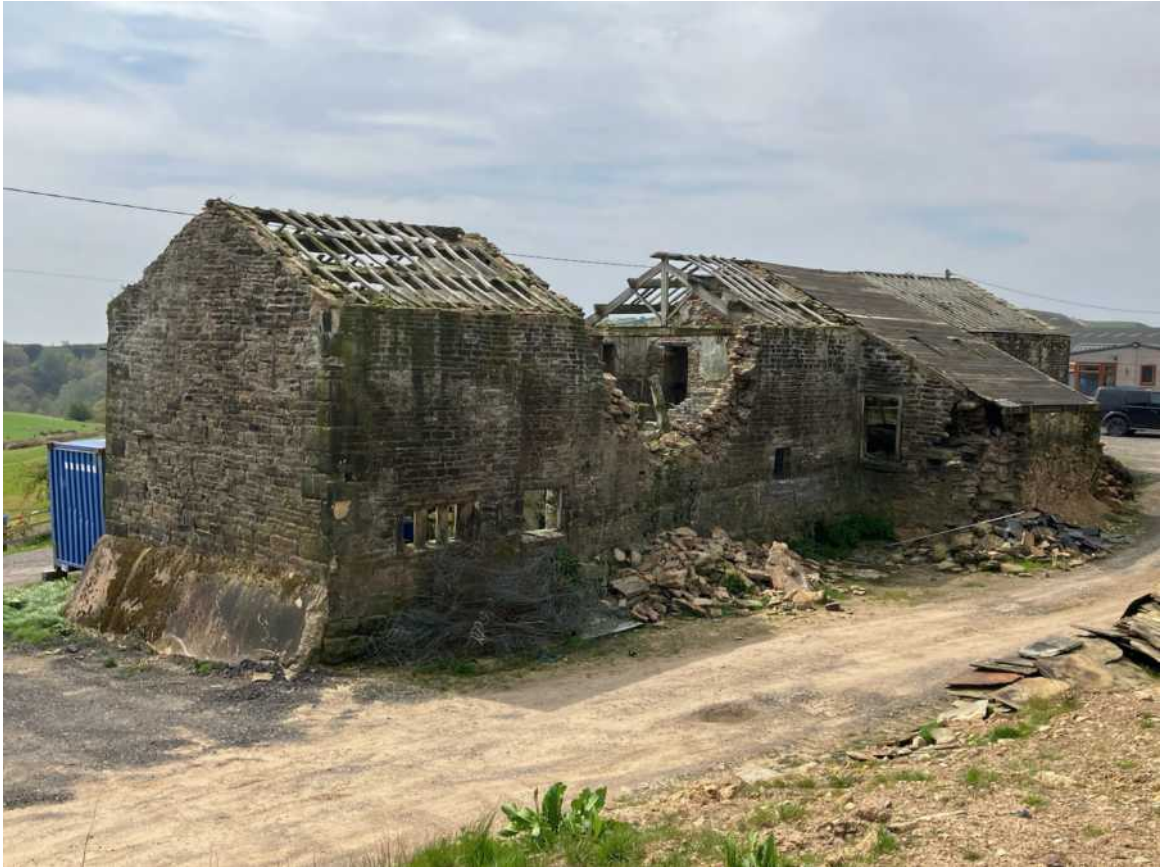
Photo 1: North Elevation

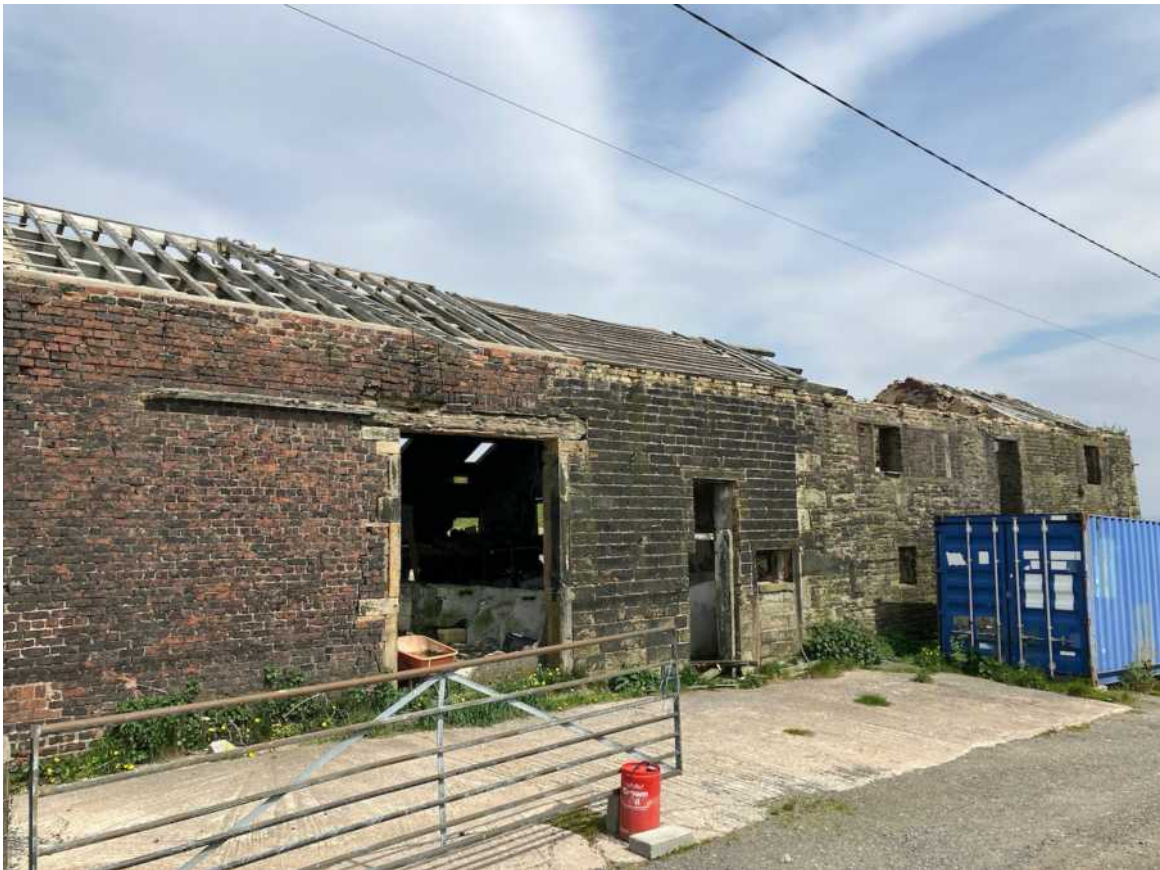
During the inspection, in the south elevation at approximately first floor level, it was noted that there were two isolated areas of bulging in the magnitude of 55mm and 140mm before returning to plumb. It is thought that this is historic movement which is not ongoing as there was no signs of disturbance of the adjacent masonry or cracking. Therefore, at present it is not a structural concern.

Photo 2: South Elevation

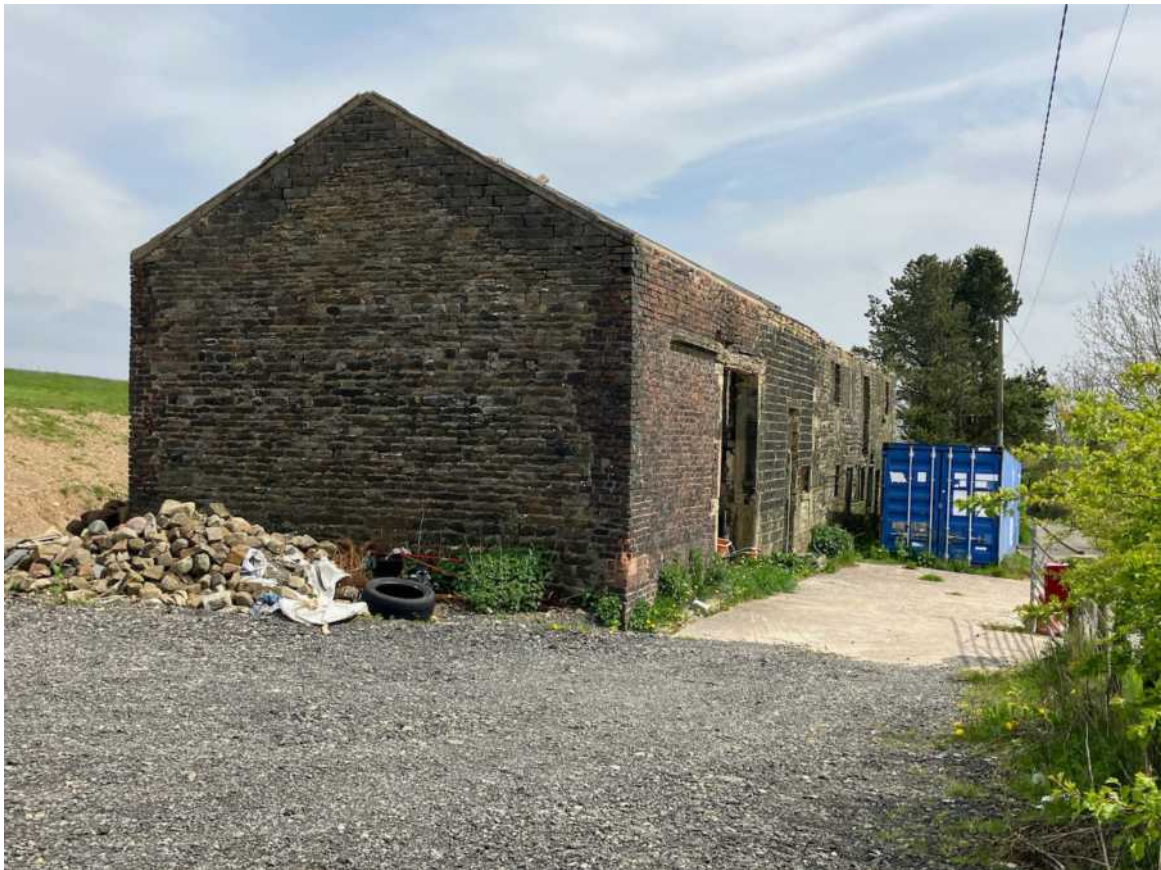
Photo 3: West Elevation

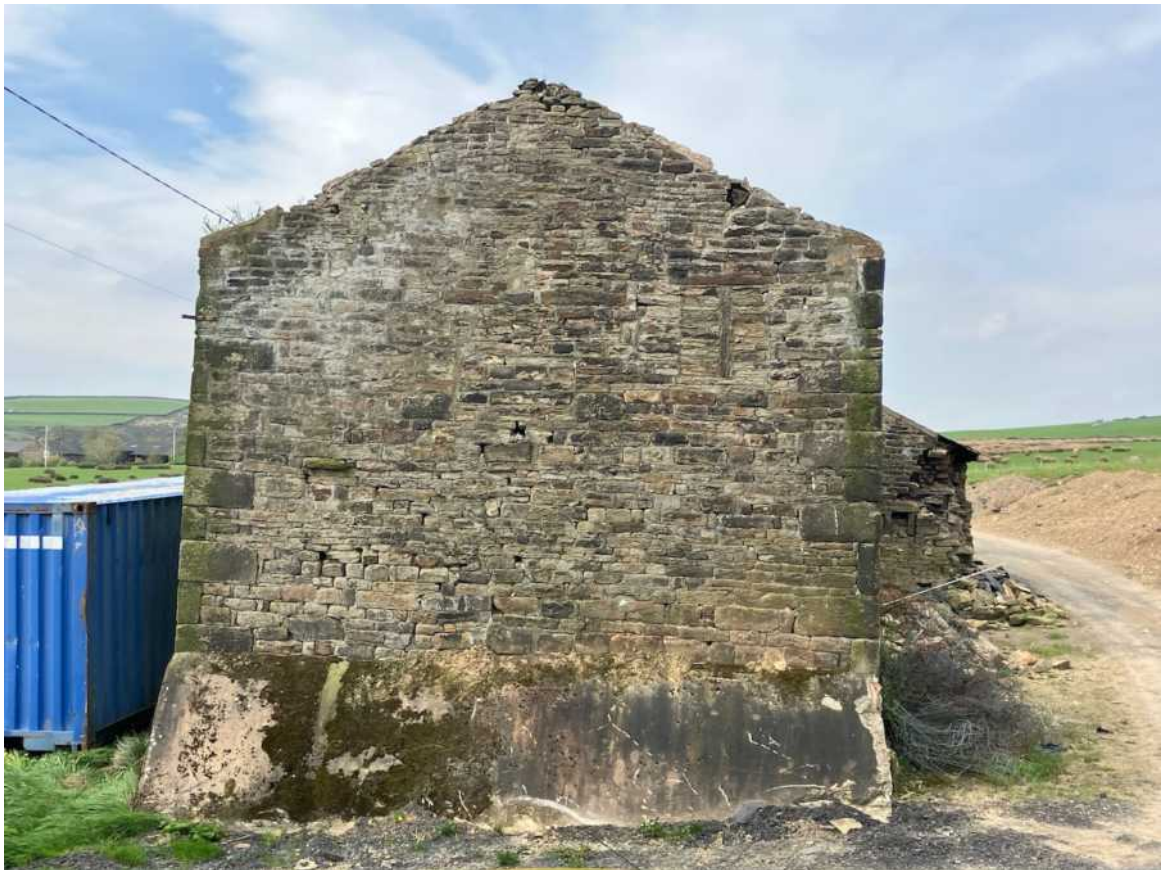
The foundations along the east gable elevation have been previously reinforced with a concrete skirt.

Photo 4: East Elevation

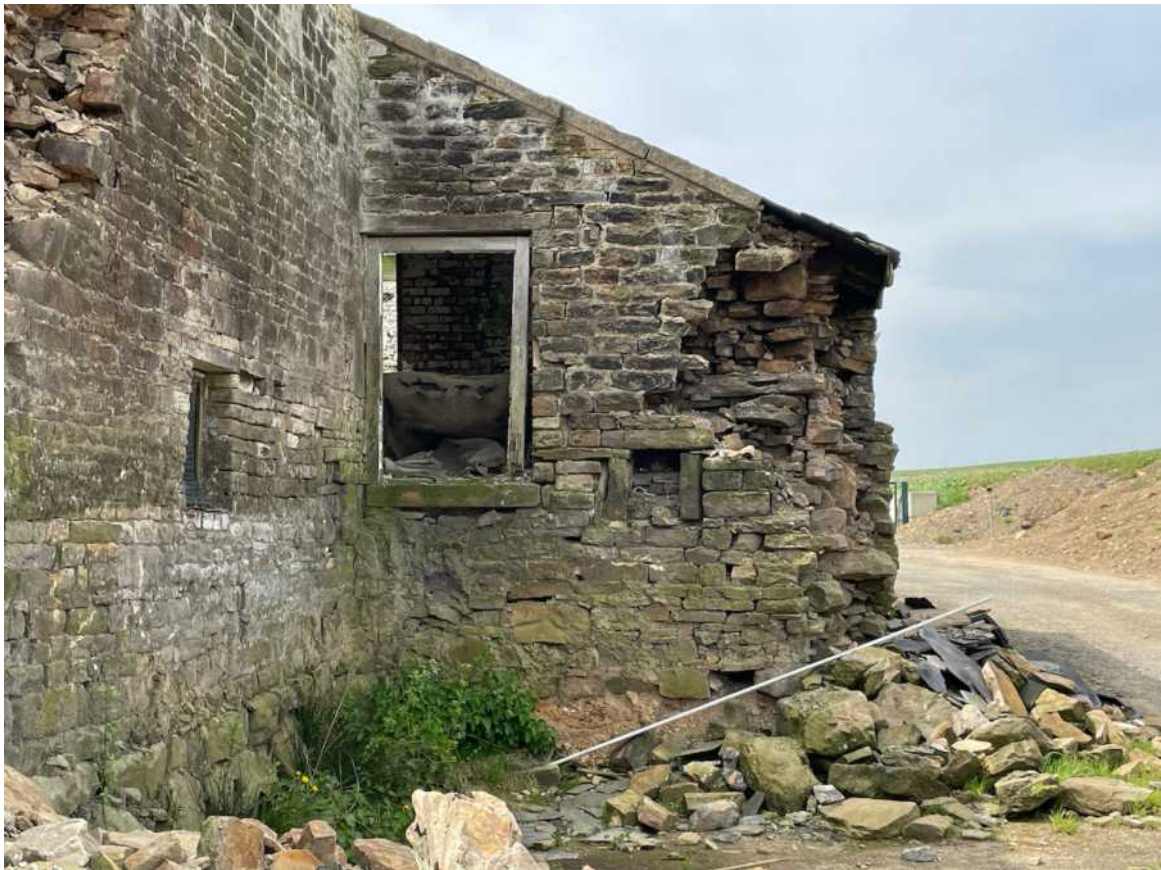
There has been a collapse of masonry in the north elevation in Bay 5 between first floor and eaves level. This is likely a result of roof spread as the remaining masonry either side of the collapse has twisted and leans outward. There has also been a collapse of a section of masonry on the lean-to extension and vertical cracking in the northwest corner which is a result of the exposed foundations, as discussed in section 4.1.

Photo 5: Lean-To Extension – Collapsed Masonry

The lean-to extension should be carefully taken down and rebuilt on new concrete footings. The north elevation of the barn will require underpinning where the foundations and clay below has been exposed.

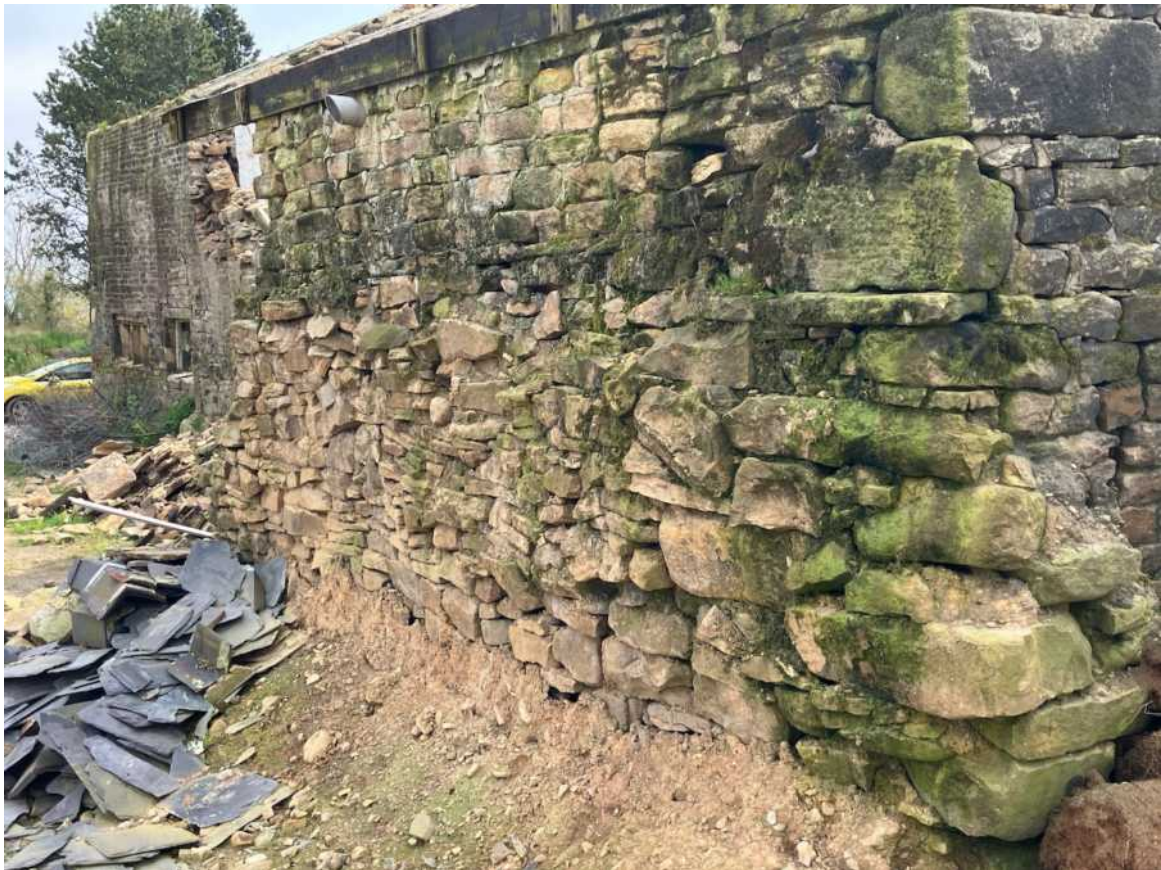
No trial pits or foundation excavations were carried out at the time of the inspection. There were no sign of settlement. However, along the north elevation, particularly around the lean-to extension, the shallow stone foundations and clay below have been exposed to a level below the base of the footing. It is likely that this is the cause of the localised collapse of masonry in the lean-to and cracking in the opposing corner. The concern is the potential for further collapse or masonry movement as the exposed clay below continues to dry out over the coming months. Alternatively, any surface water run-off has the potential to wash out the clay and undermine the foundations.

The north elevation of the lean-to extension also features some rough, unconsolidated masonry at lower level which is of poorer quality when compared to the upper courses. This provides a good indication of the original ground level before the foundations were exposed as this masonry would likely have been below external ground level where external appearance would not be critical.

Photo 6: Lean-To Extension – Foundations Exposed

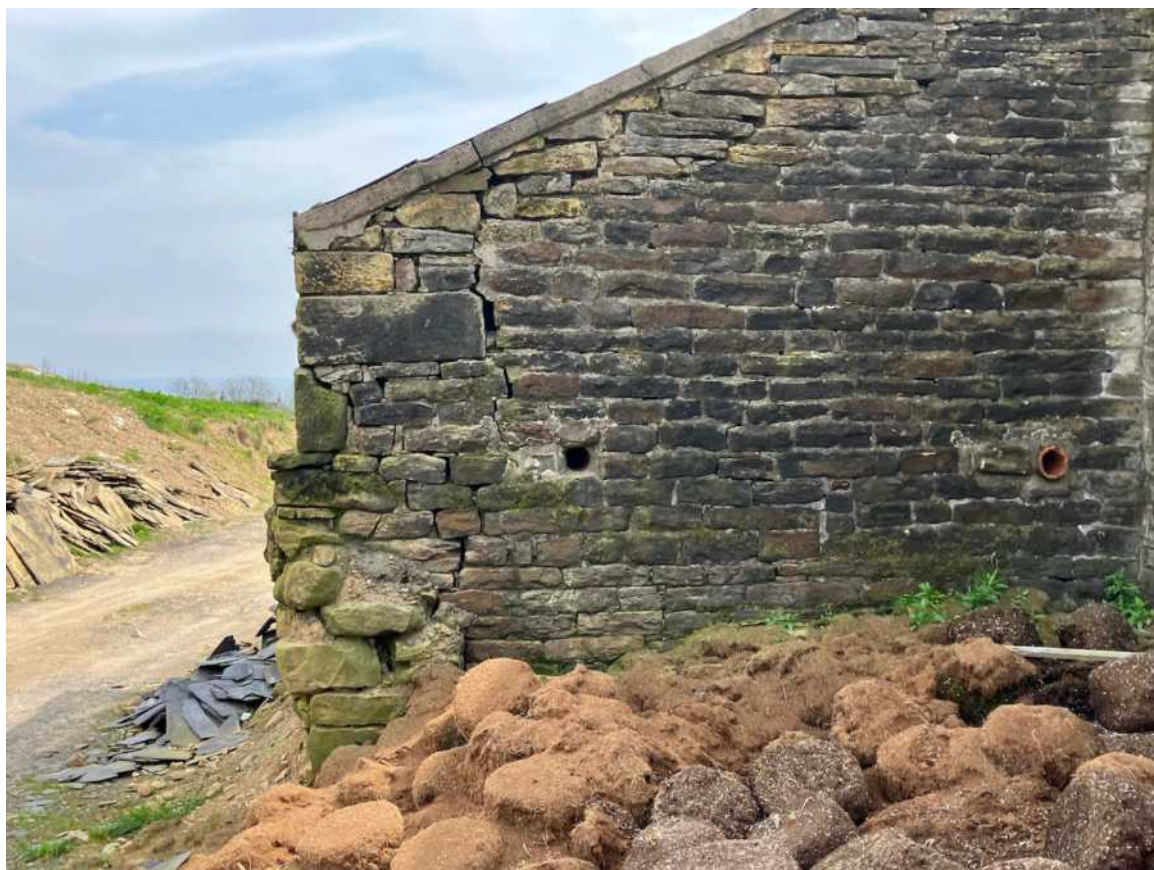
Photo 7: Lean-To Extension – Vertical Cracking

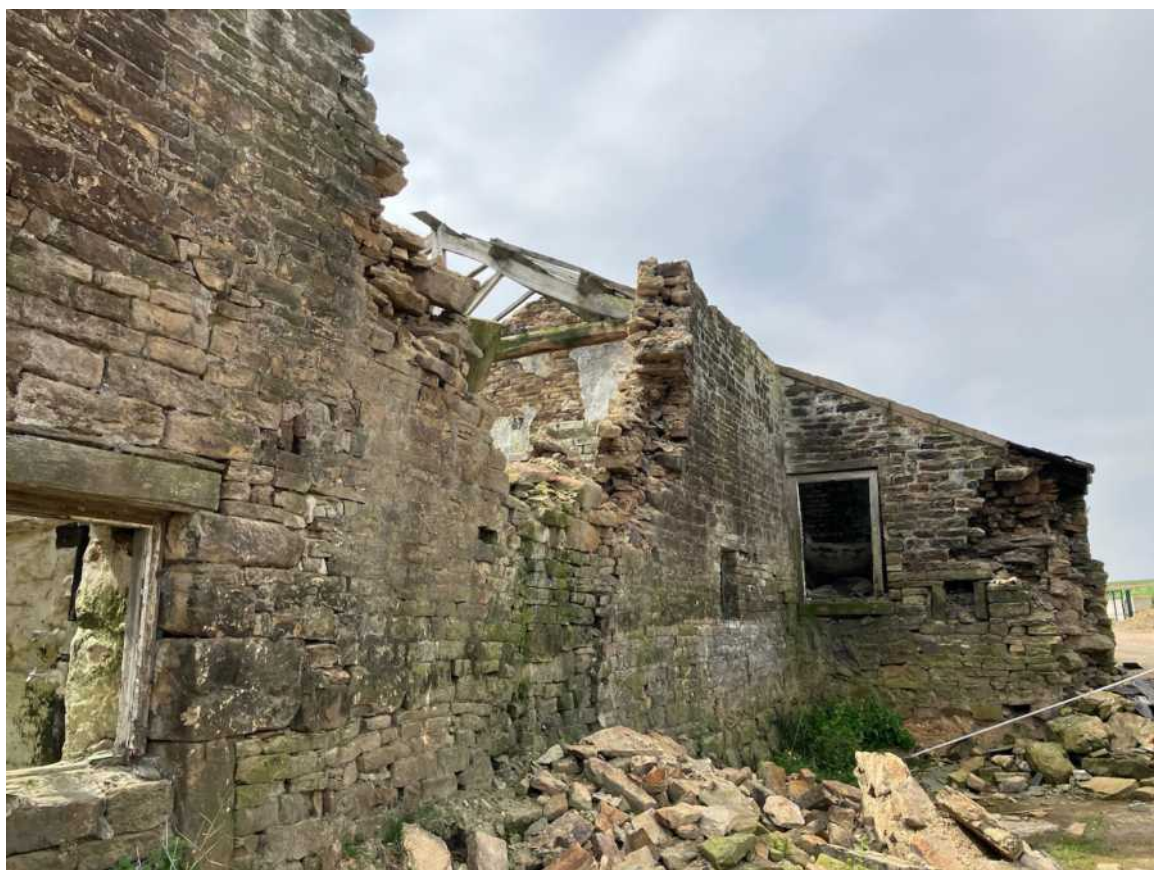
Photo 8: Collapsed Masonry

The collapsed section of masonry in the north elevation should be rebuilt. This may require careful dismantling of adjacent sections of masonry to facilitate.

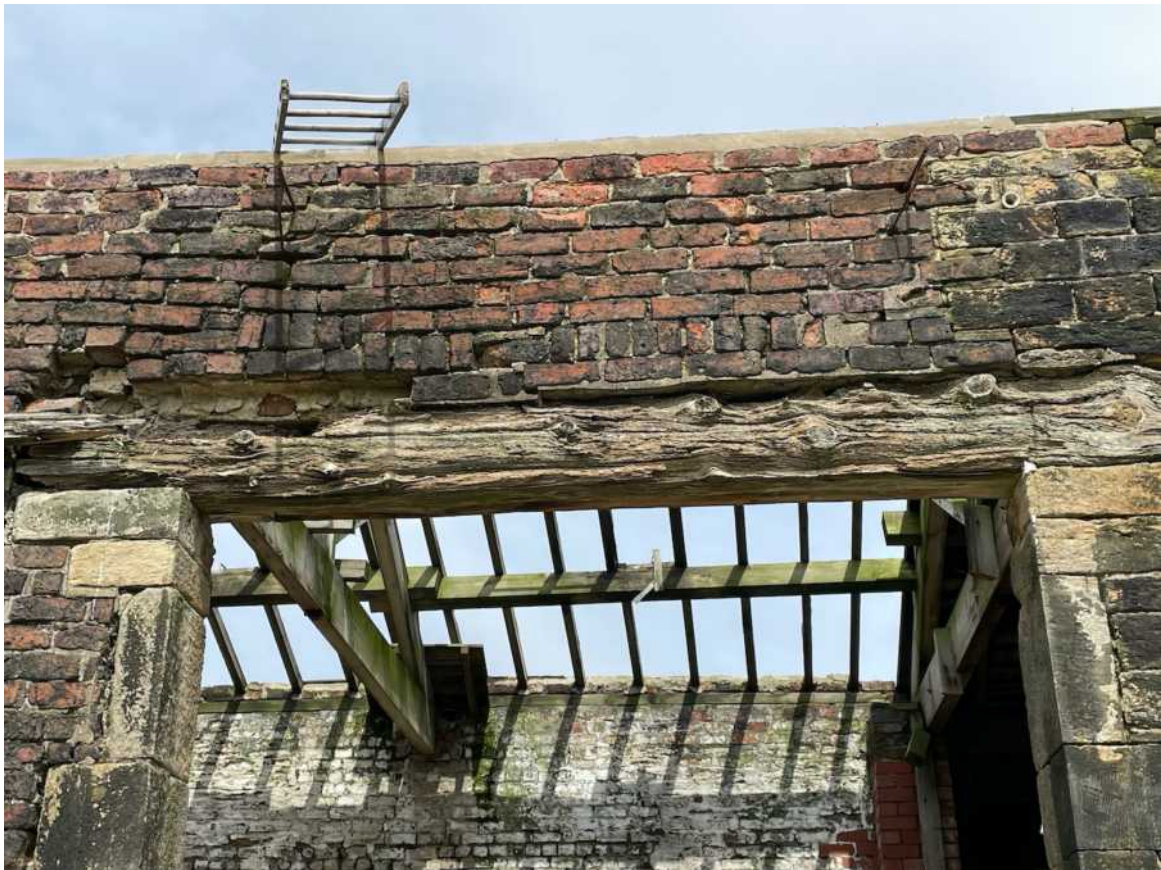
The timber lintel over the cart entrance is suffering from decay and the outer skin of brickwork over has become dislodged with some units missing. A vertical crack was noted adjacent to the west jamb of the cart entrance where the quoins are not adequately tied in.

Photo 9: Cart Entrance - Decayed Lintel & Unconsolidated Masonry

Localised repairs are required to the cart entrance in the south elevation. The vertical cracking up the western jamb should be remedied by stitching or localised rebuilding. The rotten timber lintel should be replaced and brickwork over consolidated. The other 2No isolated areas of missing masonry in the south elevation should be reinstated, any rotten timber lintels replaced and the cracked stone lintel should be repaired using stainless steel dowels.

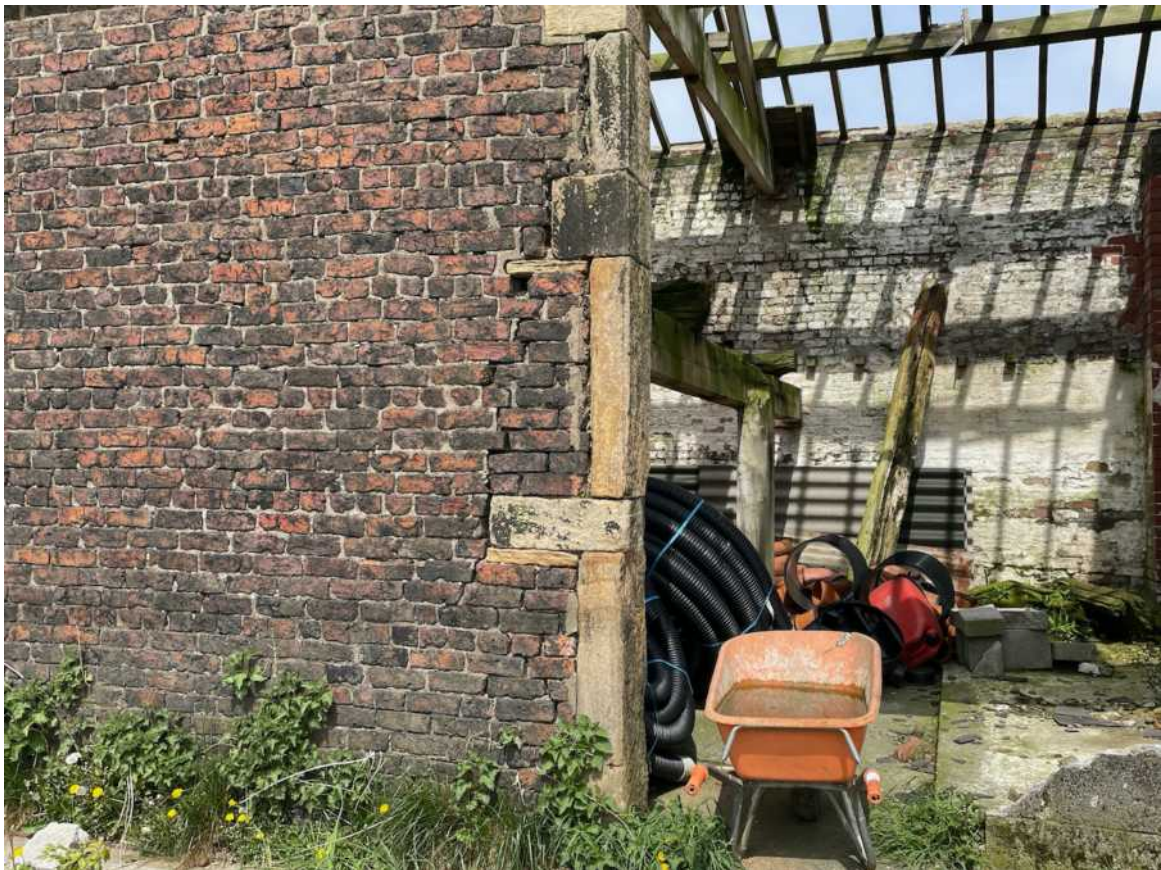
Photo 10: Cart Entrance - Vertical Cracking

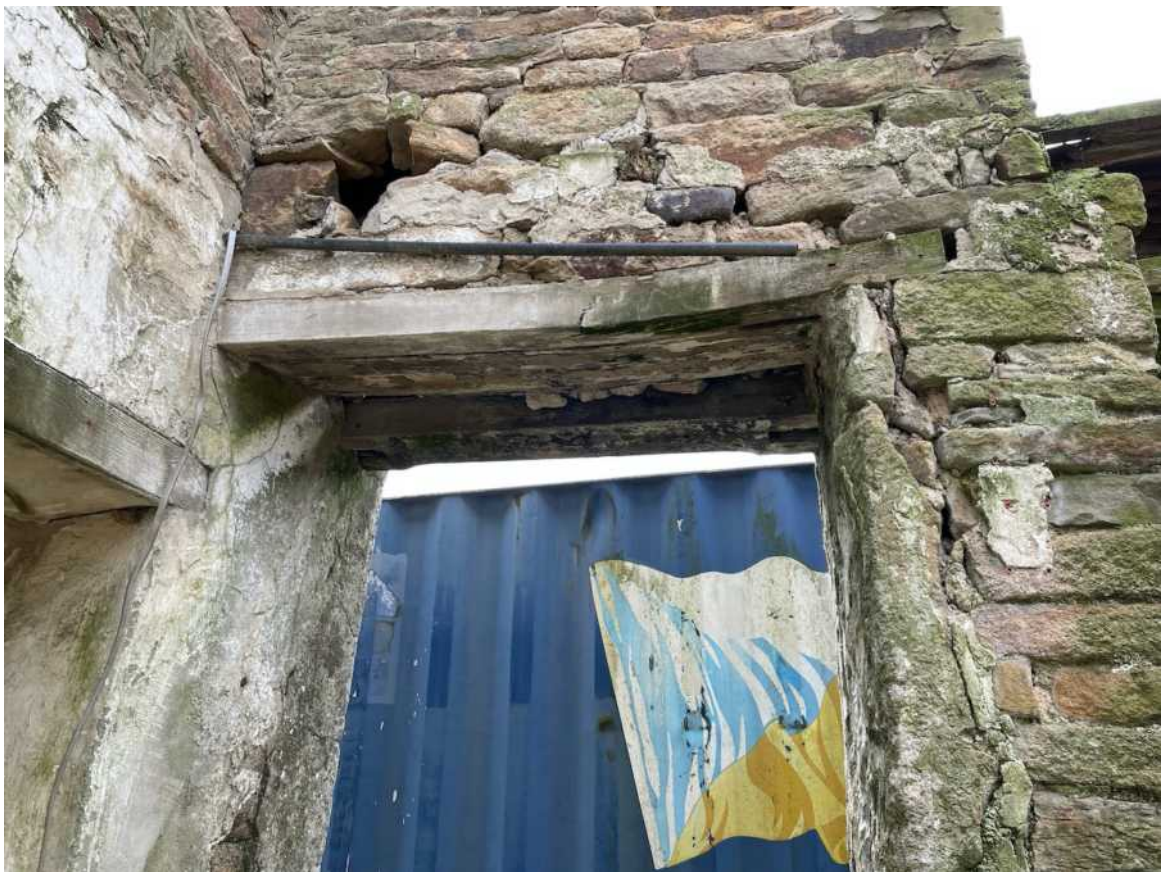
Moving east along the south elevation, there is a rotten timber lintel over a mullioned window. It is thought that the timber mullions have replaced stone mullions as seen in other window openings in the building. There is a full width stone lintel over the adjacent door opening which is cracking. East of this is a window opening which has been

Photo 11: Failing Timber Lintels

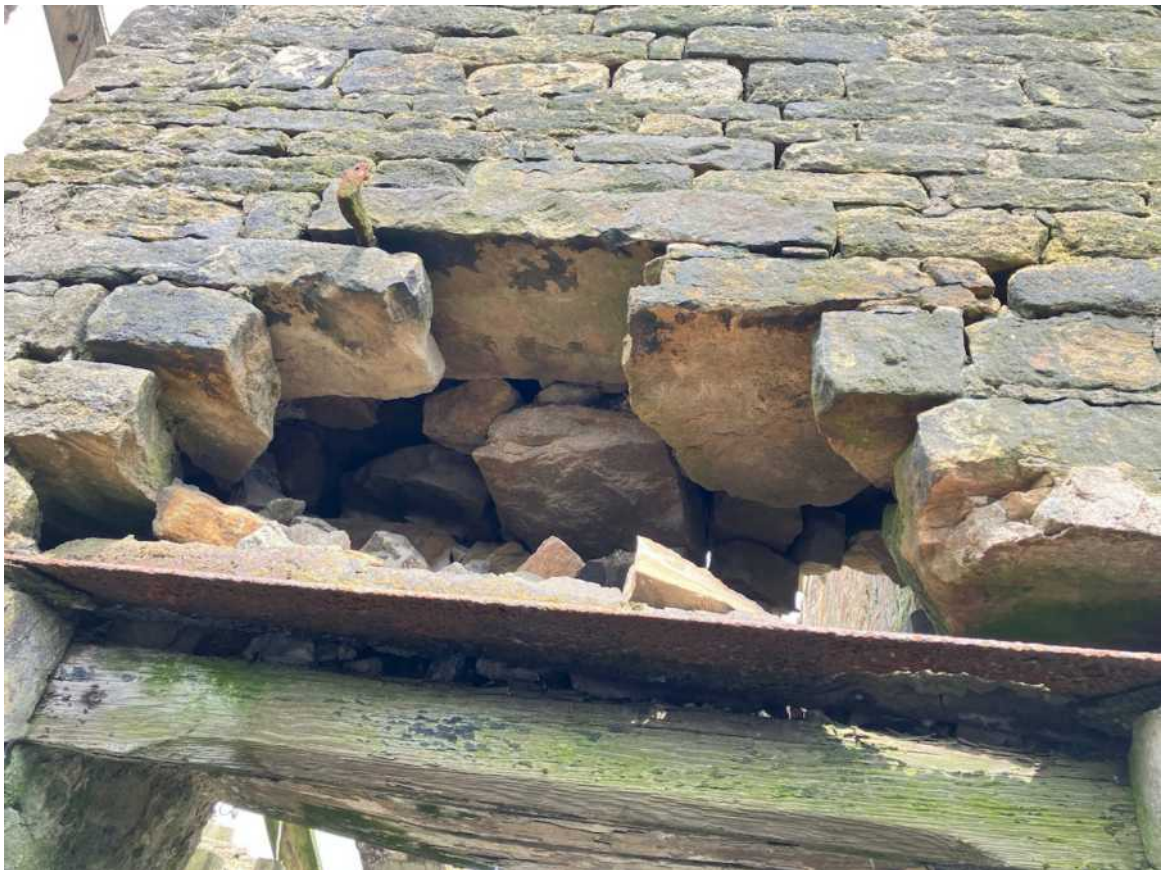
There are two further isolated areas of missing masonry in the south elevation. There is a small section of masonry that is missing between a ground floor and a first floor window opening. There has also been a loss of the outer skin of masonry over the door opening into Bay 5. This is likely due to the failing timber lintels over this door opening.

Photo 12: Missing Outer Facing Over Failing Timber Lintels

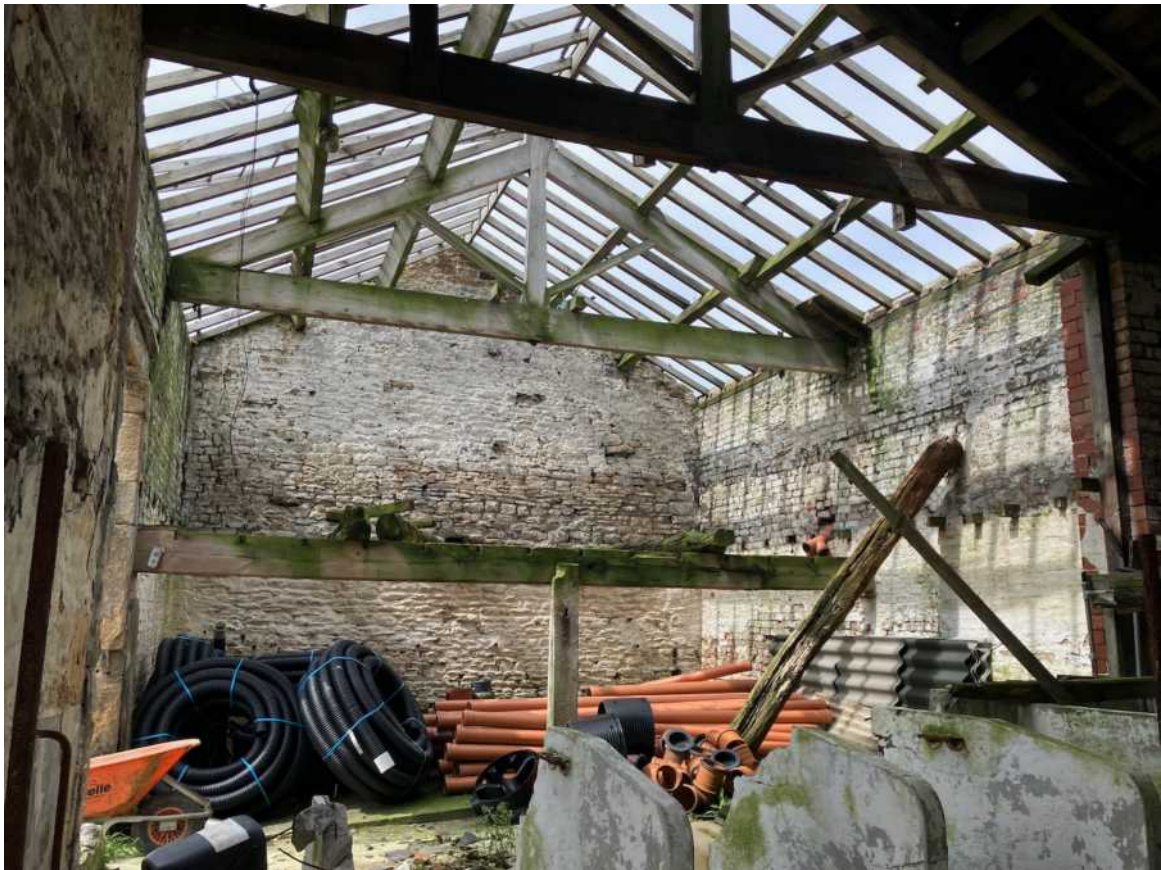
In Bay 6 the ridge beam has decayed and the common rafters are in poor condition. The ridge beam in Bay 3 has also decayed where missing sarking boards have facilitated water ingress. A visual inspection of the common rafters in Bay 1 – Bay 3 from ground level revealed no obvious defects but this could be confirmed by inspection from a scaffold once works on site commence.

Photo 13: Roof Structure (Bay 1 & Bay 2)

The decaying ridge beams over Bay 3 and Bay 6 should be replaced and the common rafters in Bays 4 – 6 should be renewed in entirety. A high level inspection of the common rafters in Bays 1 – 3 would confirm the requirement for any replacements or rafter end repairs.

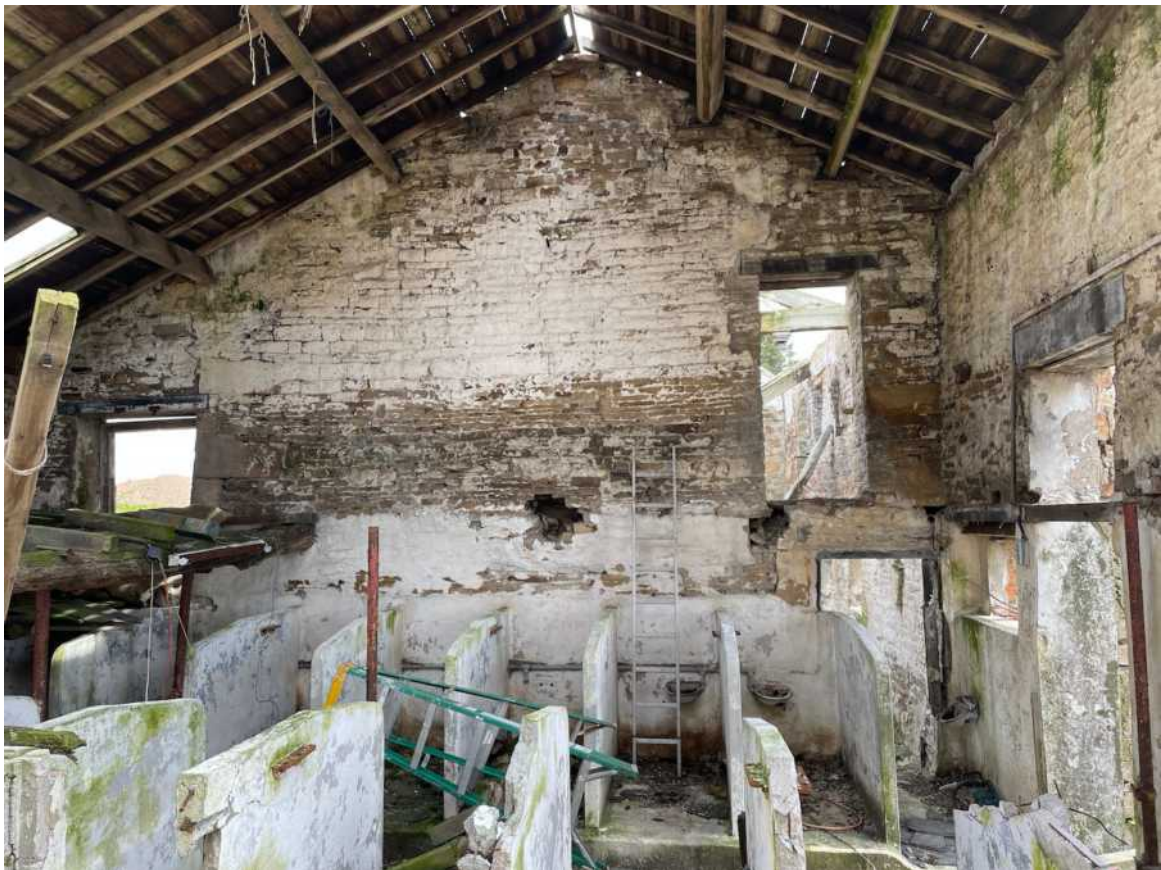
Overall the roof structure is in poor condition. There has been a collapse of the roof structure in Bay 5, including Truss No.4. Truss No.3 remains in situ but shows signs of decay due to water ingress along the tie beam. The purlins and ridge in Bay 3 also show signs of decay and there has been a loss of section where they bear onto the crosswall. The remaining common rafters in Bay 3 are in poor condition and require full replacement.

Photo 14: Bay 3 - Roof Structure & Missing First Floor

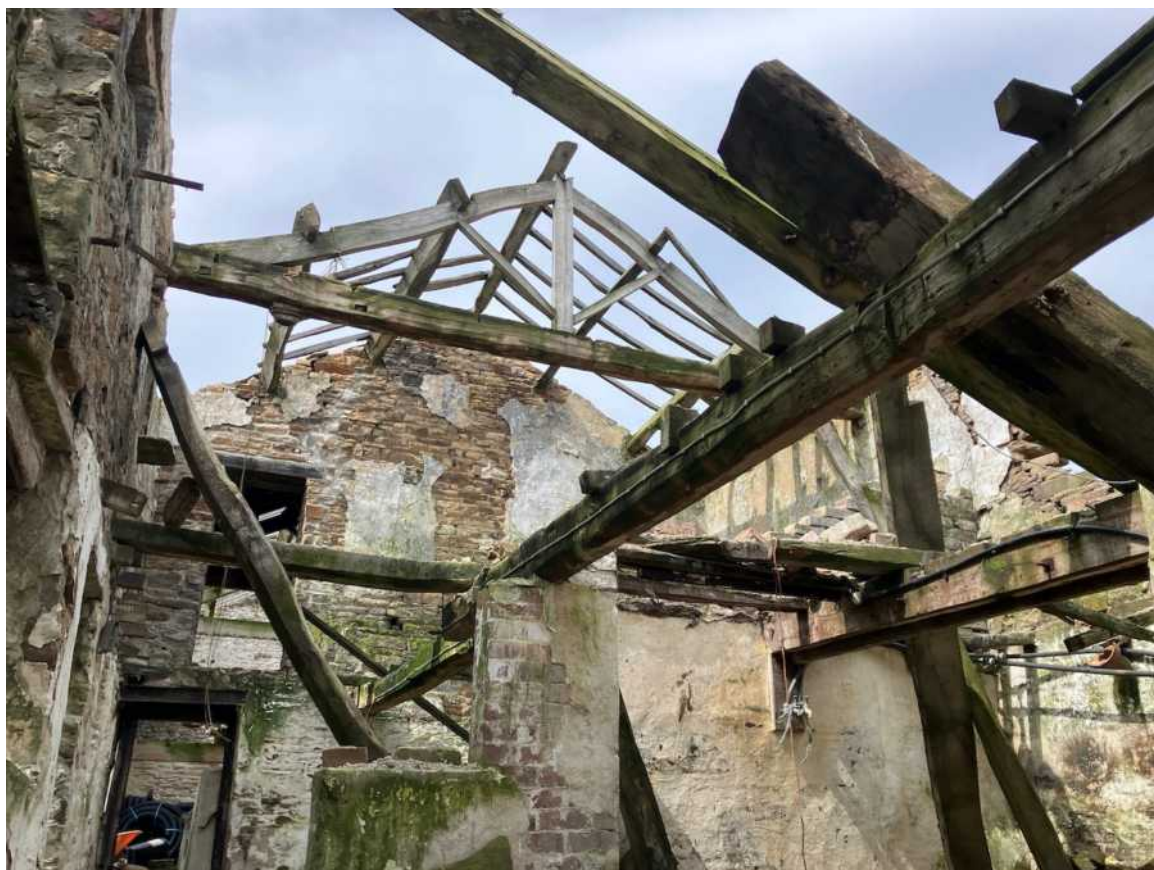
Photo 15: Roof Structure (Bay 4)

The roof structure to Bay 5 requires full replacement, including a new truss. The truss could be designed to replicate Truss No.3. It should also be allowed for replacing the purlins and ridge beam in Bay 4. A high level inspection will be required to confirm the condition and determine the section size at the bearings where section loss has occurred. Considering the weight of the natural stone flag roof covering that is to be reinstated, it may be that the purlins and ridge beam need end repairs to ensure adequate strength.

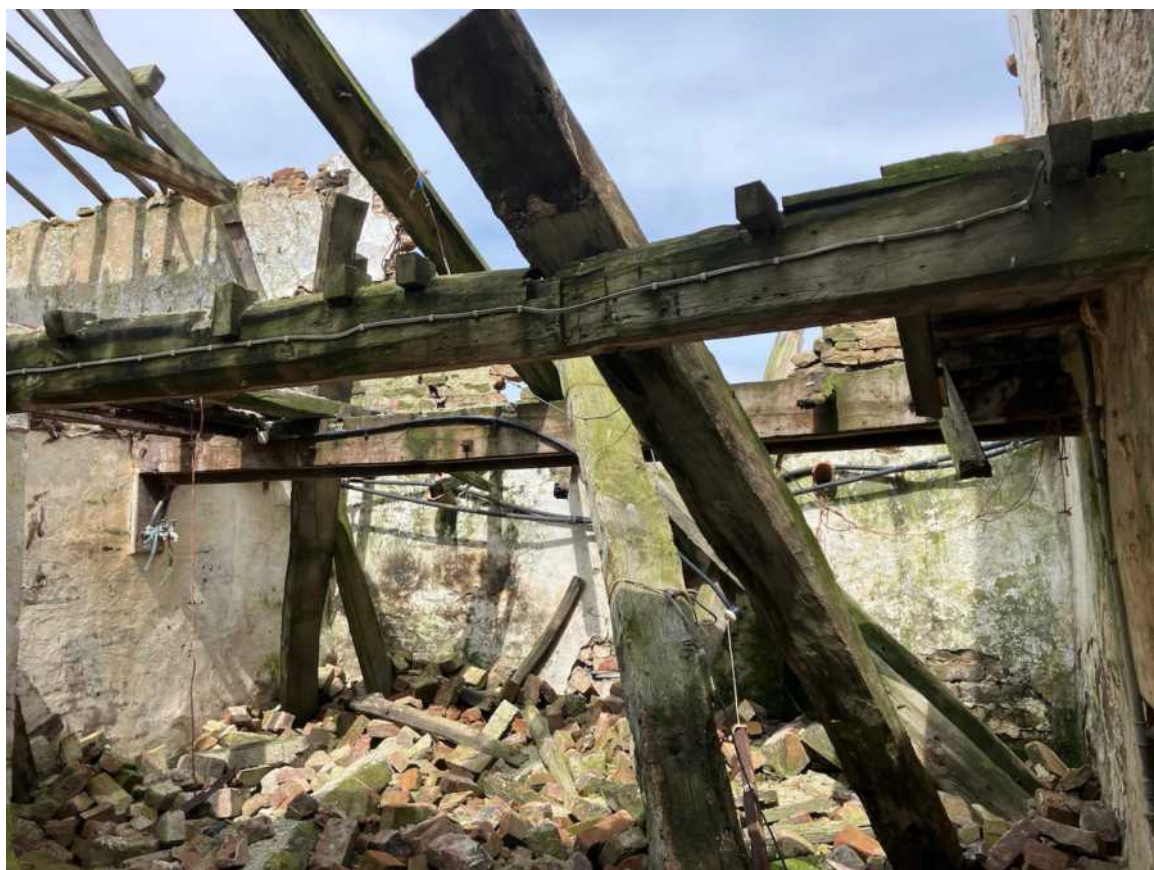
Previously, the building would have featured first floors throughout. Pockets in the masonry in the crosswall between Bay 3 and Bay 4 indicate where primary floor beams are missing. The remaining primary beams are generally in poor condition, 4No beams are suffering from significant decay and 1No has split. In Bay 3 the remaining primary beam is severely decayed, has lost its end bearing due and is now supported on acrow props.

Photo 16: Bay 5 - Collapsed Roof & First Floor Structure

The first floor structures require complete replacement. There is 1No primary timber beam that could be reused but would need to be raised to allow adequate head clearance at ground floor level.

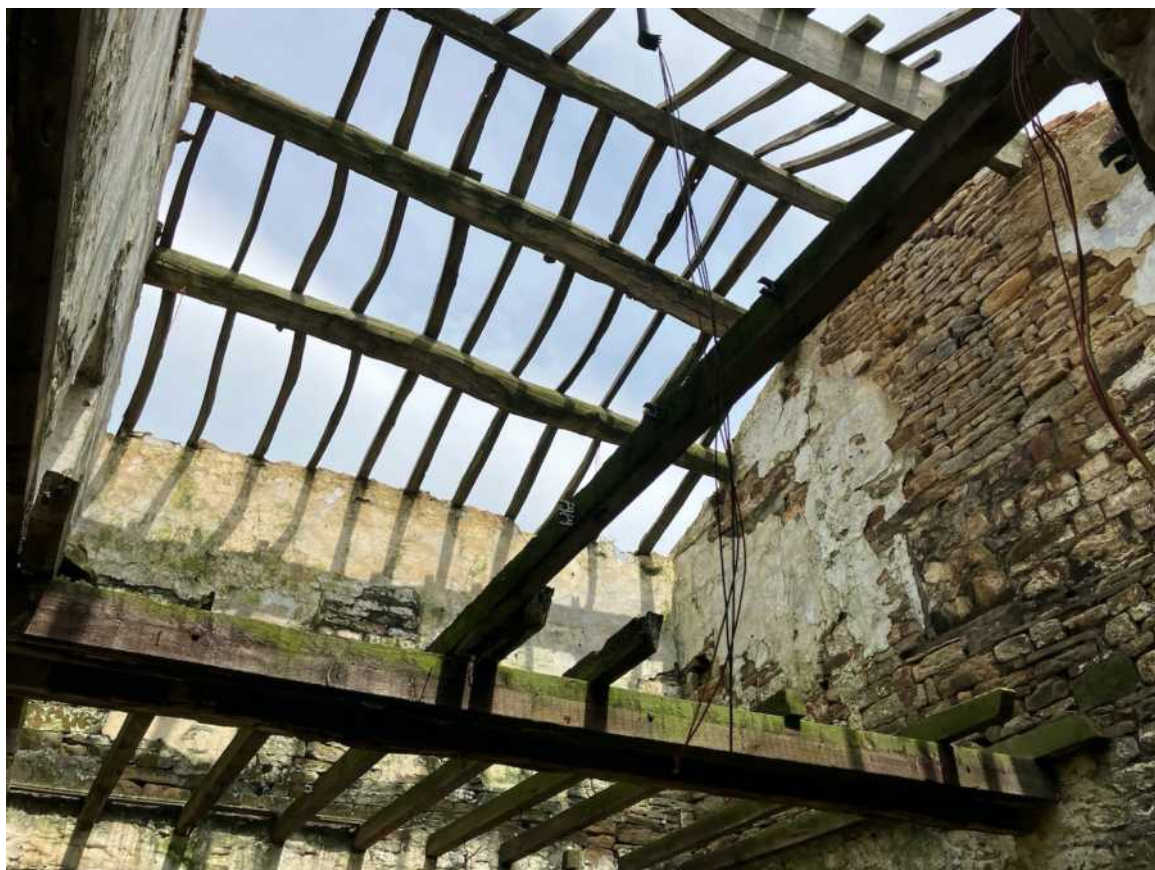
Photo 17: Bay 6 - Roof & First Floor Structure in Poor Condition
