# Drainage Report

Bowlee Park Golf Range | Heywood Old Road

**Document Reference:** 062D22-DR/01

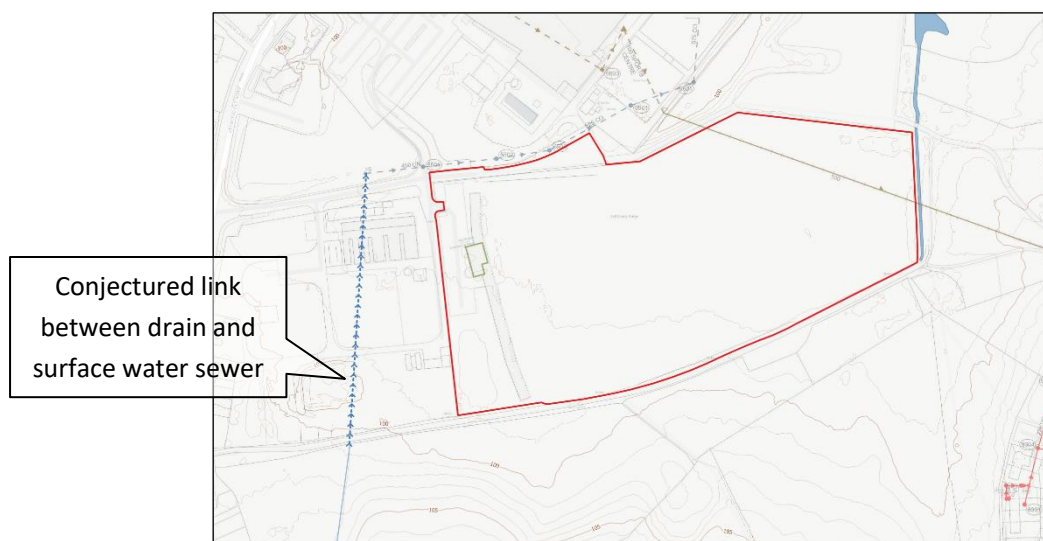
**FIGURE 2 - CONJECTURED DRAIN TO SEWER CONNECTIVITY**

With reference to United Utilities sewer record plan, it is surmised that the surface water sewer shown to the north of the development may represent the subsumed route of an ordinary watercourse with the upstream 'drain' shown to the east of Bowlee potentially flowing through the construction training and nursery curtilages to the west of the subject site as indicated at figure 2 below.

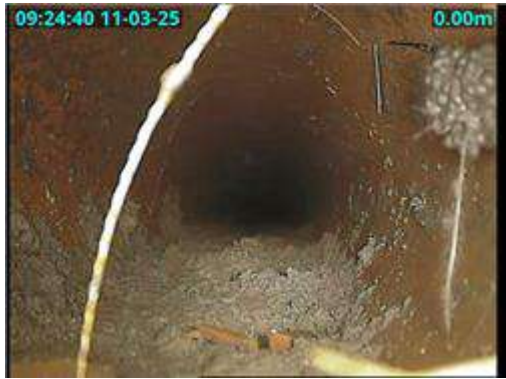
| Pos | Video Ref | Code | Description | Image |
|---|---|---|---|---|
| 00.00m | 0:00:04 | FL | Fracture longitudinal at 02 o'clock - Severity 3 | Image Provided - Ref: 2_2<br> |

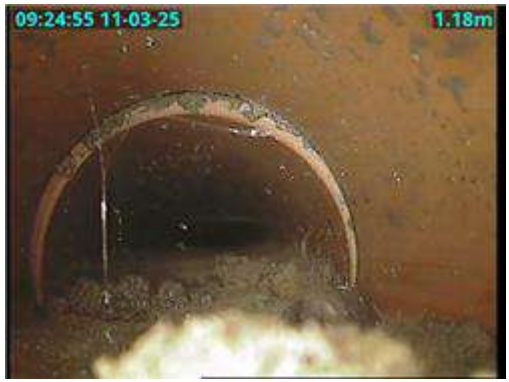
| Pos | Video Ref | Code | Description | Image |
|---|---|---|---|---|
| 01.18m | 0:00:19 | JDM | Joint displaced medium -<br>Severity 3 | Image Provided - Ref: 2_5<br> |

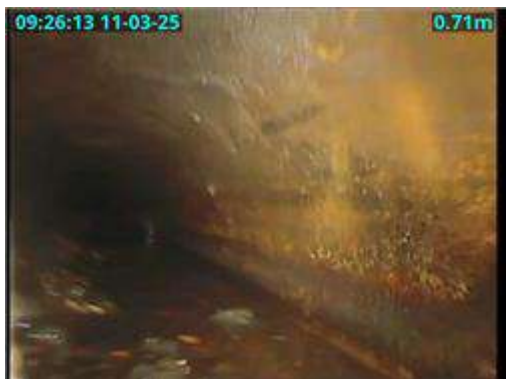
| Pos | Video Ref | Code | Description | Image |
|---|---|---|---|---|
| 00.71m | 0:00:06 | DER | Settled deposits coarse: 30% Cross sectional area loss - Severity 3 | Image Provided - Ref: 3_3<br> |

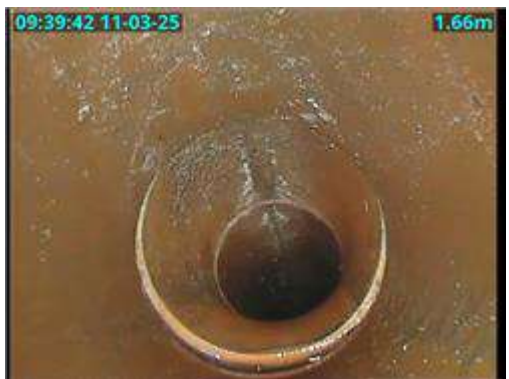
| Pos | Video Ref | Code | Description | Image |
|---|---|---|---|---|
| 01.66m | 0:00:16 | JDM | Joint displaced medium - Severity 3 | <p>Image Provided - Ref: 5_3</p> |

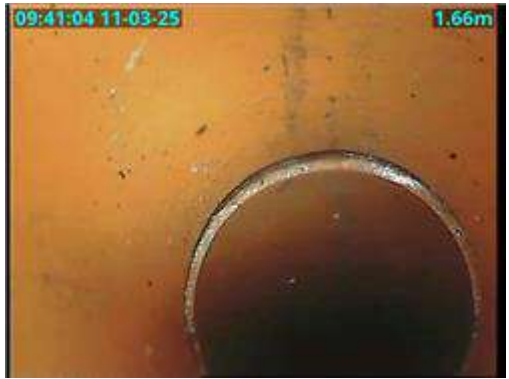
| Pos | Video Ref | Code | Description | Image |
|---|---|---|---|---|
| 01.66m | 0:00:12 | JDM | Joint displaced medium - Severity 3 | <p>Image Provided - Ref: 6_2</p> |

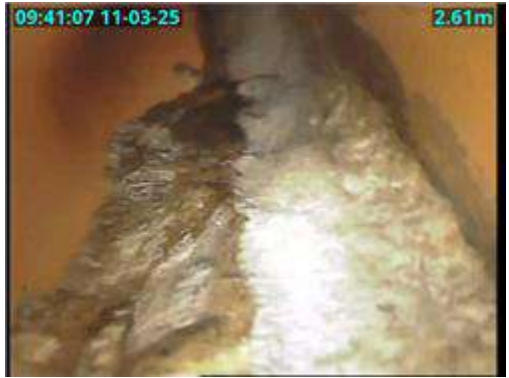
| Pos | Video Ref | Code | Description | Image |
|---|---|---|---|---|
| 02.61m | 0:00:15 | DEE | Attached deposits, encrustation: 15% Cross sectional area loss - Severity 3 | <p>Image Provided - Ref: 6_3</p> |

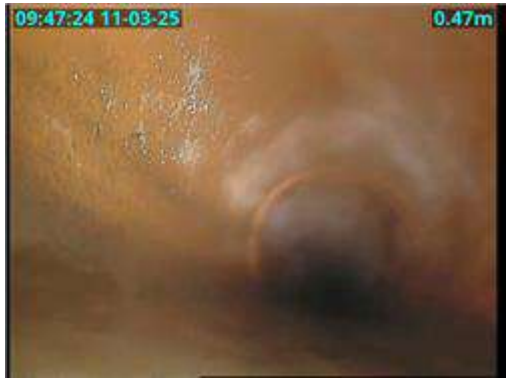
| Pos | Video Ref | Code | Description | Image |
|---|---|---|---|---|
| 00.47m | 0:01:47 | S2 DES | Settled deposits fine 0.47m - 7.57m: 10% Cross sectional area loss - Severity 3 | Image Provided - Ref: 7_4<br> |

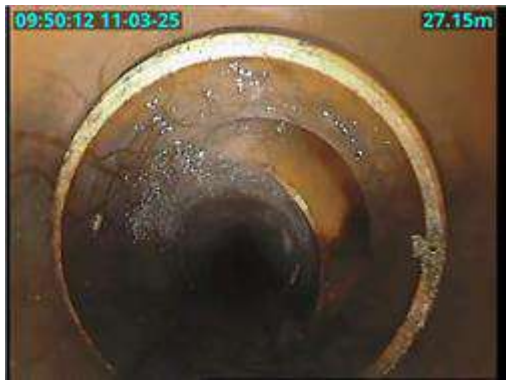
| Pos | Video Ref | Code | Description | Image |
|---|---|---|---|---|
| 27.15m | 0:01:38 | JDM | Joint displaced medium - Severity 3 | Image Provided - Ref: 8_8<br> |

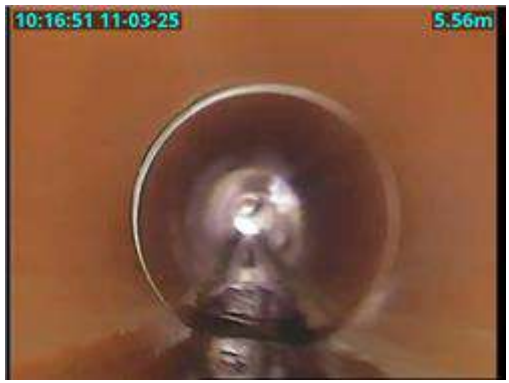
| Pos | Video Ref | Code | Description | Image |
|---|---|---|---|---|
| 05.56m | 0:00:23 | JDM | Joint displaced medium - Severity 3 | <p>Image Provided - Ref: 14_4</p> <p>10:16:51 11-03-25 5.56m</p> |

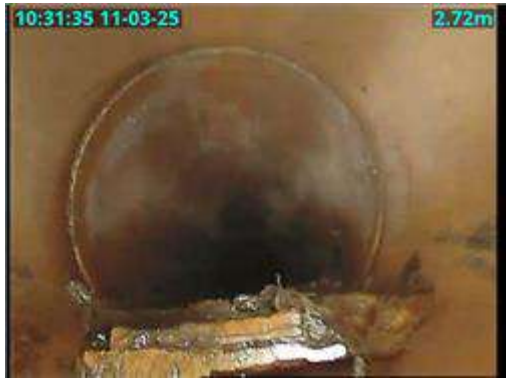
| Pos | Video Ref | Code | Description | Image |
|---|---|---|---|---|
| 02.72m | 0:00:12 | DER | Settled deposits coarse: 10%<br>Cross sectional area loss -<br>Severity 3 | <p>Image Provided - Ref: 17_2</p> |

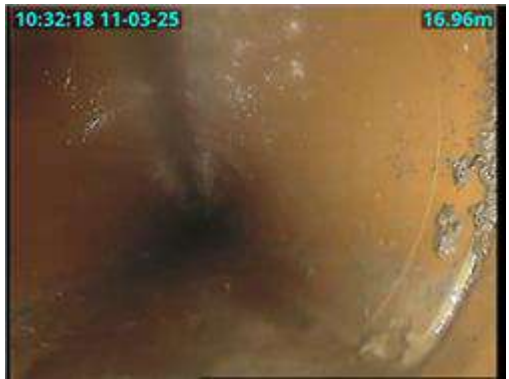
| Pos | Video Ref | Code | Description | Image |
|---|---|---|---|---|
| 16.96m | 0:00:55 | DES | Settled deposits fine: 10%<br>Cross sectional area loss -<br>Severity 3 | Image Provided - Ref: 17_6<br> |

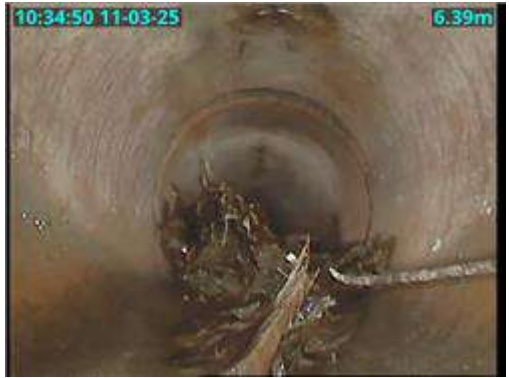
| Pos | Video Ref | Code | Description | Image |
|---|---|---|---|---|
| 06.39m | 0:00:26 | DES | Settled deposits fine: 20%<br>Cross sectional area loss -<br>Severity 3 | <p>Image Provided - Ref: 18_3</p> |

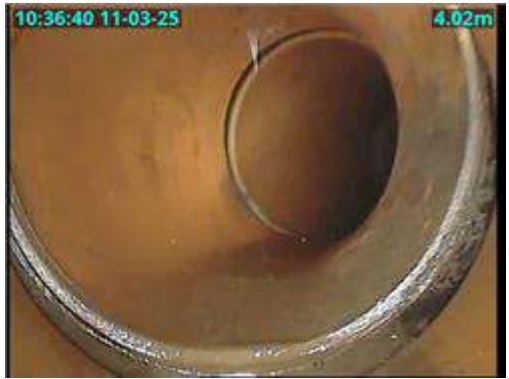
| Pos | Video Ref | Code | Description | Image |
|---|---|---|---|---|
| 04.02m | 0:00:16 | JDM | Joint displaced medium - Severity 3 | <p>Image Provided - Ref: 19_2</p> |

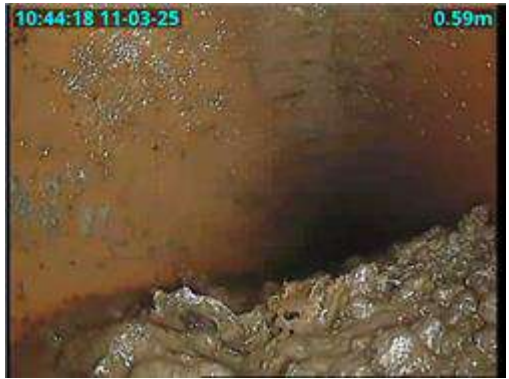
| Pos | Video Ref | Code | Description | Image |
|---|---|---|---|---|
| 00.60m | 0:00:07 | DES | Settled deposits fine: 25% Cross sectional area loss - Severity 3 | <p>Image Provided - Ref: 21_3</p> |

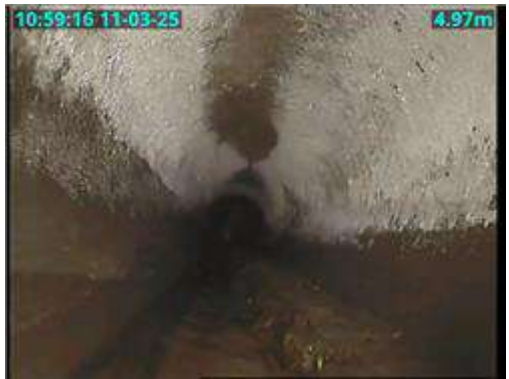
| Pos | Video Ref | Code | Description | Image |
|---|---|---|---|---|
| 04.97m | 0:00:21 | DES | Settled deposits fine: 10%<br>Cross sectional area loss -<br>Severity 3 | Image Provided - Ref: 25_6<br> |
