**ENGINEERING REPORT 9179**

**ROBINSONS EQUESTRIAN CENTRE  
HARWOOD FIELD FARM  
CASTLE HILL ROAD  
BURY  
BL9 6UL**

**CLIENT: STEPHEN ROBINSON**

**24.11.2023 MP/CH**

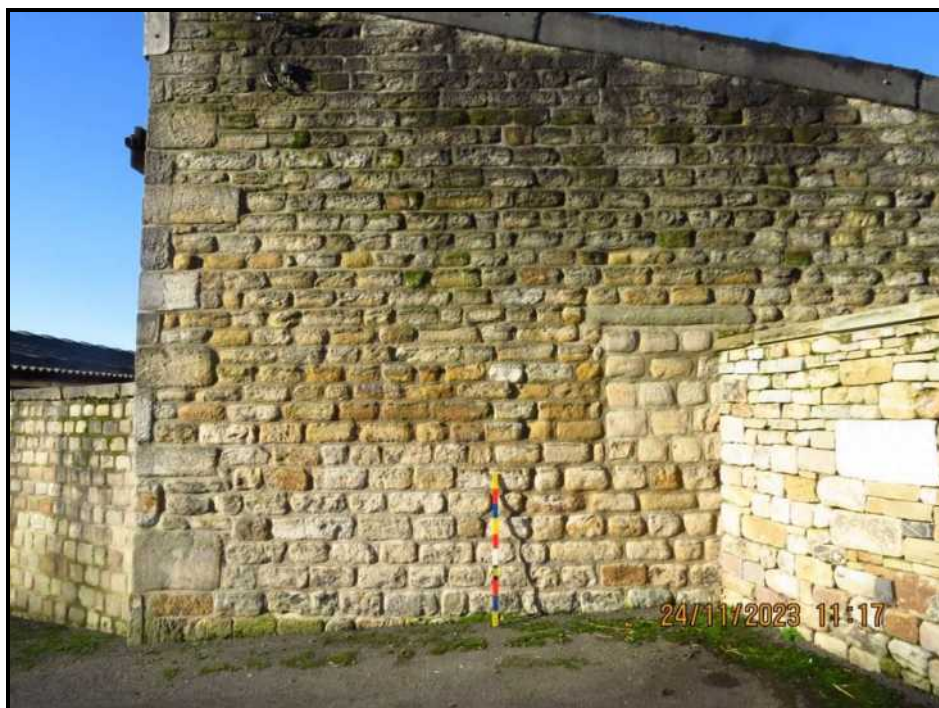
004 Chainage 0 – 5 metres

- 4.1 The Eastern elevation is half gabled constructed in a randomly coursed stonework, with larger stone sections to the quoins on the front and rear corners, completed with a mono pitched roof.
- 4.2 The Eastern half gable elevation is completed in well maintained coursed stonework with quoin returns on the front and rear wall returns. The wall extends for a length in the order of 9 metres wide, sloping from 5 metres high on the front (South Eastern corner) to 2.5 metres high on the rear North Eastern corner.
- 4.3 The existing ground level rises approximately 1 metre from front to rear. (Photographs 001, 002, 004, 005).

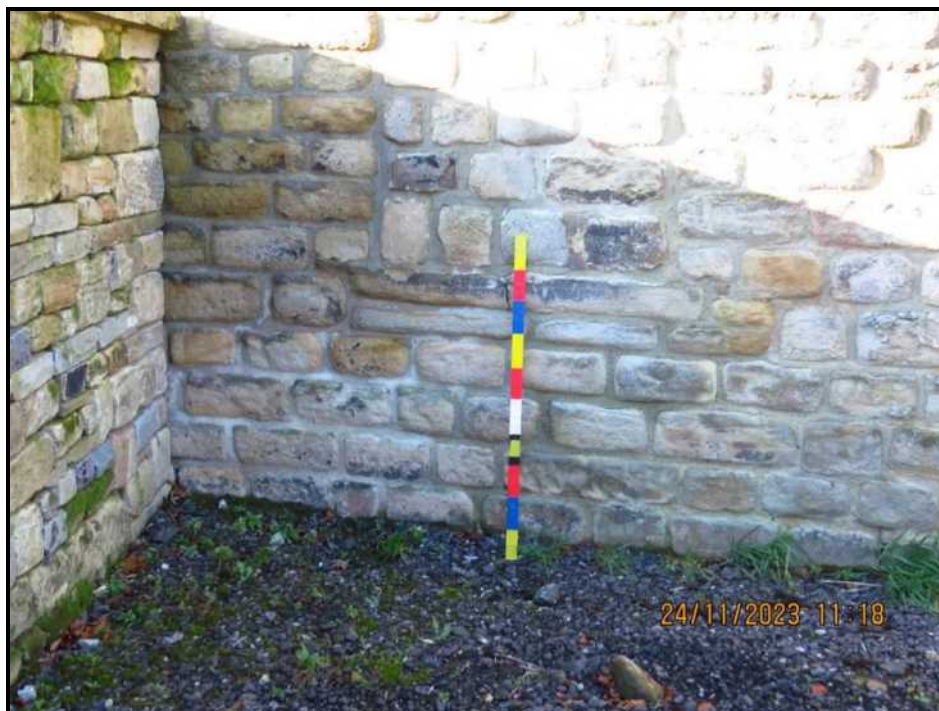
- 4.4 A 1.5 metre stone wall abuts the gable around chainage 5 metres with no evidence of any separation of movement between the two structures. (Photograph 006)
- 4.5 A former window opening has been infilled in matching stonework with the retention of the original stone lintel. The stonework and pointing are in very good condition.

006 No signs of separation between wall structures

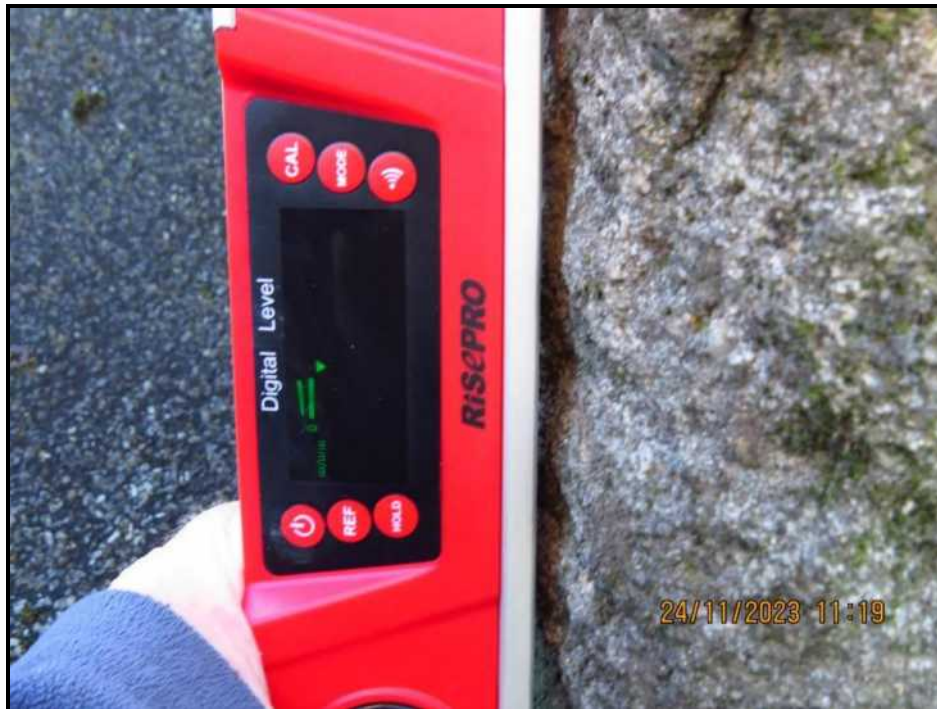
007 Satisfactory vertical alignment 5mm per metre

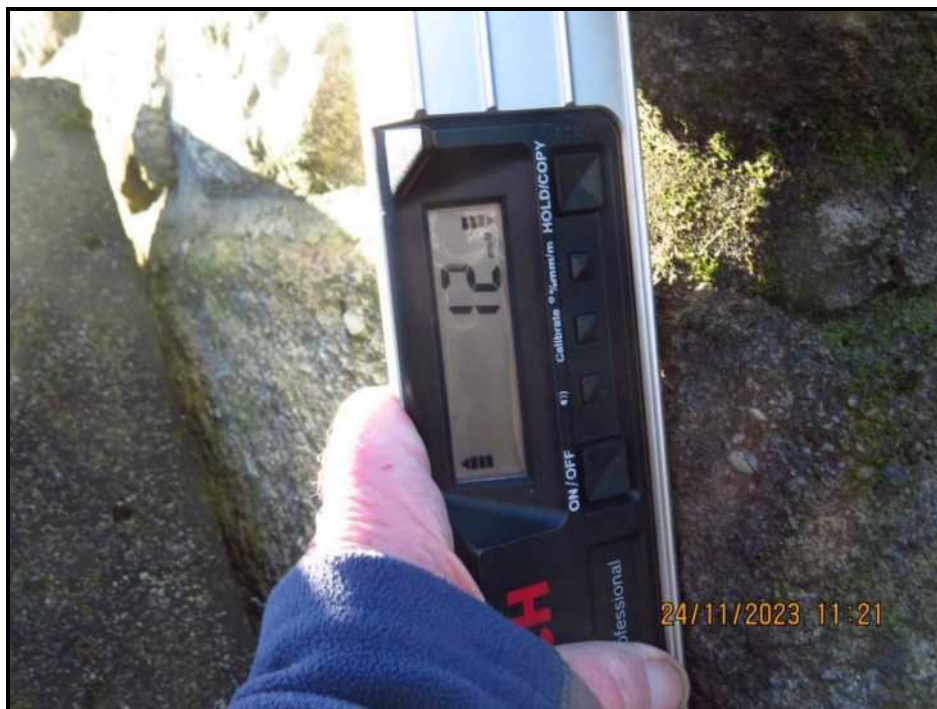
009 Vertical alignment  $\pm$  6mm per metre

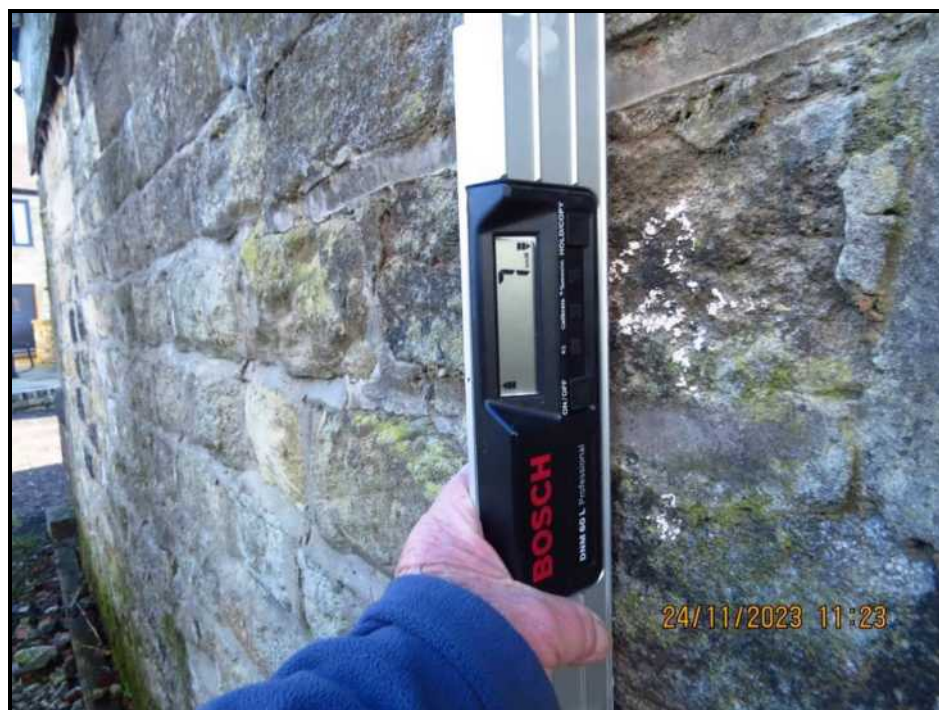
- 5.2 At chainage 0.5 metres the vertical alignment is in the order of 8mm per metre with a 7mm per metre at chainage 4 metres. (Photographs 010, 011).

011 Chainage 4 metres, 7mm per metre

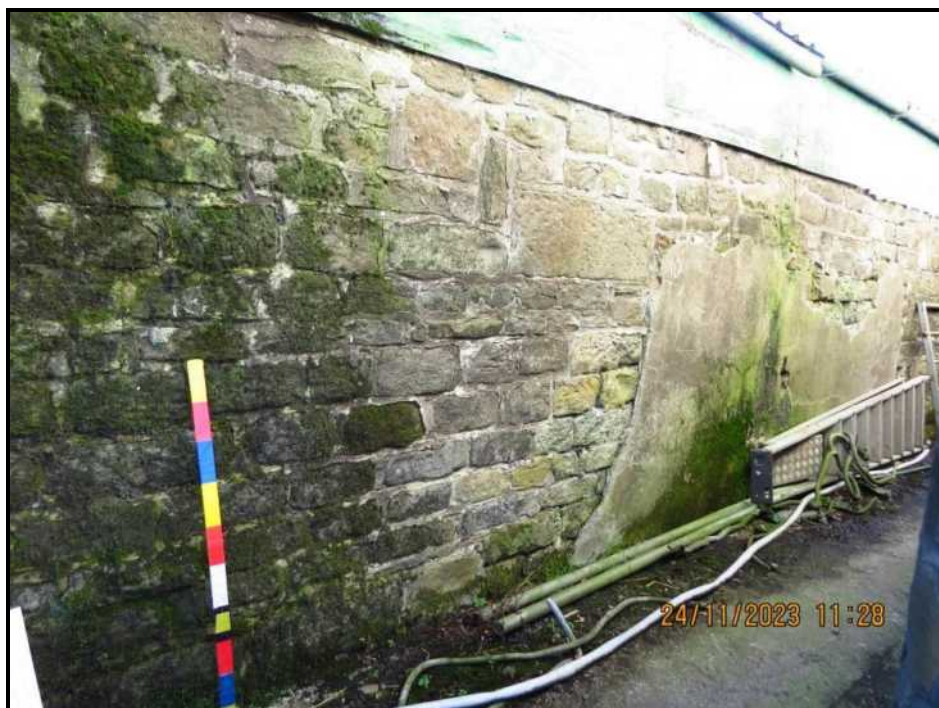
015 Chainage 8 – 12 metres

- 5.3 The vertical alignment at chainage 7 metres is good with irregularities in the order of 7mm per metre.
- 5.4 The rear wall terminates with a vertical joint between the North Eastern section and the North Western section. (Photographs 019, 020).
- 5.5 Between chainage 8 – 12 metres the wall is completed with a 25mm rendered panel extending for a height between 1 – 1.2 metres and the rendering is generally in a satisfactory sound condition with good vertical alignment. (Photographs 015, 017, 018).

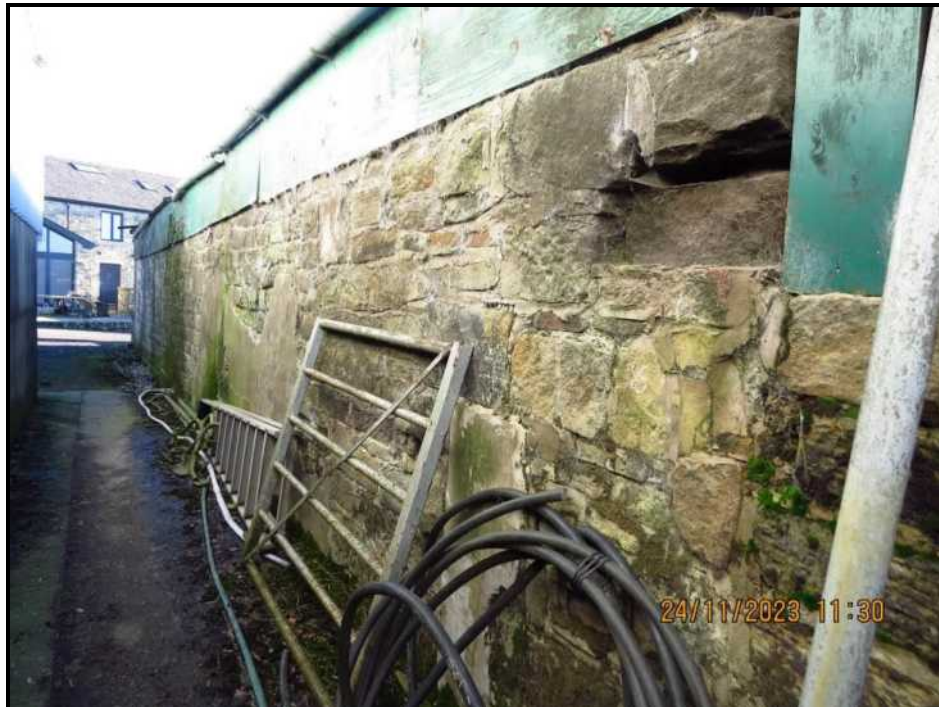
020 Rear elevation looking South East

- 5.1 The North Eastern elevation extends for a length in the order of 15 metres in regular stone course of solid wall construction, a height in the order of 3 – 3.2 metres. (Photographs 012, 013, 014, 020).

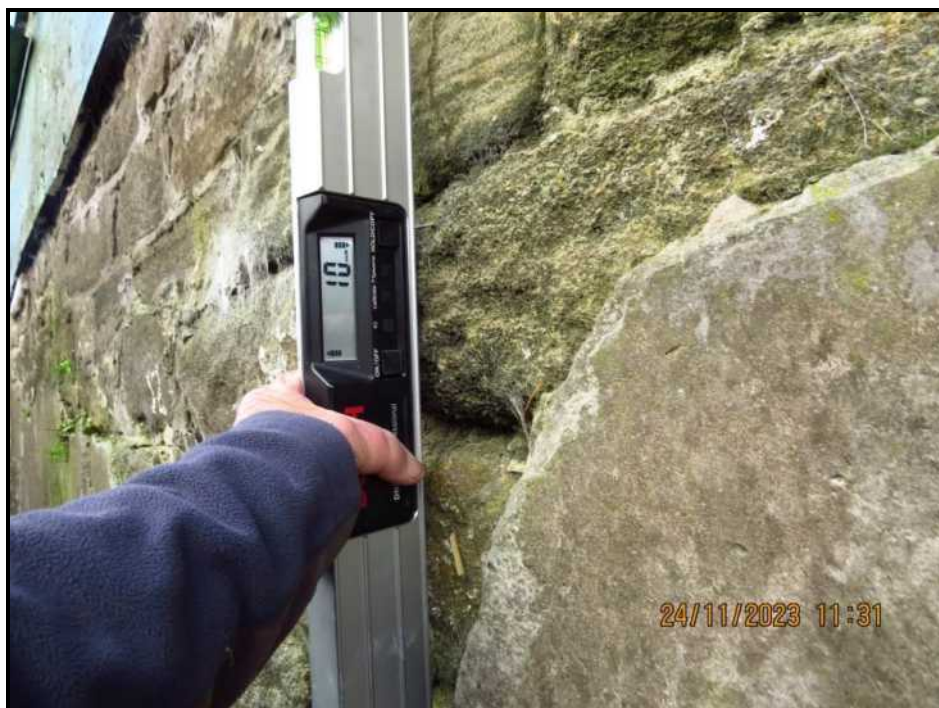
021 Satisfactory vertical alignment,  $\pm 5\text{mm}$  per metre

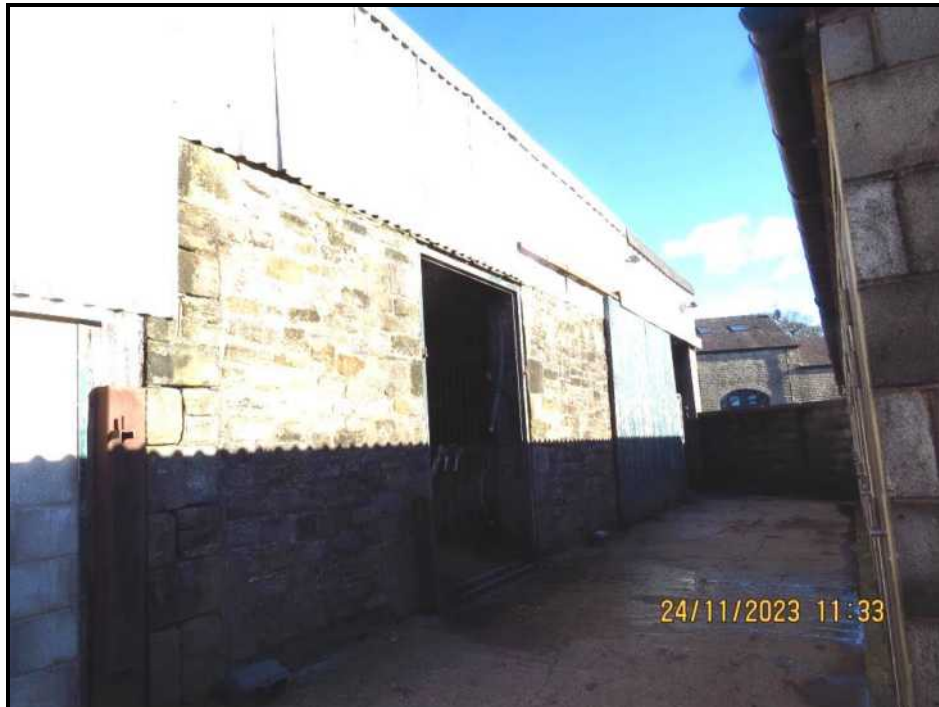
024 Front elevation

- 3.1 The front elevation extends for a width in the order of 16 metres completed in coursed natural stonework of solid wall construction with a struck pointing, incorporating larger stone quoins on the original corners of the barn (chainage 0 – chainage 16 metres).
- 3.2 The stone facing extends for the full height of the front elevation overlain at eaves level with a variable 2 – 3 metre deep profiled metal cladding from roof level.
- 3.3 The front elevation incorporates a large timber sliding door located between chainage 1.5 – 4 metres with a further doorway to the East (left) at chainage 10 – 12 metres. (Photograph 024)

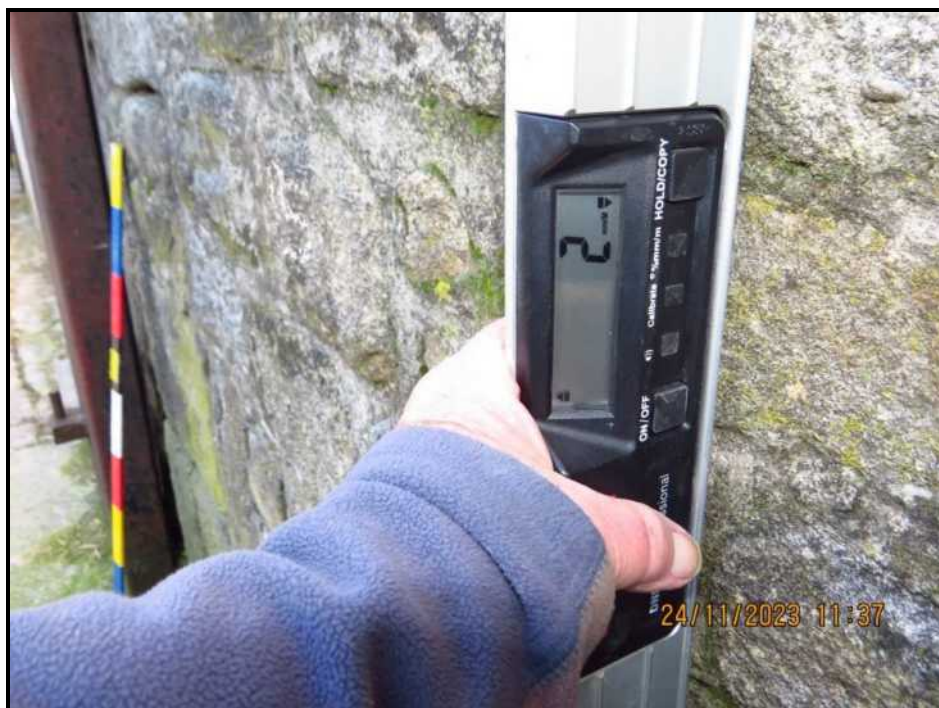
- 3.8 The vertical alignment to the right hand door reveal and the front elevation is good with irregularities less than 8mm per metre. (Photographs 029, 030).
- 3.9 The stonework and pointing on the end Western panel (10 – 15 metres) is good, isolated crazing is evident around the quoin details and some loss of pointing, but is not of any structural consequence with no evidence of any significant movement or rotation. (Photographs 023, 025, 026, 028).

029 Good vertical alignment, 2mm per metre

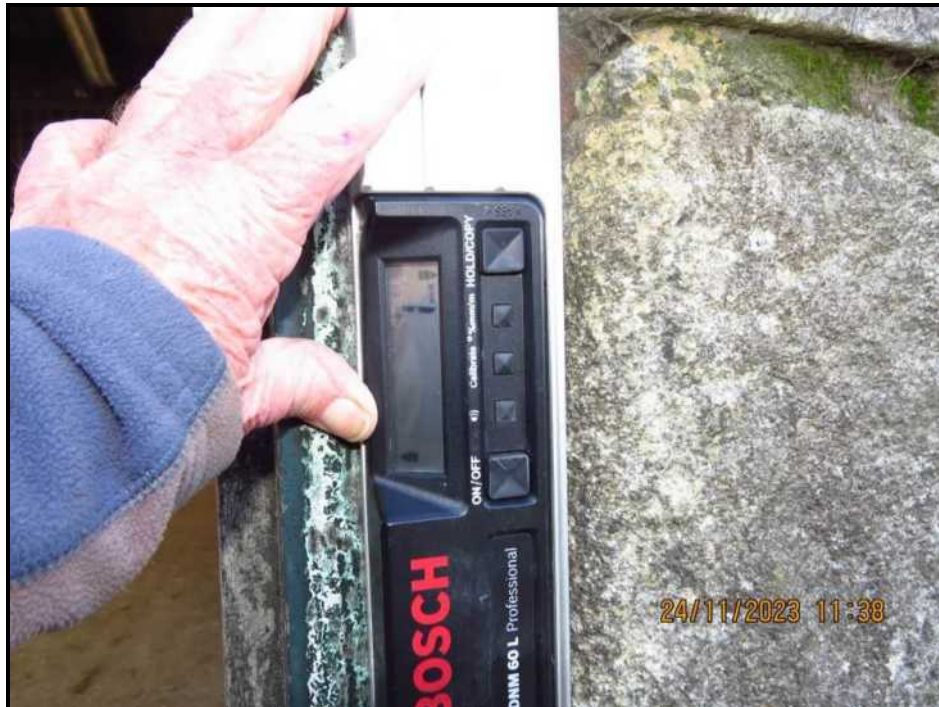
030 Good vertical alignment to right hand reveal

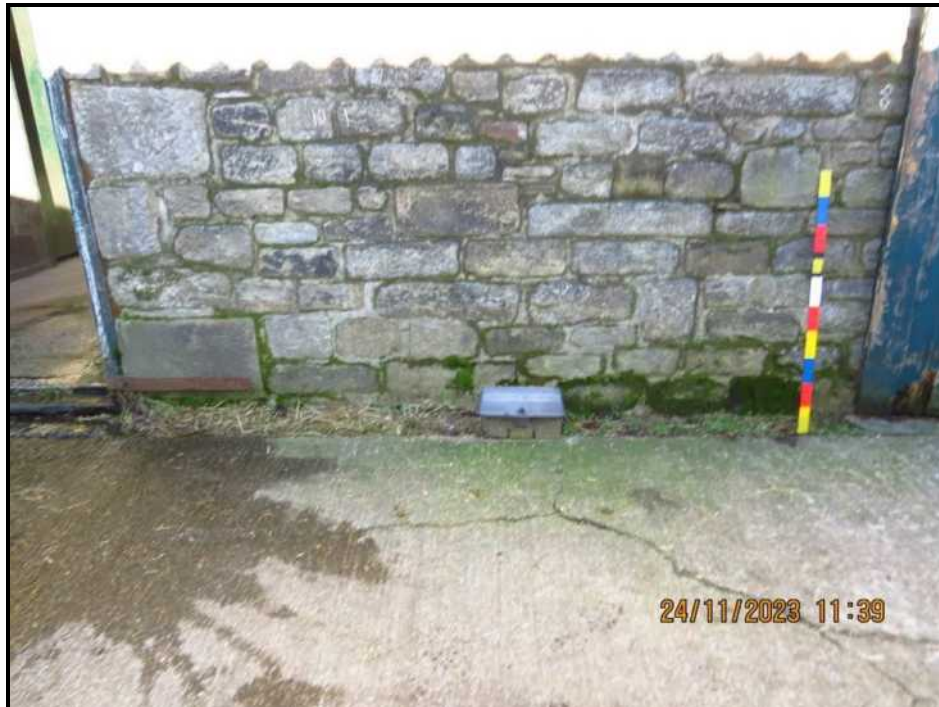
032 Plinth wall, chainage 10 – 7 metres

- 3.5 The vertical alignment of the right hand door reveal (chainage 1.5 metres) is satisfactory. (Photograph 038).
- 3.6 The sliding door covers the main wall section between chainage 4 – 5 metres but overall vertical profile on either side of the doorway is satisfactory with good vertical alignment and satisfactory horizontal coursing. (Photographs 036, 037).
- 3.7 The adjoining stone panel (chainage 8 – 10 metres) is well pointing with satisfactory vertical alignment. (Photographs 032, 033, 034, 035).

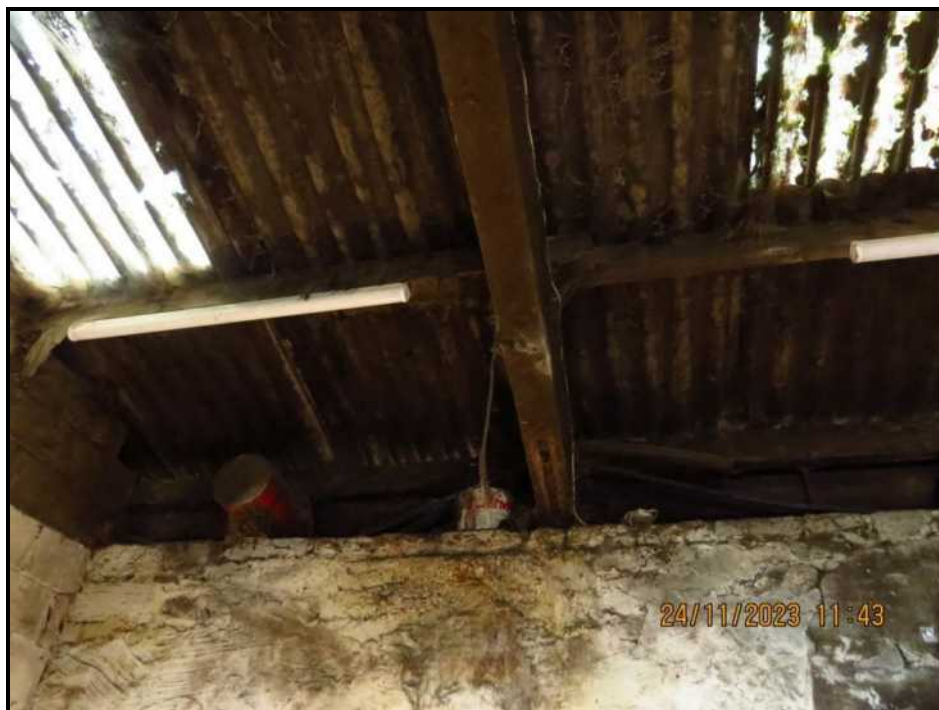
042 Rear wall rafter beam

- 7.2 Stable No. 1 is sub-divided into three stalls adjoining the internal cross wall and the inside face of the Western half gable wall is completed with a random render finish. The render finish follows a satisfactory vertical profile, the wall supporting 400mm x 150mm rafters at wall plate level spanning from the rear elevation to the front elevation. The Eastern gable wall supports the lateral purlins spanning from East to West. (Photographs 040, 041, 042).

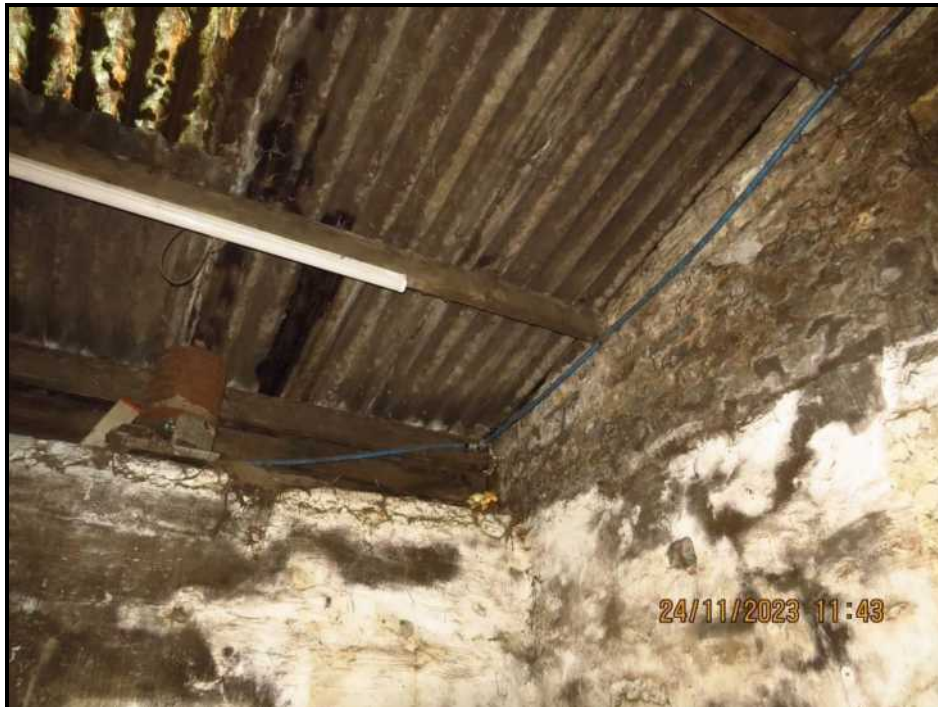
043 Roof, Northern corner

- 7.3 There are no signs of any separation where the rear wall adjoins the return half gable Eastern elevation. (Photographs 043, 044).

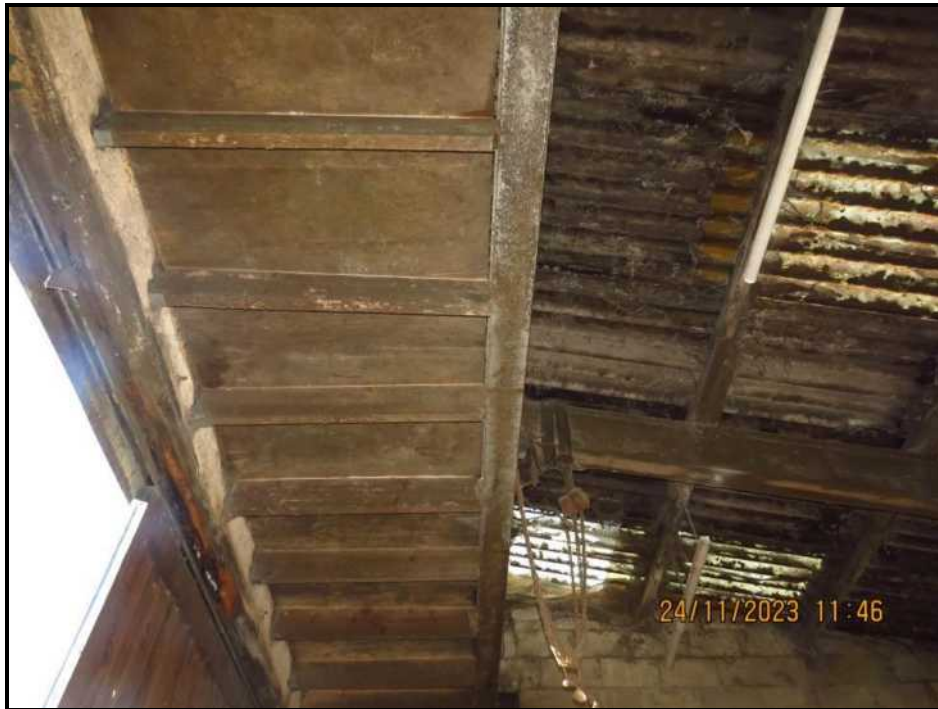
056 Front elevation supporting timber detail

- 7.6 In the front stall the roof incorporates 300mm x 150mm joists spanning longitudinally onto a blockwork seating.
- 7.7 The vertical and horizontal alignment of the internal cross wall is good and the blockwork and pointing in very good condition.
- 7.8 Parallel to the front wall there are suspended beams supporting a timber platform between the gable and the internal cross wall. (Photographs 056, 057, 058).

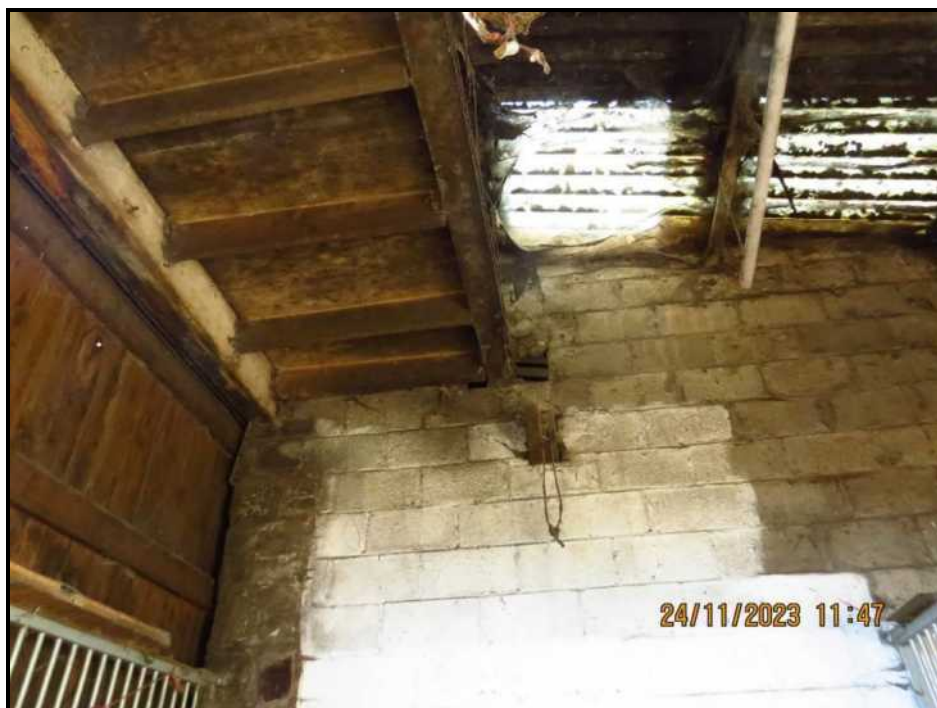
061 Internal party wall with Stable No. 2

- 7.9 The internal party wall between stables 1 and 2 is completed in well maintained blockwork following a satisfactory line and level, with no evidence of any lateral movement where the purlins and rafters seat on the internal walls. (Photographs 061, 062, 065, 066).

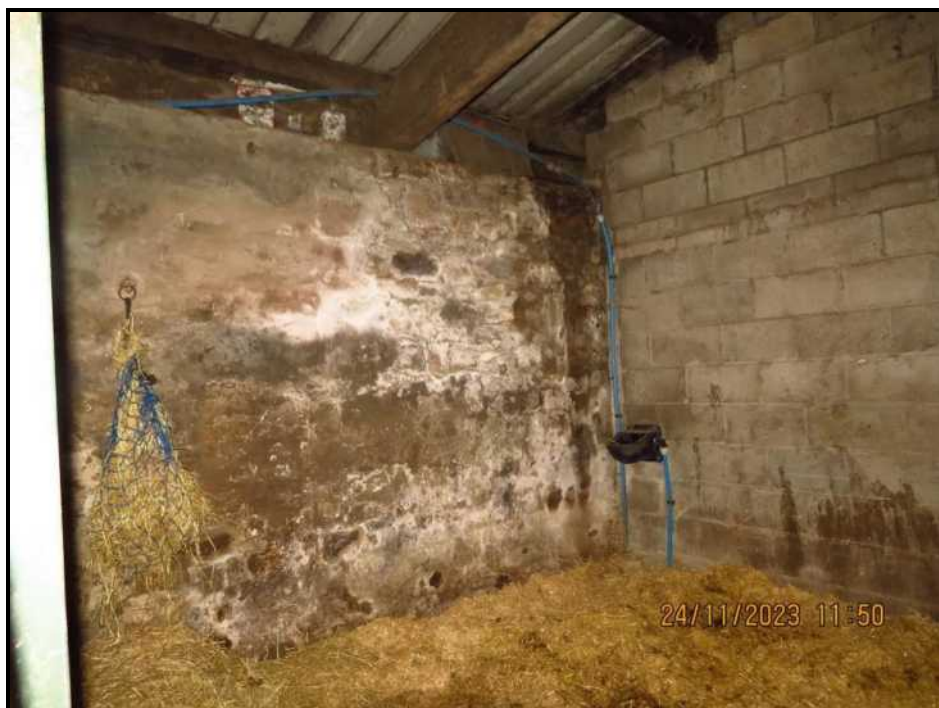
072 Rear wall and party wall, North East corner

- 7.10 Stable No. 2 incorporates two Tack Rooms with limited access to the rear walls. (Photographs 070, 071).
- 7.11 The rear wall of the original building is finished with a weathered and stained render finish, with a reasonable vertical alignment, with the internal party wall completed in satisfactory blockwork.
- 7.12 There are no signs of any separation where the blockwork cross wall adjoins the original rear and front elevations. (Photographs 072, 073, 074).

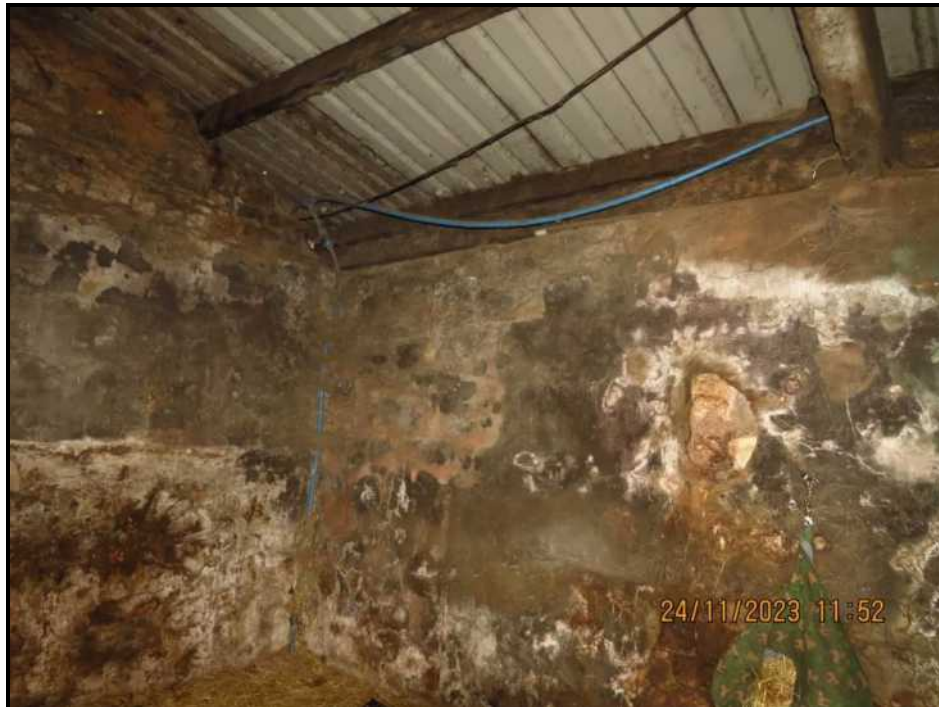
075 Rear wall Unit No. 2

- 7.13 In the North Western corner the rendering to the rear wall shows evidence of weathering and deterioration but there are no signs of any separation or rotation of the purlin seatings onto the internal cross wall (proposed external wall). (Photographs 075, 076).
- 7.14 The blockwork party wall is completed with well maintained blockwork and pointing with good horizontal and vertical alignment to the wall supports, the structural purlin seatings onto the main roof rafters. There are no signs of any separation where the party wall adjoins the front masonry. (Photographs 083, 084).

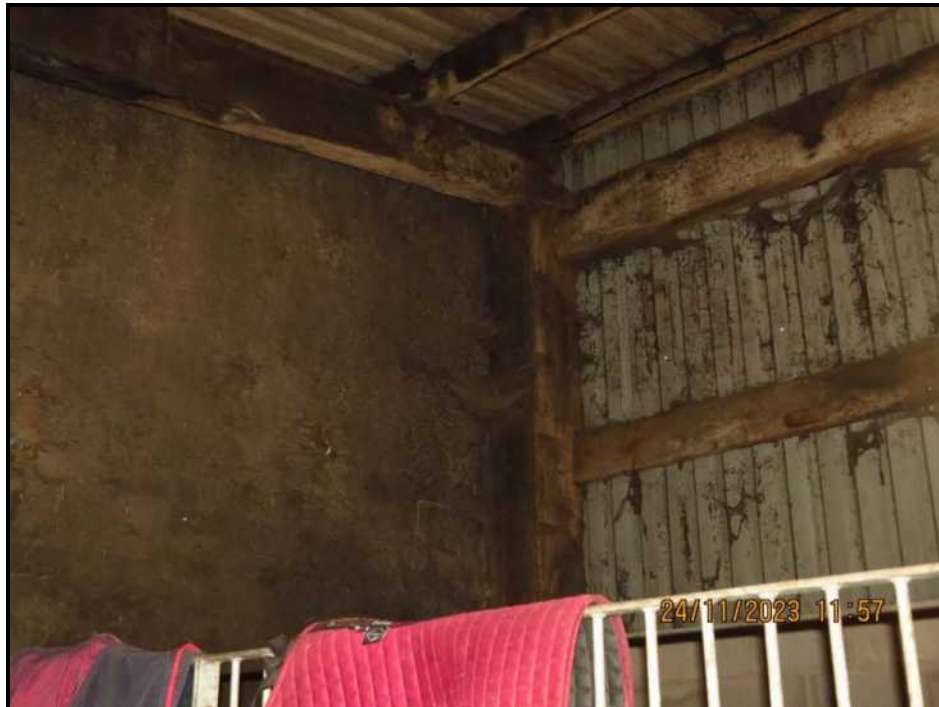
093 'Outside' of Western wall

- 6.1 The North Western half gabled wall currently acts as an internal party wall between stable units 1 and 2 to the East, and stable units 5 to 4 in the Western section (to be demolished).
- 6.2 The inspection of the Western outside face of the proposed gable elevation is limited with the existing usage (limited access).
- 6.3 The stone wall is completed with a flat cement render supporting the lateral purlin members, spanning from East to West towards the front elevation. (Photographs 093, 094 and photograph 090 towards the rear elevation).
