# TECHNICAL AUDIT SITE INSPECTION REPORT

| Planning ref Number | 23/01280/FUL | Inspections Required: | 6 Monthly |
| Address: | Longley Hey Farm<br>Halifax Rd<br>Littleborough<br>OL15 OLB | Inspection No: | 1 |
| Description: | Path Dilapidation- Ref to Condition 4 | Date: | 11/06/24 |

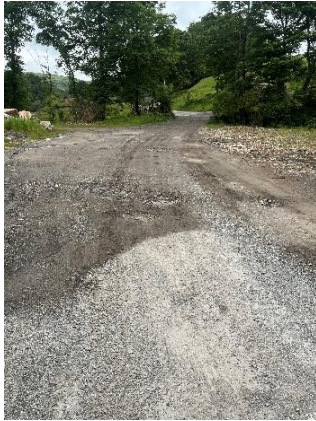
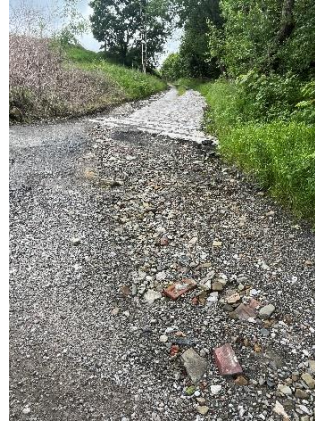
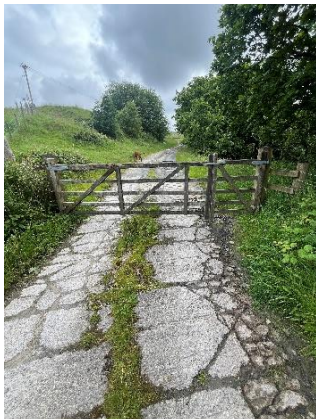
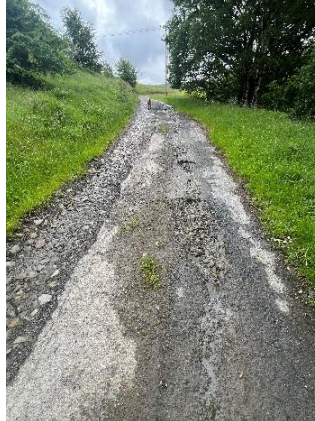
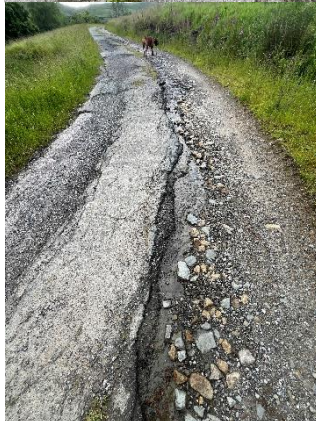
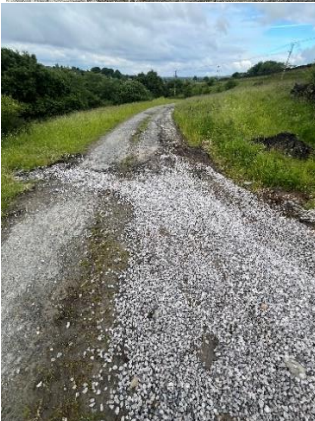
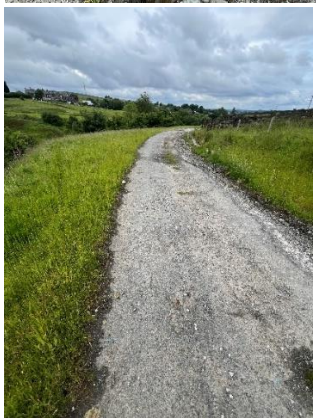
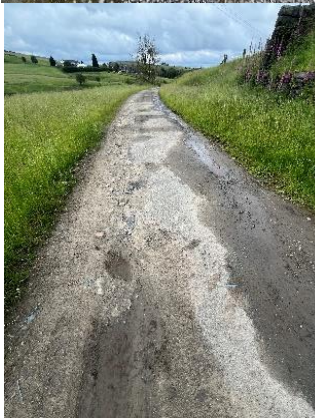
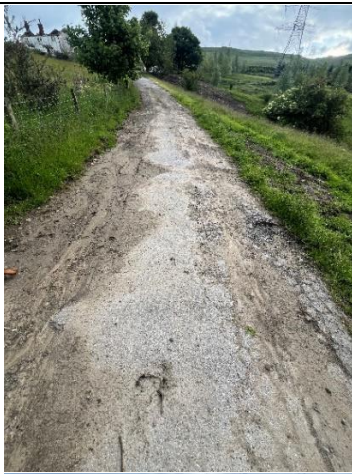
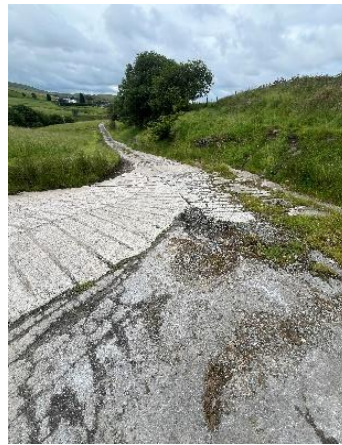
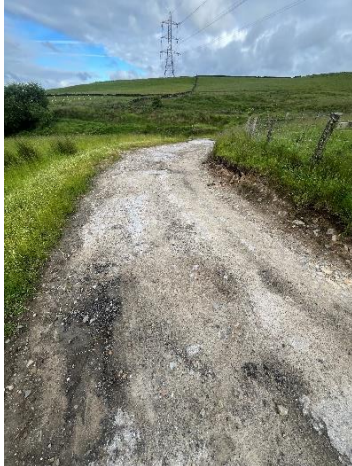
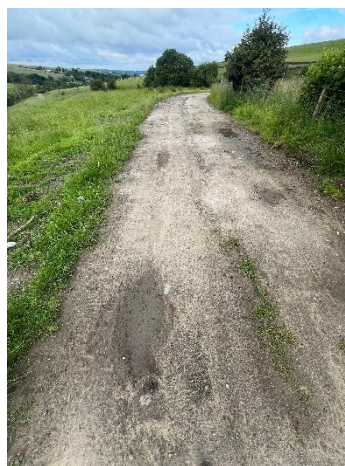
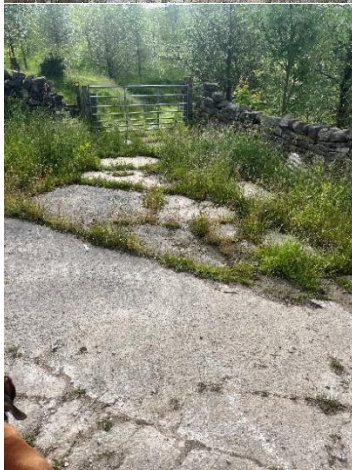
| Summary of Visit: | Farm track is used as vehicle access alongside a footpath as a right of way through part. The path is made up of hardcore in areas and existing tarmac in areas. No obstructions are apparent. | | |

.01 Path make up and current state.
