R3271

Higher Moorgate Farm, Gristlehurst Lane, Birtle  
Heywood, OL10 4BJ

Proposed Conversion of the former "Chicken Shed"

# REPORT ON STRUCTURE

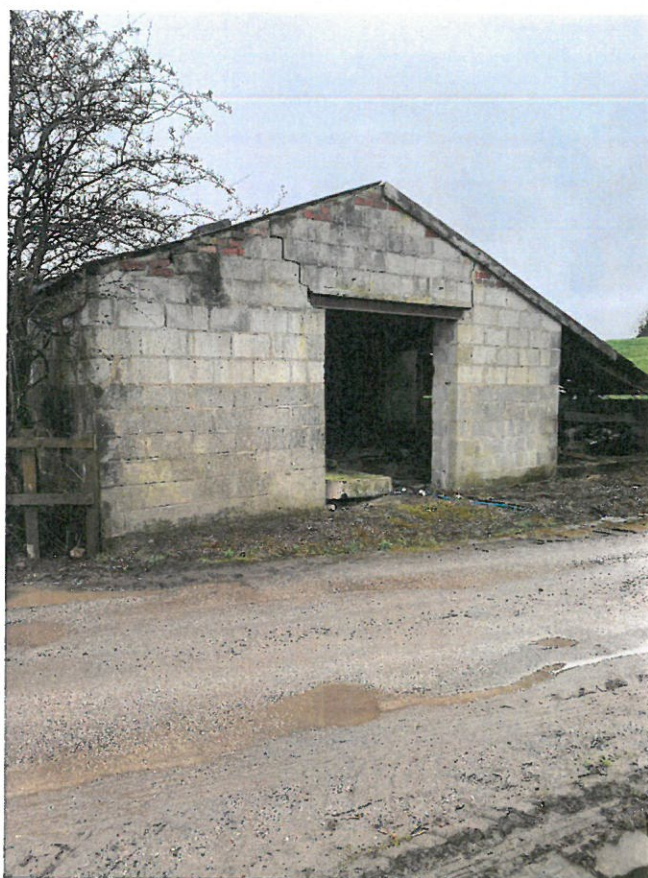
Photograph 2

When viewed from the farm drive, there is gable elevation with a central large door opening, photograph 2.

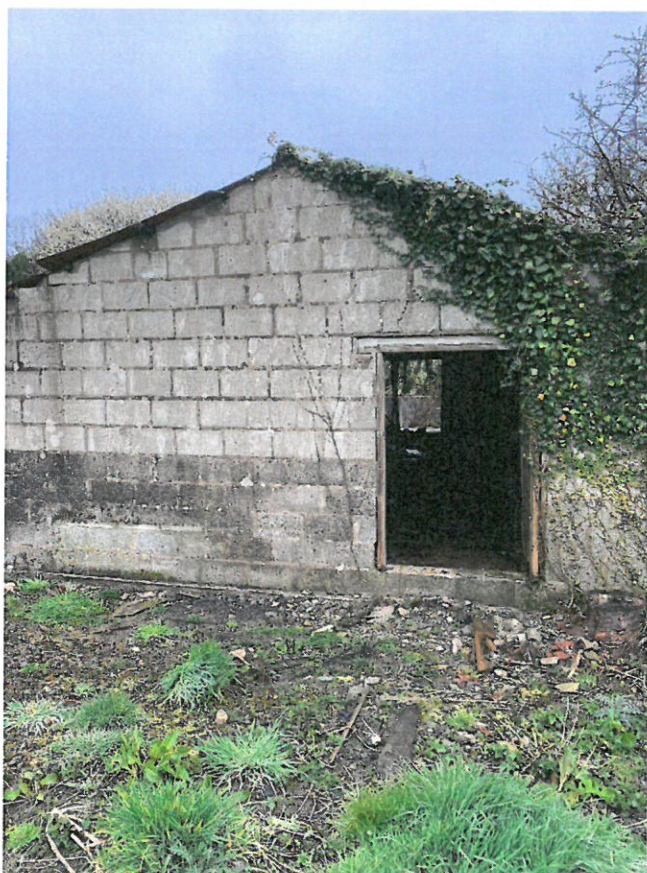
Photograph 3

**2.02** The opposite gable has a smaller door opening positioned closer to the front, photograph 3.

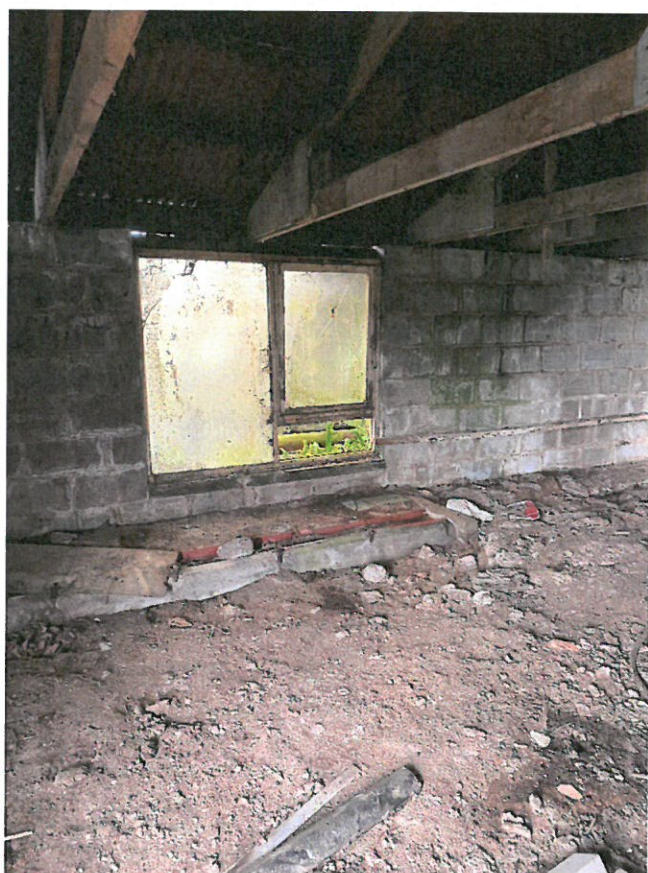
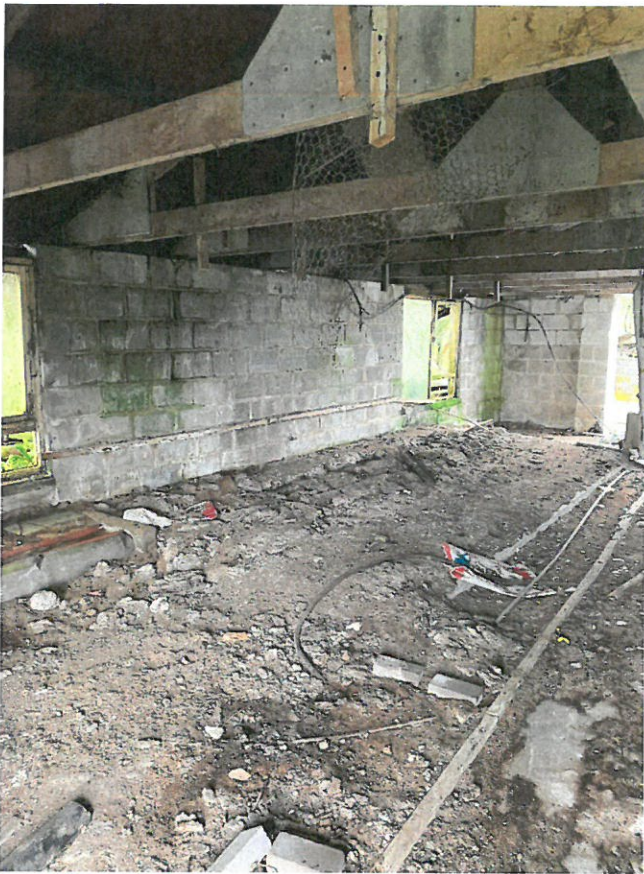
**2.04** The rear elevation is best viewed from within where there are two window openings, photographs 4 & 5.

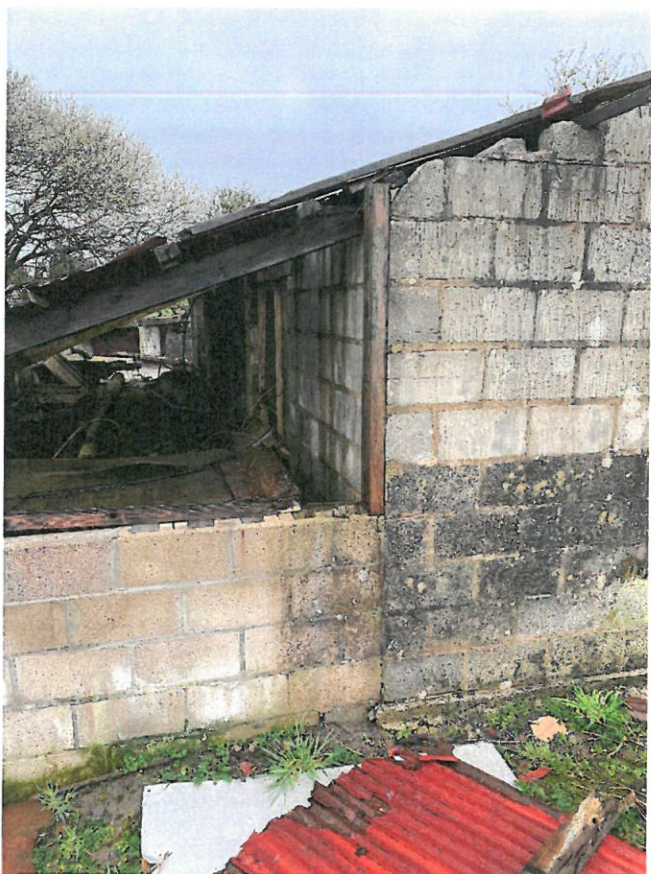
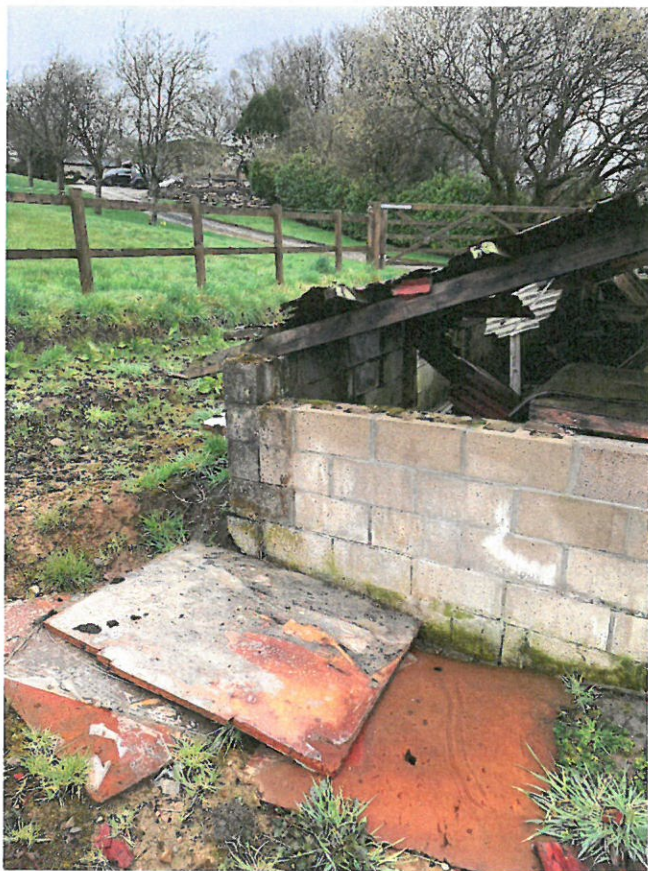
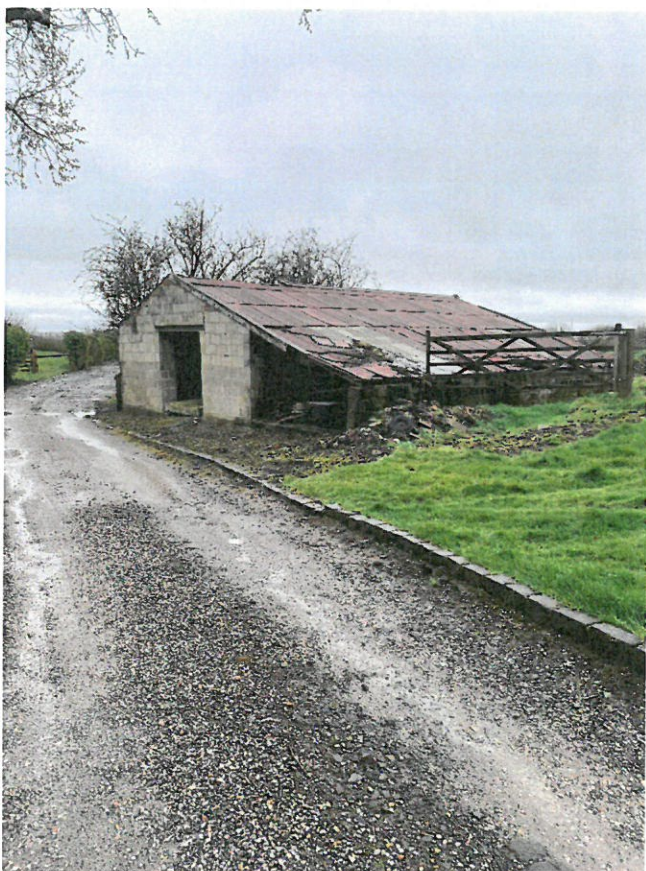
**2.05** The roof is duo pitched front to rear and has an asymmetric appearance due to the fact that the roof extends beyond the main rear elevation to a dado wall. The area beyond the dado acts as a covered external store. Photographs 6, 7 & 8.

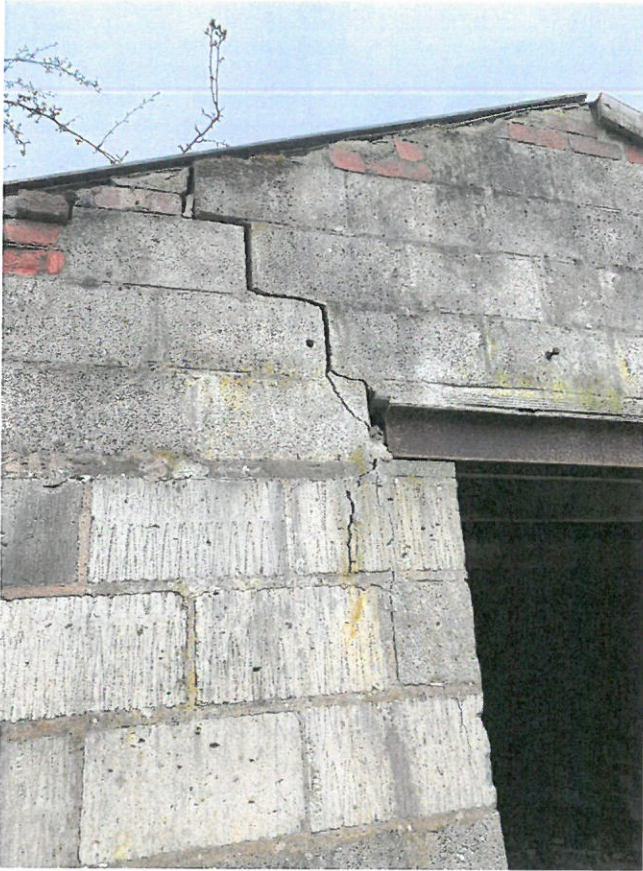
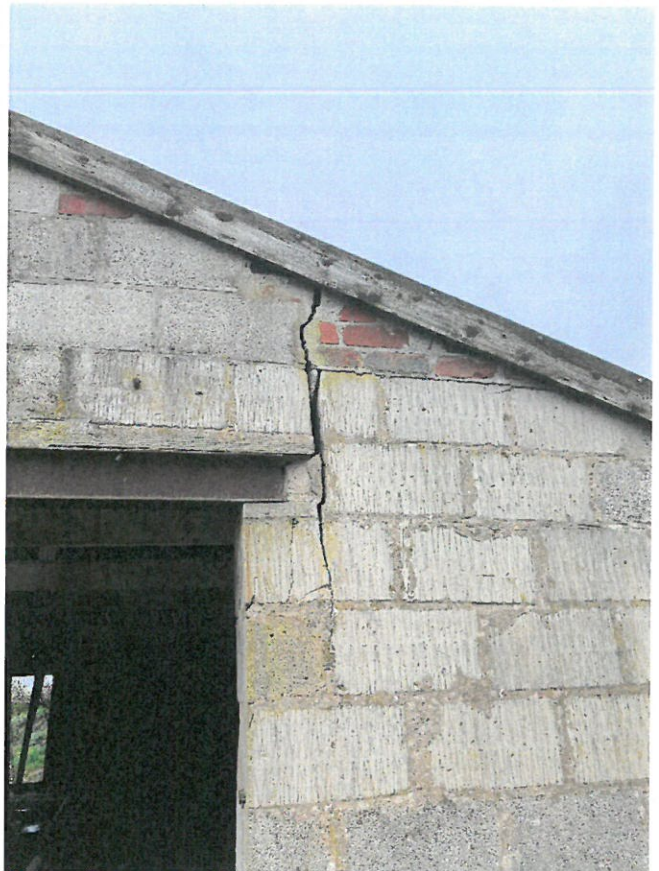
On the right-hand side elevation facing the drive there are buttressing piers either side of the large door opening. Above the door is a steel lintel. The lintel is unprotected and is exposed to the elements.

At each bearing of the lintel there is stepped cracking. This is visible both internally and externally. Photographs 9 & 10.

The area of masonry directly above each lintel bearing will require careful rebuilding. The lintel will also need to be replaced.

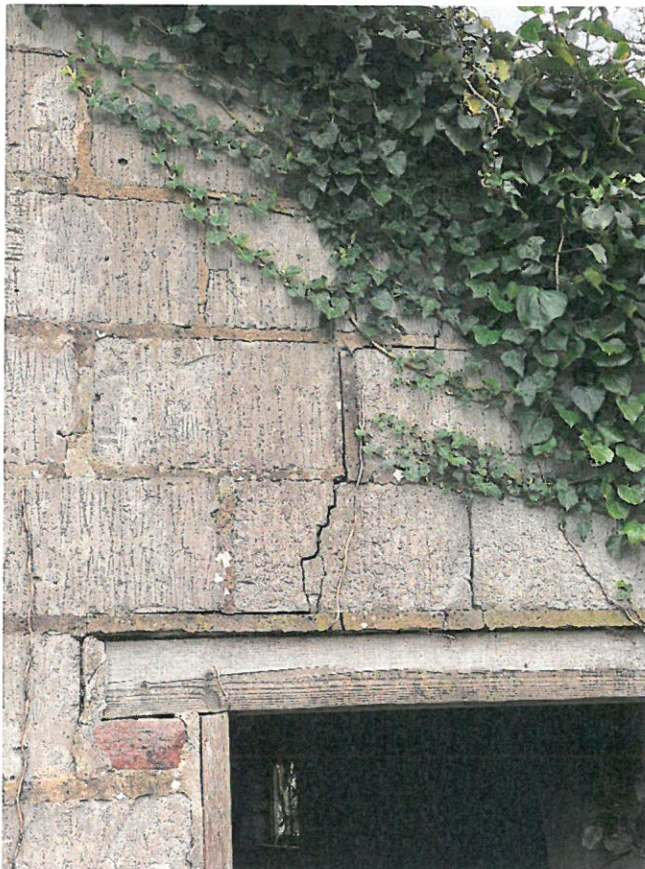
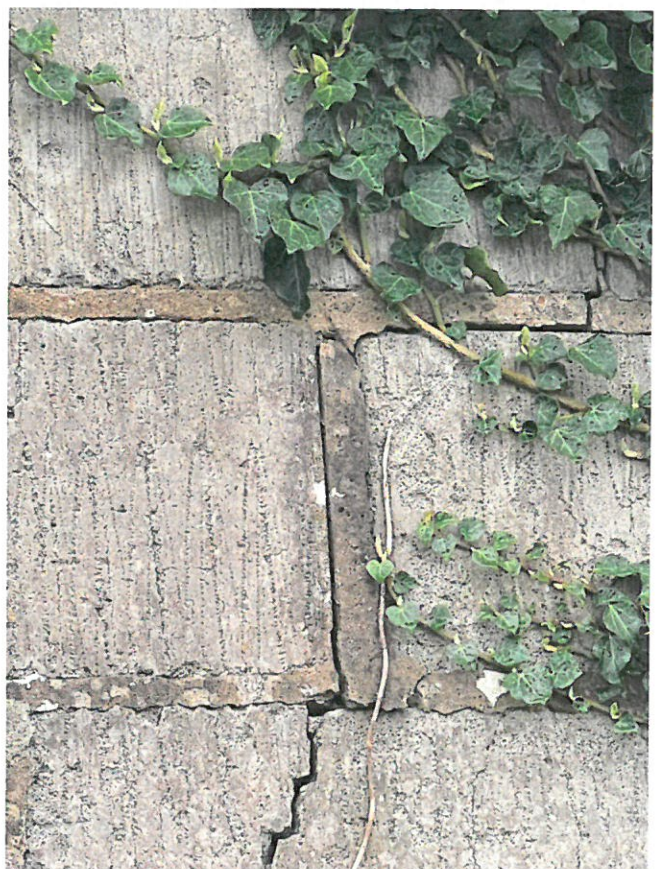
There is nominal cracking above the door on the right-hand side elevation, photographs 11 & 12. This will require only nominal repair.

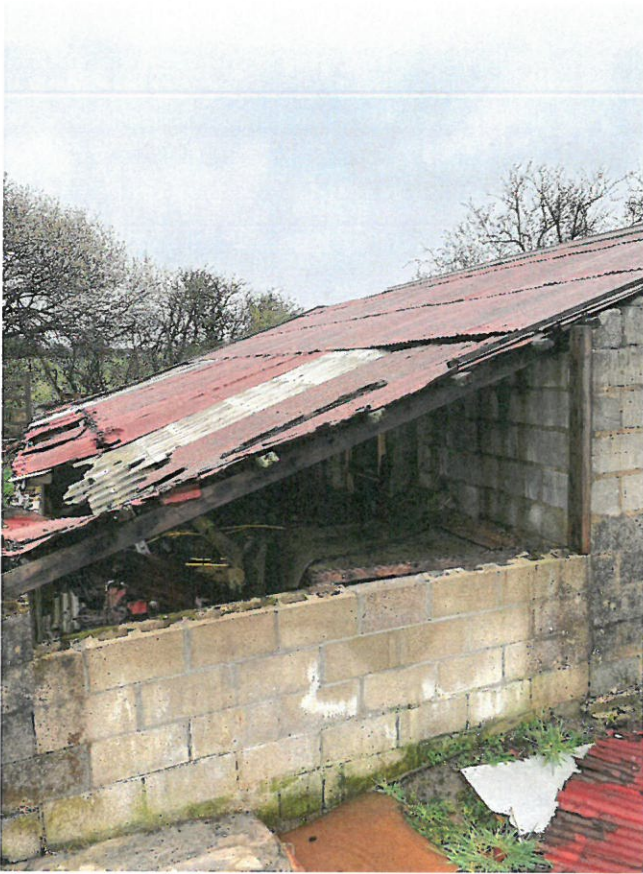
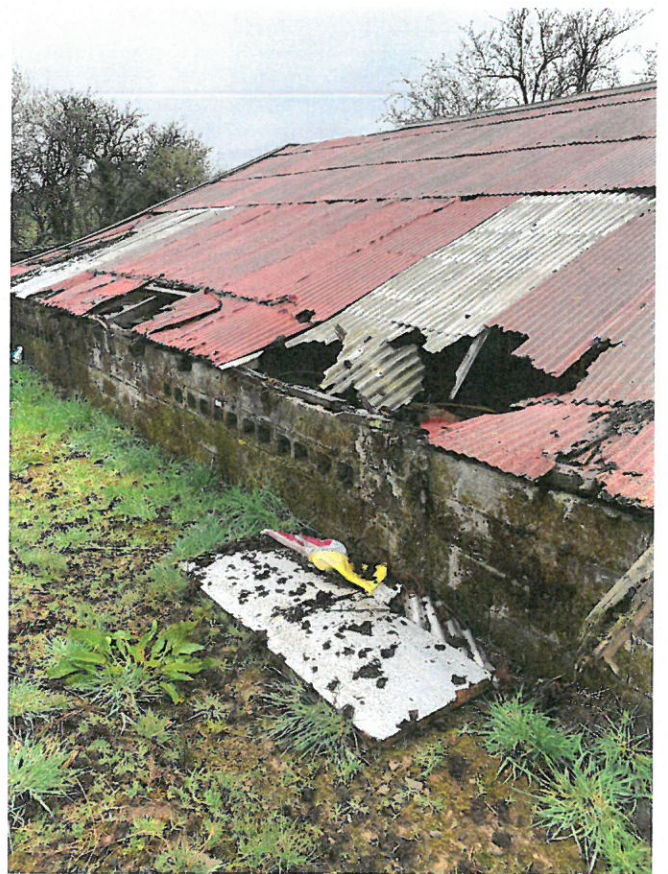
The roof covering is of a single skin corrugated metal deck which has perished and will need to be replaced in its entirety. Photographs 13 & 14.

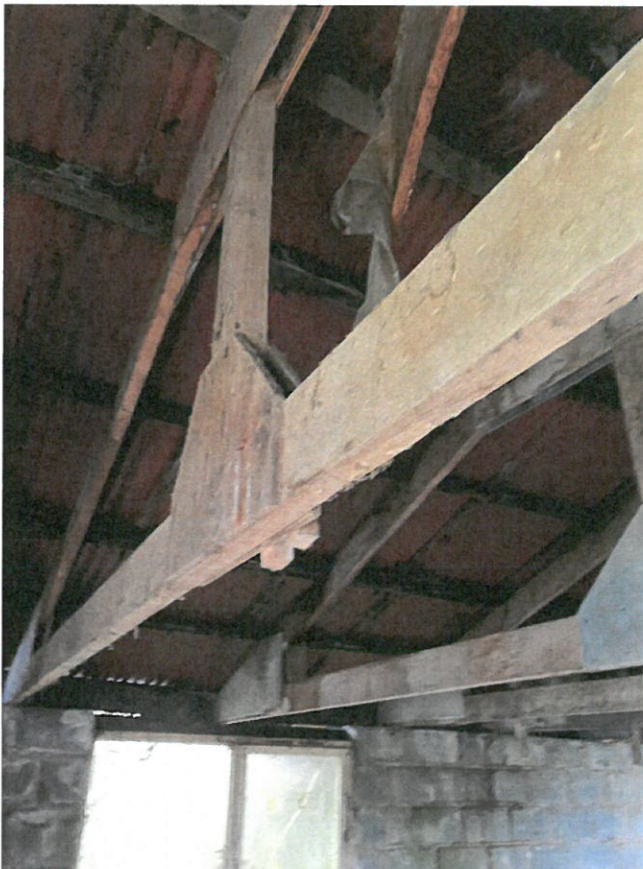
*Photograph 15*

The roof structure is of timber trusses that are non-standard and are reinforced at node positions with plywood gussets. Photographs 15.

The trusses provide a limited head room and would ideally need to be converted insitu into a raised collar tie truss. It is highly likely that the trusses will need to be sheathed with a ply diaphragm prior to providing new battens and a new roof covering. Additional bracing will be required.

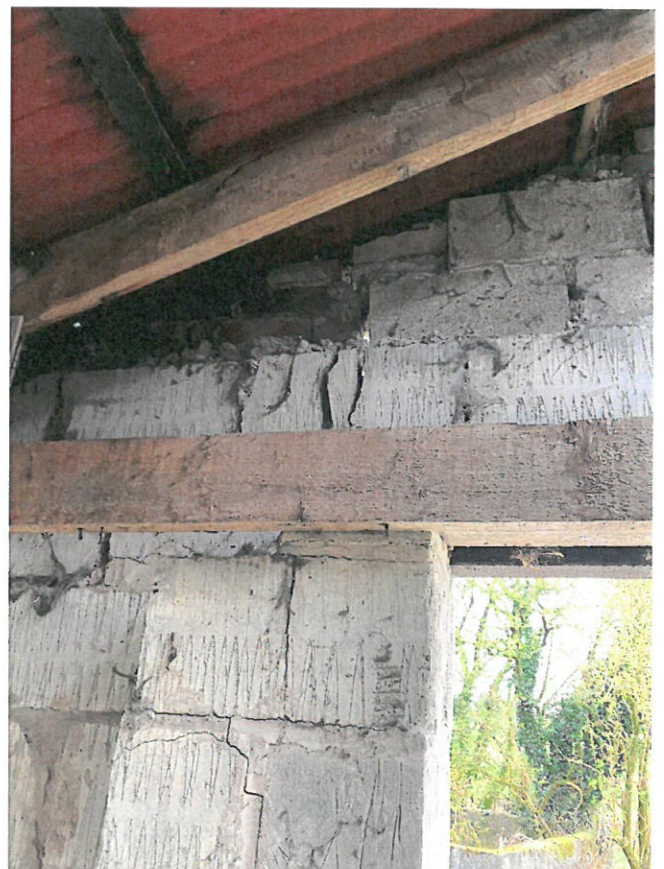
*Photograph 16*

The trusses are at 900mm centres. There are metal purlins spanning between the trusses, photograph 16. There is no bracing.
