# Post Arboricultural Impact Assessment

663 Bury Road  
Rochdale  
OL11 4 AX

Post impact assessment of a residential property and its landscaping

**Treestyle Consultancy Ltd**

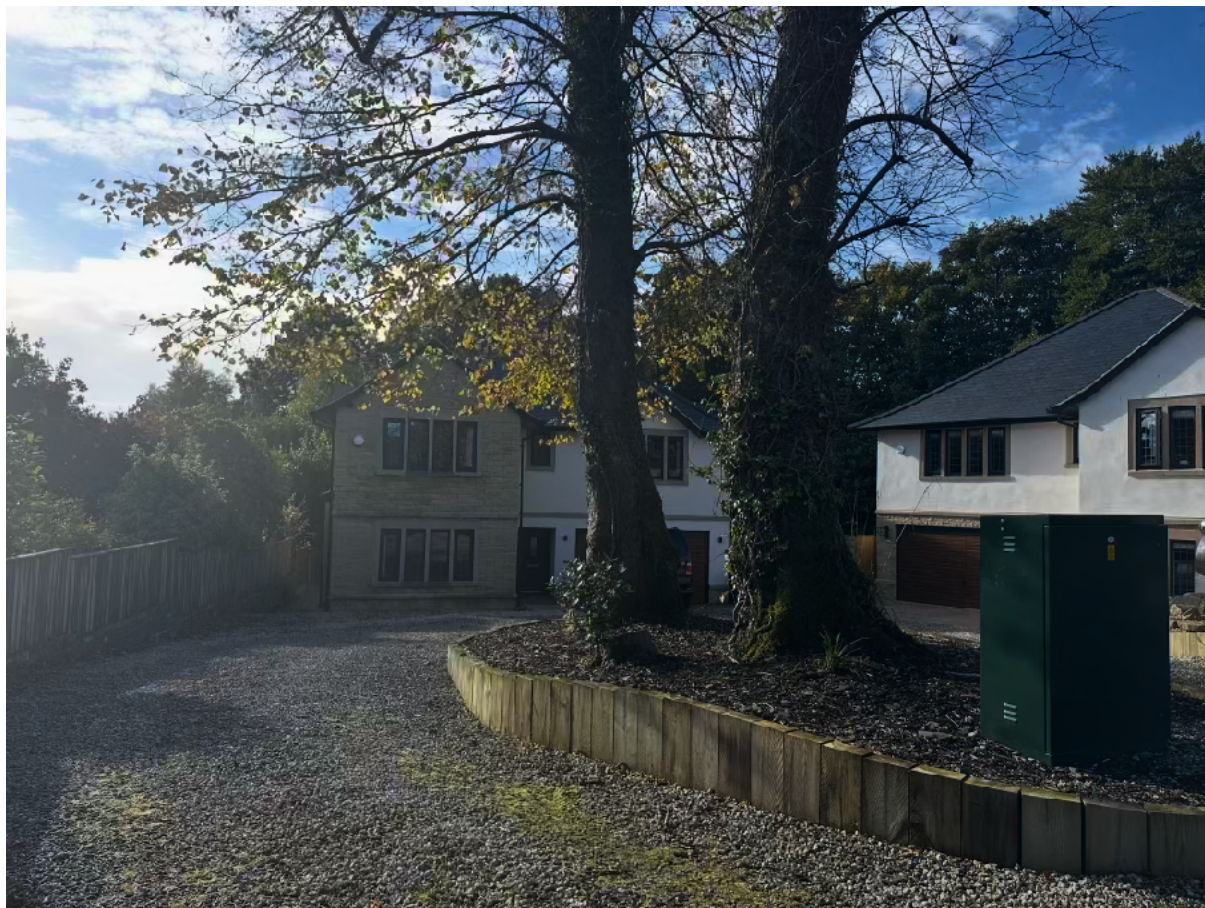
Overlooking the front turning area where two large mature trees provide outstanding visual aesthetics

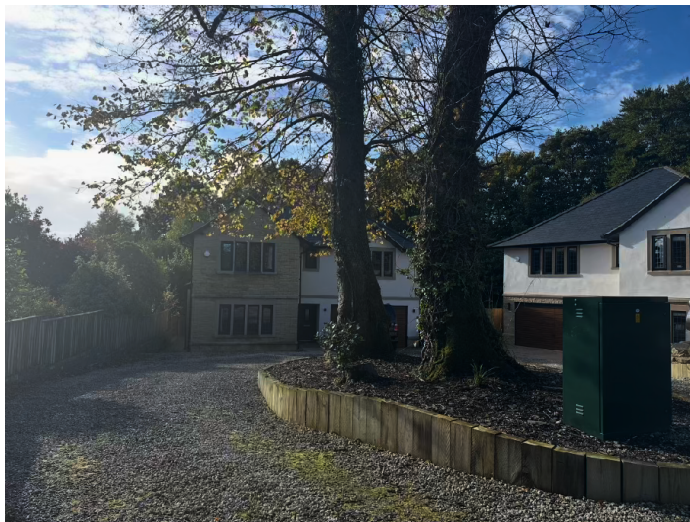
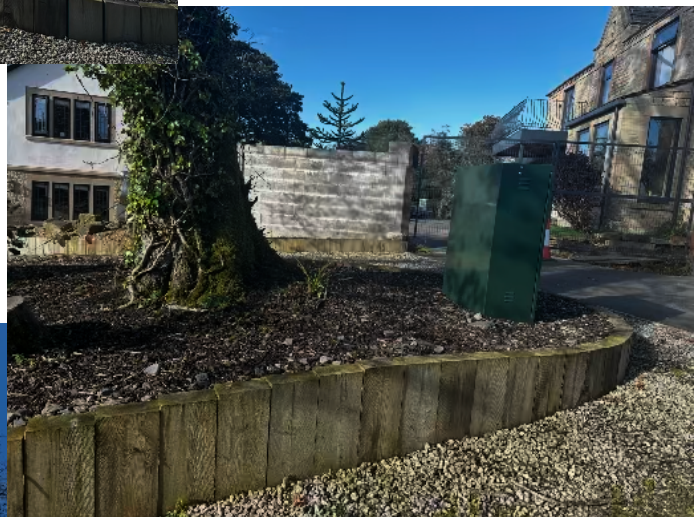
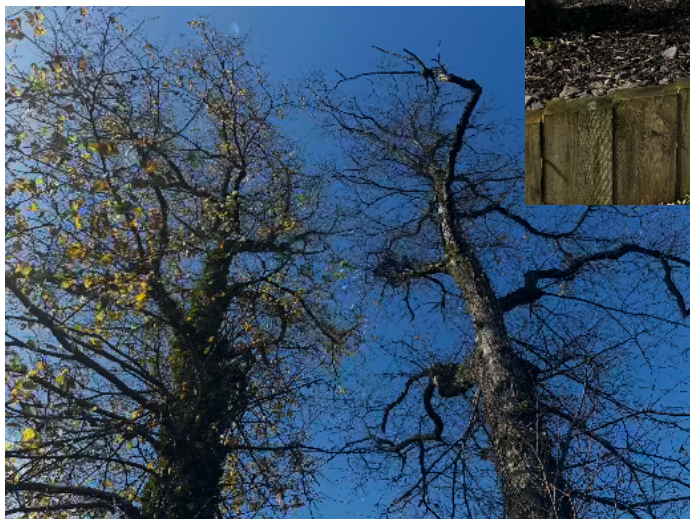
- 9.1.1 Direct damage would be from the severing of roots as can be seen with T1 & T2 lime (*Tilia cordata*) whose RPA's have been breached by the development of a level surfaces for vehicles. There are two possibilities; either changes to the soil levels around their RPA's which would suffocate the trees roots or the severance of tree roots to allow for safe levels for vehicles, the latter is highly probably the likely impact. This can cause tree instability and allow an entry point for pathogens.
- 9.1.2 The installation of below ground services was noted with T6 oak (*Quercus pate*) where the services incur on its RPA. This could have resulted in the severance of tree roots, soil compaction and contamination.

Top left showing proximity of T1 T2 at the front of the property where root severance is highly likely

Canopy decline can be seen in the lower picture

- Removal T1 & T2 lime (*Tilia cordata*) from the front area.
- The removal of T3 copper beech (*Fagus sylvatica Purpurea*) from the rear garden.
- Reassessment of all neighbouring trees summer 2025.
- Tree planting to mitigate tree loss.

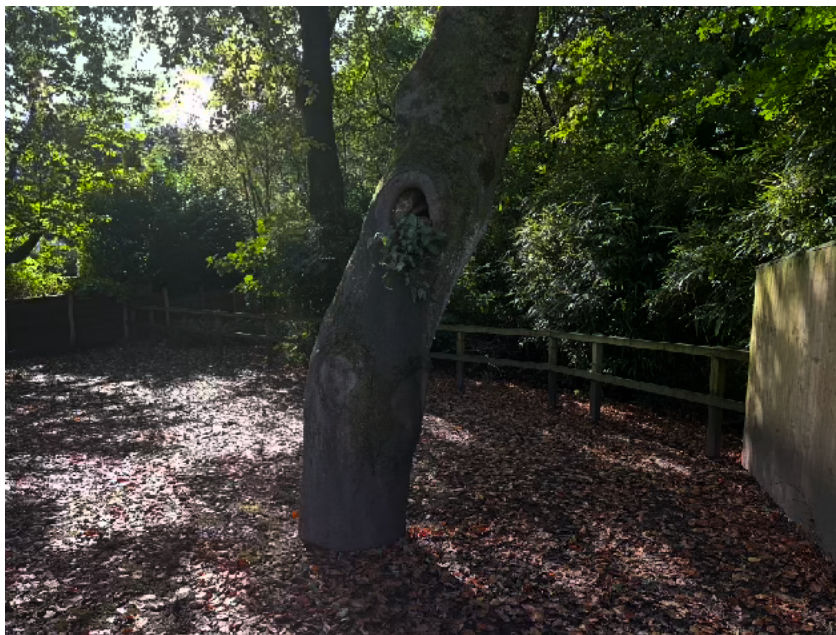
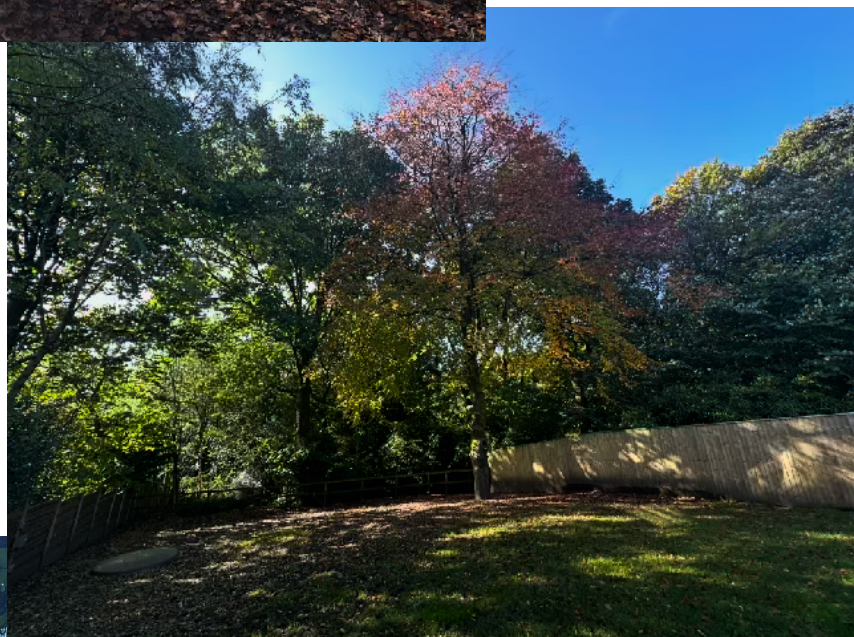
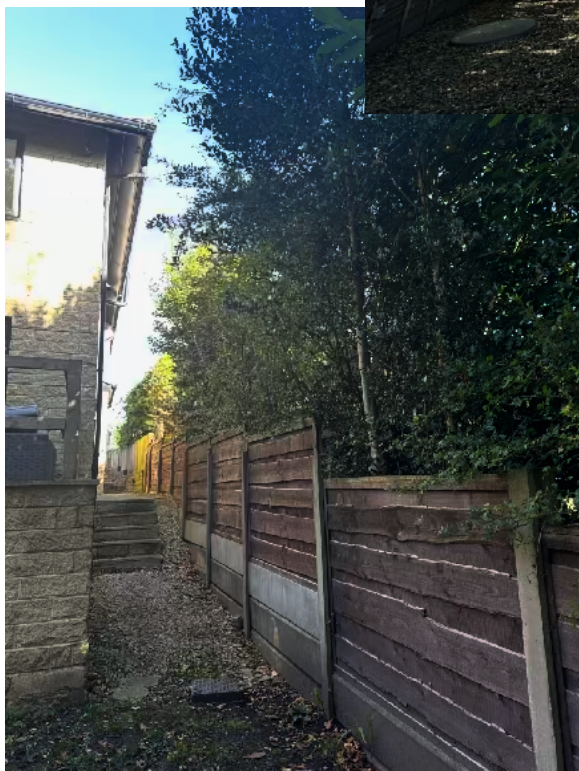
Top left showing T3 at the rear of the property where the lack of trunk flare suggests soil mounding

Cement can be seen lining the boundary of neighbouring trees
