# **TREE SURVEY & REPORT**

87 CHURCH STREET  
LITTLEBOROUGH

## **TREE SURVEY / SCHEDULE AND REPORT**

Date: 25/08/2023

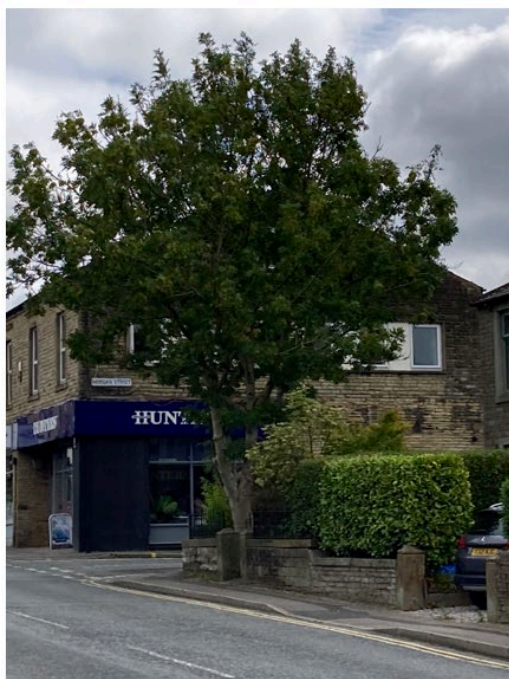
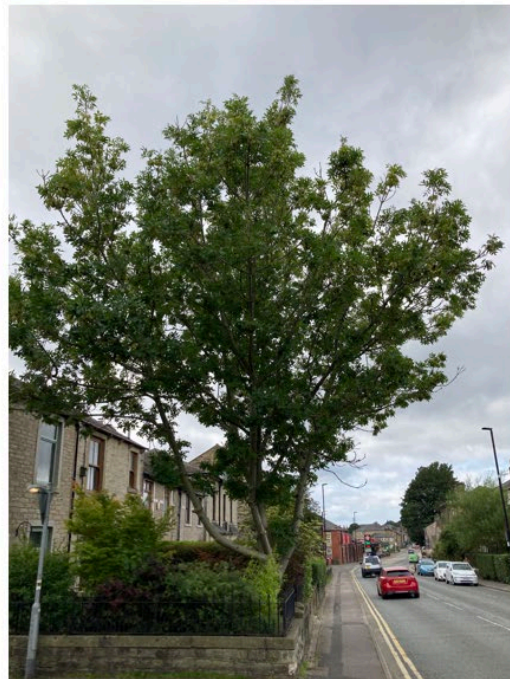
The tree is sited within the curtilage of the property and owned by the residents. The tree overhangs the front garden, public path and highway junction. The trunk of the tree presses against the boundary wall which runs along the public footpath.

Tree location showing proximity to public path and highway

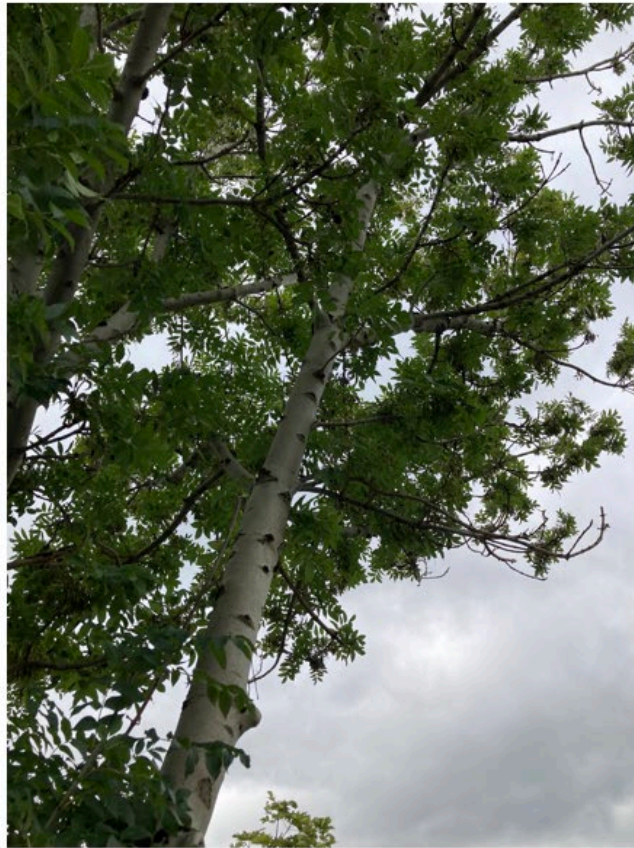
First impressions are one of a healthy tree starting to out grow its position. On closer inspection from the ground possibly the first signs of Chalara / ash dieback (*Hymenoscyphus fraxineus*) can be seen at the tips of branches; Monitoring of this fungal disease to determine whether the tree has the disease would be needed.

Branch tips showing possible Ash dieback

| 1 | Ash (Fraxinus excelsior) | 40 | 10 | SM | SS RHR C1 | <p>REMOVE BY SECTION DOWN.</p> <p>EARLY ONSET OF ASH DIE-BACK.</p> <p>OUT GROWN ITS SURROUNDINGS BY STARTING TO PUSH BOUNDARY WALL NEXT TO PUBLIC PATH.</p> <p>REPLANT WITH A MORE SUITABLE SPECIES</p> |

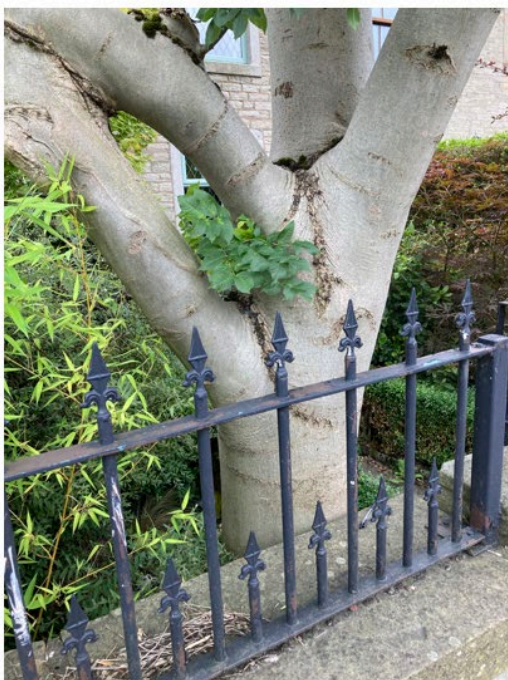
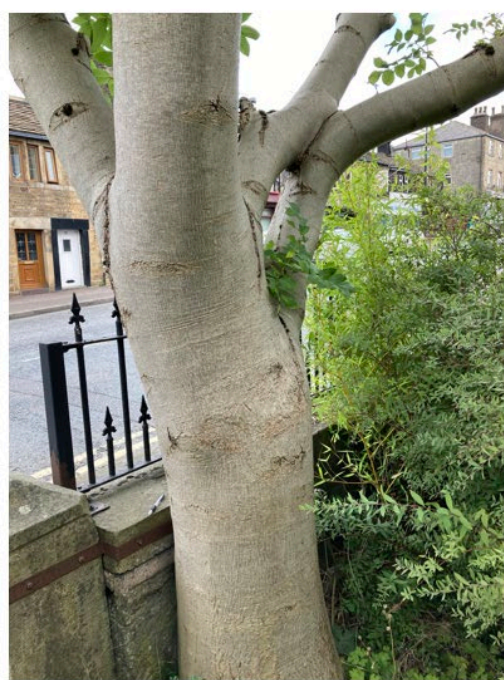
Further inspection of the main trunk clearly shows that the tree is outgrowing its location as it is pushing the boundary wall adjacent to the public footpath. The past choice to plant/position the tree in its final place has been a poor choice; the species is not suitable as it will dominate the immediate area with a risk of dieback and deadwood in the future.

Trunk pushing the wall and proximity to public footpath and road. Also seeing possible epicormic growth starting as Ash die back tries to establish.

The location of the tree, the maturity and faults lend itself to the tree being dismantled.
