## Tree condition survey

Ashworth Hall Farm, Rochdale, OL11 5UP

Report Date: 28 February 2025

Jason Isherwood's Tree Consultancy (Roots and Shoots Arborists Limited)

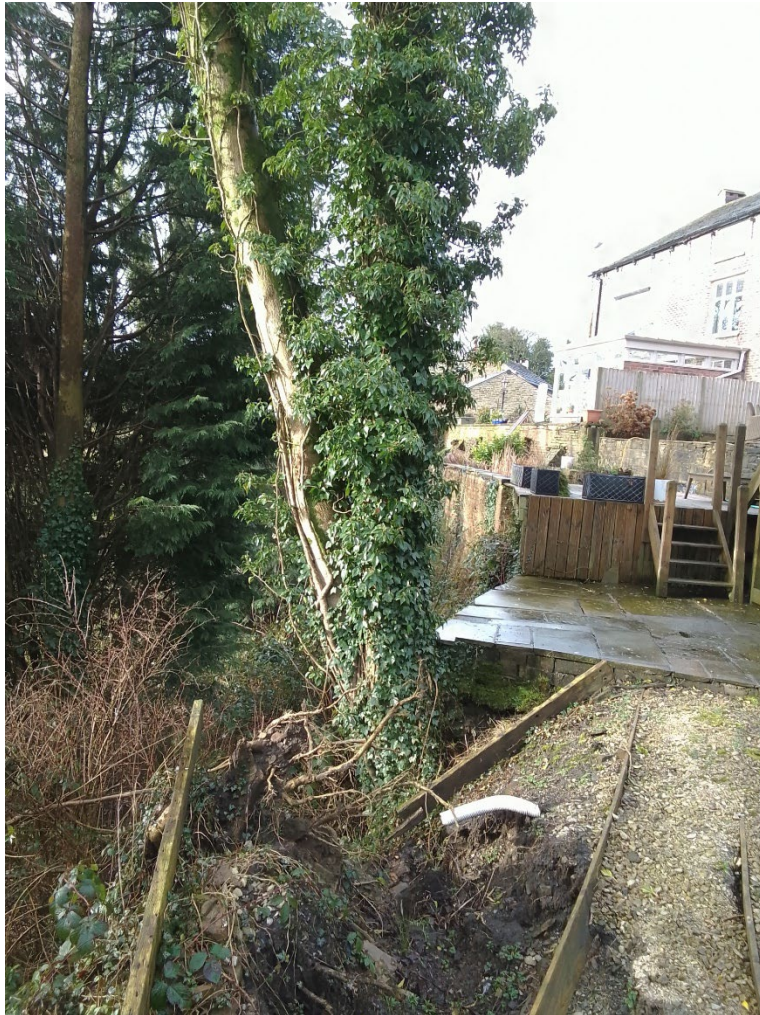
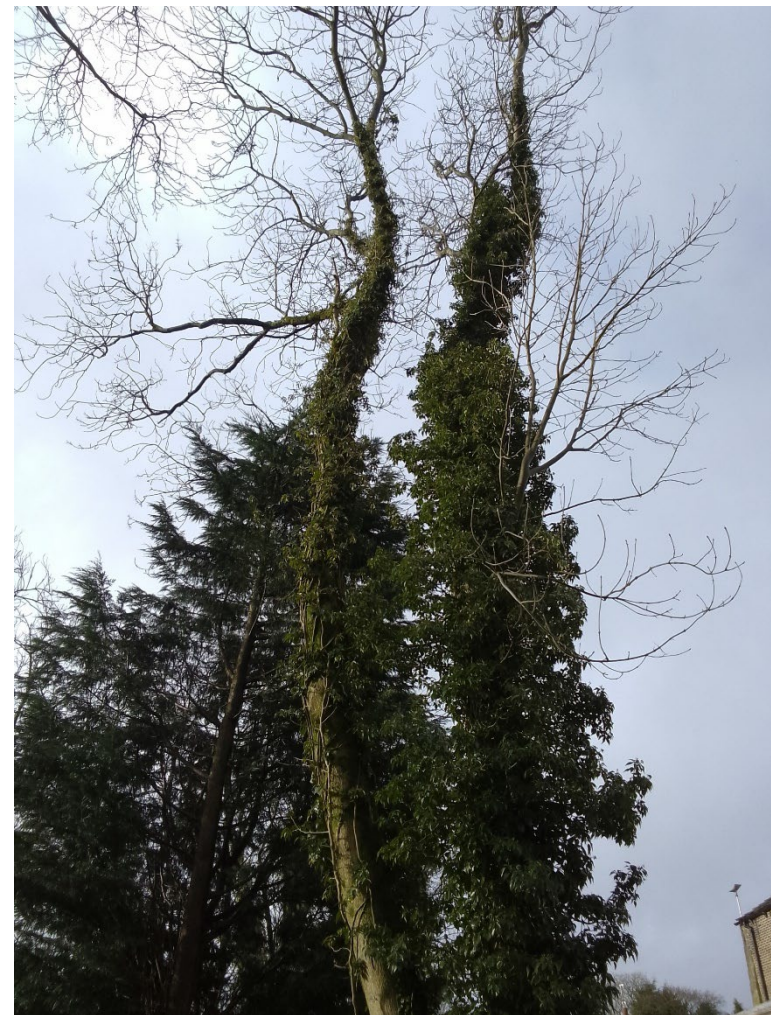
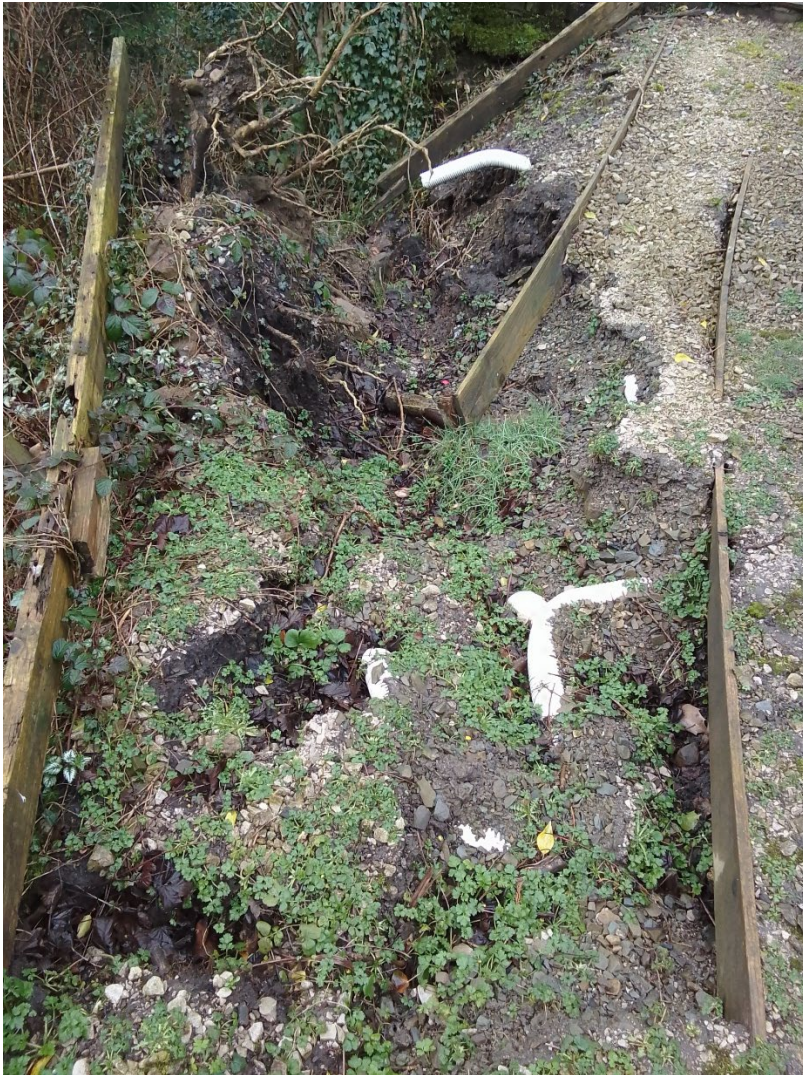
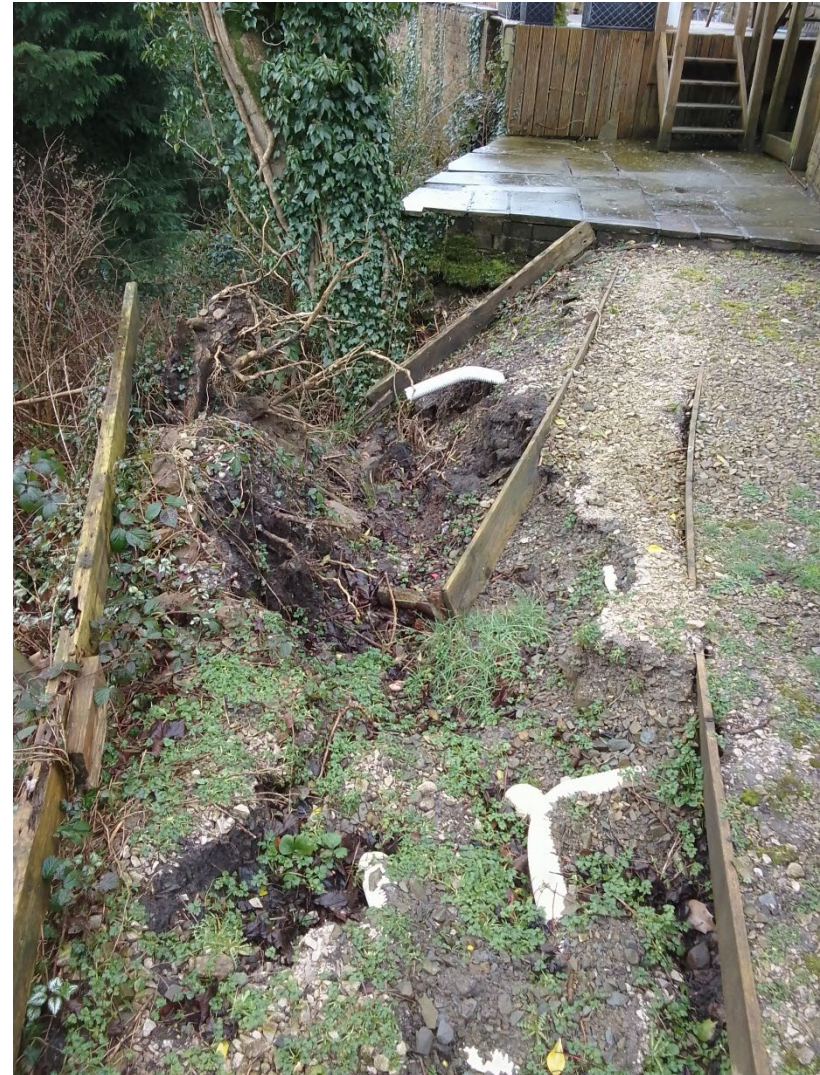
| Ref. | Species | Description | Measurements | Survey Notes | Overall Condition | Risk Rating | Inspect Period | Recommendations | Photo |
|---|---|---|---|---|---|---|---|---|---|
| T001 | Ash<br>( <i>Fraxinus sp.</i> ) | Target # - dwelling.<br>Target # - footpath.<br>- Occupancy - Constant(4). | Height (m): 20<br>Stems: 2<br>Life Stage: Mature | The tree is situated on a steep slope where the soil profile is poor and the land has slipped and there have been two other root plate failures. This has resulted in two trees falling into the garden. The tree is covered with ivy. The crown is asymmetrical towards the east | Poor | Moderate | 1 Year | Tree risk mitigation: remove the tree.<br>Timescale: 26-Aug-2025 (6 Months) | |

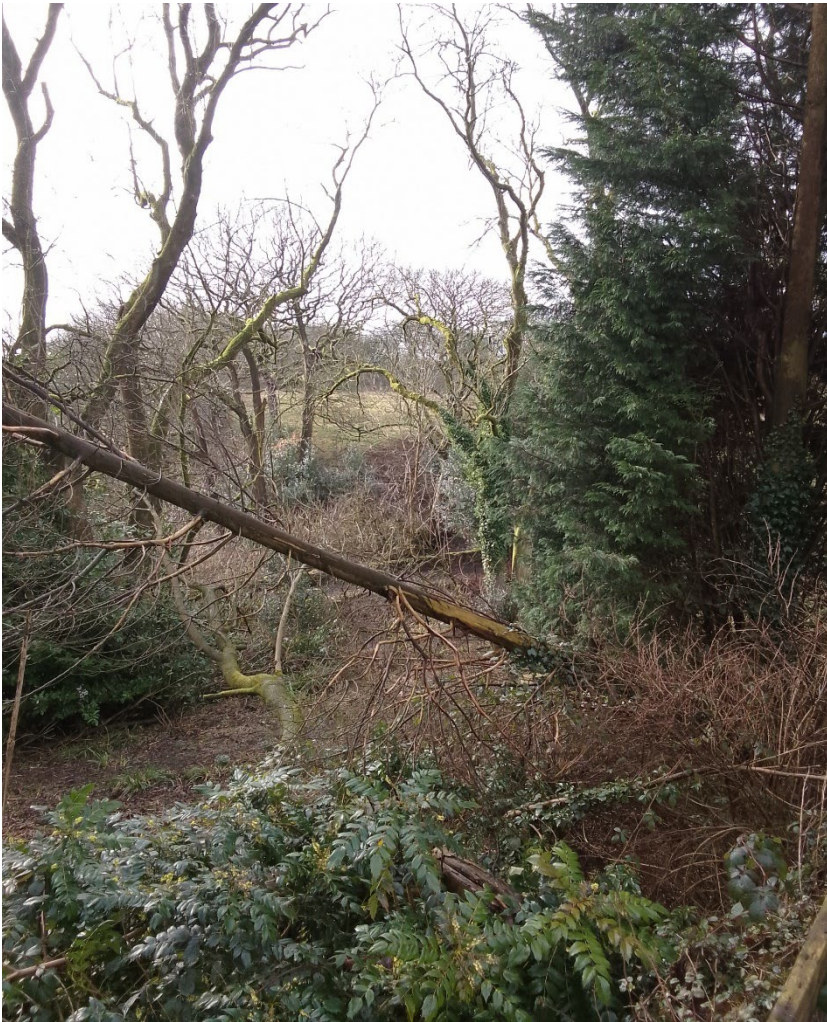
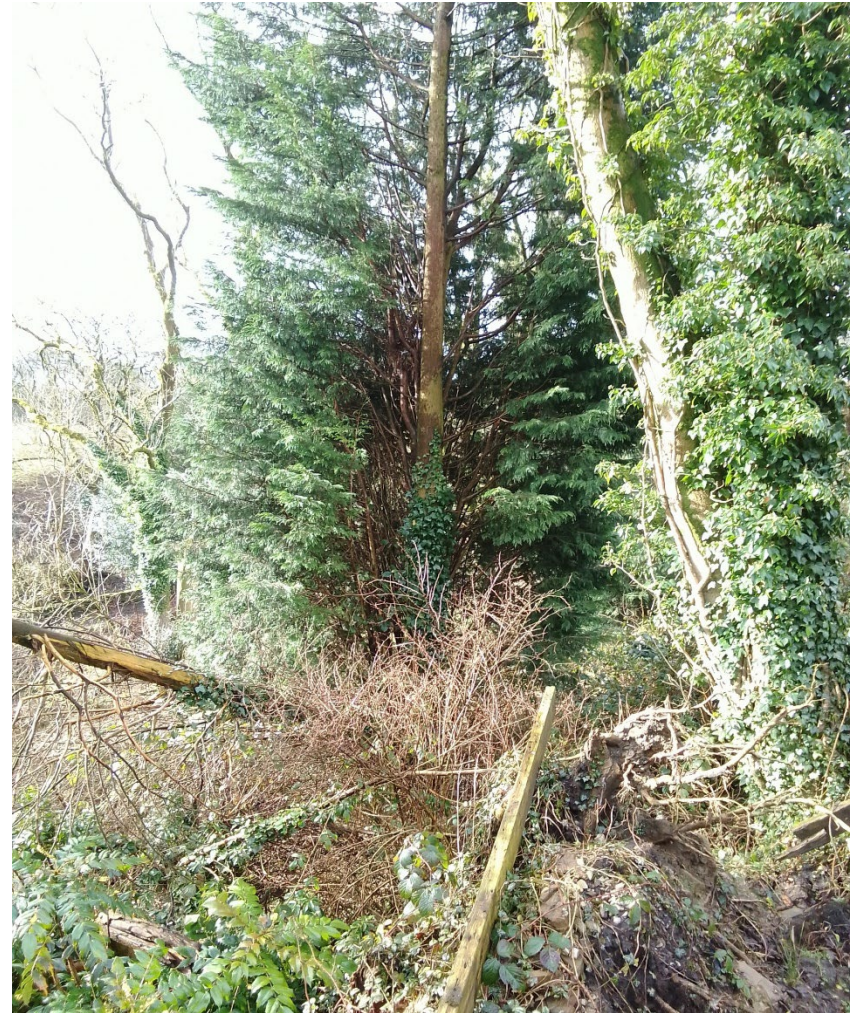
| Ref. | Species | Description | Measurements | Survey Notes | Overall Condition | Risk Rating | Inspect Period | Recommendations | Photo |
|---|---|---|---|---|---|---|---|---|---|
| T002 | Leyland cypress<br>( <i>X Cuprocyparis leylandii</i> ) | Target # - footpath.<br>- Occupancy - Occasionally(2). | Height (m): 12<br>Life Stage: Semi Mature | Previous failure of one of the two stems on the tree. Significant rot at the point where the stem failed | Poor | Low | 1 Year | Tree risk mitigation: remove the tree.<br>Timescale: 26-Feb-2026 (1 Year) | |

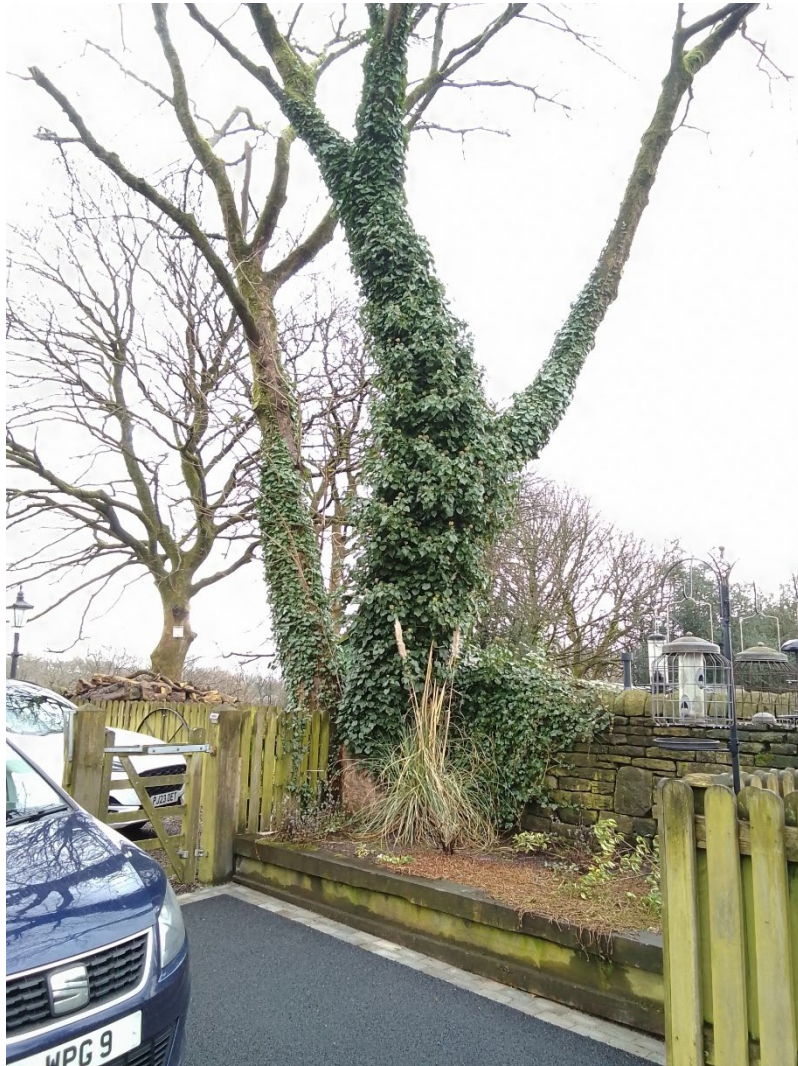
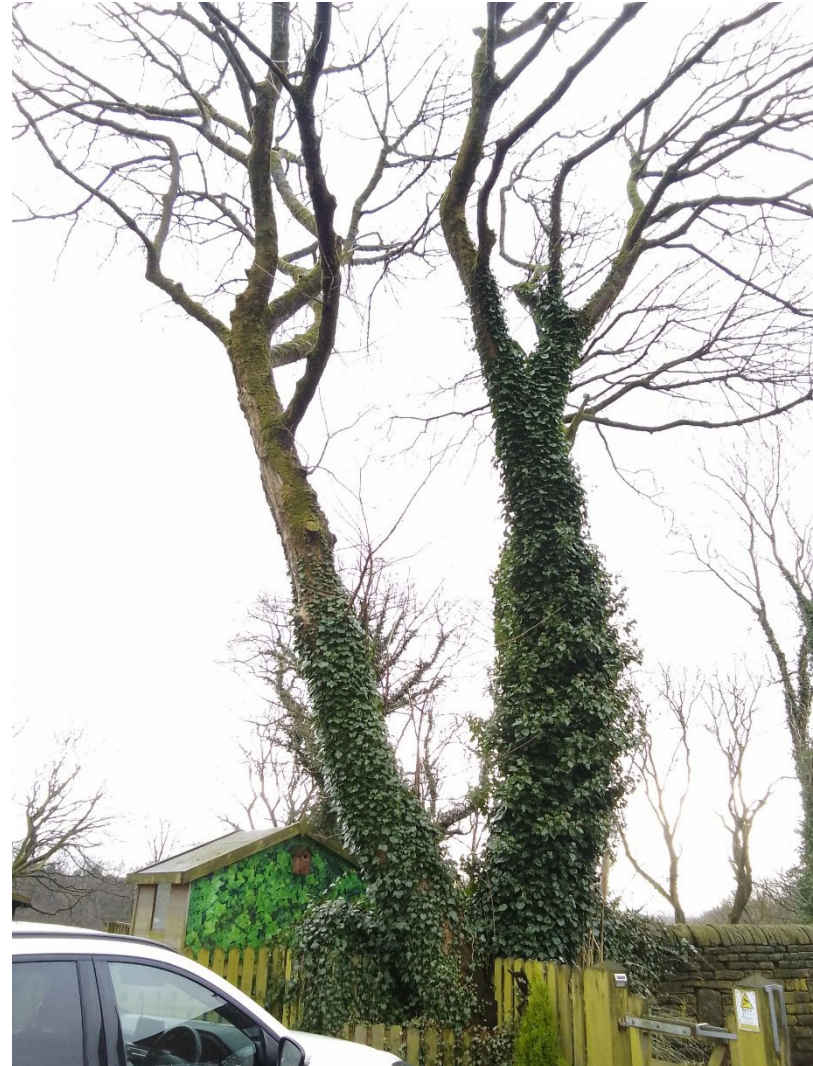
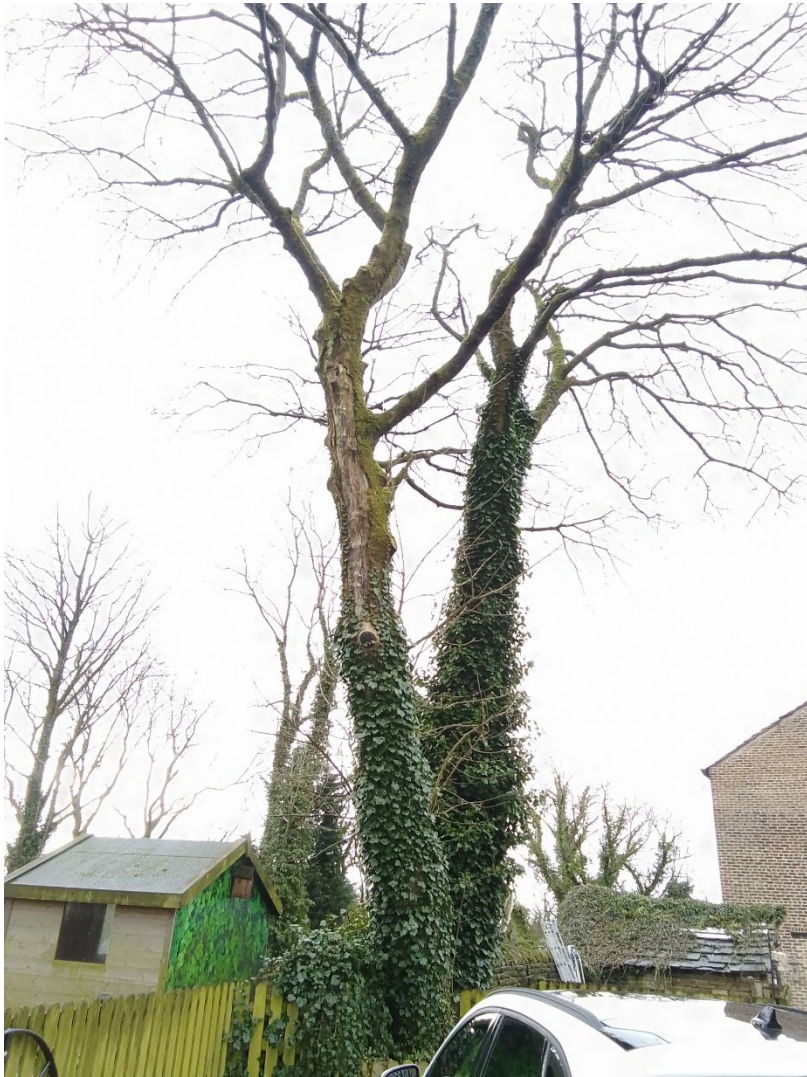
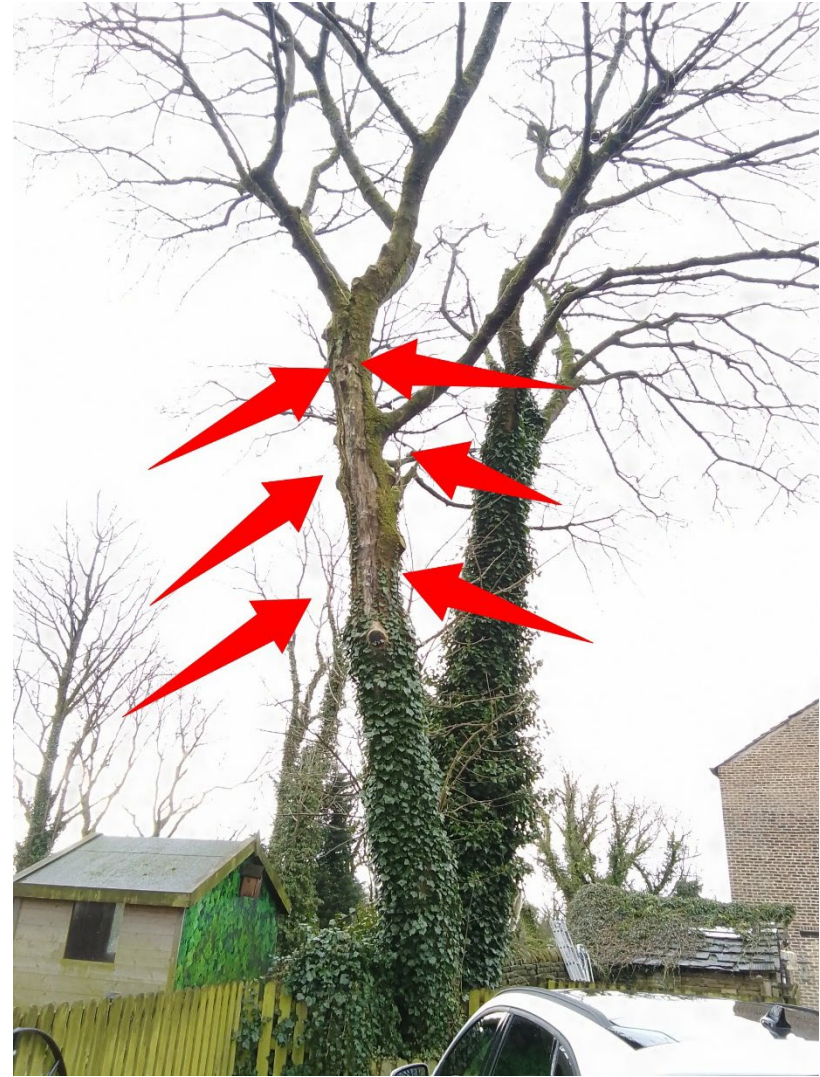
| T003 | Sycamore<br>( <i>Acer pseudoplatanus</i> ) | <p>Target # - car park.</p> <p>Target # - dwelling.</p> <p>Target # - overhead wires.</p> <p>Target # - road.</p> <p>Target # - street lights.</p> <p>- Occupancy - Constant(4).</p> | <p>Height (m): 15</p> <p>Life Stage: Mature</p> | <p>The tree is co dominant within a metre of the root plate.</p> <p>The soil level is forty centimetres higher on the North east side.</p> <p>Ivy is growing up the trunk of the tree.</p> <p>The stem on the North side has a significant amount of bark missing from the trunk of the tree. The wood underneath is discoloured. Much of the wood is black and beginning to rot. On the highest point where the bark is missing the bark is continuing to flake and fall off the tree. The wound is beginning to occlude but too late in this case.</p> <p>Although only one side is clearly affected the tree ought to be</p> | Poor | Moderate | 1 Year | <p>Tree risk mitigation: remove both sides of the tree.</p> <p>Timescale: 26-Aug-2025 (6 Months)</p> | |

| | | | <p>treated as a whole.<br/>Leaving the other half of the tree would leave the crown of the tree artificially asymmetrical as and potentially destabilise the root plate of the tree.</p> | | | | |
